Damage assessment of various structures by hurricane Andrew using aerial photographs

Sondwip Dhar

Florida International University

A thesis submitted in partial fulfillment of the

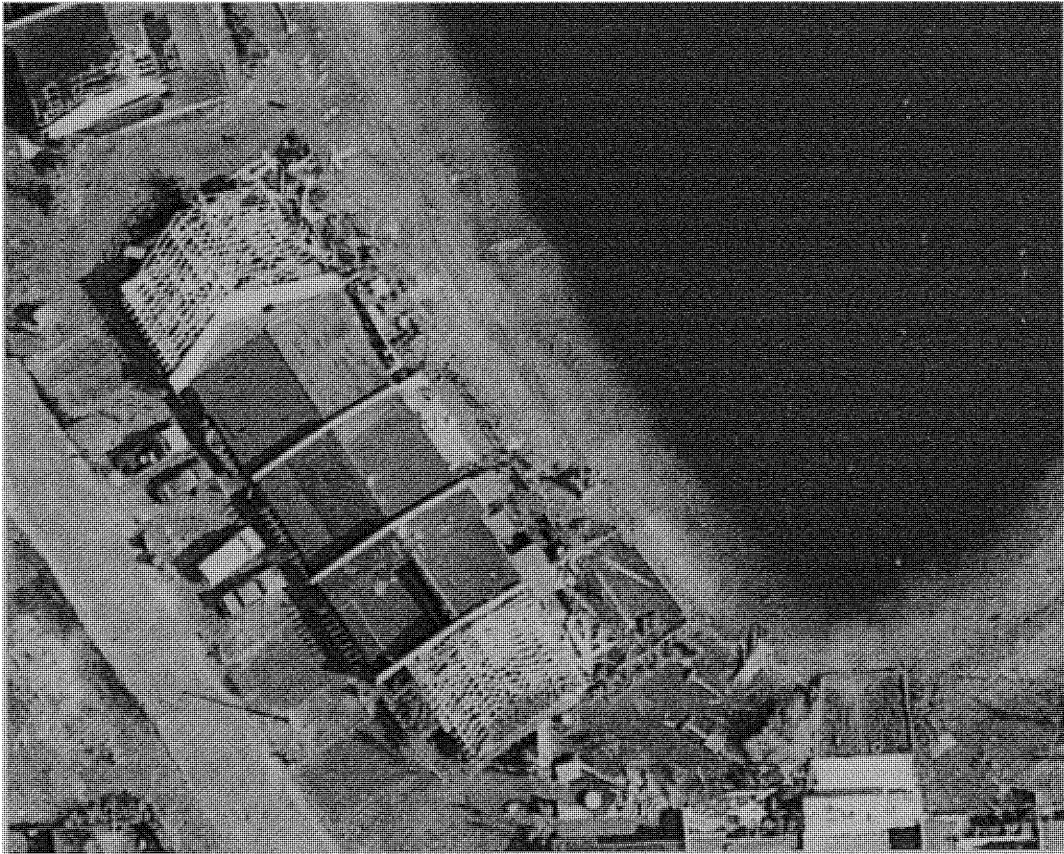
Town House is generally series of single-family houses without individual boundaries. As seen in the following figures it can be noted that the corner houses are prone to damages. The damage depends on the location of the residential units, their orientation, adjacent units etc. Roof cover and sheathing failures are observed to be maximum. It might be due to window breakage or door failure on the windward side of the buildings caused most of the roof failures. Wind-borne projectiles are the major factor in home damage and destruction during the hurricane. Penetration of the building envelope by wind-borne debris was directly responsible for many catastrophic failures of the roof systems, because such penetration allowed the uncontrolled buildup of internal air pressure. The pool of potential projectiles that can be picked up by hurricane-force winds and turned into wind-borne debris include roofing materials such as shingles, tiles and gravel; inadequately attached cladding components such as sheathing and siding; and rocks and tree limbs.

Figure 7.1.5.1. Displacement of trusses.

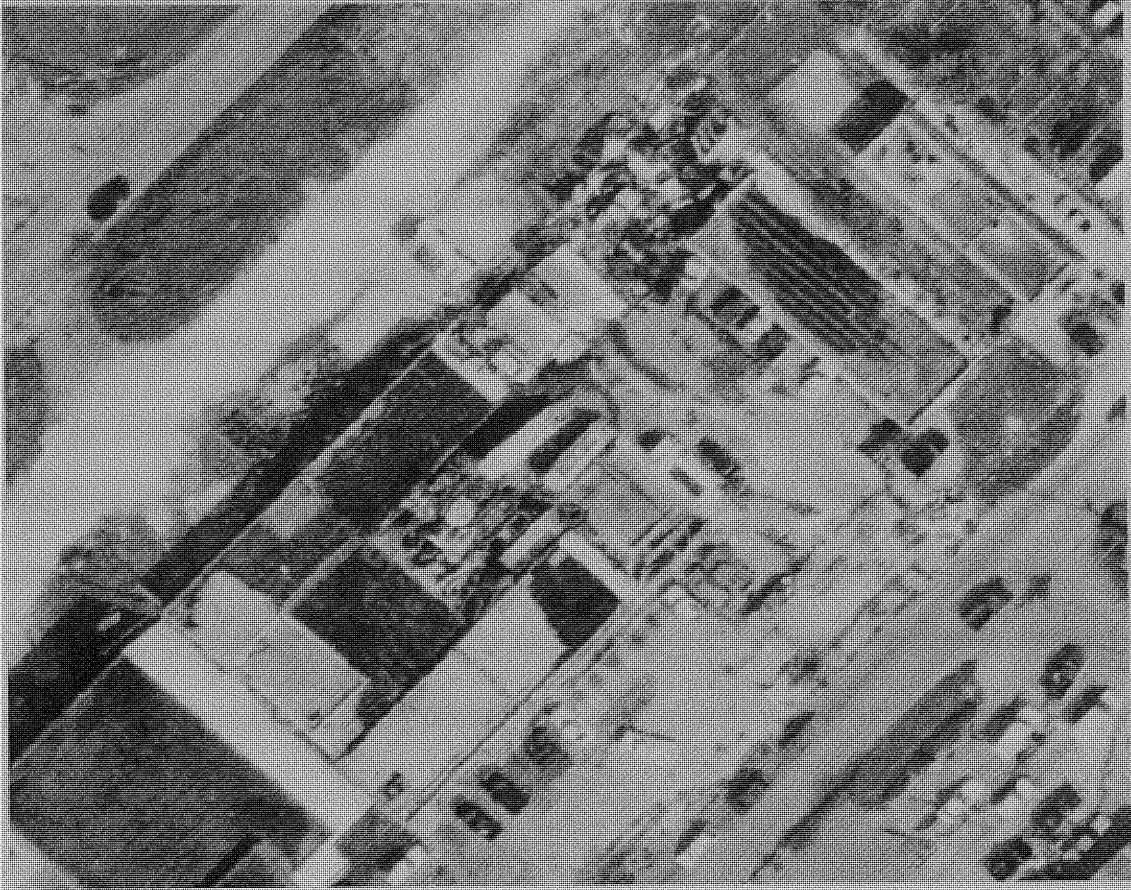
Shopping Centers are huge structures with concrete roof or steel roof truss. When the span increases for concrete roof proper reinforcement and high grade concrete should be used as per building codes to sustain wind impacts during a hurricane. In case of truss system large sheets of roof covers should be securely fastened to the rafters. Often, rafters were attached by toenails to the top plate and in other cases hurricane clips attached to the rafters to only the top plate rather than to the wall studs.

Figure 7.2.2.1. Concrete roof damage.

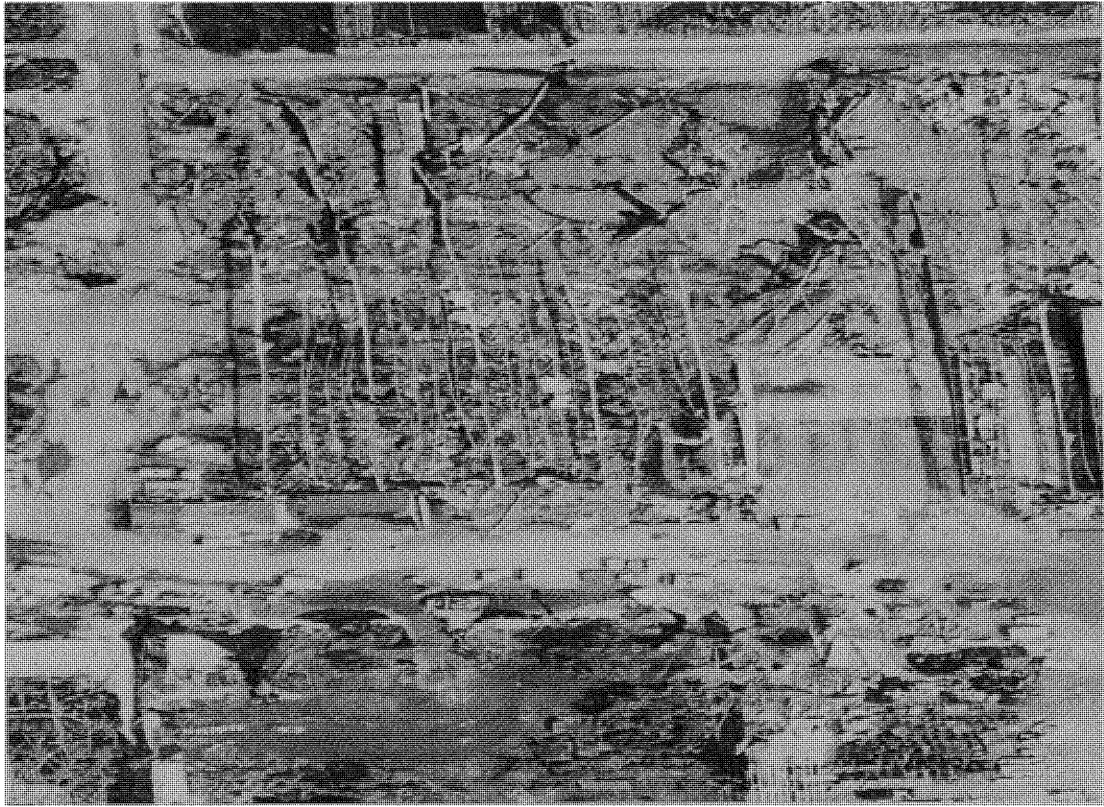
Industrial buildings may consist of steel truss, wood-frame truss or concrete roof depending upon the type of industry and its usage. In one of the case it has been observed that the roof covering, which are in the form of long sheets, have been badly bend and twisted resulting 100% damage. Roof coverings, which were not adequately attached, and the corner and eaves regions of the roof were frequently damaged. Roof failures occurred because of lack of proper connection between the roof and the exterior walls. With roof gone, walls lost the support provided by roof system and were subjected to collapse even when exposed to lesser winds. The structural failures of steel and wooden trusses may be due to design shortcomings such as inadequate fastening of AC sheets and insufficient anchoring. Wind-borne projectiles were also the major factors for many catastrophic failures of the roof systems.

Figure 7.4.1. Installation and design shortcomings.

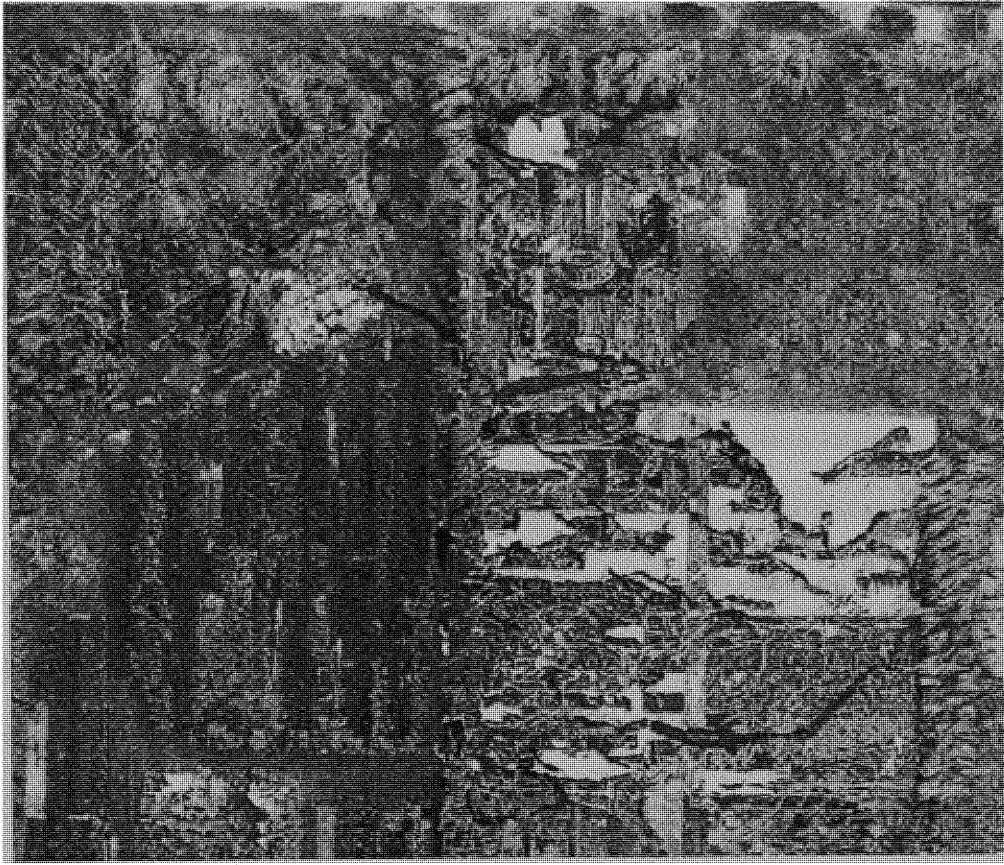
During an hurricane or cyclone only concrete roofs have better resistance to damages. Even though concrete performed better than tiled roof in some cases it did not withstand the impact of wind. Concrete slabs were damaged with large cracks. Due to damage to the concrete slab the steels were exposed. A possibility of concrete slab failure was because high strength concrete was not used during the construction. Damage was usually associated with insufficient reinforcement for continuous load paths from the upper tie beam, through the wall to the foundation. The intersection in the slabs provides continuity of the tie beam reinforcement. When this deficiency exists in combination with failure of the tie beam to roof connection, the wall collapsed. Sometimes composite constructions such as concrete and timber construction are done depending upon the usage and importance.

Figure 7.5.1. Insufficient reinforcement.

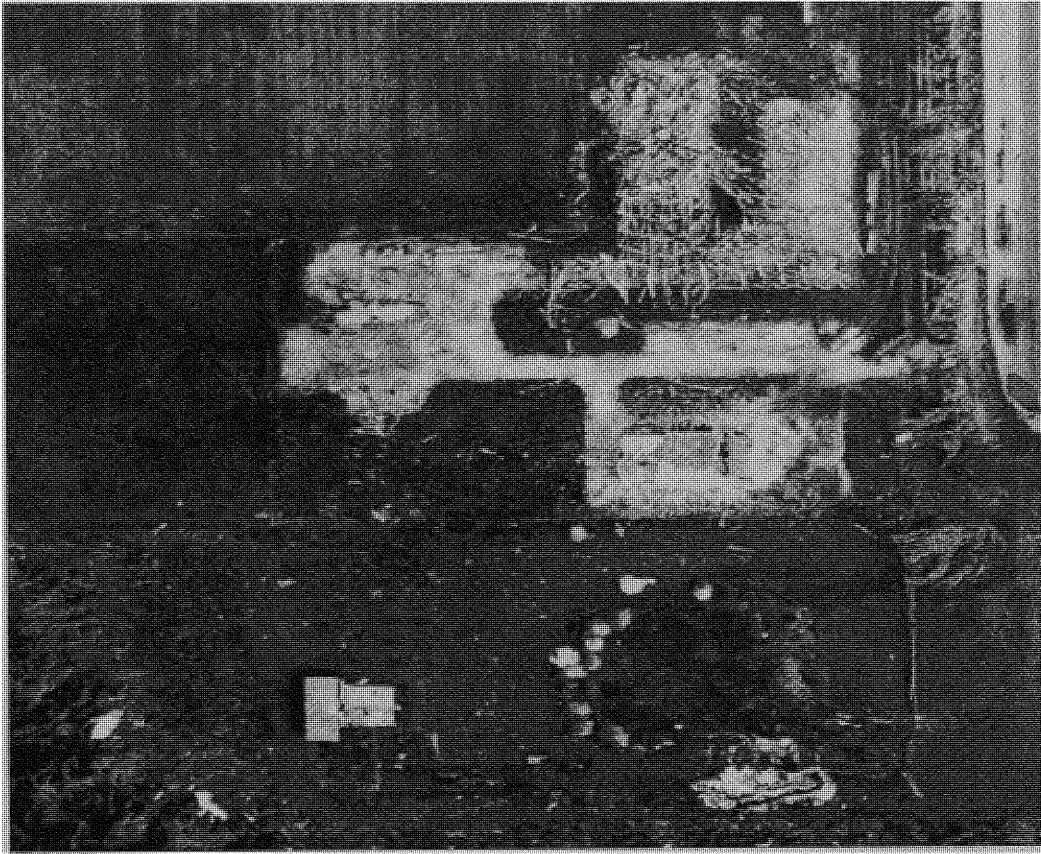
Farm Structures include small or large houses in an isolated area. These houses lack any kind of barrier such as trees or other houses. These houses have inefficiently designed roof trusses and foundations and hurricane accompanied with rain may completely damage the roof framing system. As rain quickly saturate the insulation and the ceiling and the loss of ceiling strength will occur due to increased weight of the wet insulation. The wind stream generates uplift as it divides and flows around the structure. Once the building envelope is breached may be due to small openings such as ventilation windows or doors, pressurization or depressurization of the building takes place. Pressurization pushes wall panels and sheathing out, while depressurization can pull ceiling down. Internal pressure coupled with external suction adds to the withdrawal force on sheathing fasteners. When the openings are on the leeward side of the building, the result is a pressure drop in the interior, which can pull ceiling material away from the framing. Also in some cases it is observed that the roof has been destroyed due to fallen trees.

Figure 7.7.1. Lack of adequate bracing support.

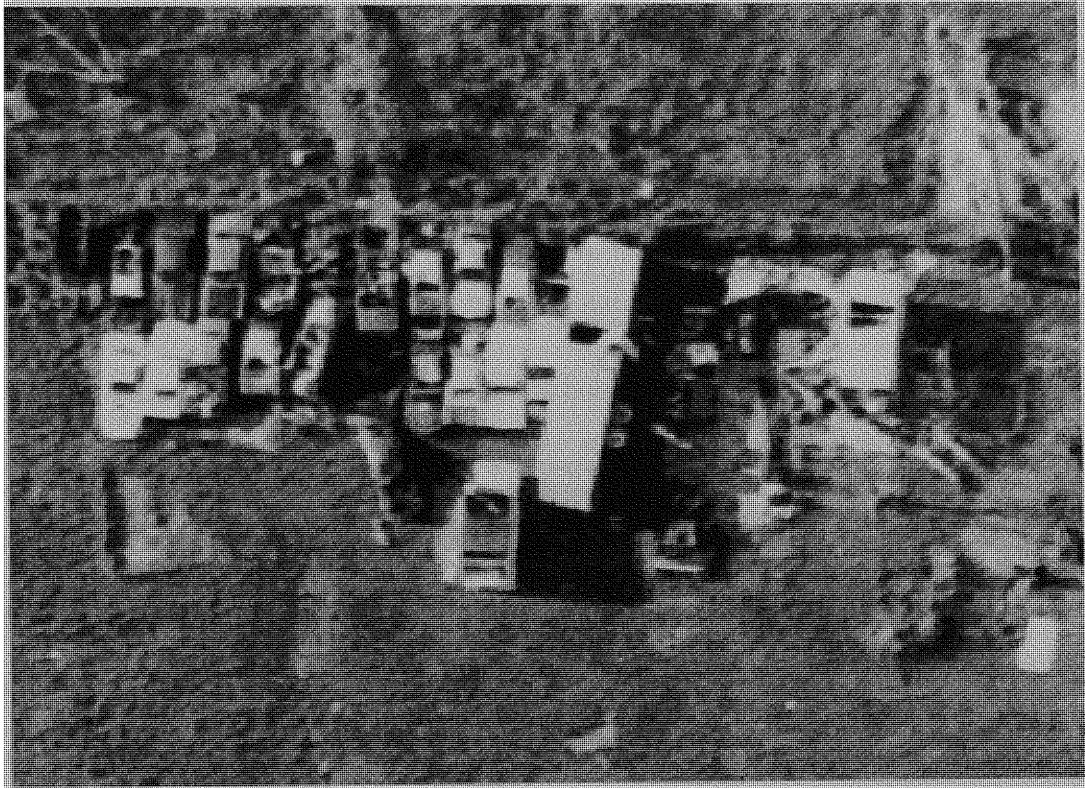
Transportation Vehicles includes small family vehicles, trucks, trailers, buses, airplane, etc. The examples in the following figures such as grounding of airplanes can be concluded that any dynamic object present during the hurricane may not withstand the impact and can lead to accidents. The wind pressure was high enough to push the airplane down. Dynamic objects fall on property it can create massive destruction. Even heavy weight trailers are dislocated due to the wind force.

Figure 7.8.1. Displacing of heavy weight vehicles.

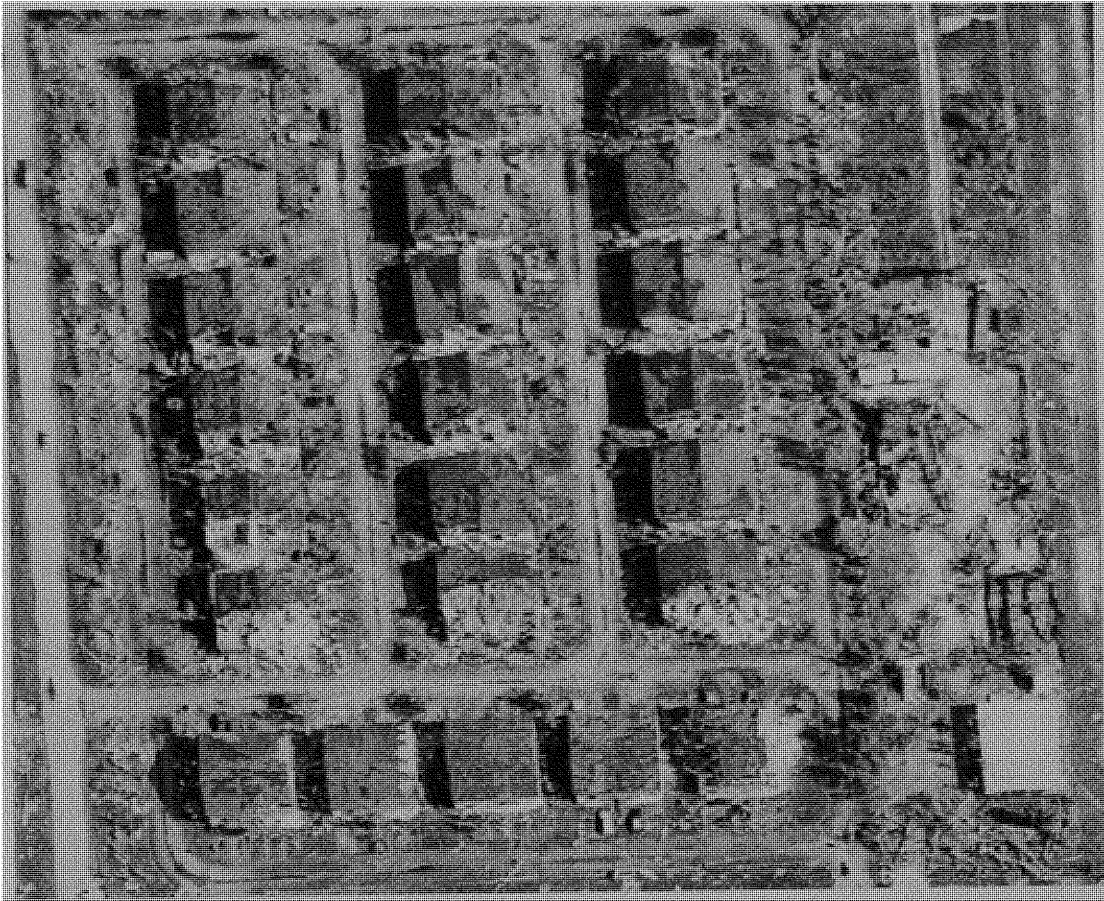
In this picture major damage was the roof cover damage. The velocity of the wind was adequately strong enough to blow off the roof covers of various houses, which means that roof cover material was not securely fastened together. The wind path was very clear in this picture. The wind takes a curved course from south-west to north-east direction. Wind borne debris can be seen all around the places. All the houses were structurally strong enough to resist the velocity of the wind hence major damages cannot be observed except for the roof cover damage.

Figure 1.3. Progressive roof cover damage.

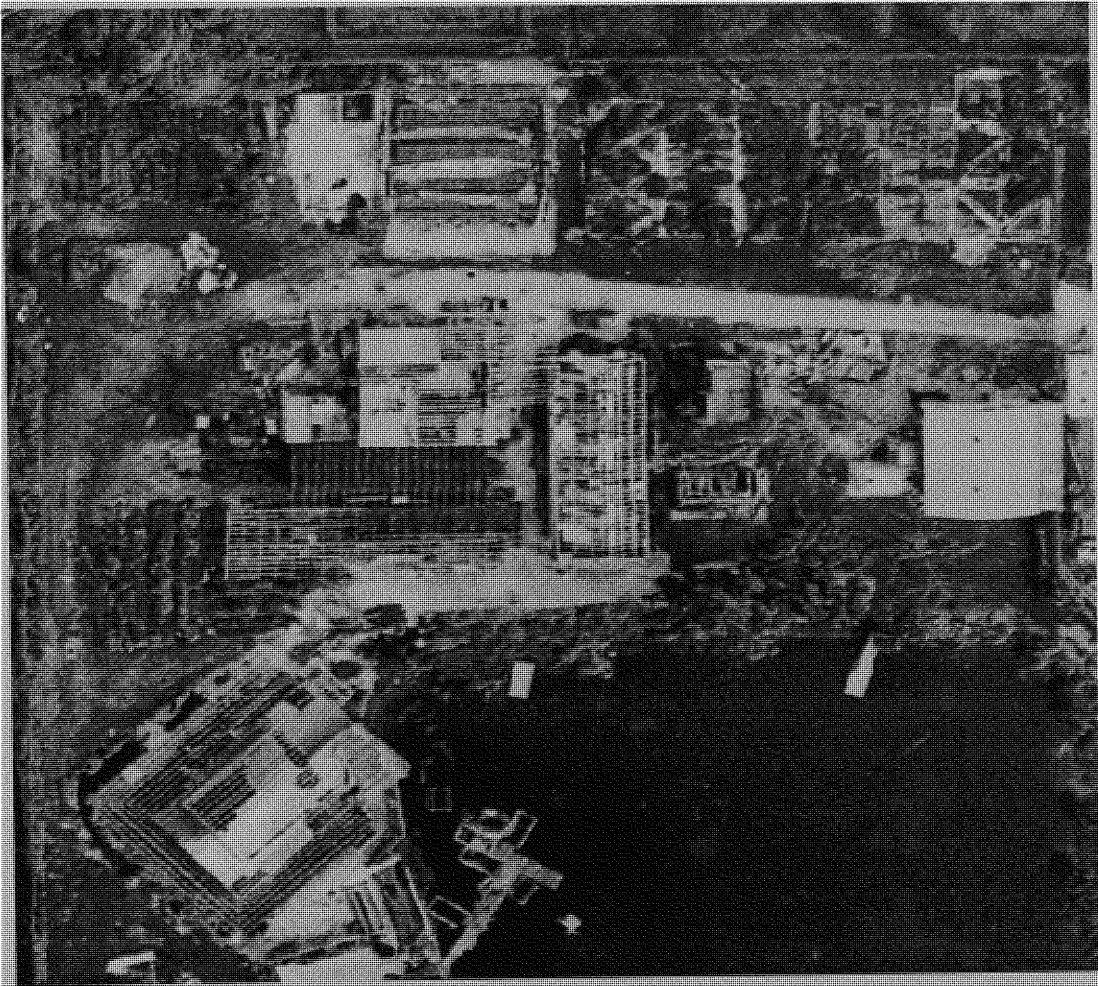
The figure shows a community of homes, which are closely spaced. They suffered major destruction. In some cases the dry wall has been completely destroyed. Most of the houses have roof cover and sheathing damage. Debris were scattered all around the individual houses. The wind direction can be predicted accurately by the extent of damage. The direction of wind was from south to north. It is seen that houses at front are damaged more than the houses at the back. The reason being that the houses in the front provided a barrier for the houses at the back.

Figure 1.4. Roof cover, sheathing and gable-end damages.

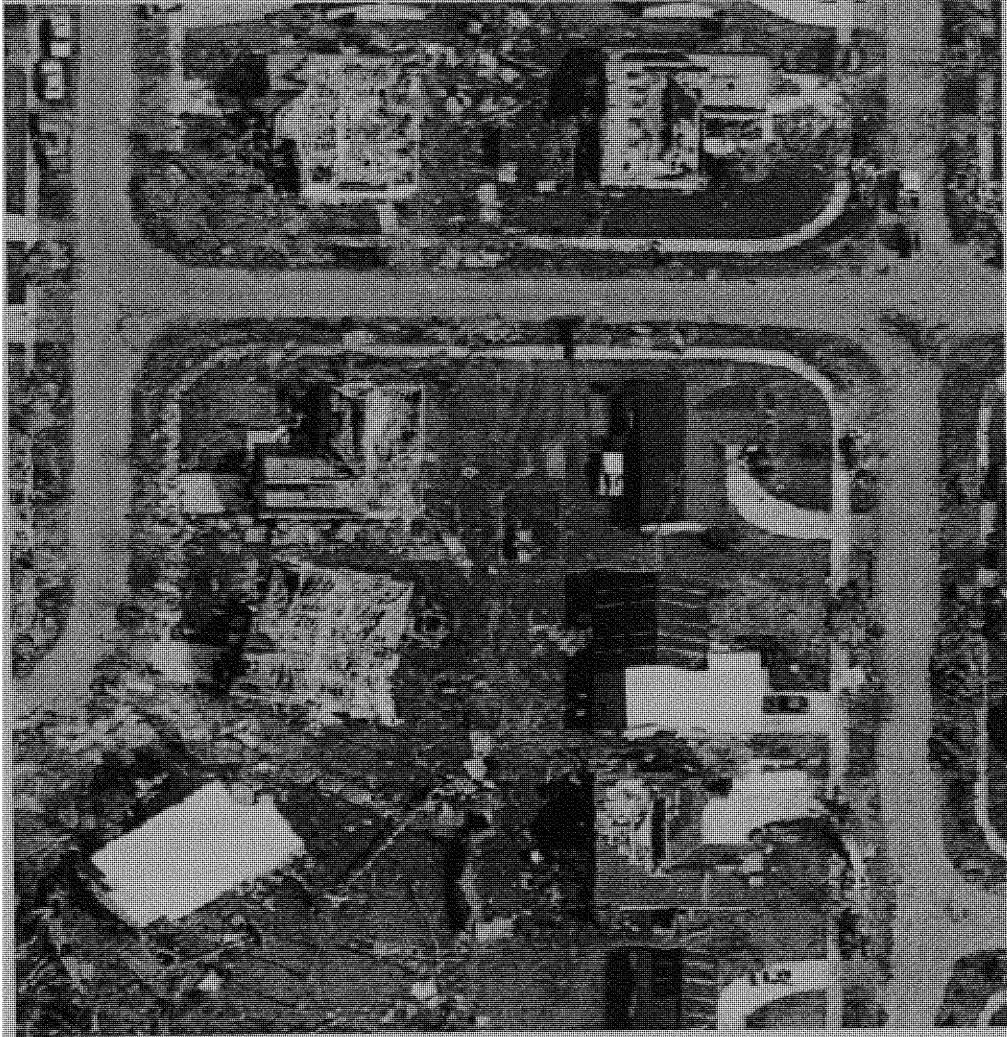
The figure shows single-family homes, located around a lake, which has been extensively damaged by strong winds. The major damage is in the roof system. In most houses there were roof cover, sheathing and gable end damages. The structural component of the truss was intact without major damages. Debris can be found around the house. The wind direction cannot be easily predicted, as there are no trees either around the houses or surrounding the lake.

Figure 1.5. Dislocation of truss members due to strong wind force.

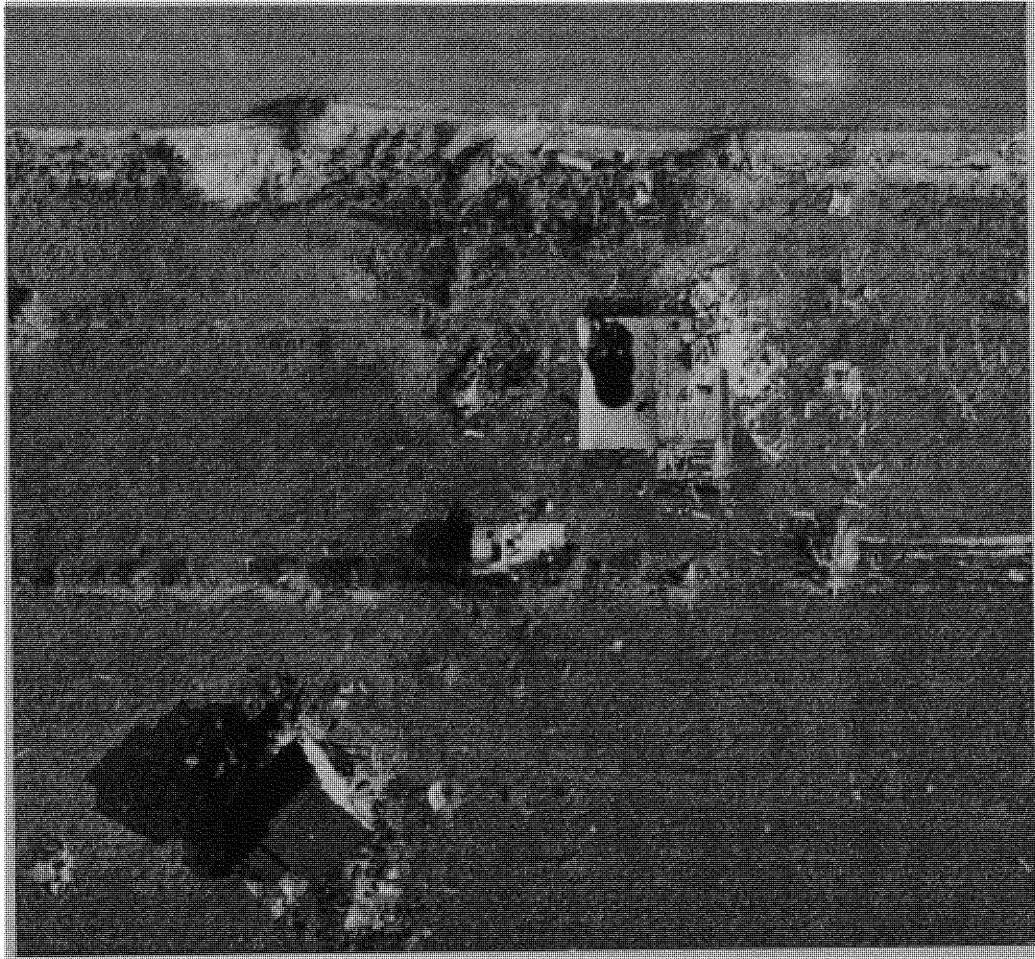
This figure shows some single-family homes. Some of them are highly damaged while others have minor damage. Minor damage includes only roof cover and sheathing while major damage includes roof truss and gable end damage. In case of the house, which has the roof truss, damage the wind might have blown perpendicular to the gable end. Those houses, which stood in the wind path, had minor damages to the roof cover and the sheathing. The wind direction was from east to west.

Figure 1.7. Comparison of damage between two isolated houses.

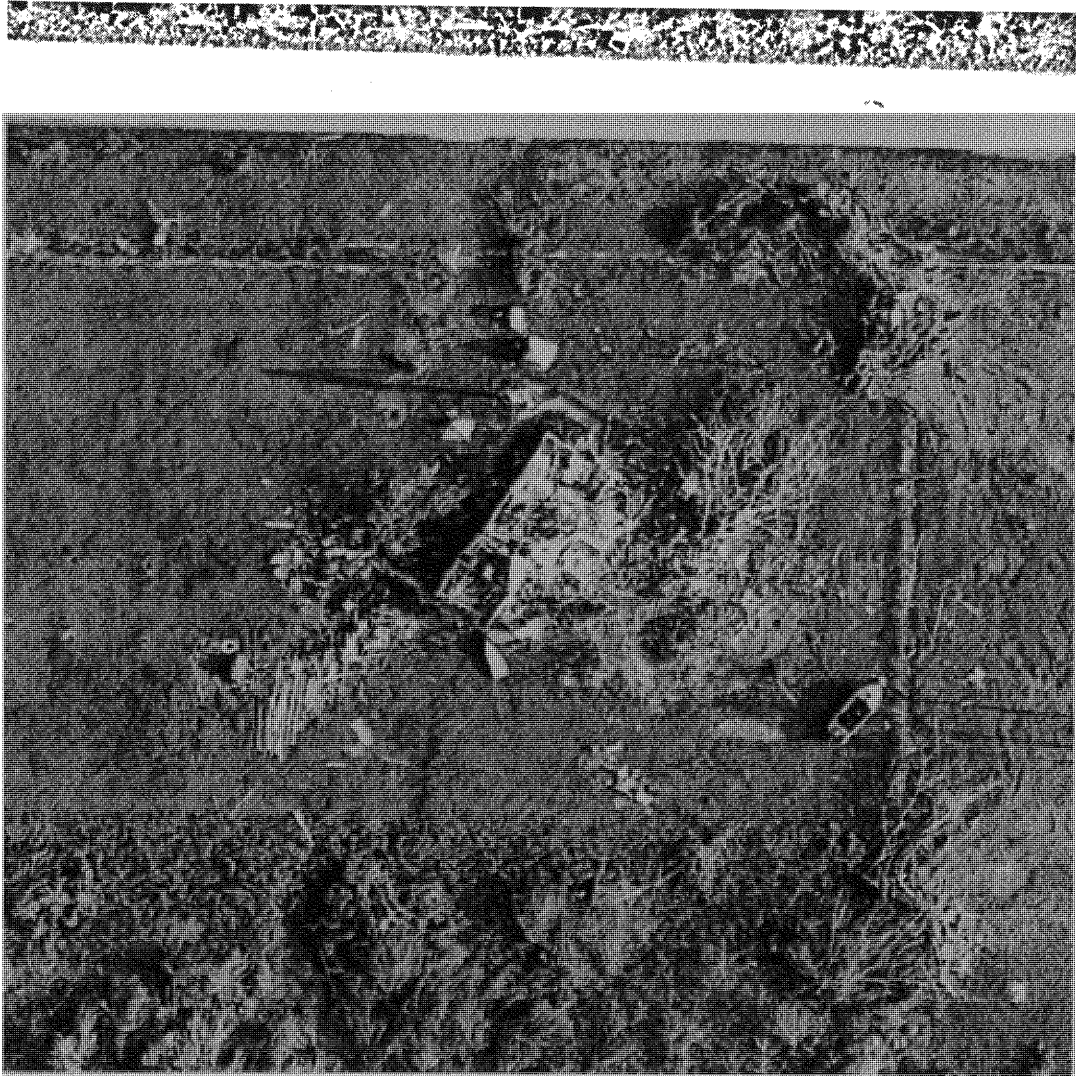
The figure shows two single-family houses. One was partly damaged and the other was badly damaged. The one that has been partly damaged has wind borne debris surrounding the house and debris might have been accumulate from the house that has been badly damaged. The house that has been severely damaged has major structural roof damage. The entire roof frame has been damaged including gable ends. The wind direction cannot be predicted from the damage and there are no major trees surrounding the houses to sustain the wind impact. Debris can be found all around the damage house.

Figure 1.8. Collapsing of the roof system.

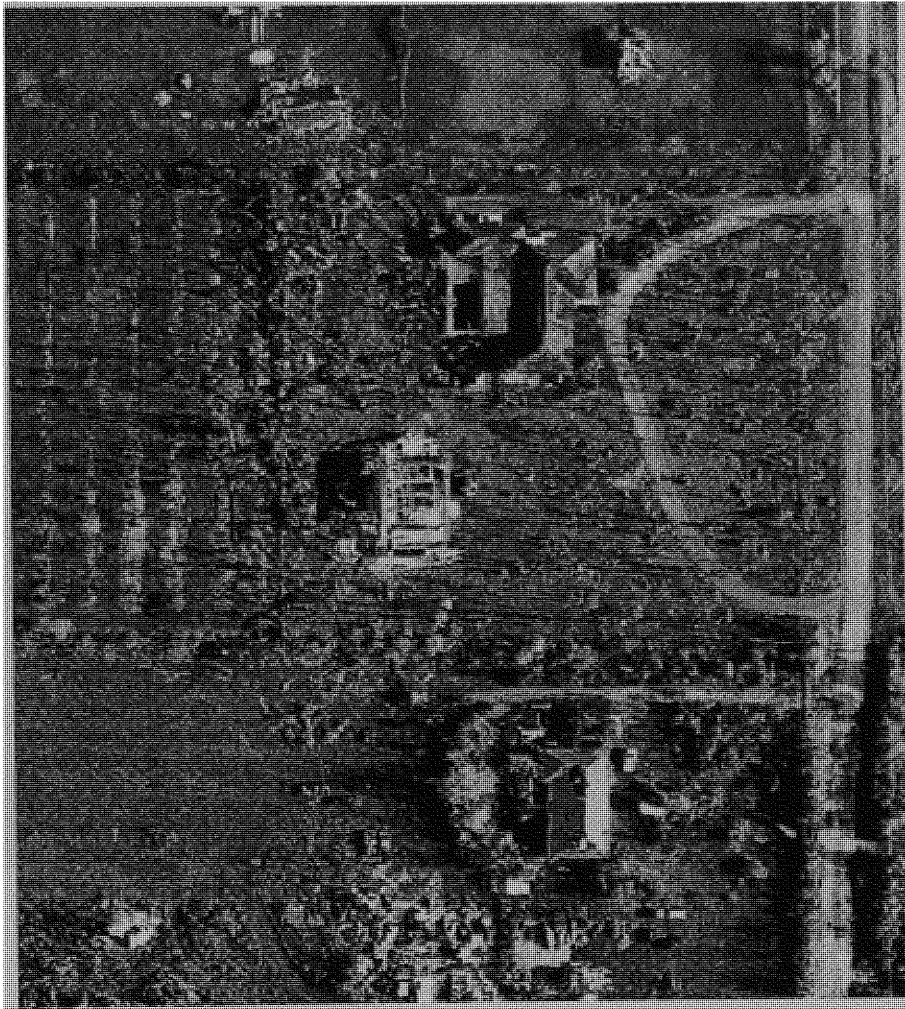
This figure shows an isolated single family home surrounded with small trees. The house has been severely damaged with the entire roof is reduced to rubble. Even the dry wall has been shattered. The foundation of the dry walls was not so adequate to resist the wind velocity. The dry walls rely heavily on the roof system to provide lateral support. When the roof structure fails, the wood-frame dry walls may lack the strength by themselves to withstand severe wind loads. Numerous trees can be found around the house.

Figure 1.9. Roof lacked bracing support and ridge blocking.

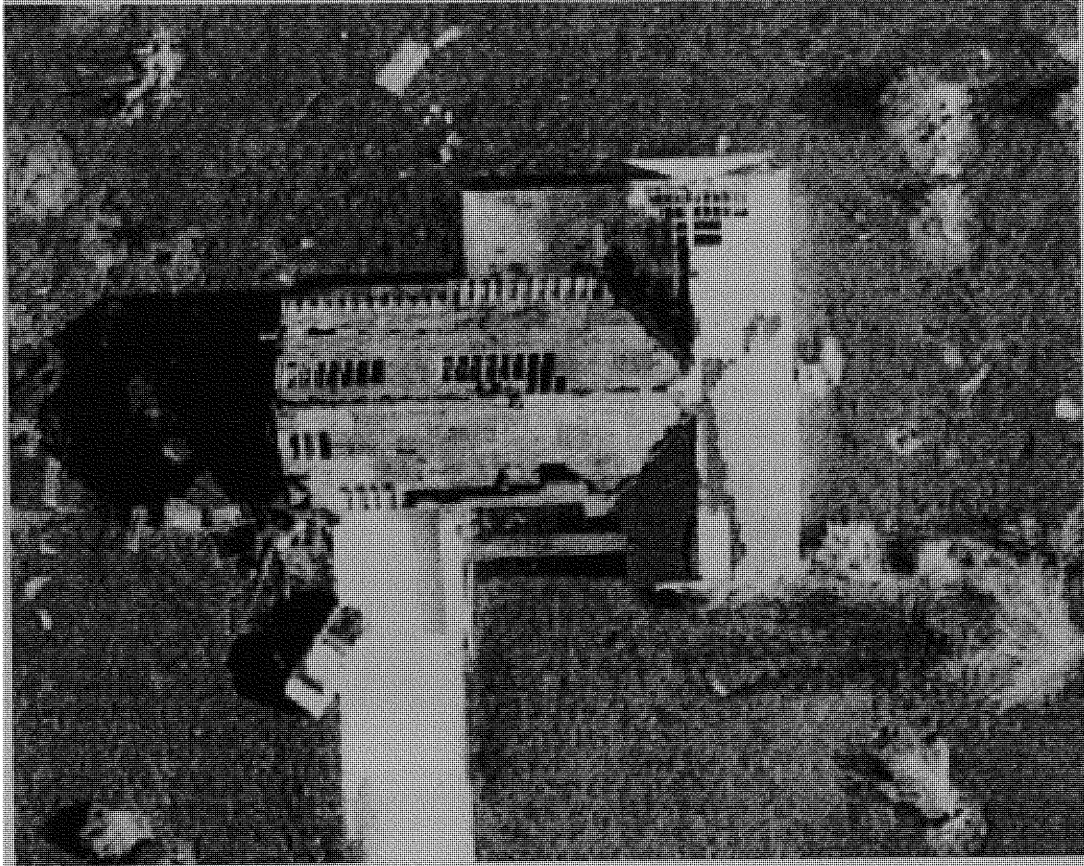
This figure shows few scattered single-family homes. Some of the houses were badly damaged while others had minor damages. Major damage could be observed in the house having a roof with a gable end than the hip roof. In case of the gable end it got separated and there was inadequate connection between the wood roof framing. Also due to lack of bracing support and ridge blocking there was an inward collapse. Debris can be found surrounding these damaged houses. There were few small trees surrounding the houses, which could not provide enough protection to these houses.

Figure 1.10. Blown roof cover and sheathing.

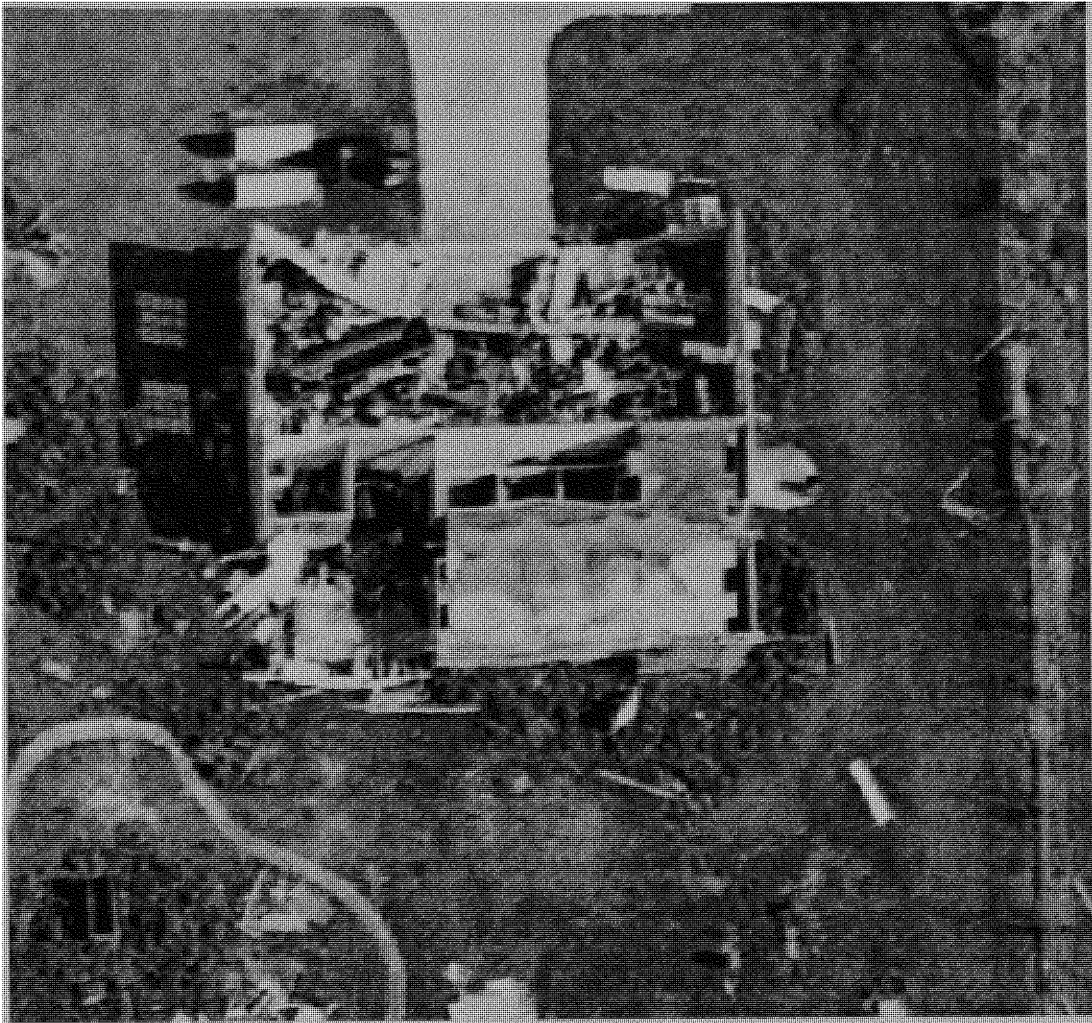
The above figure shows three single-family homes of which the middle house has been badly destroyed. The wind blew from east to west and striking the middle house damaging the entire roof frame. The over all roof damage is 100%. Consequently debris from this middle house flew and fell on the building on the left hand side and damaging the roof and the dry wall of the building. Any extension of the roof beyond the wall surface elevates wind pressure on both the sheathing and framing systems at these locations.

Figure 1.17. Weak foundation for exterior walls.

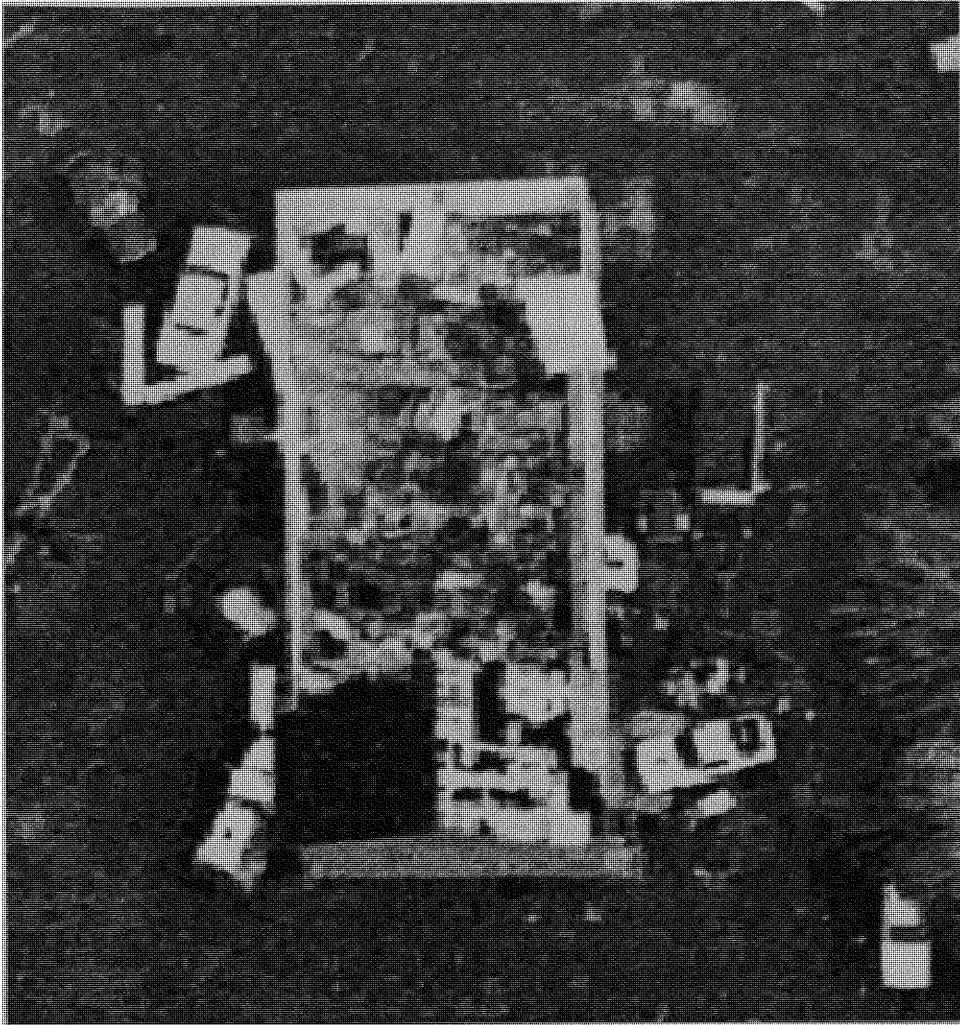
Figure 1.21. Damaged isolated house due to pressurization and depressurization.

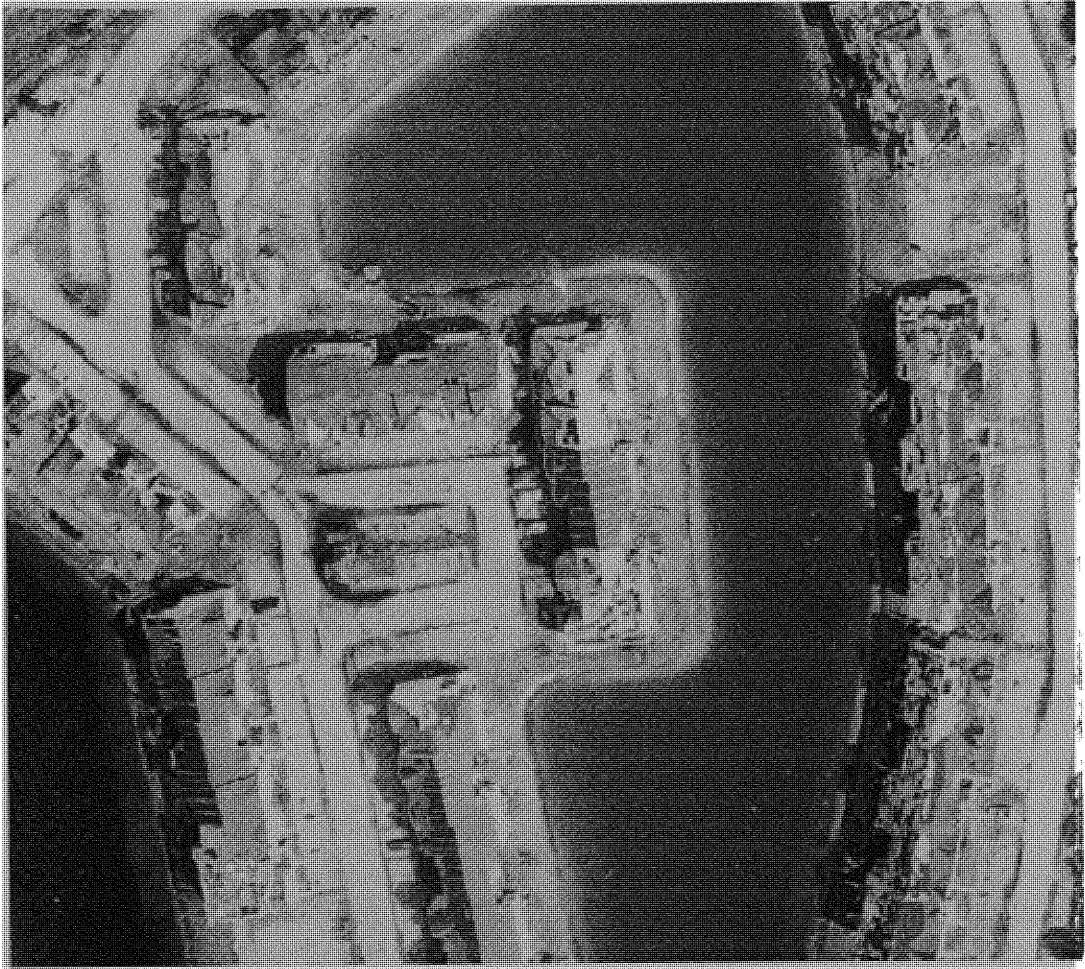
Figure 2.1. Clear wind path due to artificial lake.

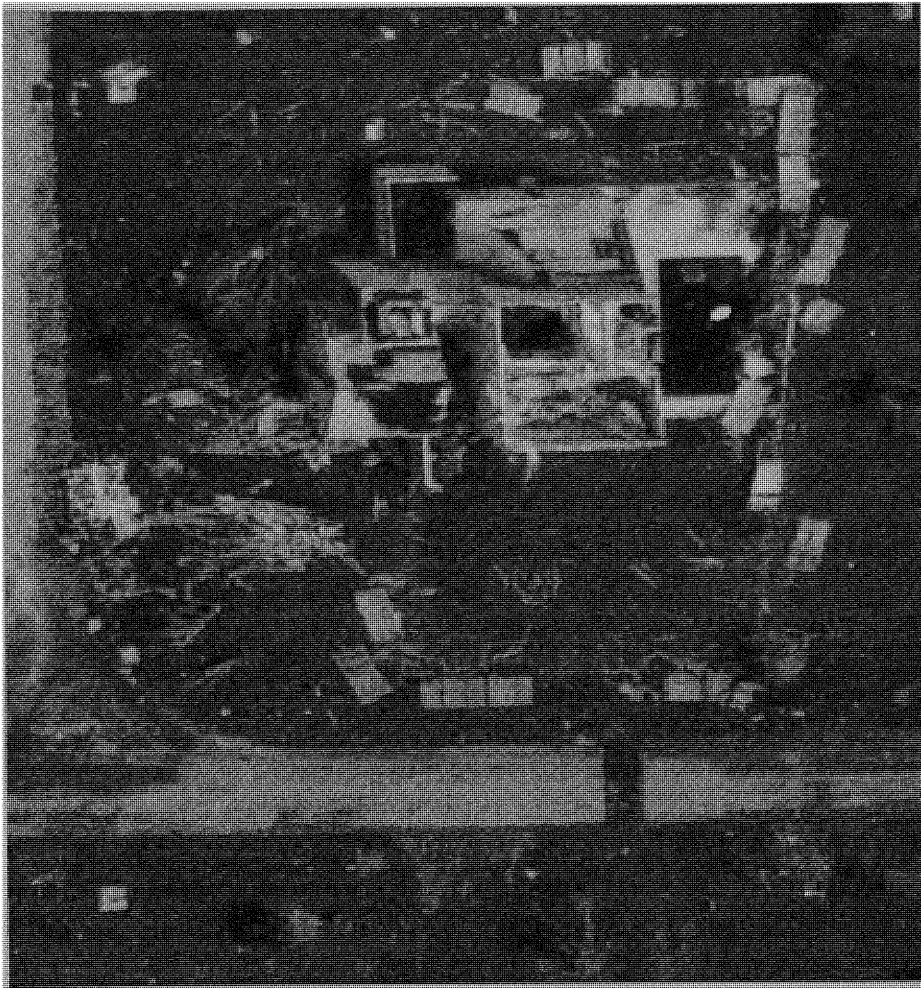
Figure 2.2. Collapse of roof truss.

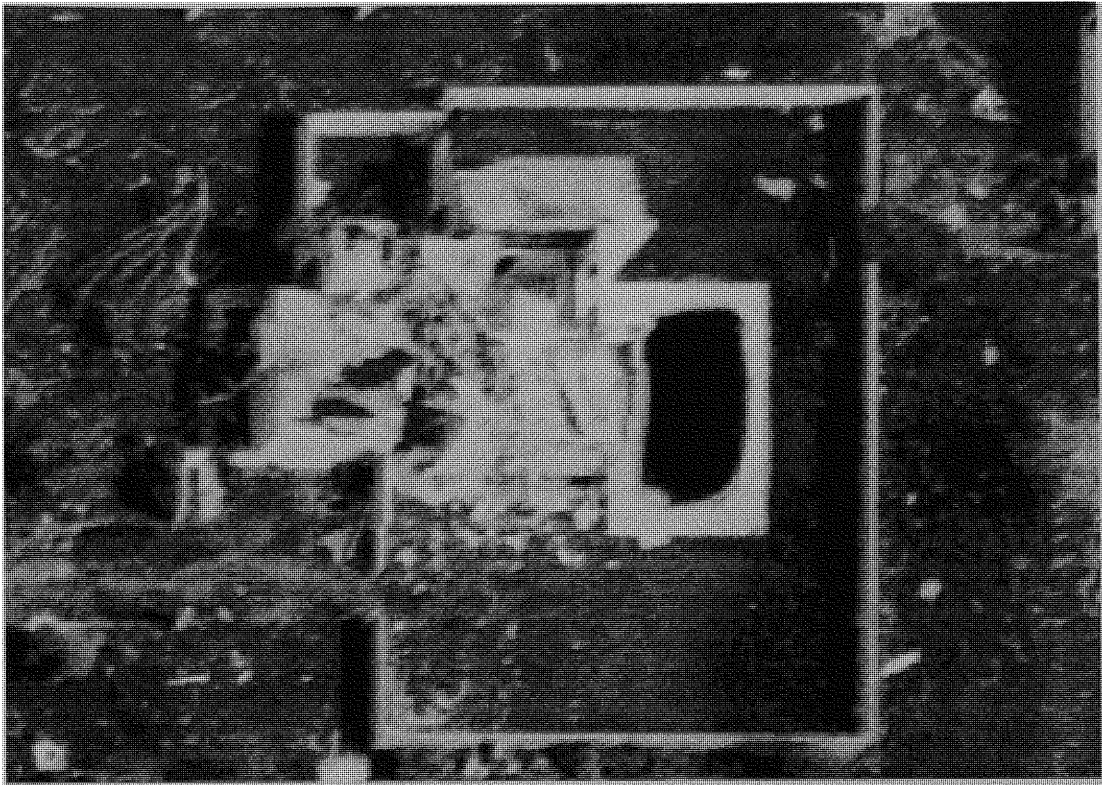
Figure 2.3. Isolated house with no barriers.

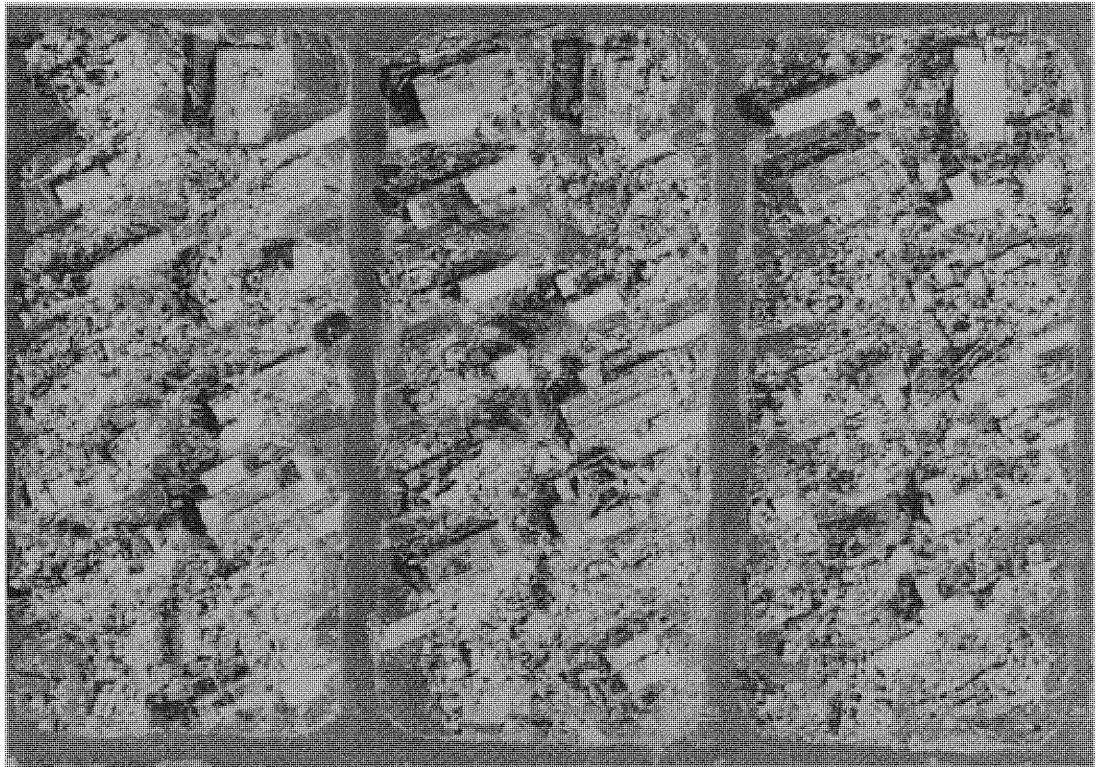
Figure 3.3. Tattered roof structure and faulty shear wall construction.

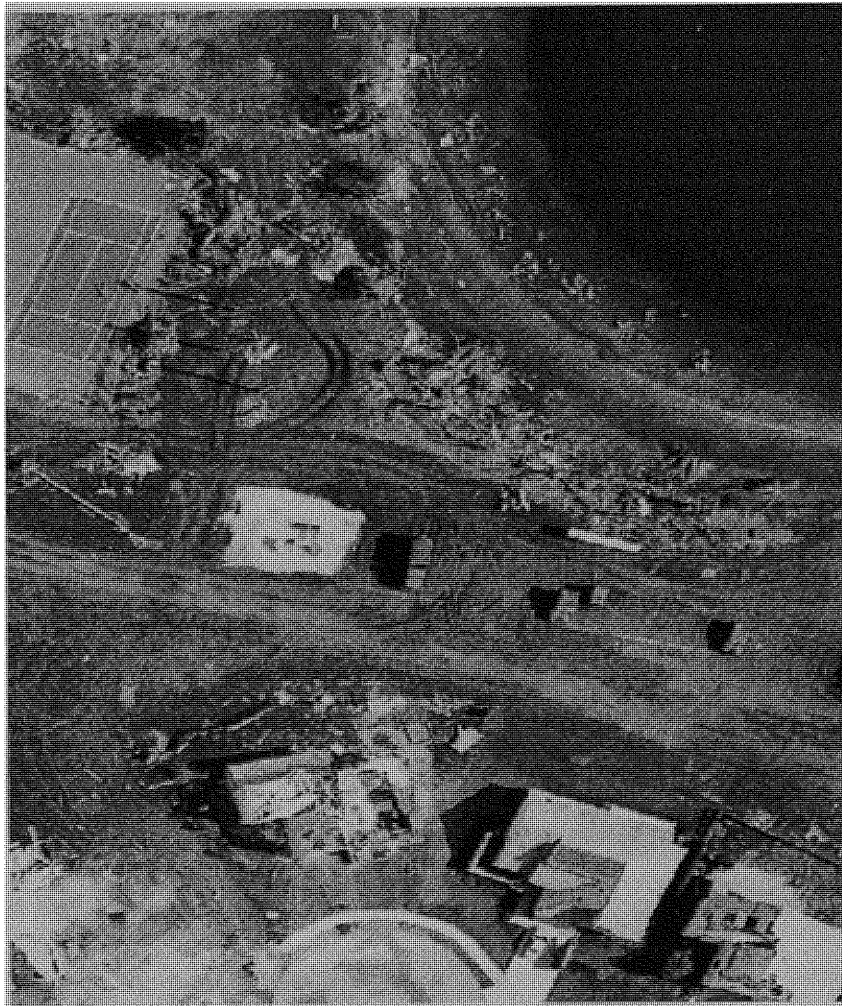
Figure 4.1. Corner plot damage.

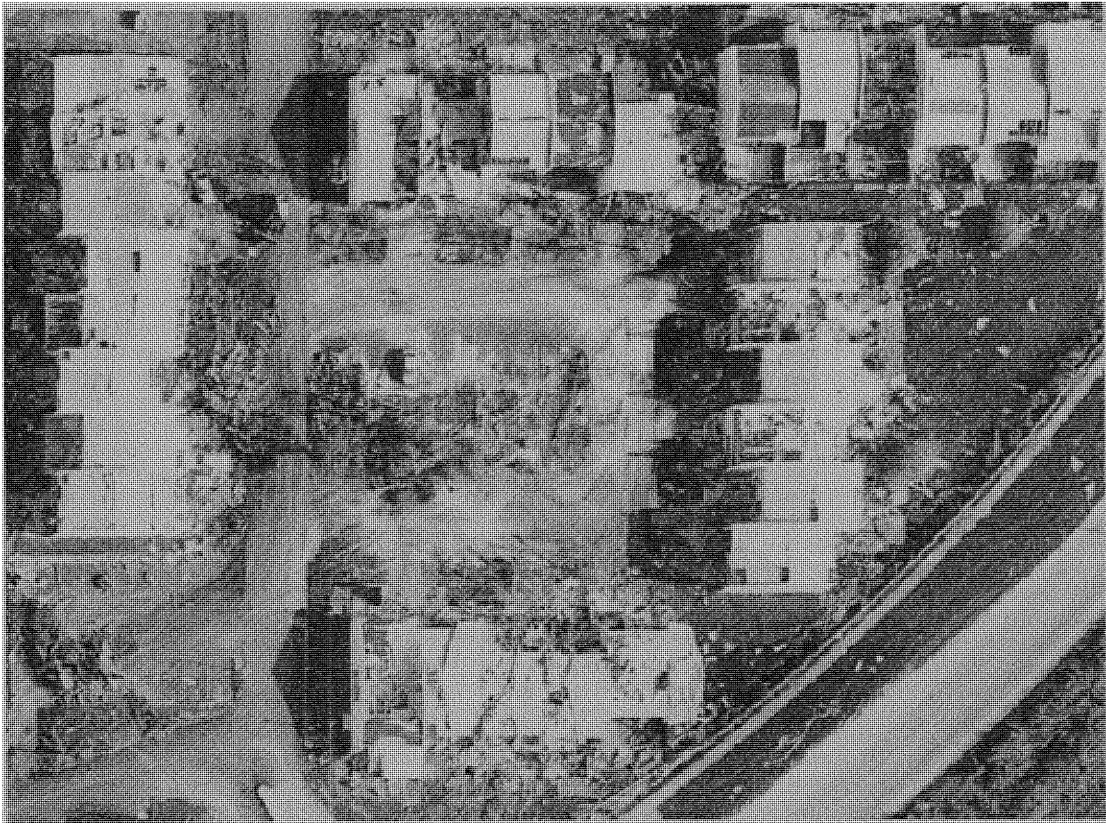
Figure 5.1. Improper connection between the roof and the exterior walls.
