Damage assessment of various structures by hurricane Andrew using aerial photographs

Sondwip Dhar

Florida International University

A thesis submitted in partial fulfillment of the

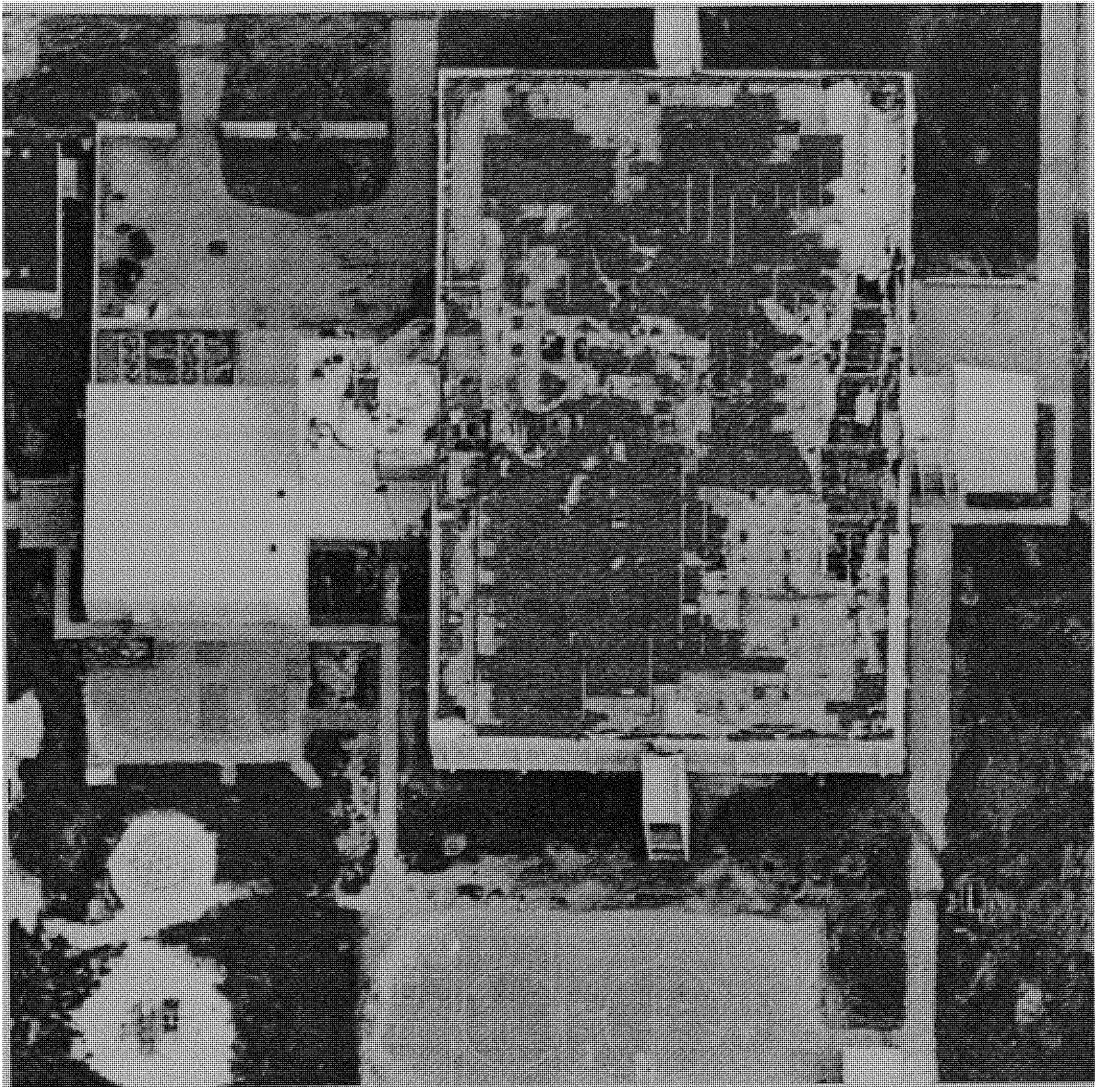
Figure 6.1. Minor damage to concrete roof.

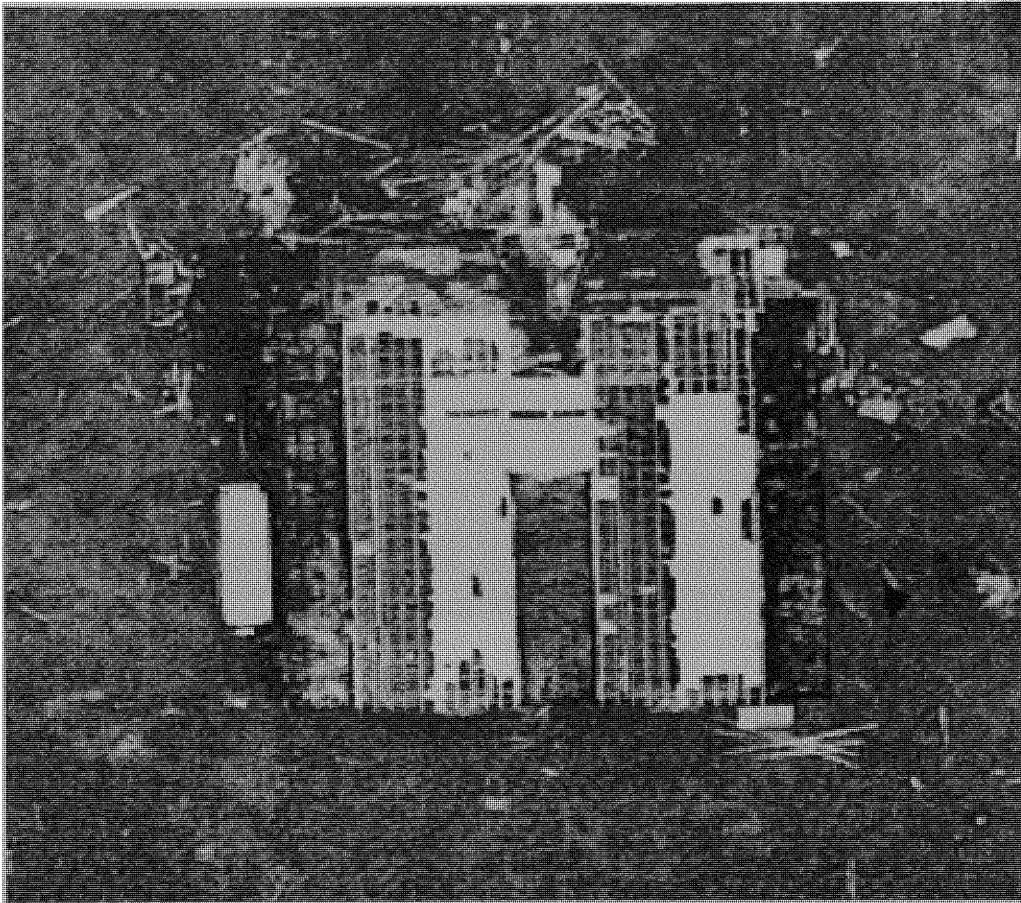
Figure 8.1. Roof cover damage.

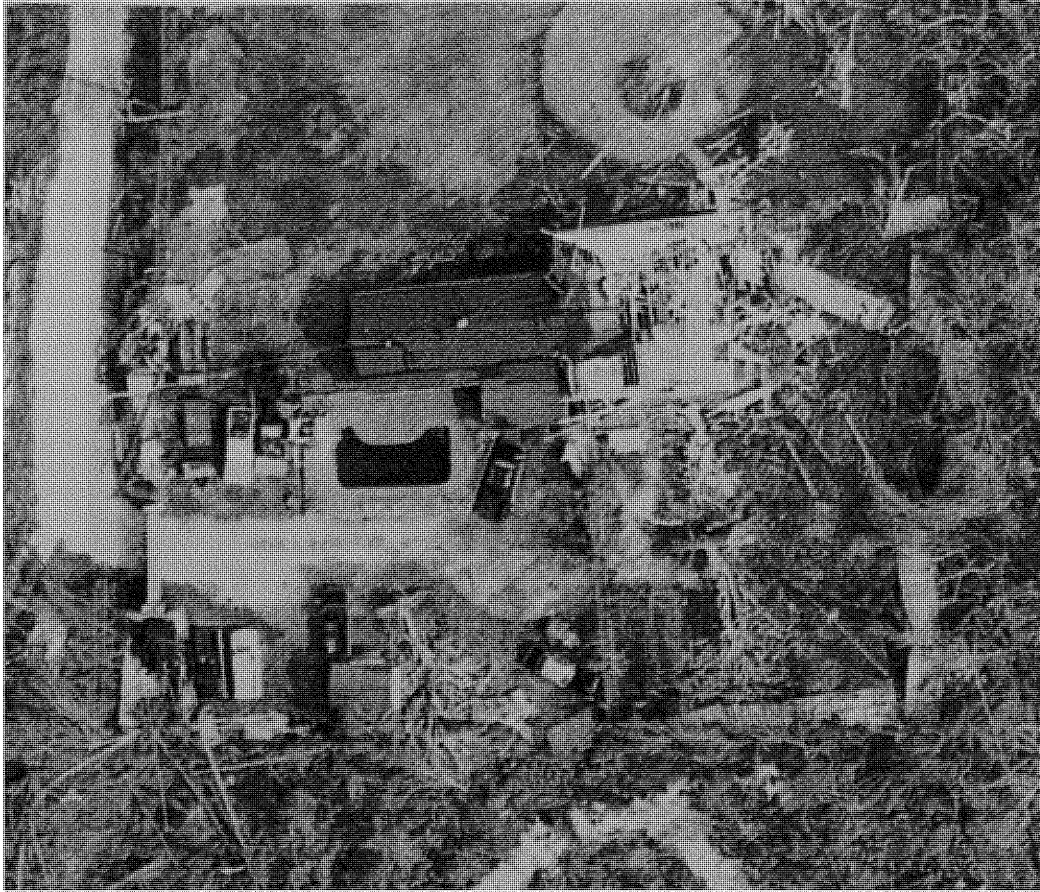
Figure 8.4. Upliftment due to strong wind force.

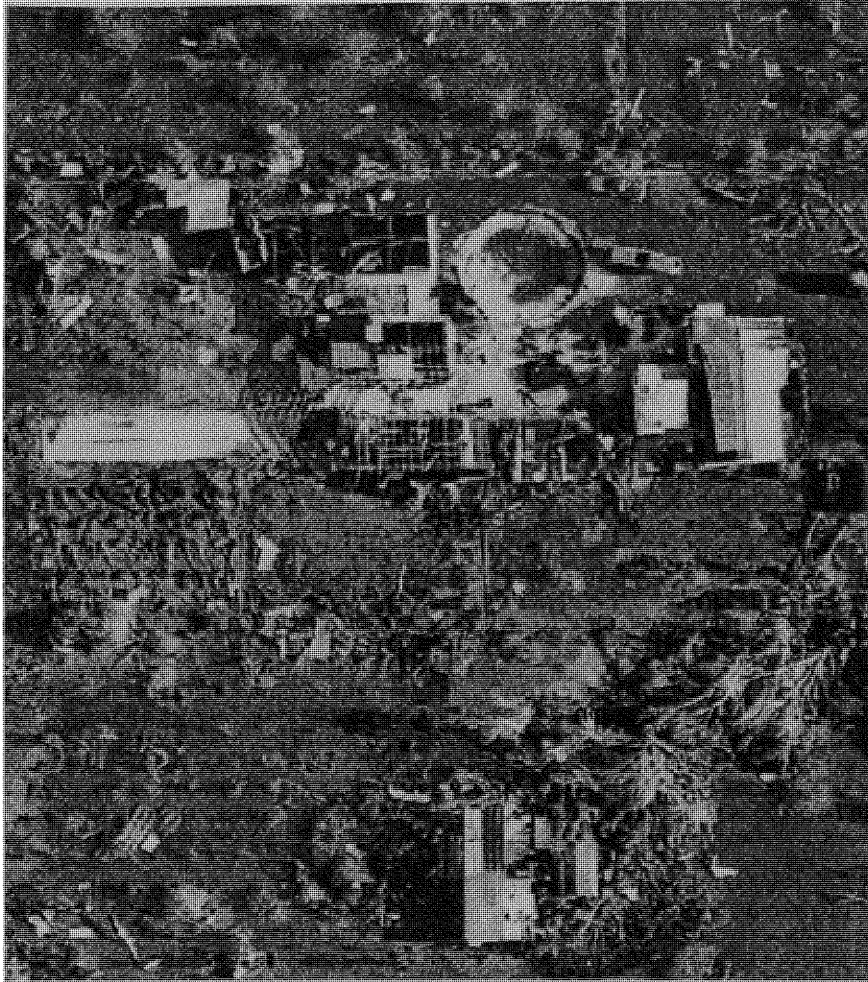
Figure 8.5. Sheathing blown, exposing the truss.

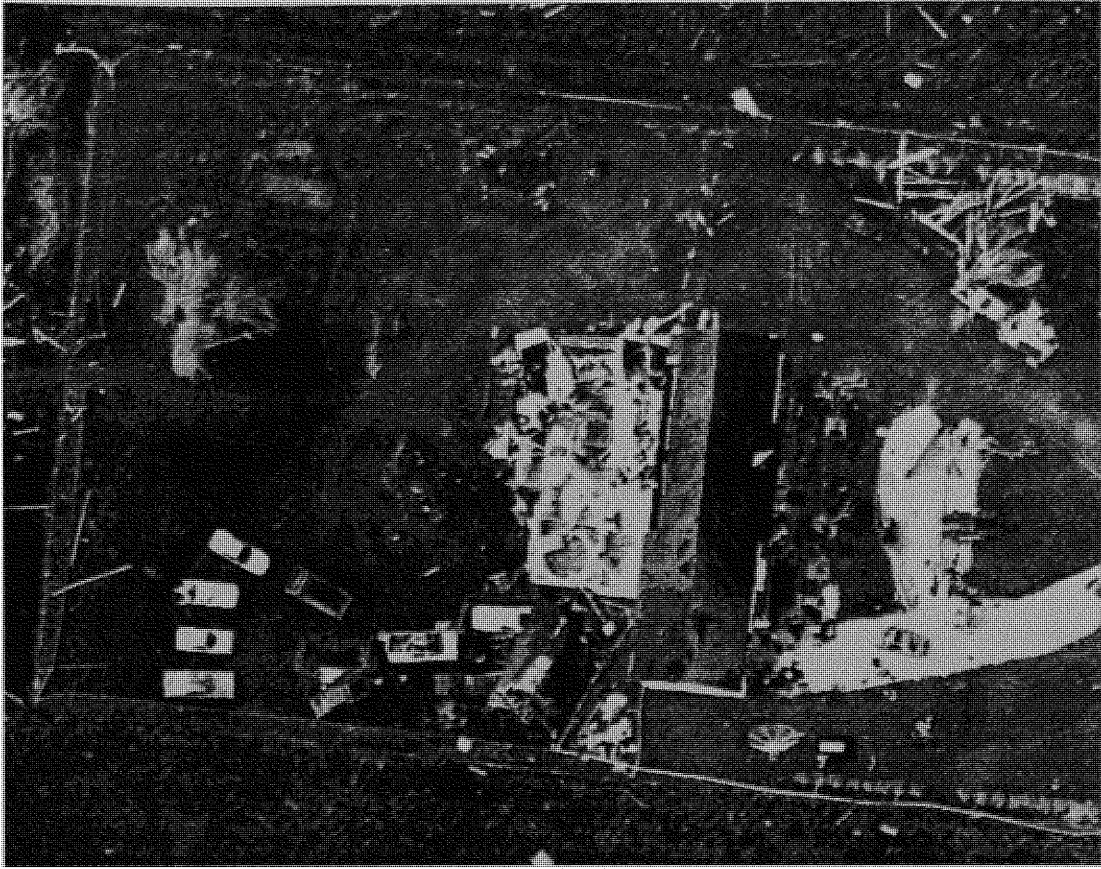
Figure 8.7. Collapsing of main roof structure.

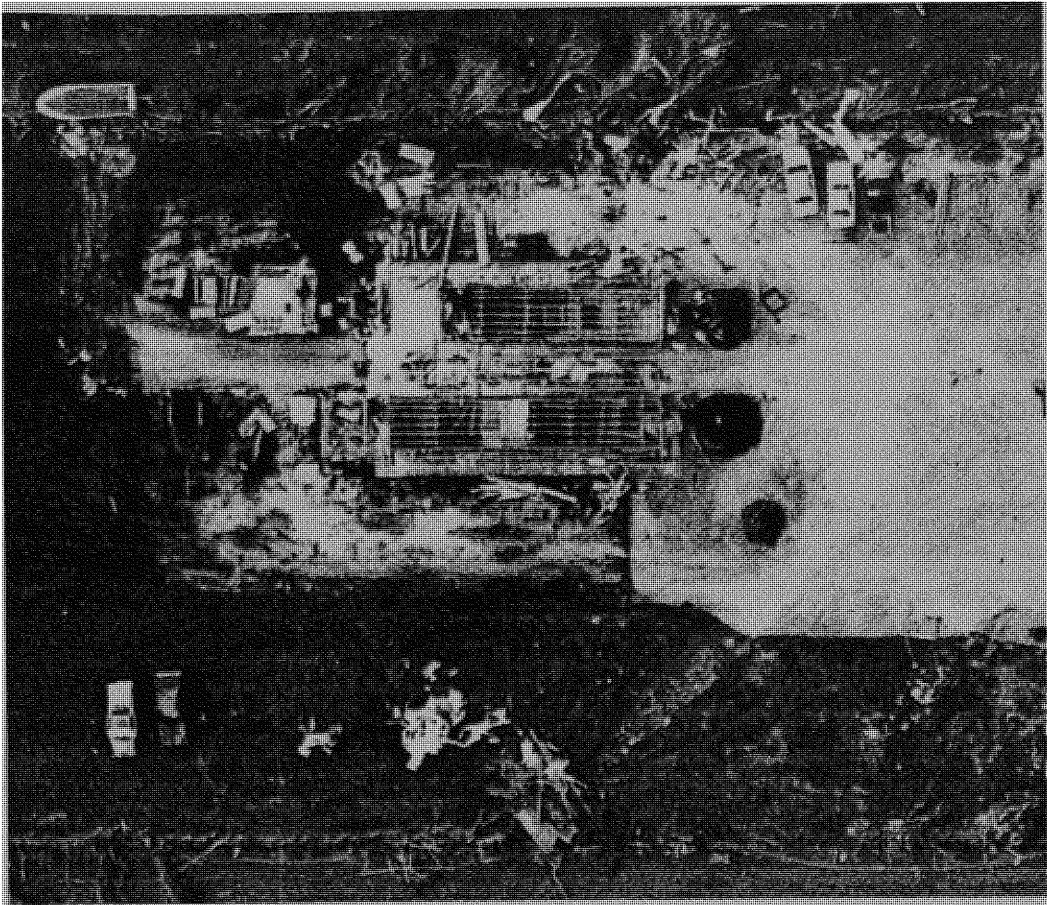
Figure 8.8. Inadequate binding material used.

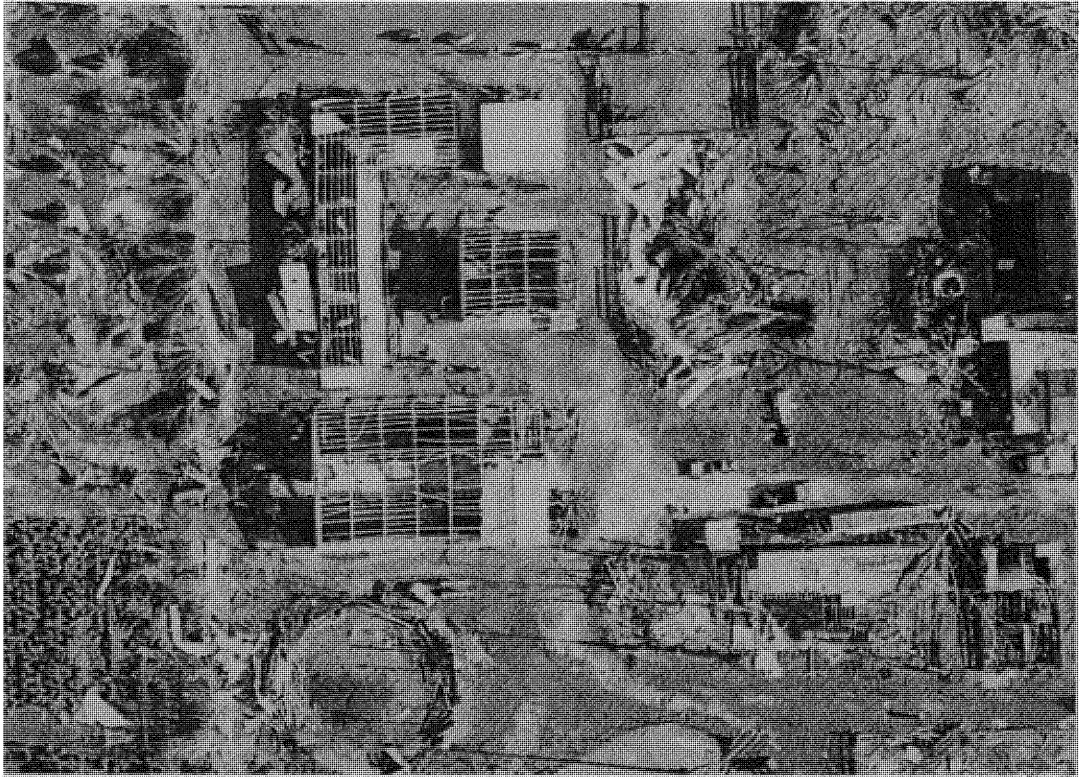
Figure 8.11. Missing roof covers and structural damages.

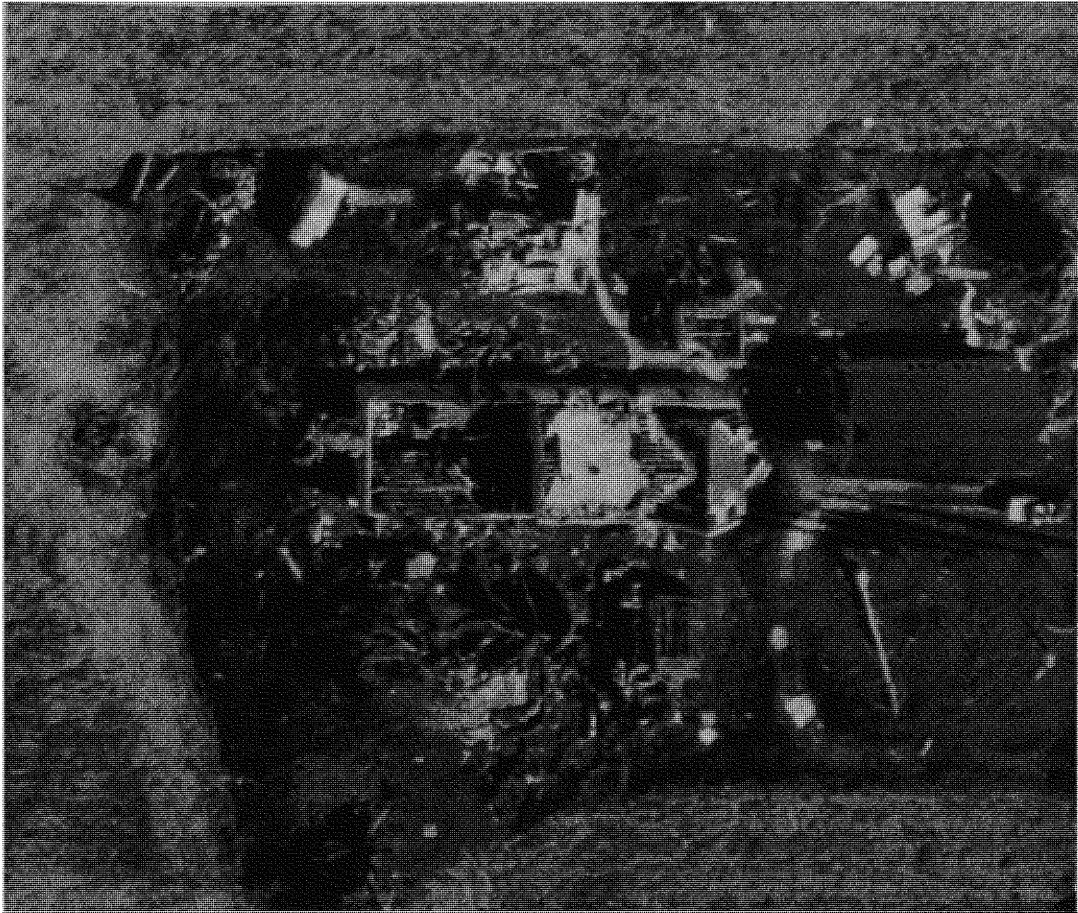
Figure 8.12. Collapsed trusses.

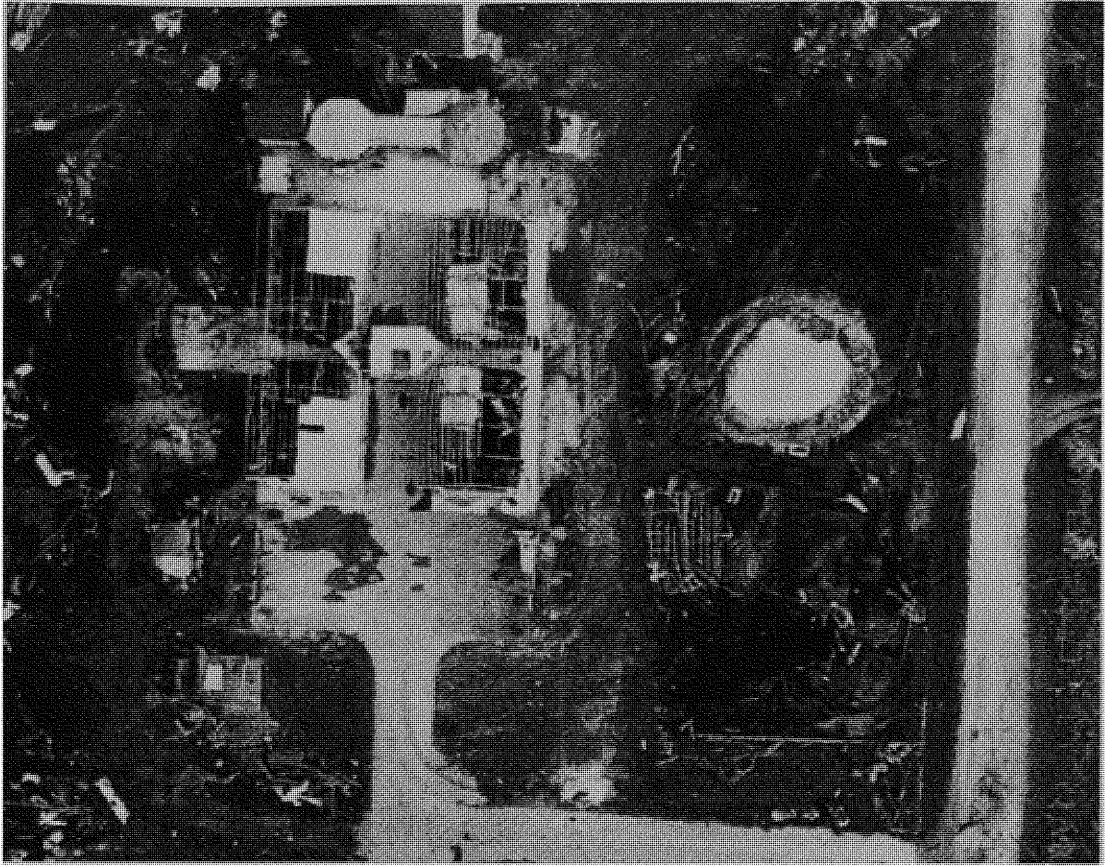
Figure 8.13. Severe loss of plywood sheathing.

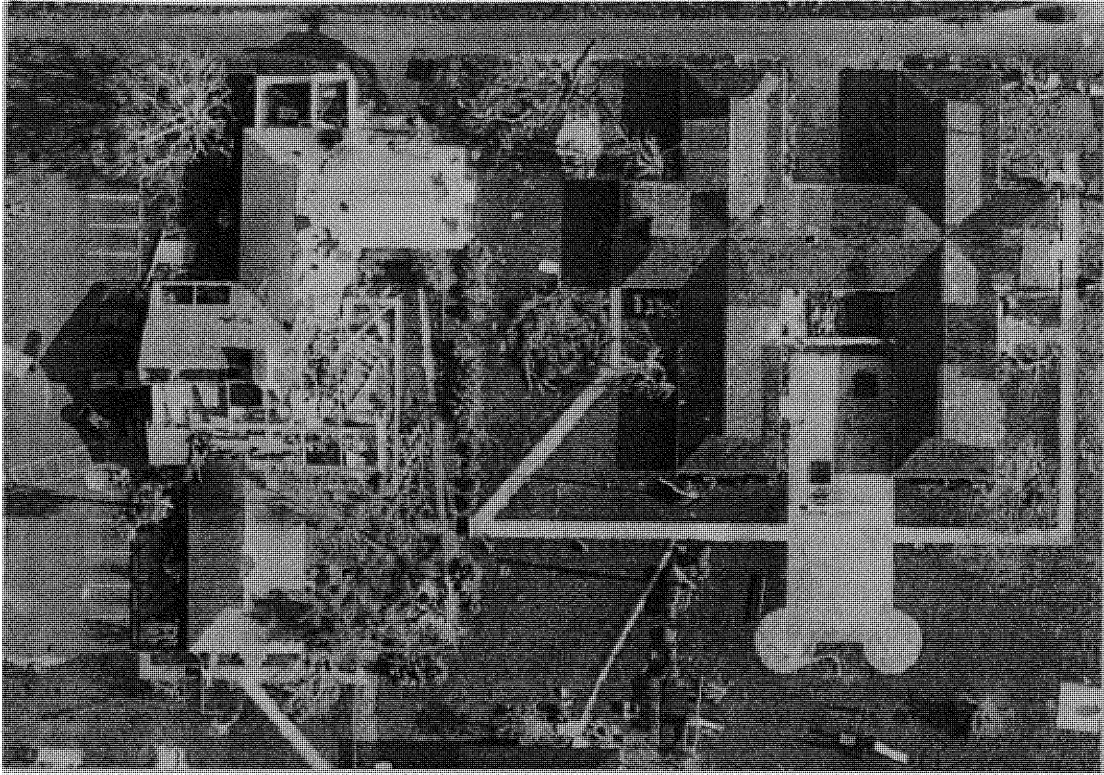
Figure 8.14. Damage to differential roofing system.

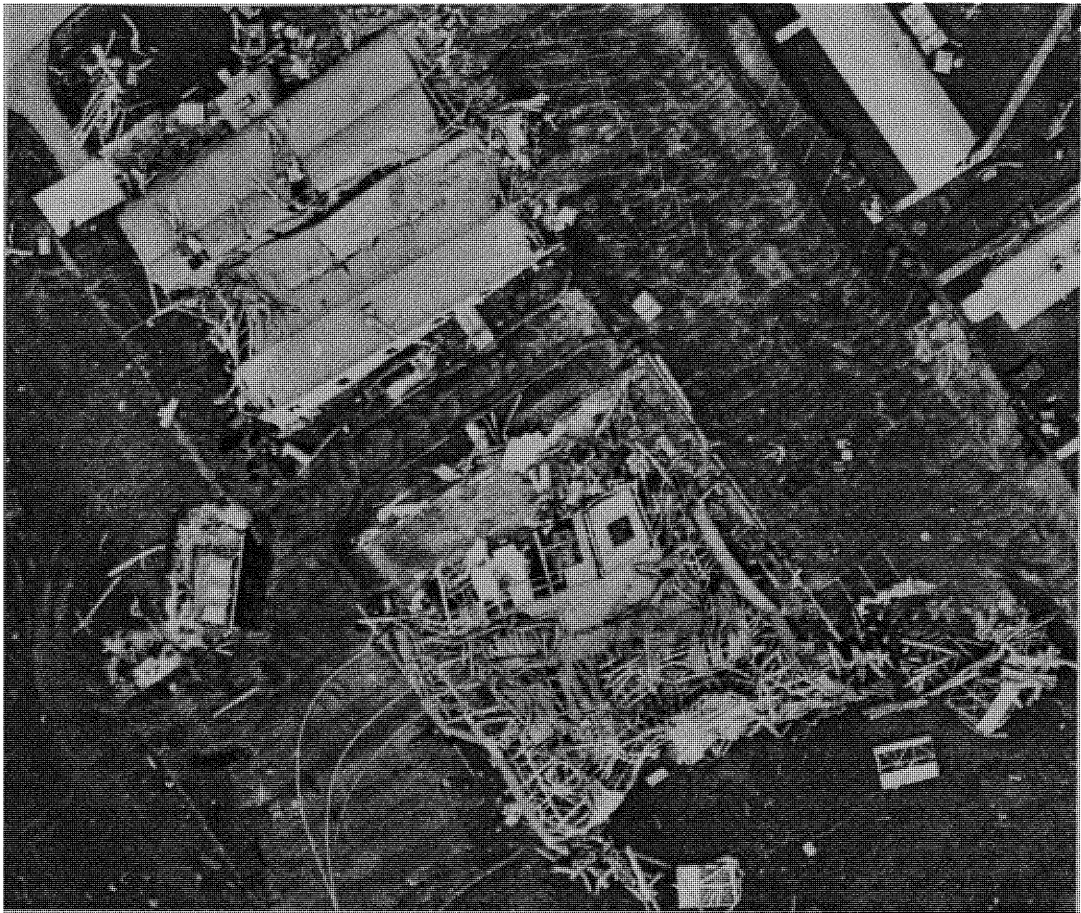
Figure 8.15. Loss of ceiling strength due to water saturation.

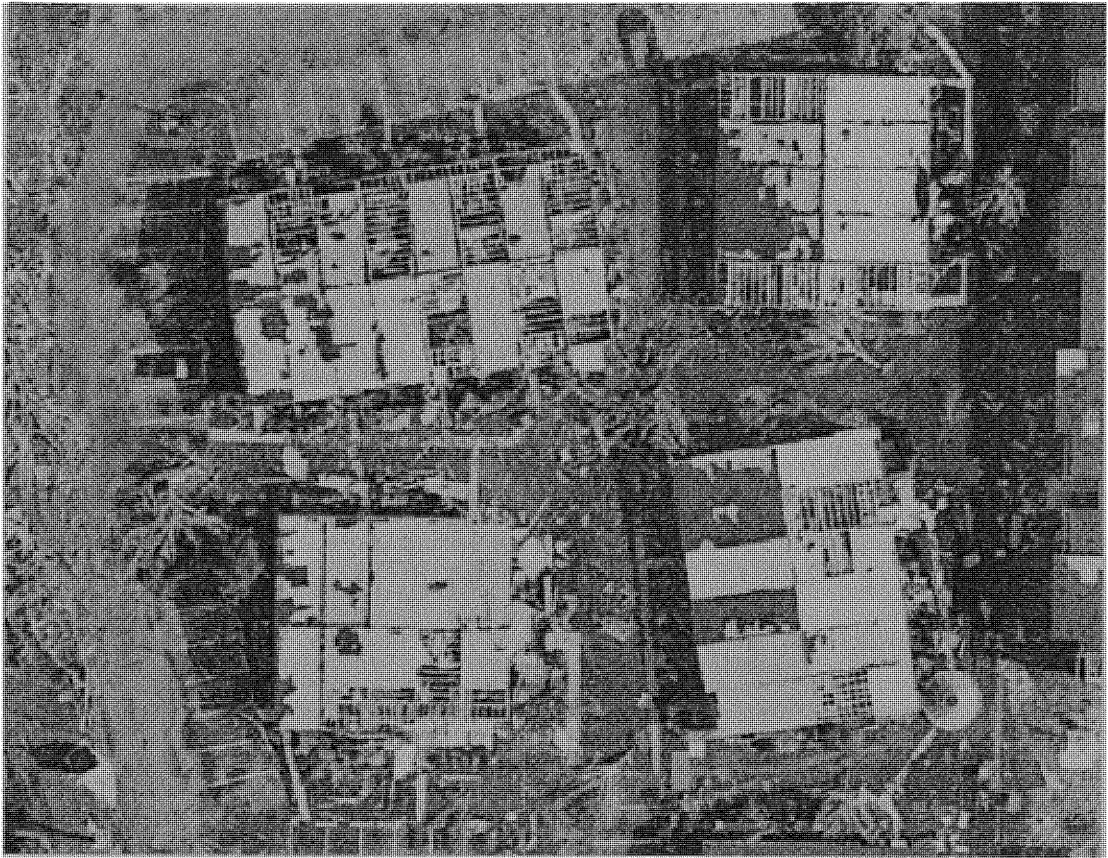
Figure 8.17. Upliftment of rake overhangs.

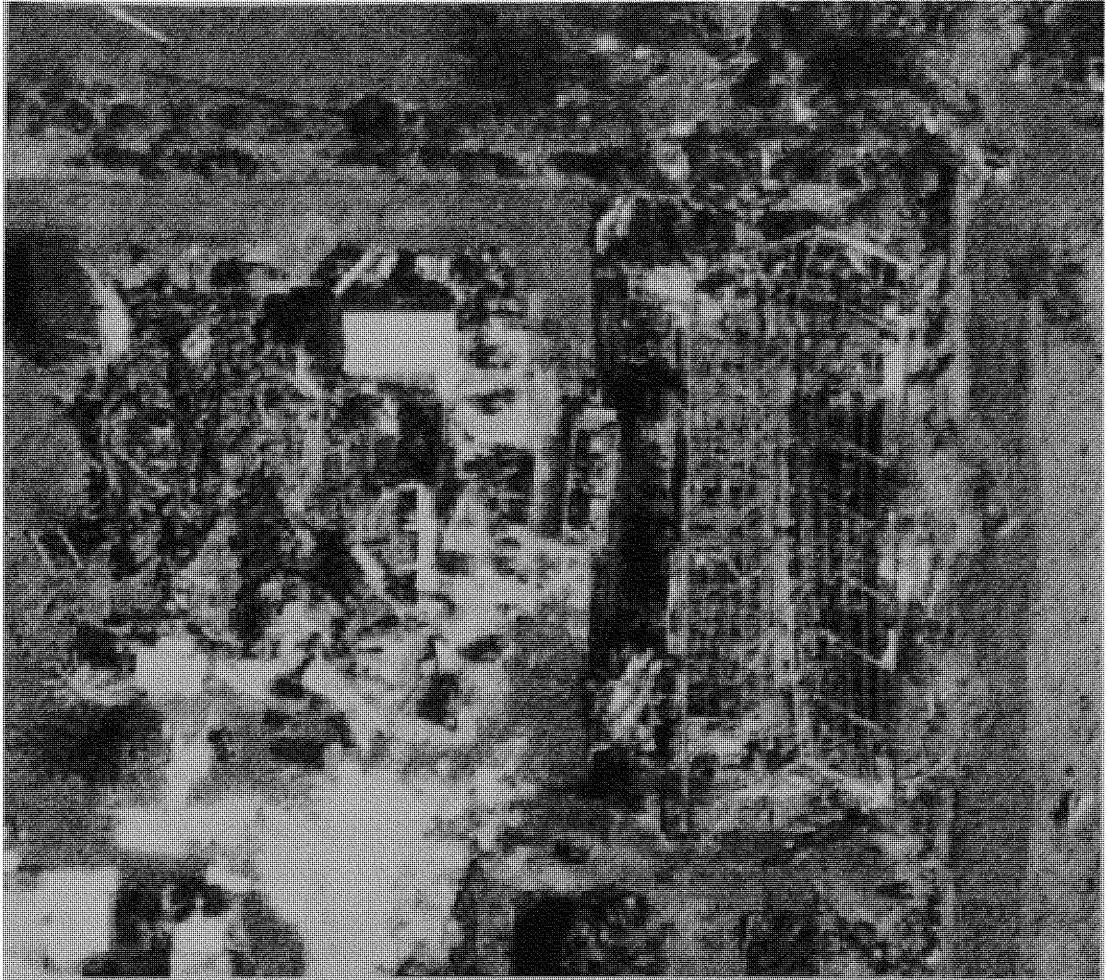
Figure 8.19. Curvature in the main rafter.

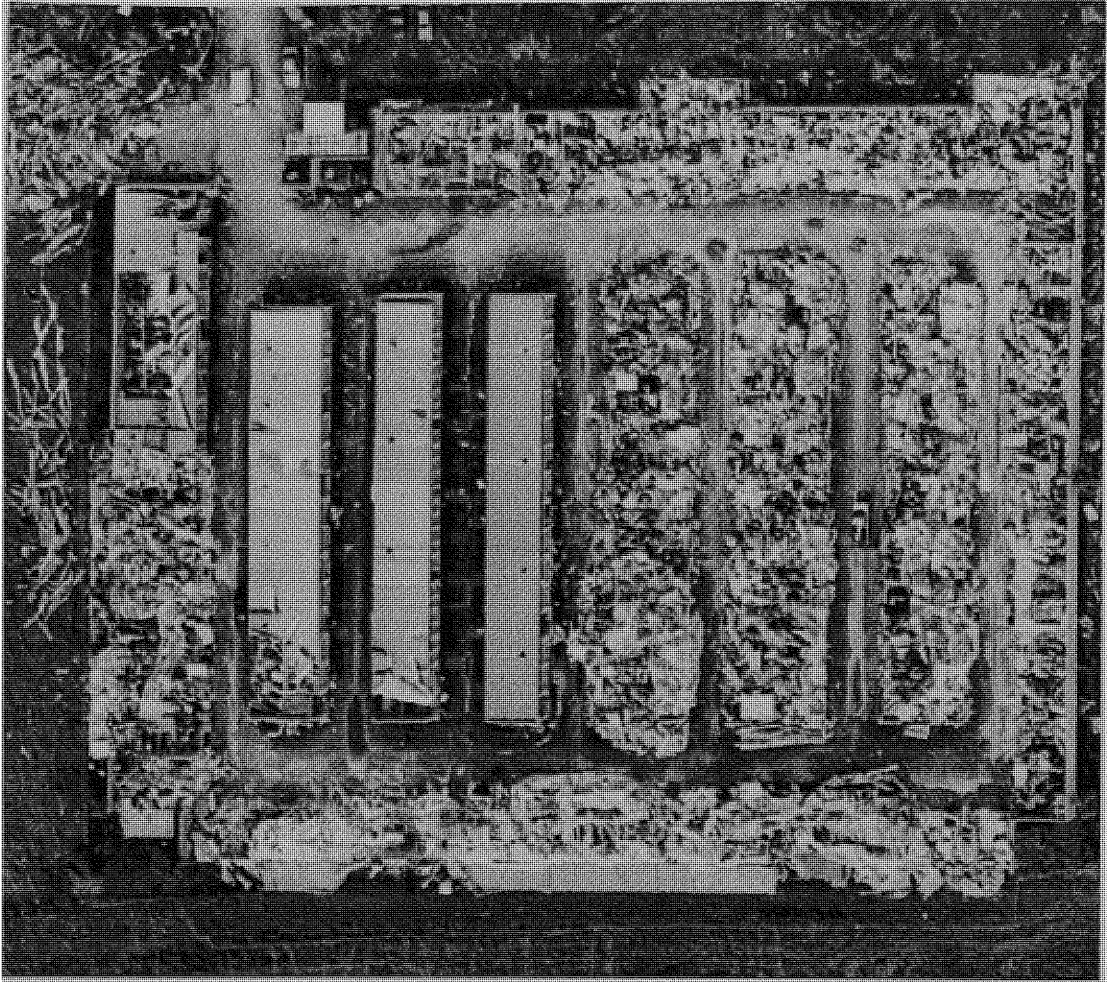
Figure 9.3. High upliftment pressure.

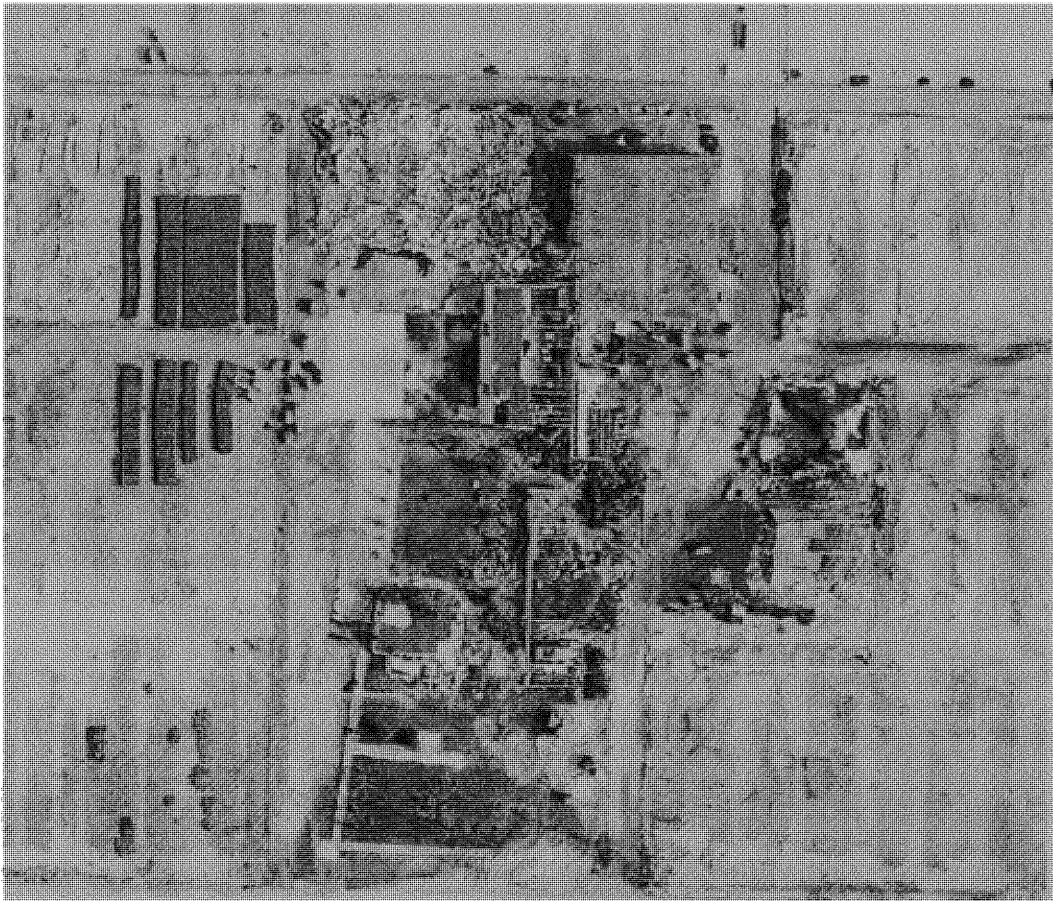
Figure 11.1. Clear wind path for isolated warehouse.

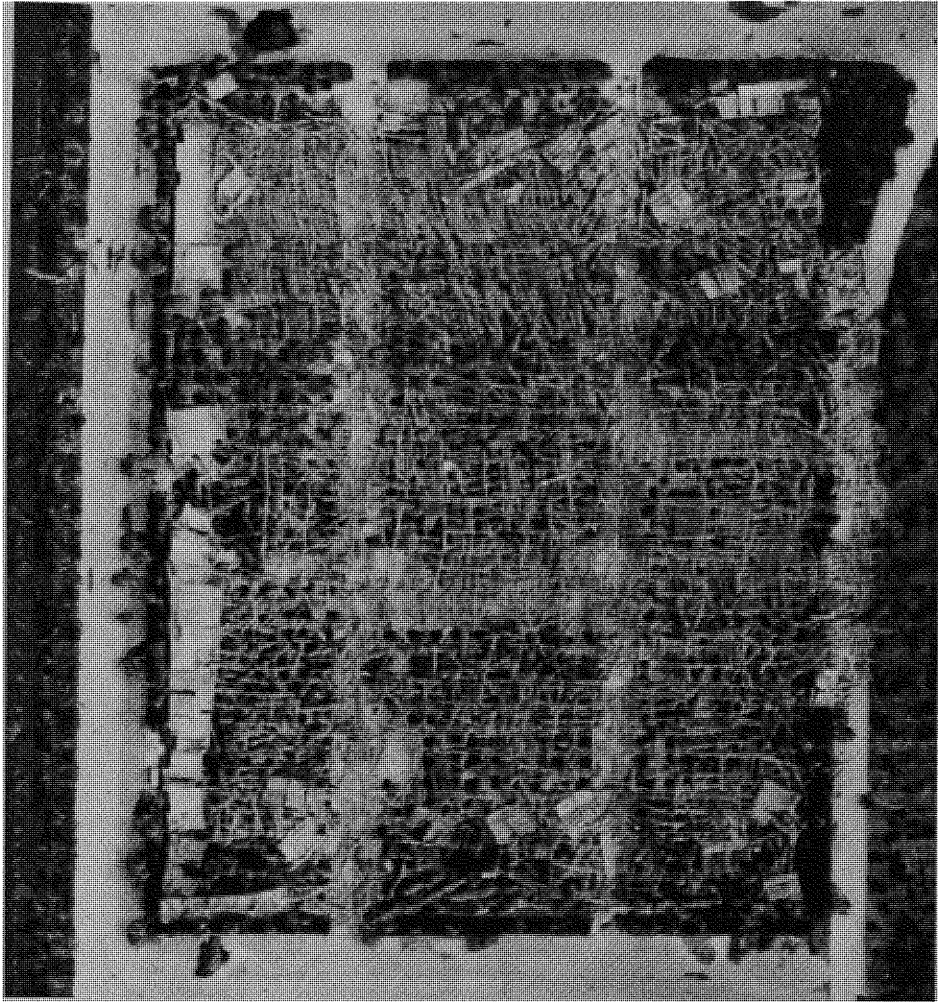
Figure 11.3. 100% damage to roofing system.

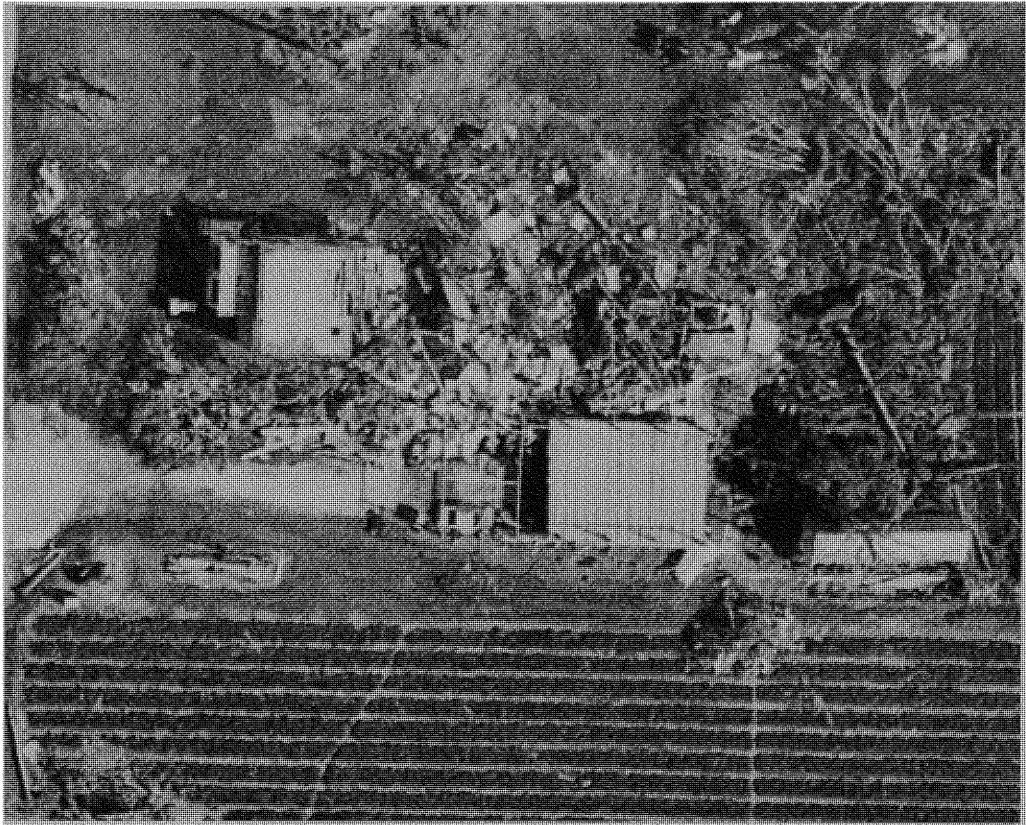
Figure 12.1. Damage due to wind borne debris.

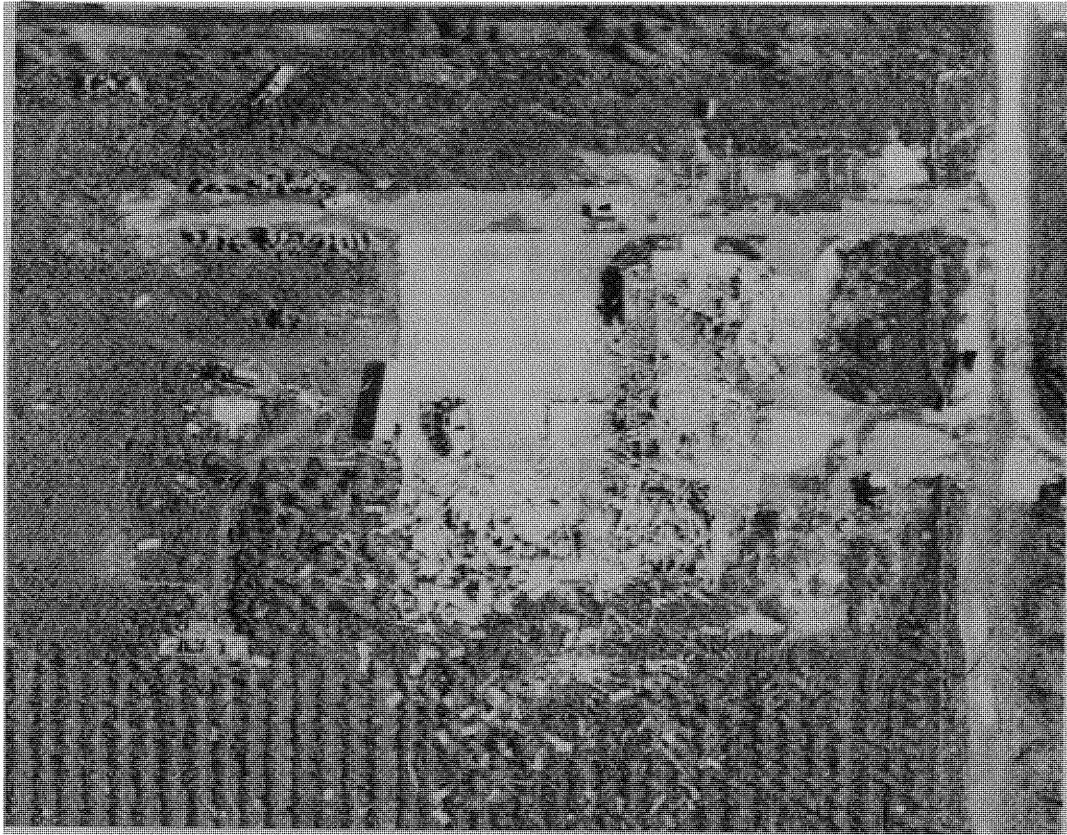
Figure 12.3. Insecurely fastened roof frames.

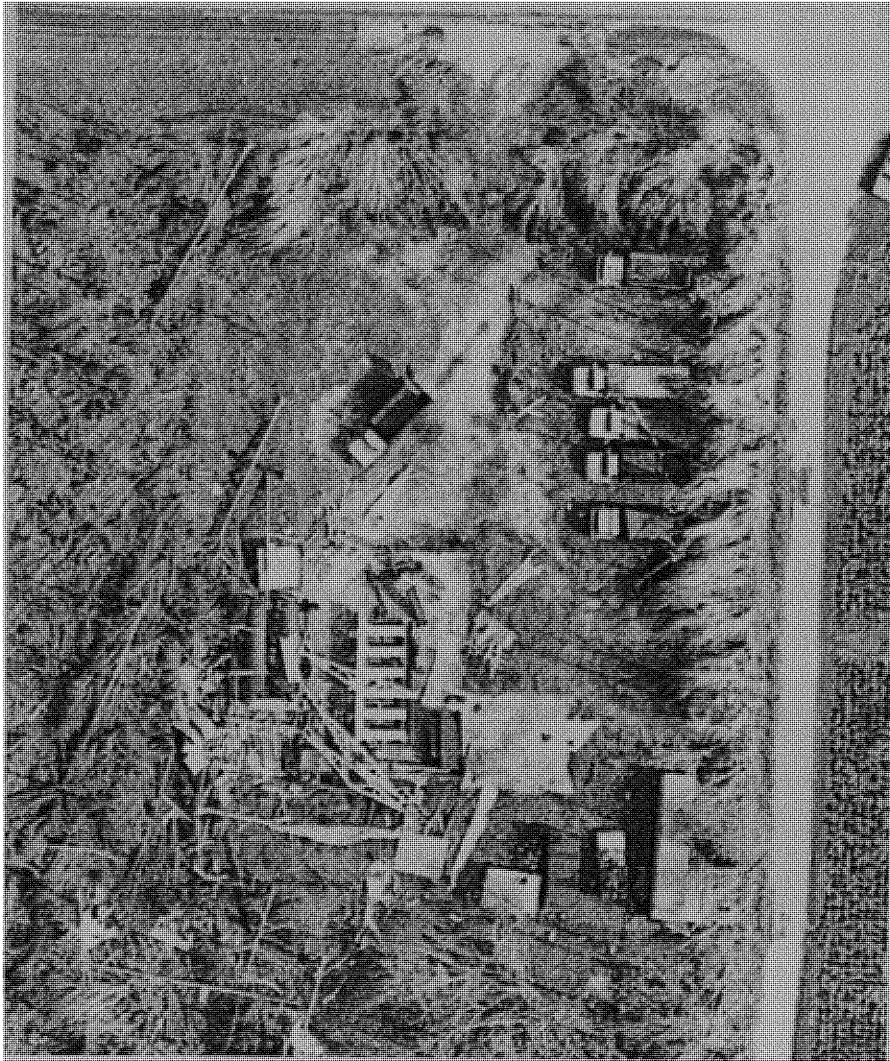
Figure 12.4. Accumulation of debris due to dislocation of trusses.

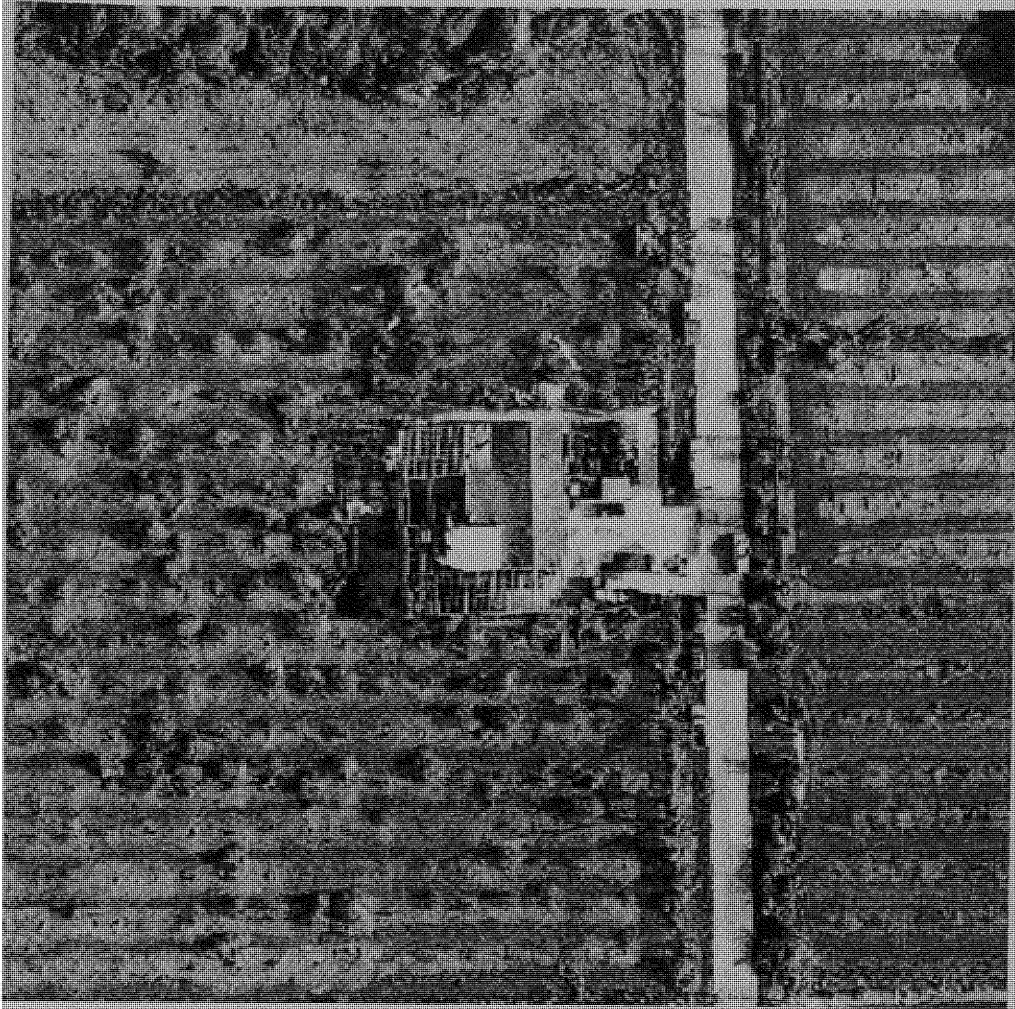
Figure 12.6. Damage to windward portion of the house.

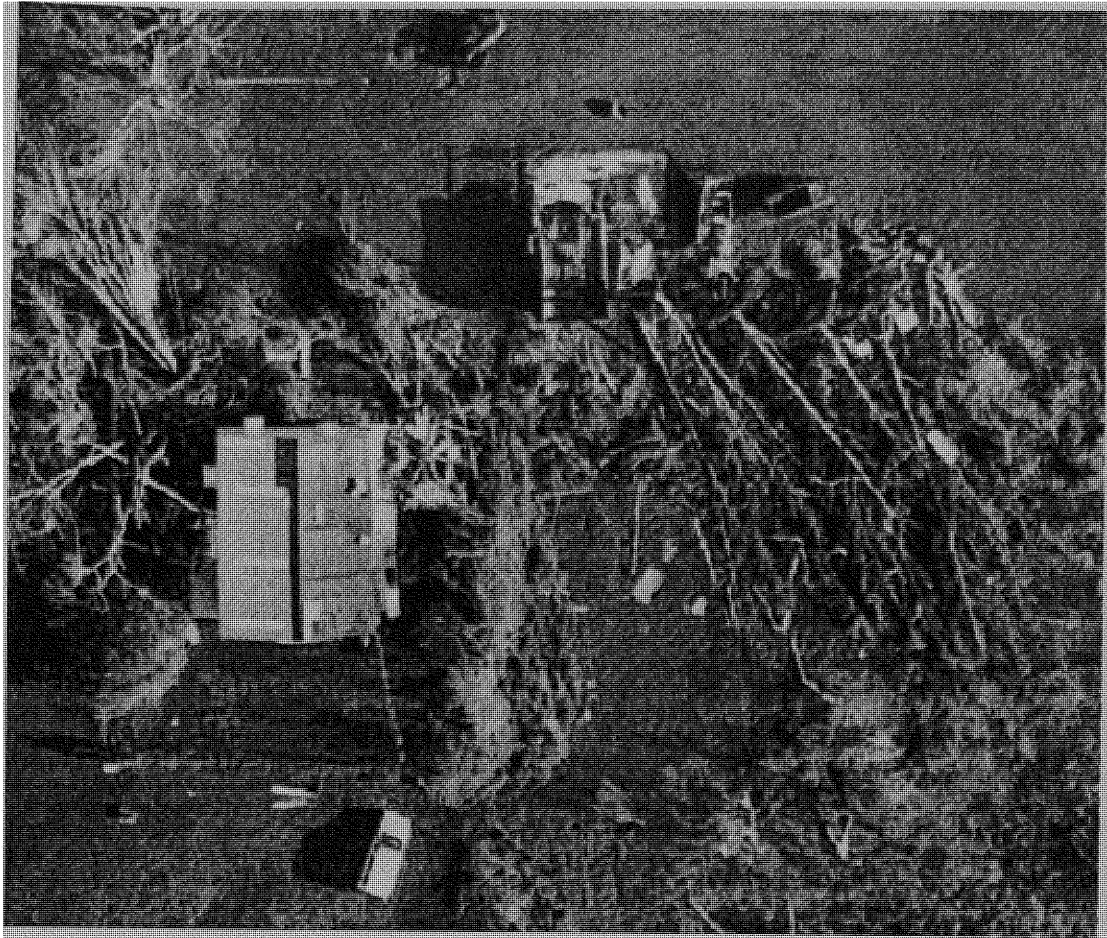
Figure 12.7. Damage due to fallen trees.

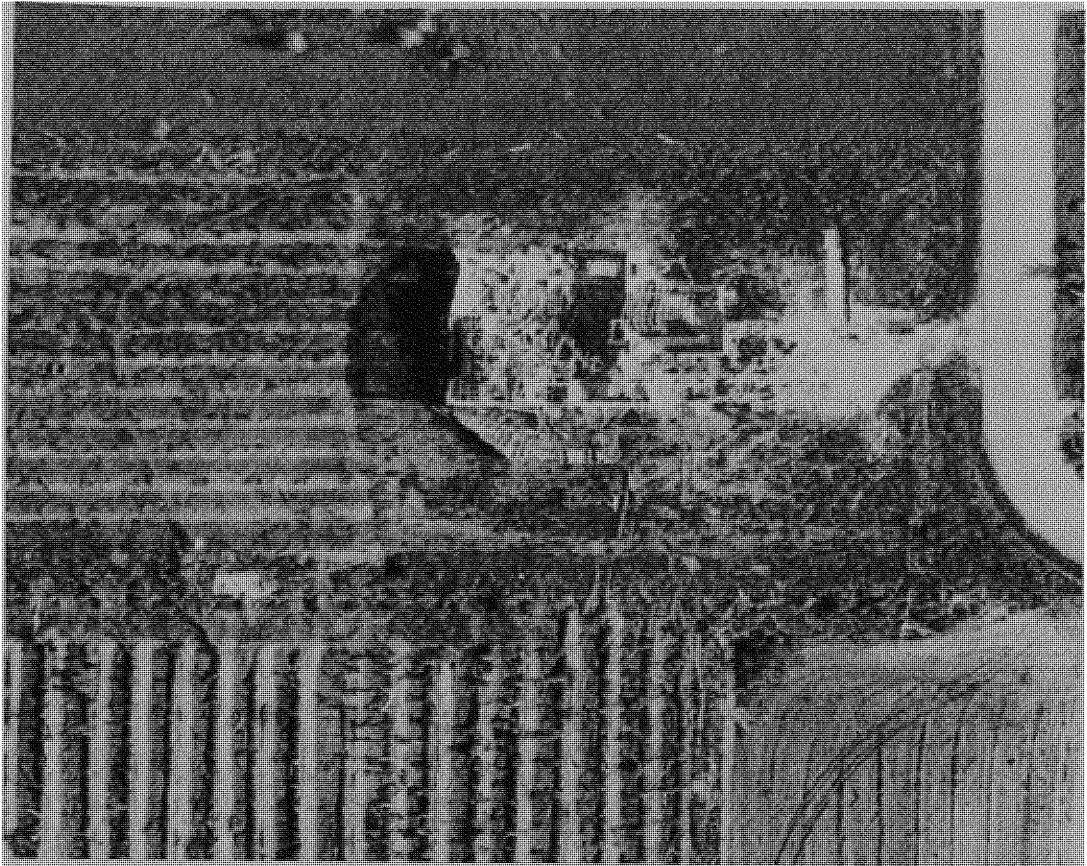
Figure 12.8. Damage due to lack of barrier surrounding the house.

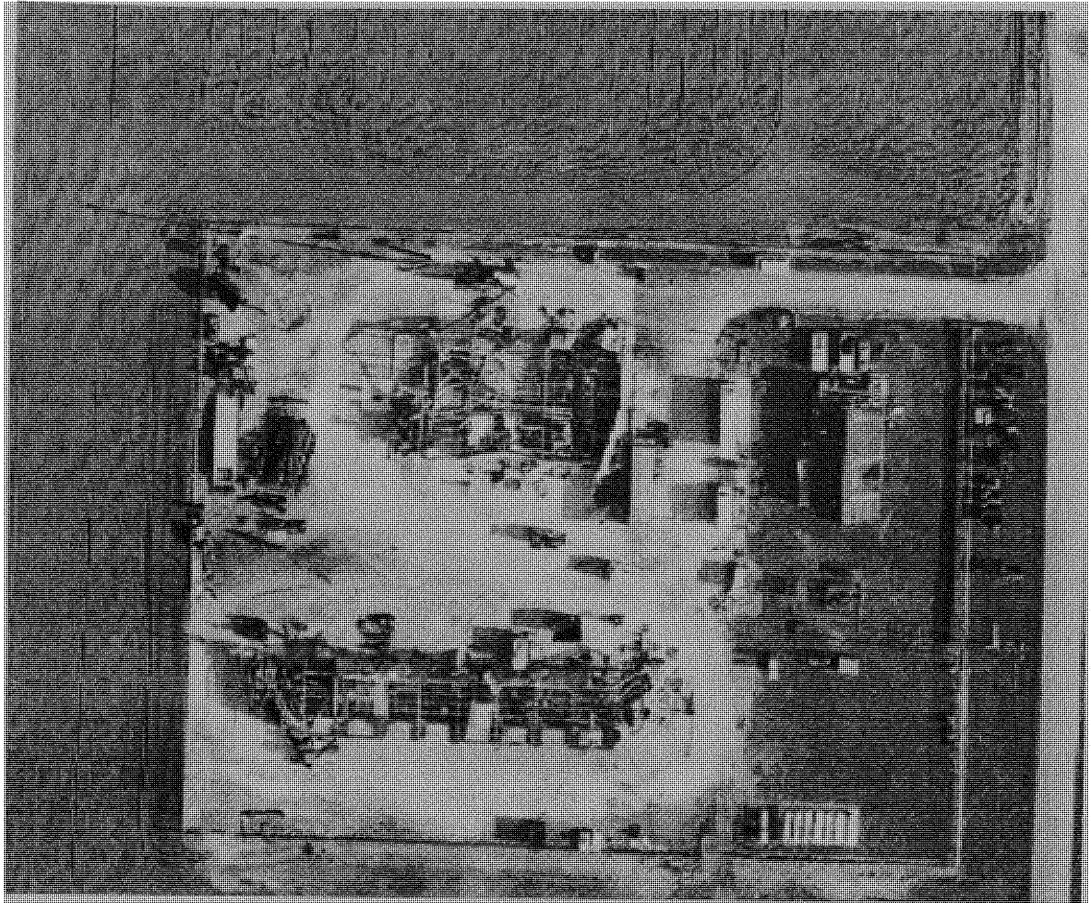
Figure 12.10. Severe structural damage.
