Damage assessment of various structures by hurricane Andrew using aerial photographs

Sondwip Dhar

Florida International University

A thesis submitted in partial fulfillment of the

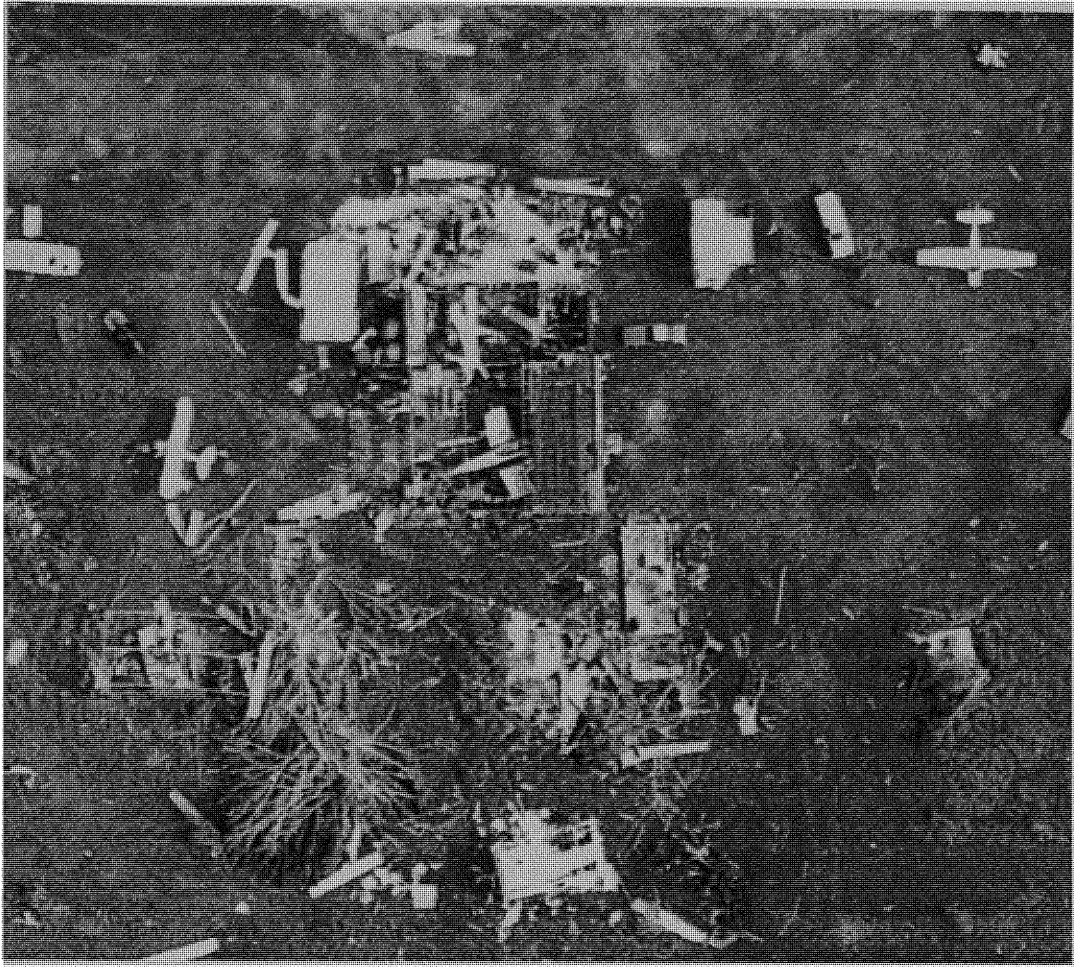
Figure 13.1. Destruction of hanger.

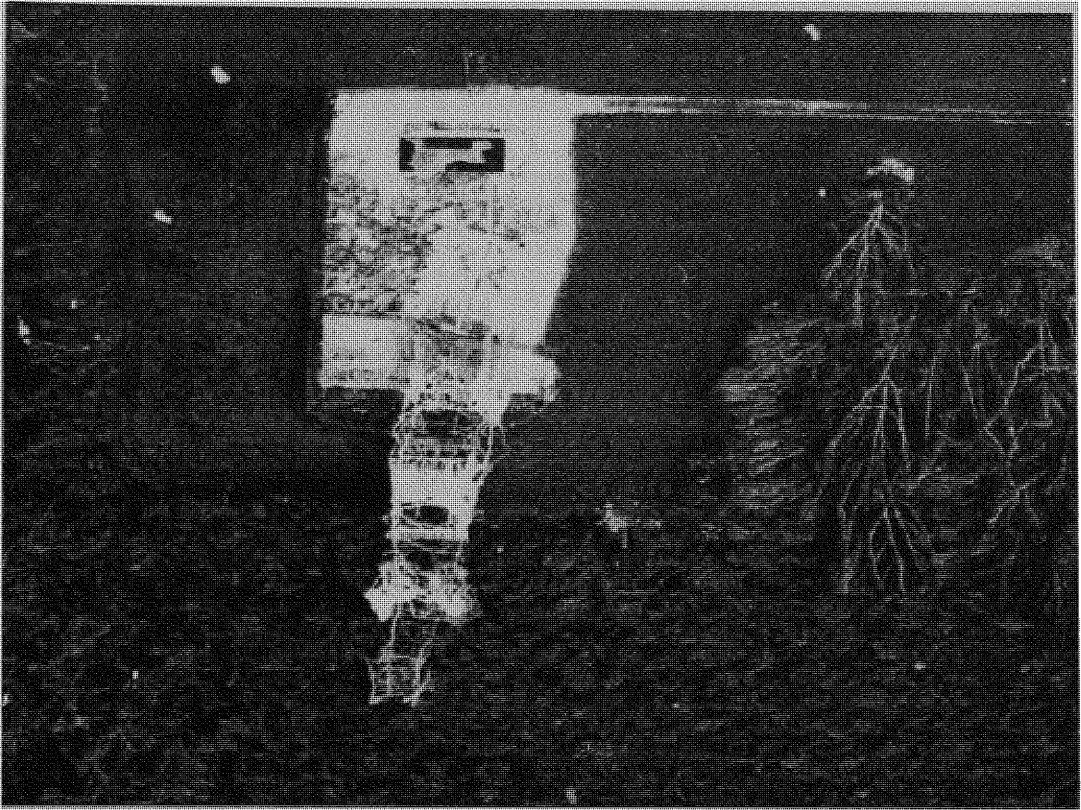
Figure 14.1. Dislocation of secondary steel bracings.
