## **A Framework for Field Inspection of In-service FRP Reinforced/ Strengthened Concrete Bridge Elements**

1. Report No. 800014727	2. Government Accession No.	3. Recipient's Catalog No.	
4. "A Framework for Field Inspection of In-service FRP Reinforced/Strengthened Concrete Bridge Elements"		5. Report Date February 2024

12. Sponsoring Agency Name and Address Office of Bridges and Structures Federal Highway Administration 1200 New Jersey Ave SE, Washington, DC 20590		13. Type of Report and Period Final Report

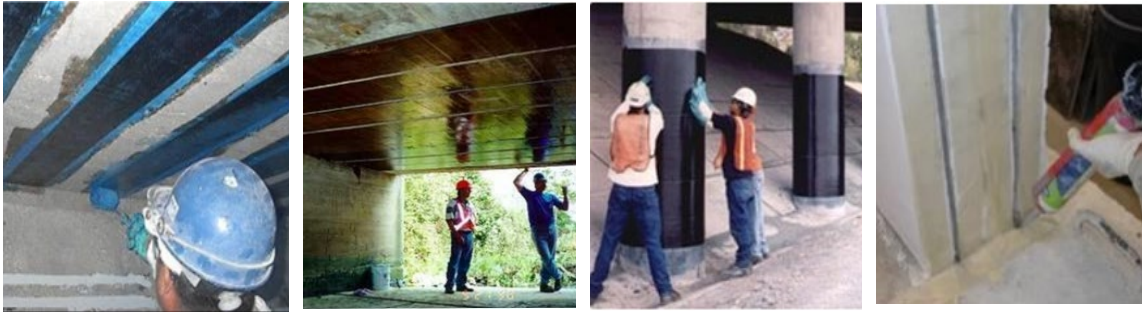
**Figure 4 Types of FRP application (Khedmatgozar Dolati et al. 2022)**

There has been significant growth in the use of FRP composites in concrete bridges over the last decades as shown in Figure 4. They have been used for new construction or rehabilitation of existing bridges. FRP applications in concrete bridge elements can be subdivided into two main categories; FRP bars, rods, and strands as an internal reinforcement; and FRP sheets, wraps, and near-surface mounted (NSM) FRP bars as external reinforcement as shown in Figure 5.

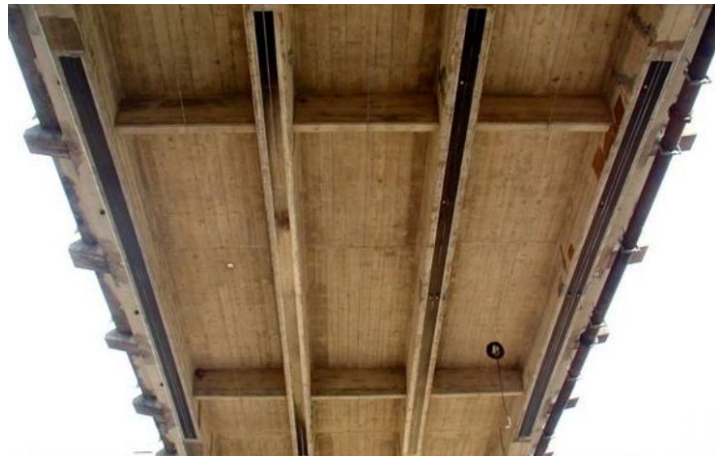
**Figure 6 FRP strengthened bridge girders** (Carmichael and Barnes 2005)

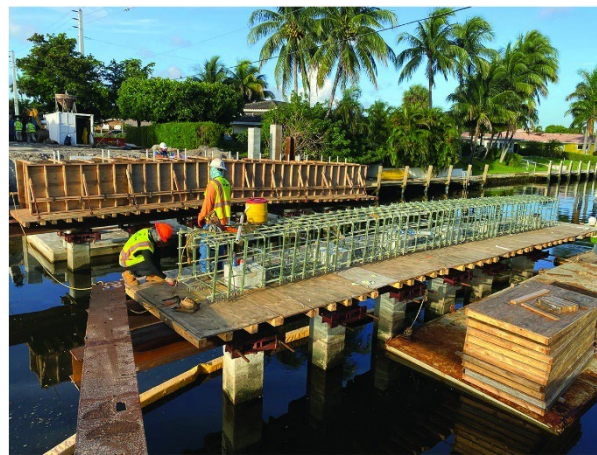
**Figure 8 The use of FRP reinforcing bars for piers and bent caps (Broward County, FL, USA) (Ekenel, y Basalo, and Nanni 2021)**

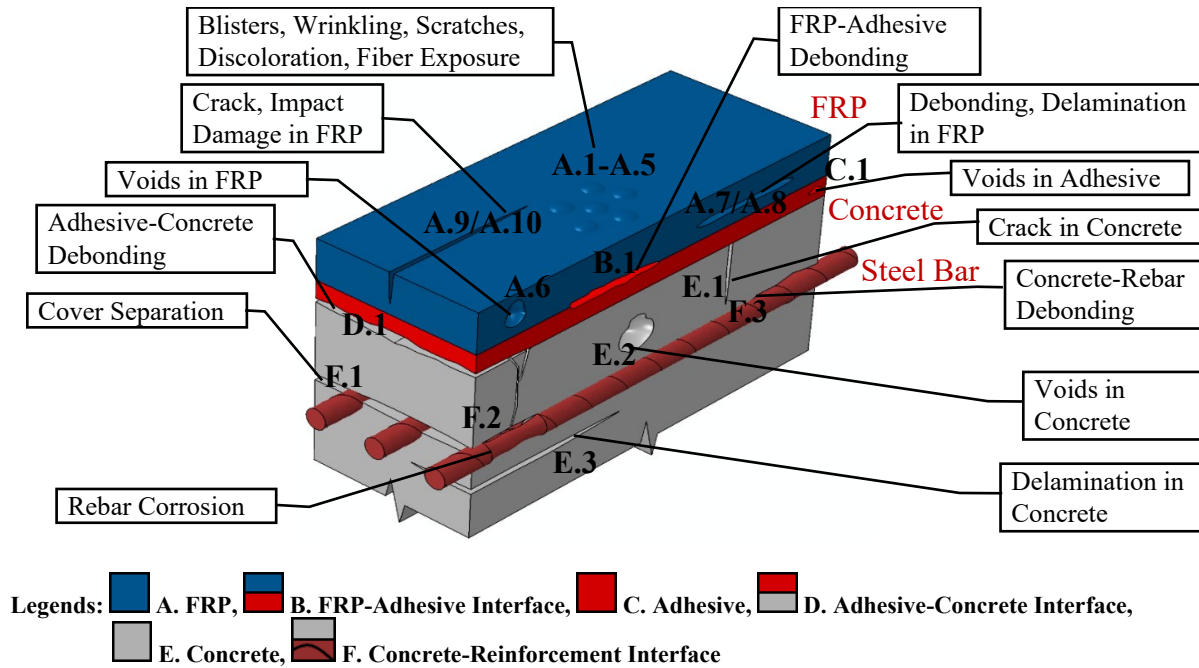
**Figure 9 Deficiencies in external FRP application** (Source: Authors)

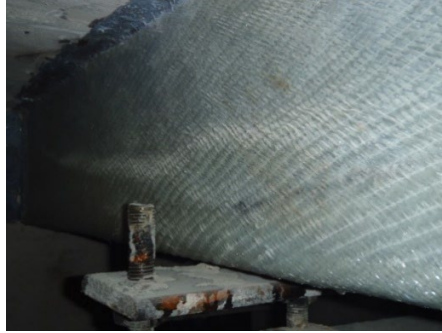
Wrinkling appears as creases or folds on the surface of the FRP composites (Figure 11), often occurring at corners and curves of the structure. It is caused by improper installation practices during the hand lay-up process, such as excessive stretching or shearing of the fabric. The safety of the structure may be compromised if it results in insufficient surface contact of the FRP composites with the substrate.

**Figure 11 Wrinkling** (Source: Authors)

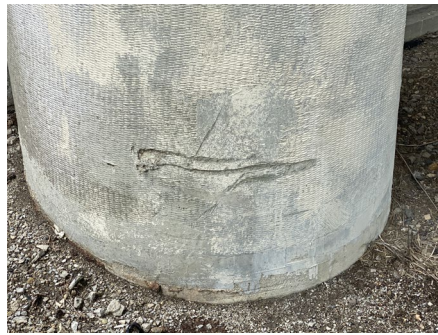
Scratches at the surface of externally applied FRP range from superficial scratches to deeper grooves (Figure 12). They can occur anytime during the installation and service life of the structure. They are detrimental if they develop into full-depth cracks as they propagate deep into the fibers of the composite.

**Figure 12 Scratch caused at the externally applied FRP** (Source: FHWA)

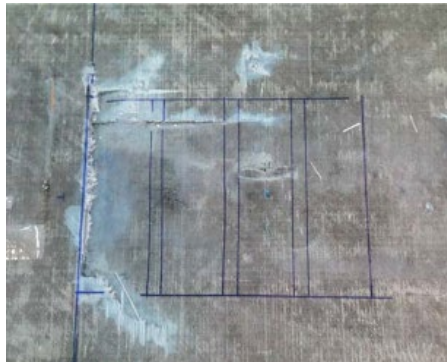
Discoloration (Figure 13) is mainly caused by exposure to UV rays, heat, chemicals, fire, excessive strain, subsurface defects, voids, and moisture penetration. It may be a sign of composite degradation, which may be followed by cracks and embrittlement.

**Figure 13 Discoloration** (Telang et al. 2006)

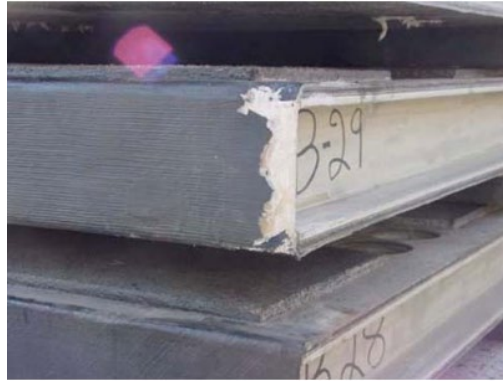
Fiber exposure, as shown in Figure 14, are simply exposed fibers of the FRP composite caused mainly by improper handling and installation of FRP composites. These are the entry points of moisture and contamination into the composite which deteriorates the composite properties.

**Figure 14 Fiber exposure** (Telang et al. 2006)

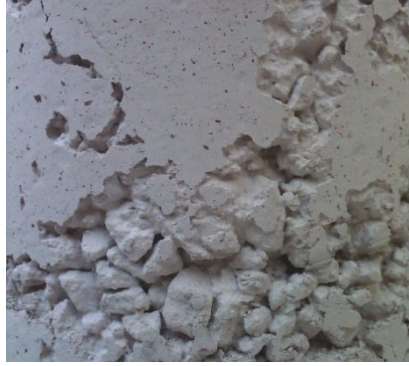
The formation of voids in concrete is independent of the external application of FRP and related to the inadequate design and construction measures during the casting of the concrete substrate. Voids can form due to improper vibration of concrete during casting in addition to stiff or unworkable concrete, segregation, crowded rebar, insufficient concrete consolidation, and irregular aggregate sizing. It may cause concrete structures to deteriorate over time. Figure 23 shows voids formed on the surface of concrete.

**Figure 23 Concrete voids** (Source: Authors)

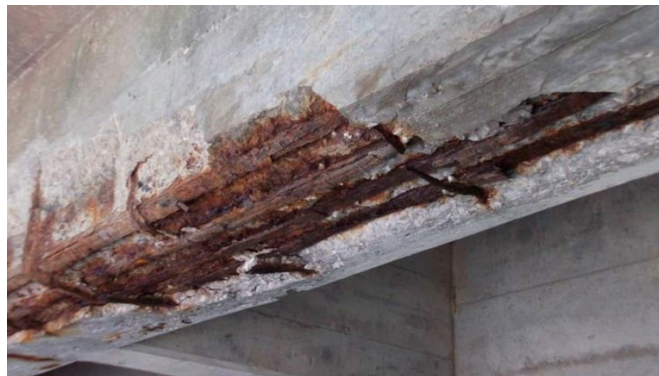
**Figure 26 Corrosion in steel reinforcement embedded in concrete substrate (Jung, Jeong, and Lee 2022)**

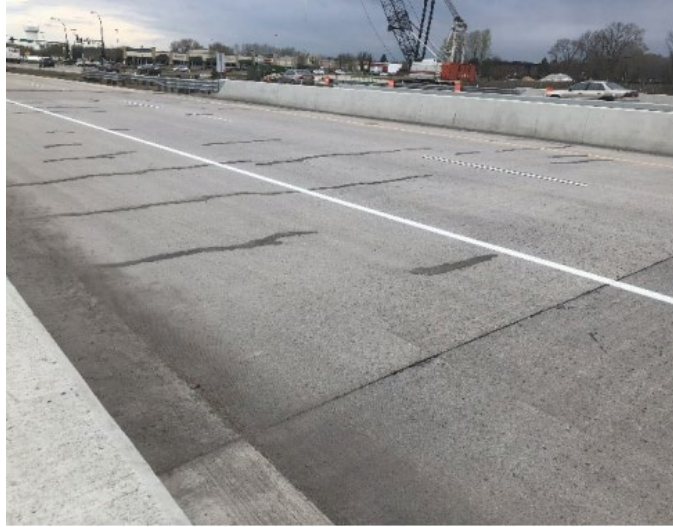
**Figure 28 Top surface cracks in GFRP reinforced bridge deck (Shafei 2023)**

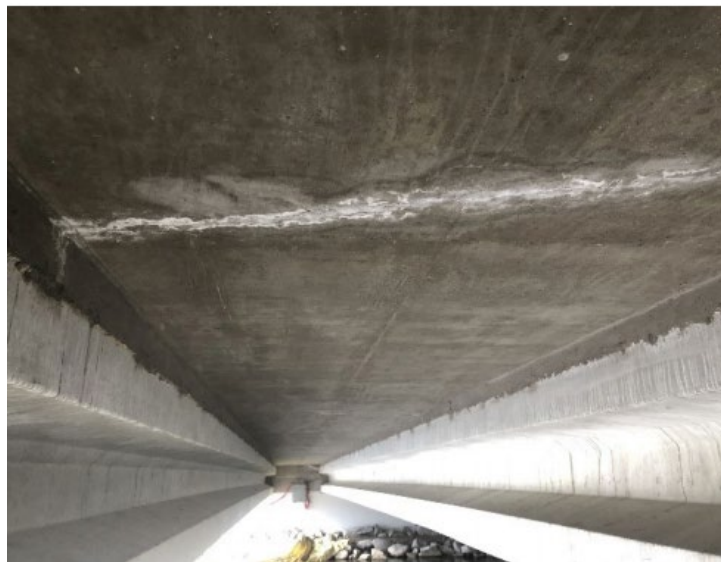
**Figure 29 Full depth crack in GFRP reinforced bridge deck (Shafei 2023)**

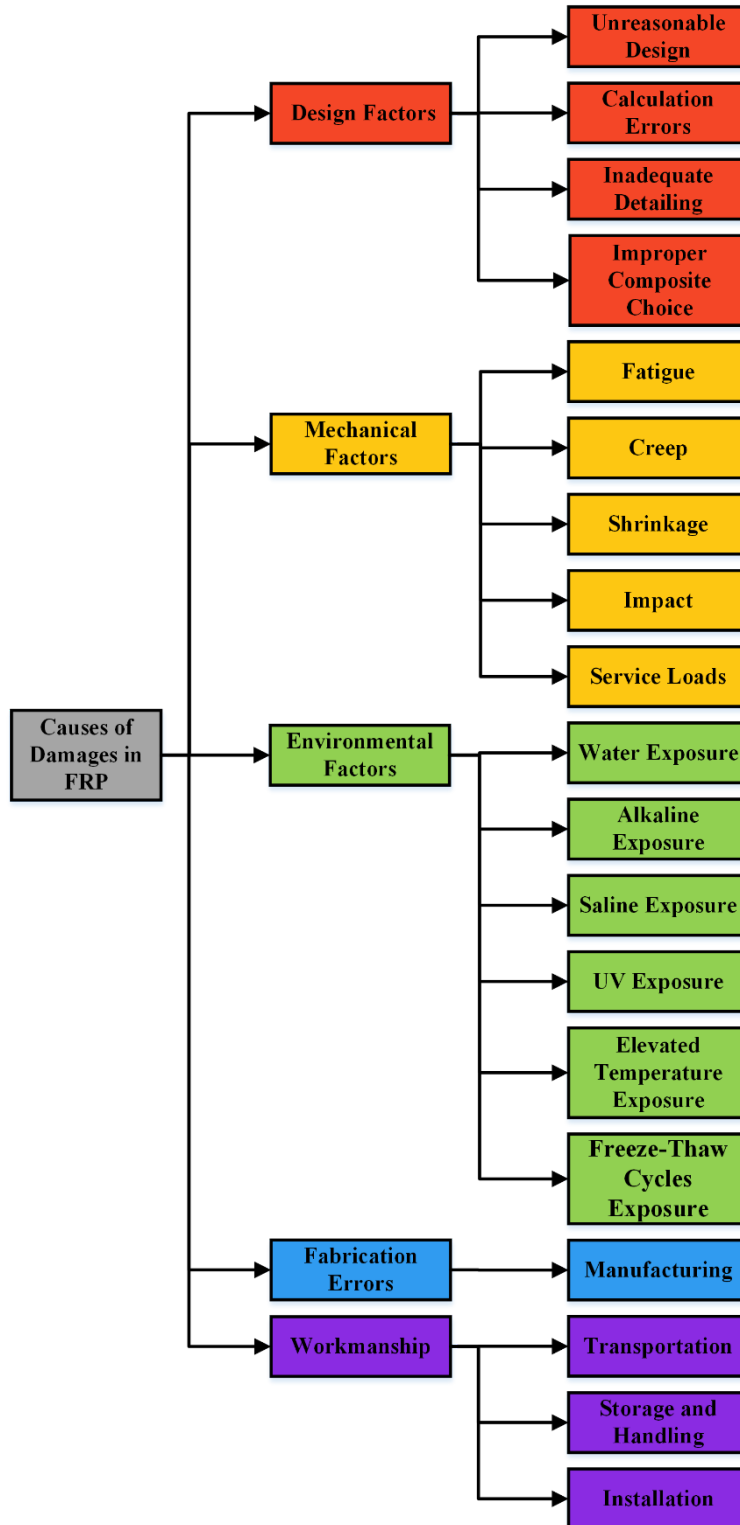
**Figure 31 Sources of deficiency in FRP (Source: Authors)**

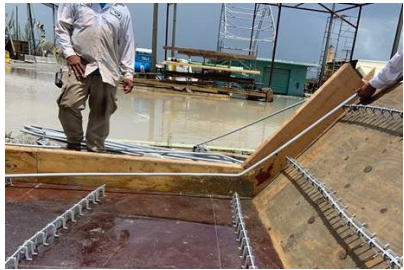
<p>FRP composites are manufactured by a variety of methods, and the defects can be introduced at any stage of manufacturing anywhere within the matrix, fiber, and interface of the composite. They are more susceptible to variations in material and geometric properties due to their complicated manufacturing processes, as can be seen in the figure above which shows an example of incorrectly bent bars by manufacturer.</p>

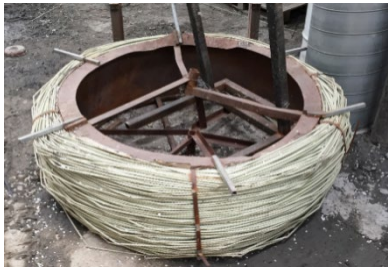
<p>FRP composites may bend, break, and get coated with dirt, oil, or other materials during transportation as shown in figure above (GFRP bars broken due to coiling on a reel with unacceptably small diameter). Similarly, improper lifting, dropping, and dragging during handling introduce deficiencies in them. Care should be taken for their storage as prolonged exposure to UV rays and temperatures above 120 °F deteriorate their mechanical properties.</p>

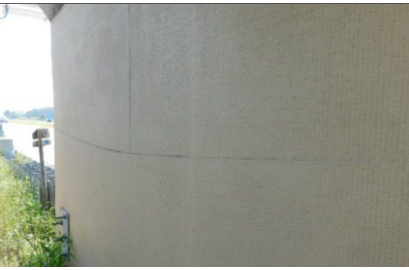
<p>Workmanship problems, faulty equipment used for their application, unfavorable temperature or moisture conditions, inconsistent surface preparation, improper mixing or quantity of resins, uneven distribution of resins, inadequate curing of resins, inconsistent layering and sagging of FRP plies (as shown in figure above), and many other deviations from the suggested method of their installation could all result in errors during the installation of external FRP.</p>

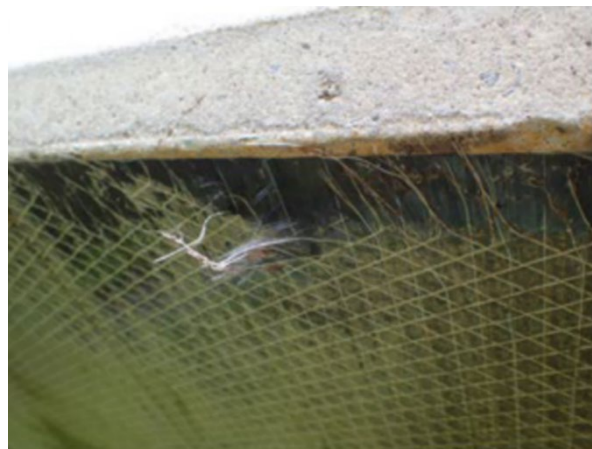
**Figure 37 Fiber exposure** (Baniya et al. 2022)

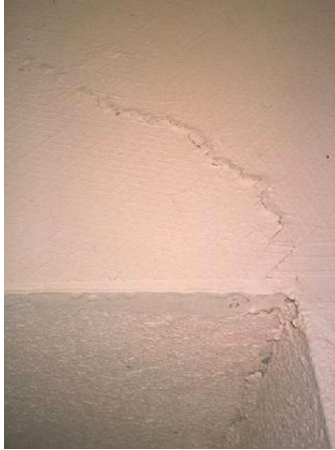
**Figure 38 Cracks** (Source: Authors)

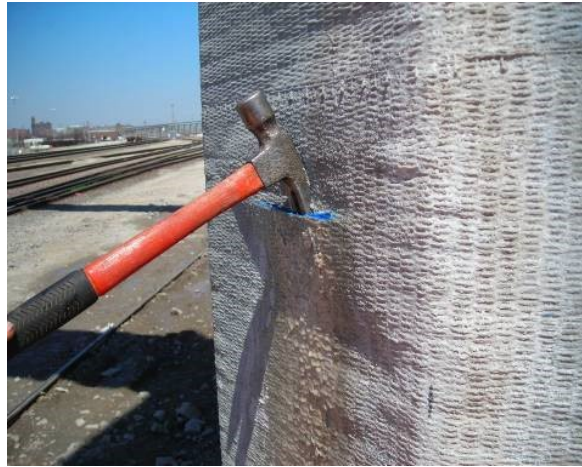
**Figure 39 Rupture due to moisture entrapment** (Source: Authors)

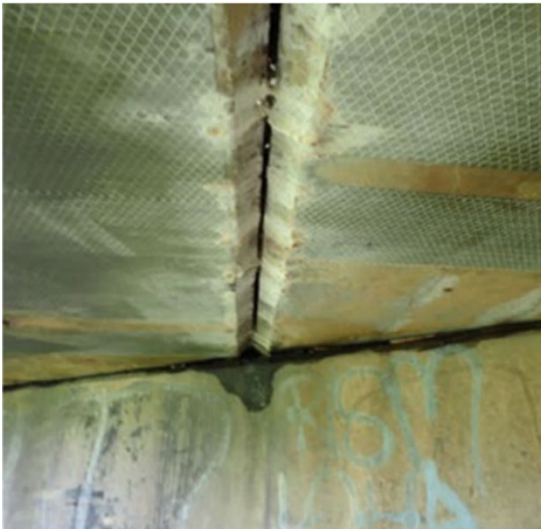
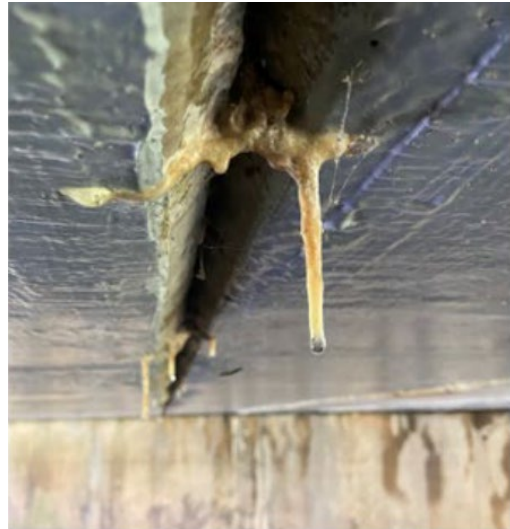
**Figure 40 Efflorescence near joints of adjacent box beam girders** (Baniya et al. 2022)

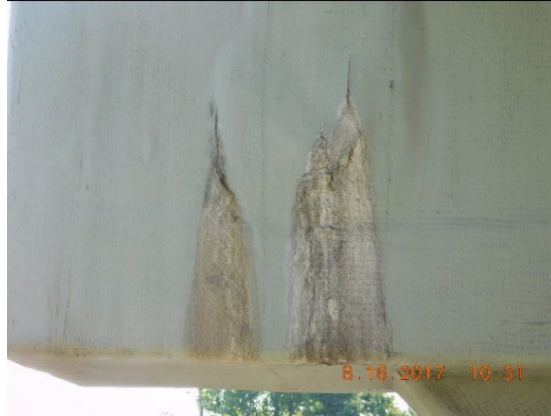
**Figure 41 FRP discoloration** (Pevey et al. 2021)

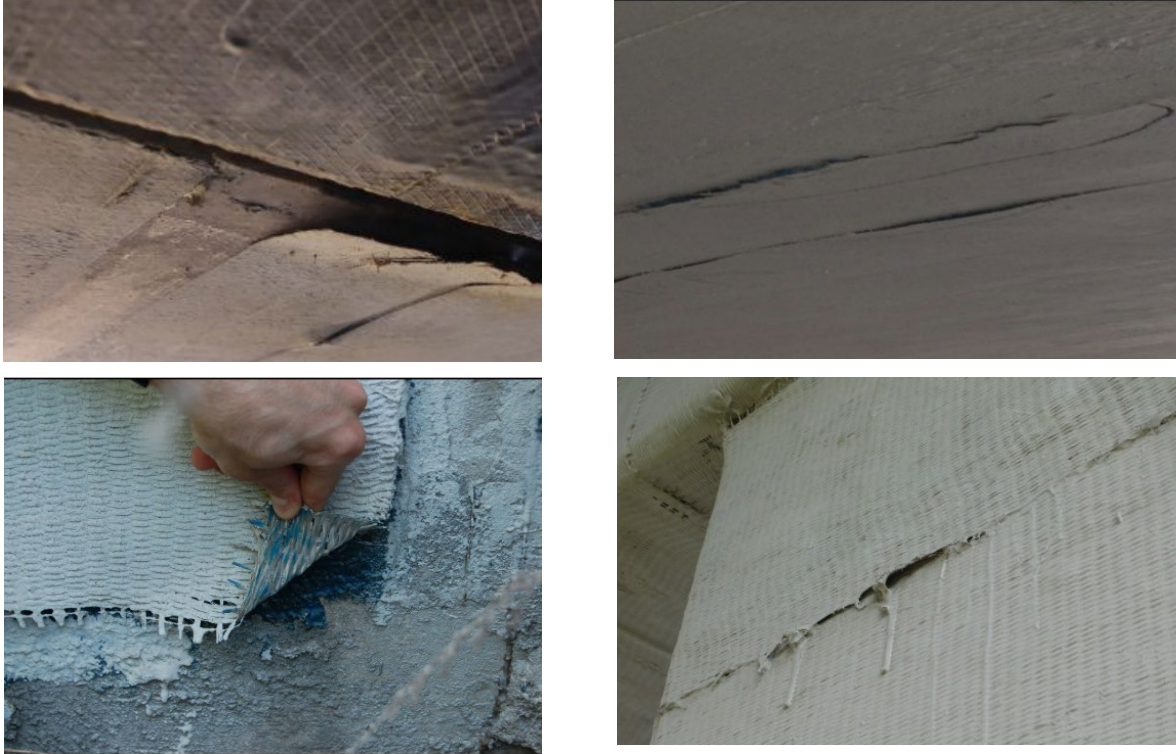
**Figure 42 Debonding** (Baniya et al. 2022; Pevey et al. 2021)

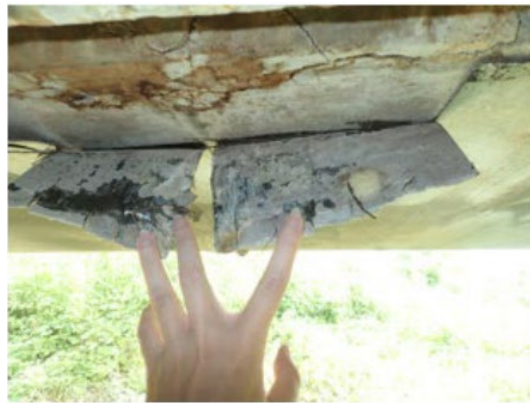
**Figure 43 End peeling** (Baniya et al. 2022)

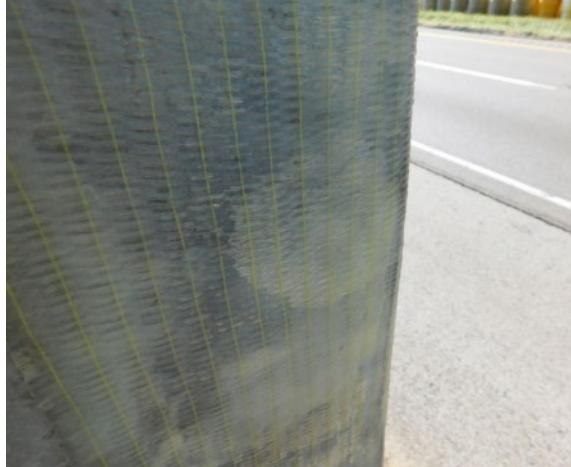
**Figure 45 Potential void** (Baniya et al. 2022)

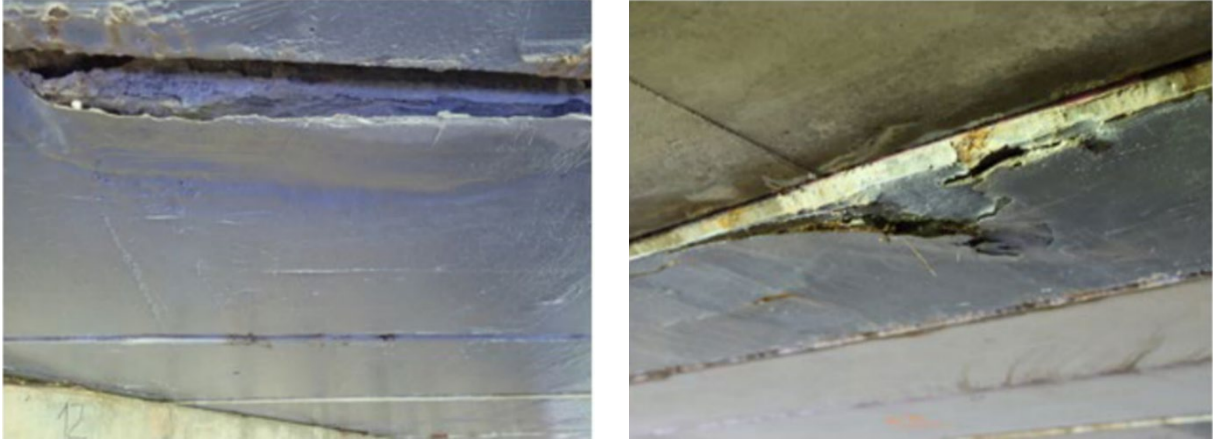
**Figure 46 Spalling of substrate concrete causing tearing of externally applied CFRP**  
(Baniya et al. 2022)

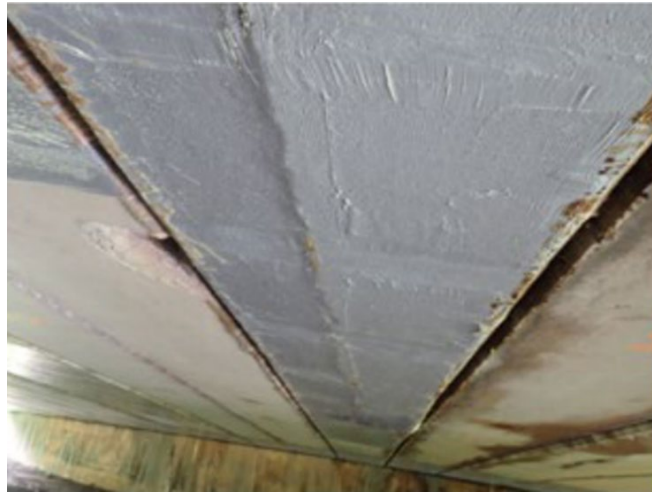
**Figure 47 Bulged CFRP layer indicating the presence of a longitudinal crack beneath**  
(Baniya et al. 2022)

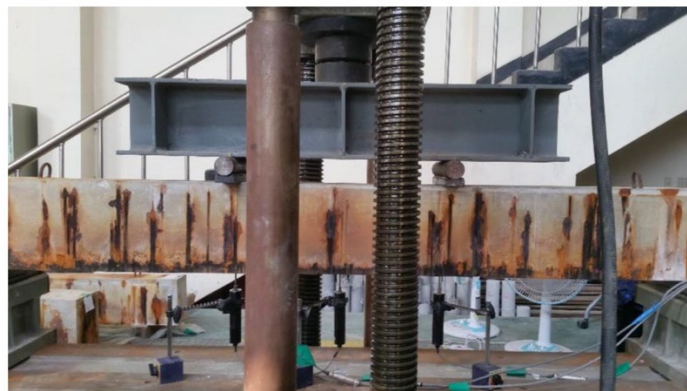
**Figure 48 Rust stains indicating corrosion of steel reinforcement in concrete substrate**  
(Jung, Jeong, and Lee 2022)

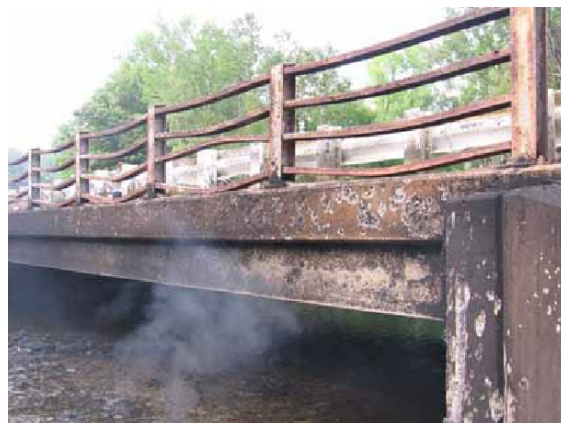
**Figure 52 Fire damage (Graybeal 2007)**

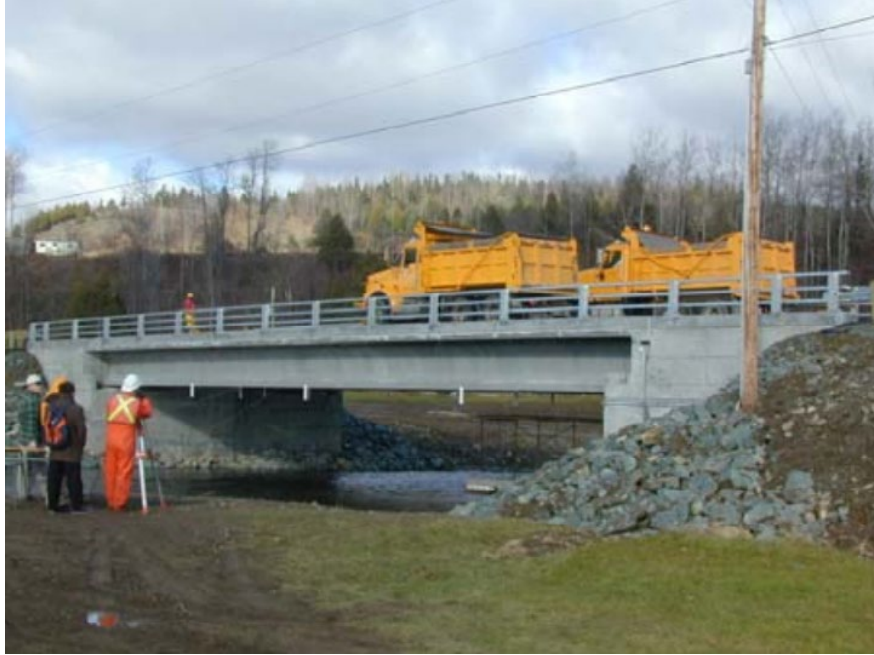
**Figure 53 Deflection measurement (El-Salakawy, Kassem, and Benmokrane 2002)**
