Development of Innovative Load Transfer Mechanism to Reduce Hurricane-Induced Failures in New and Existing Residential Construction

DEVELOPMENT OF INNOVATIVE LOAD TRANSFER MECHANISM TO REDUCE
HURRICANE-INDUCED FAILURES IN NEW AND EXISTING RESIDENTIAL
CONSTRUCTION

MASTER OF SCIENCE

CIVIL ENGINEERING

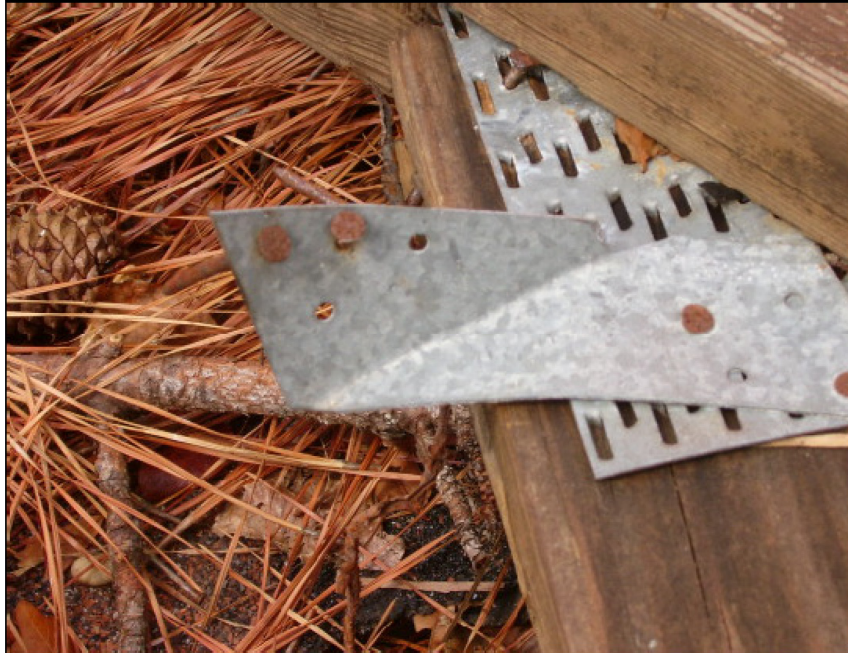
In metallic connections the failure modes could be the tear or buckling of metal plate or nail-withdrawal. Intense penetration due to nailing can crush the wood fibers. This generates cracks in the wood. Nail penetration may elevate the wood moisture content by water infiltration around the nail, resulting in corrosion of the nail as shown in Figure-1.4. Retrofitting the damaged house due to hurricanes using hurricane clips will further weaken the structural members by the intrusion of nails through the metallic plate. All the above stated problems may result in weaker connections and discontinuous load path. The severe drawbacks of intrusive connections have been demonstrated by past studies and experiments (Riley and Sadek, 2003; Rosowsky et al., 1998; Reed et al., 1997).

Figure 1-4 Failure of Hurricane clip connecting roof truss and wall with a corroded nails (Van de Lindt, 2005)

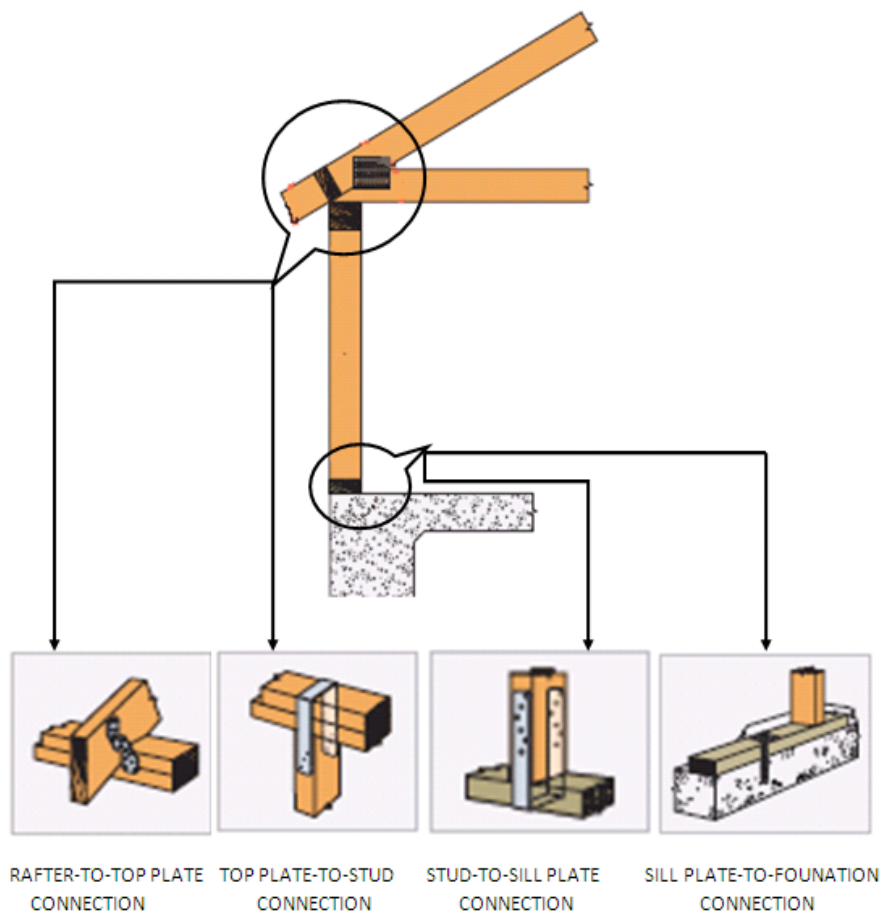
For many years, risk of significant property loss due to hurricanes seemed to be small. However failure of residential structures during Hugo (1989) and Andrew (1992) highlighted the weakness of the mechanism connecting the structural members. During hurricanes when wind blows over the top of the structure it causes suction on the roof, thus causing the roof to be lifted. These uplift forces must be transferred down to the foundation to prevent damage. Several connections are required to create a continuous load path (Figure 2.1).

Figure 2-1 Traditional connection system (T-HFCG06, Simpson Strong Tie, 2006)

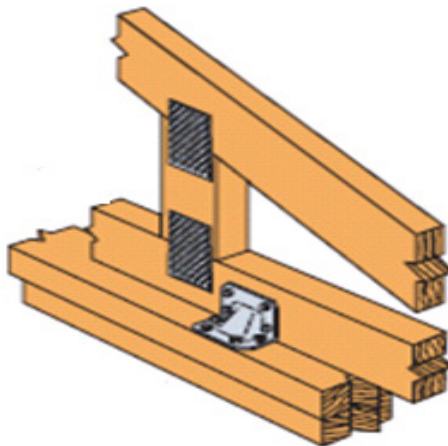
The gable end wall is a common area for wind damage. The continuous load path for the gable end wall should be from gable-end framing to the foundation. This gable end joist to double top plate connection provides resistance against the uplift forces through the roof system and transfer forces to the gable end wall framing as shown in the Figure 2.2.

Figure 2-2 Gable end wall connection (C-2008 Simpson Strong Tie, 2008)

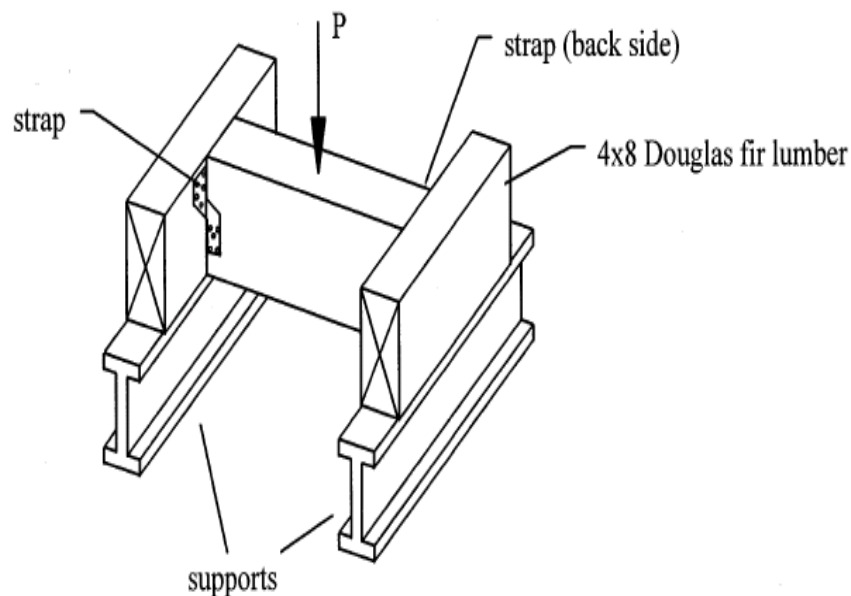
were constructed using Southern yellow pine (SYP) double top-plates and either SYP or Spruce pine fir (SPF) rafter and wall studs. The rafter was 14 in long with a 1-3/8 inch overhang to accept the top-plate. The top-plate was nailed together with the rafter using six 8d nails through the metallic hurricane clips. Uplift loads were applied using hydraulic jacks mounted to a reaction frame. The loads were applied to rafter, on either side of the top-plate at a rate of between 0.1 and 0.2 in/min. During the test load and deformation data were collected. Figure 2.3 shows the test setup for roof-to-wall connection developed by Rosowsky et al. (1998) with actual loading conditions.

Figure 2-3 Standard test setup (Rosowsky et al., 1998)

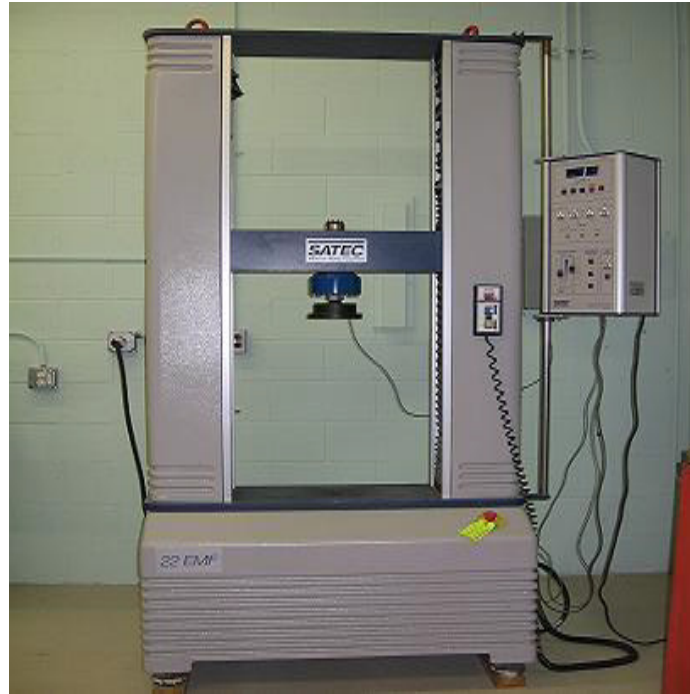
A universal testing machine with 22 kip capacity (model Mark III, 22 EMF) was used to perform all the tests as shown in Figure-3.3.

**Figure 3-3 Universal Testing Machine with 22 kip capacity
(Model Mark III, 22 EMF)**

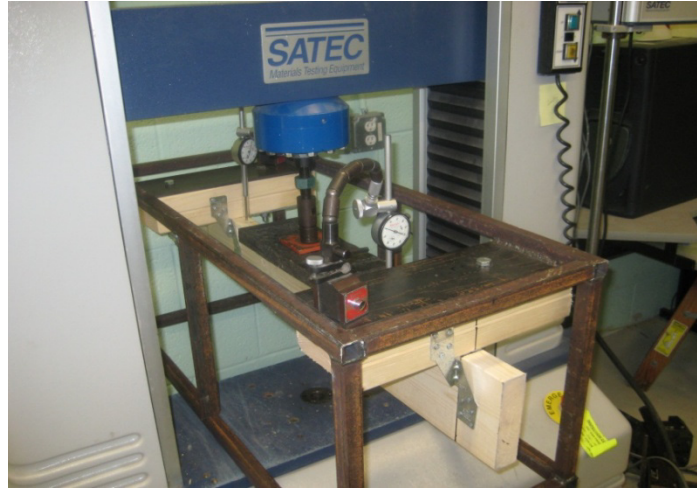
The test specimen was setup on a steel tube frame which was built with a 1 in x 1 in x 1/8 in members. SYP and SPF specimens were bolted with the steel frame as shown in the Figure-3.4. Only the DF specimen was placed on the top of the frame as shown in the Figure-3.5. Specimens were loaded at the center of the joist using a rubber pad (14 in x 6 in x 3/4 in) to spread the load over the joist from the machine. A loading rate of 0.035 in/min was maintained during the test until the ultimate load was achieved. Load at 1/8 in deflection and ultimate load at failure were recorded during each test.

Figure 3-4 Experimental setup for testing clips using SPF and SYP wood types

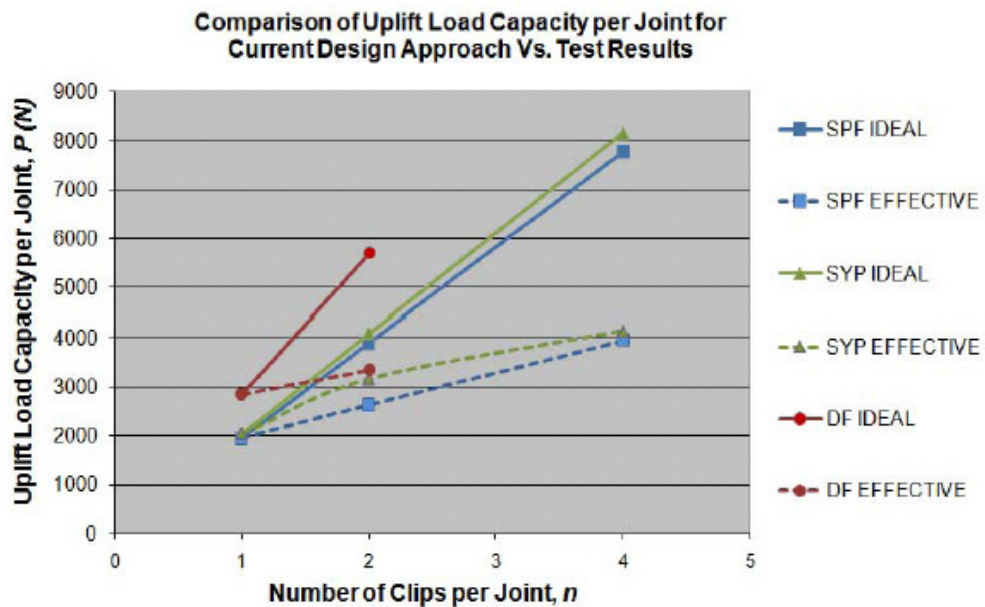
It is evident from the test results for the three wood types; allowable load capacity of the connection joint with two fasteners is less than twice the allowable load capacity of the connection with one fastener. According to the result shown in Figure 3.6, the current design practice overestimates the capacity of these joints and can therefore may results in the failure of roof to wall connection.

Figure 3-6 Comparison of uplift load capacity per joint for current design approach vs. test results.

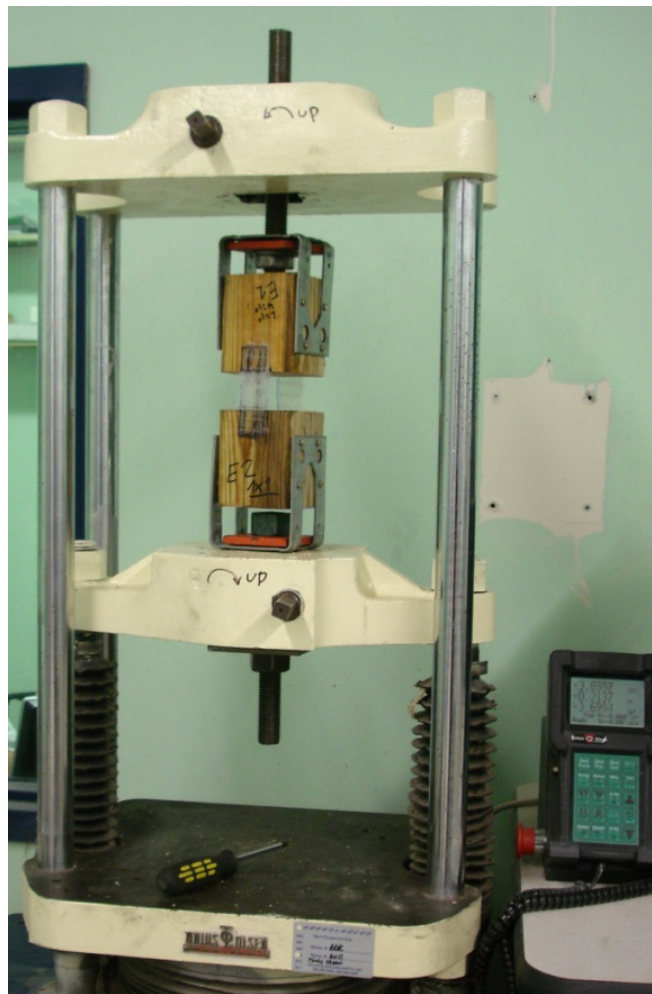
The development of roof-to-wall FRP connection was performed by Canbek (2009). In order to develop non-intrusive connection system preliminary test was done using FRP to determine the FRP-wood bond strength in shear. Specimen used for shear connection test consisted of two wood pieces with 1.5 inch spacing between them. Two pieces were joined together using two FRP ties on either side of the wood as shown in the Figure 4-1.

Figure 4-1 Shear connection test (Canbek,2009)

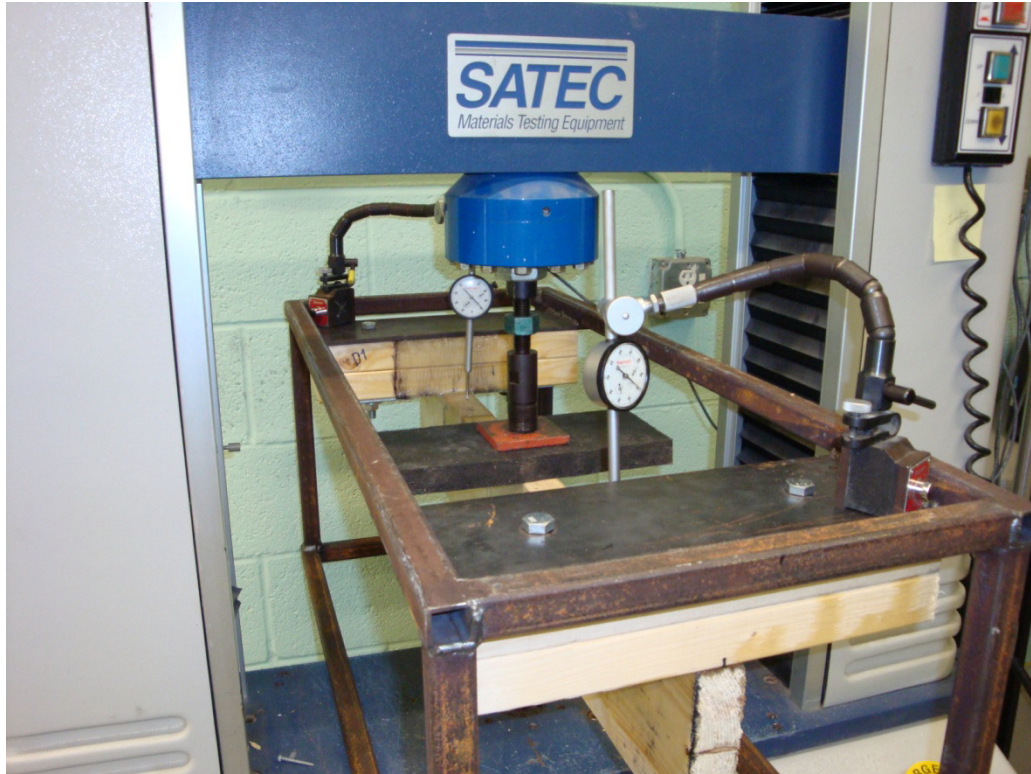
Development of roof to wall connection was started with the test specimen and test setup as shown in Figure 4-2.

Figure 4-2 Test setup for the uplift capacity of roof to wall connection(Canbek,2009)

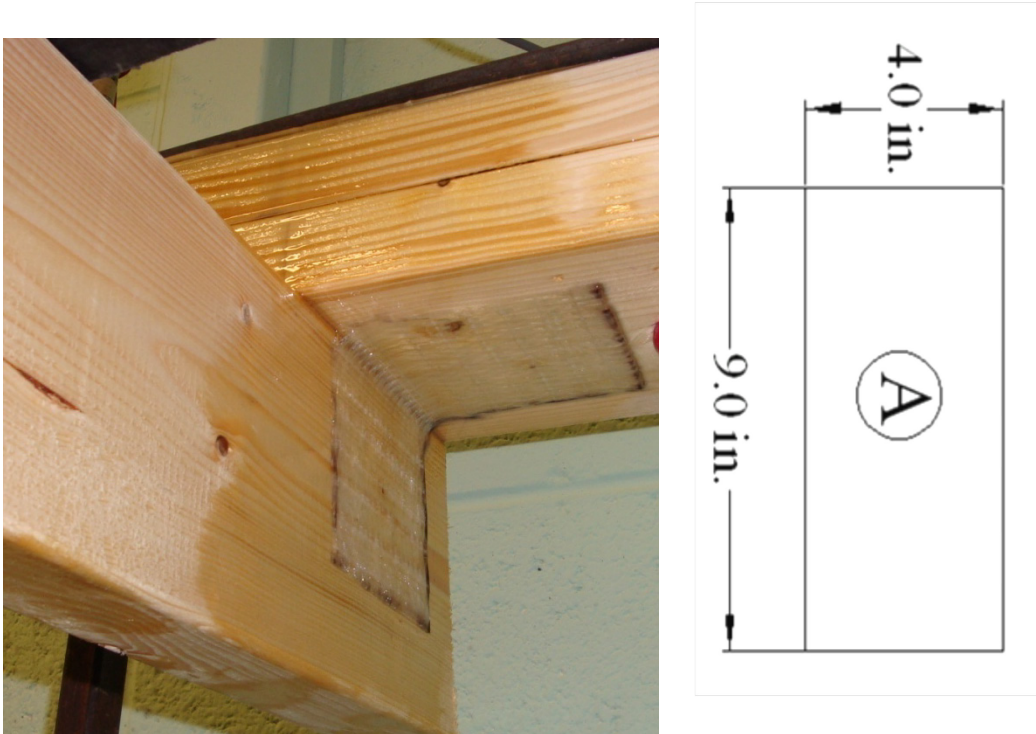
Five different configurations were tested with uni-axial CFRP and GFRP. The results showed that CFRP specimen failure load was 20% higher than GFRP. The configuration which showed that maximum failure load of 4320 lbs, is shown in the Figure 4-3.

Figure 4-3 FRP Configuration with highest uplift load capacity for roof to wall connection (Canbek, 2009)

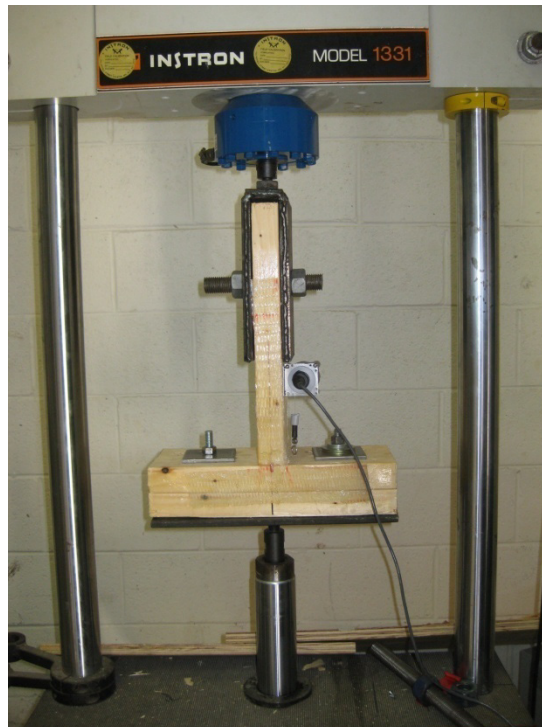
In-order to provide the upward force on the specimen, the stud simulator was attached to a U-shaped metal assembly which in turn was attached to the reacting beam. To anchor the test specimen with the U-shaped metal assembly a 1.5 inch diameter hole was drilled at the same level (4.5 inch from the top), in both of the vertical stems of the U-shape. Once the stud-simulator was placed inside the U-shaped metallic assembly, a rod was passed through the holes in the stems and the specimen. This resulted in the anchoring of the specimen with the U-shaped metal assembly and allowed for the transfer of the upward force from the reacting beam to the test specimen. This assembly is shown in Figure 4-7.

Figure 4-7 Test setup for stud to top plate connection

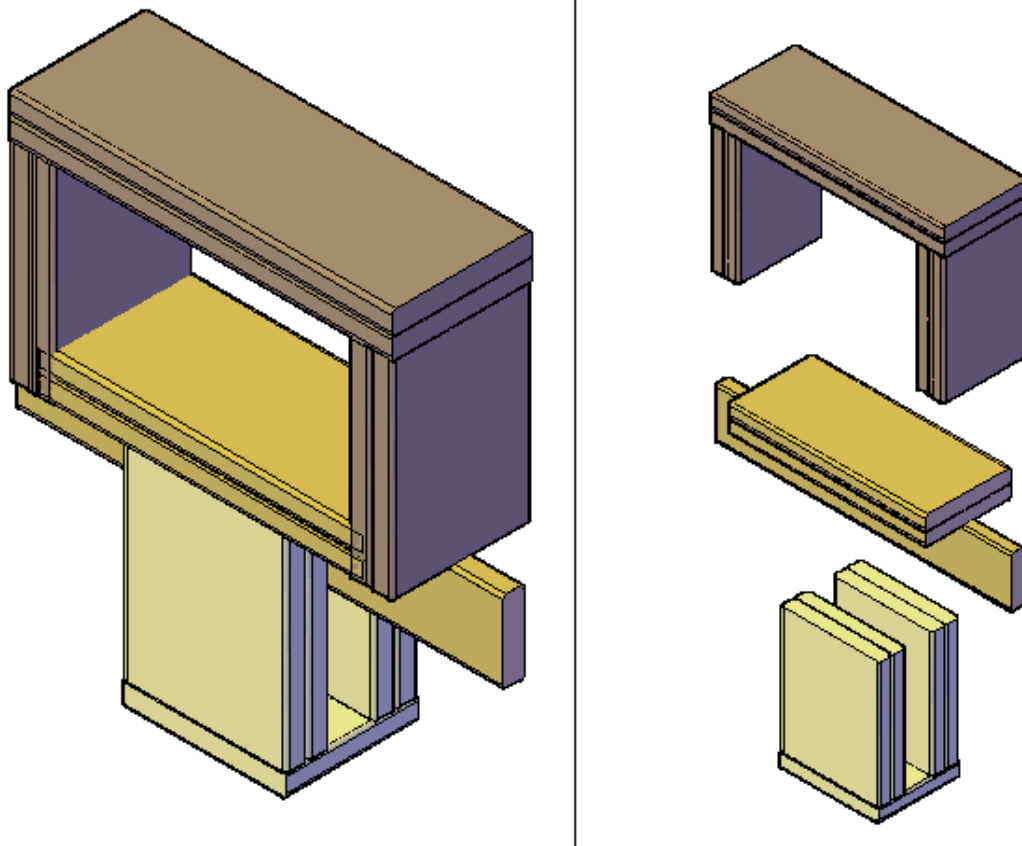
Figure 4-9 Test setup for gable end connection

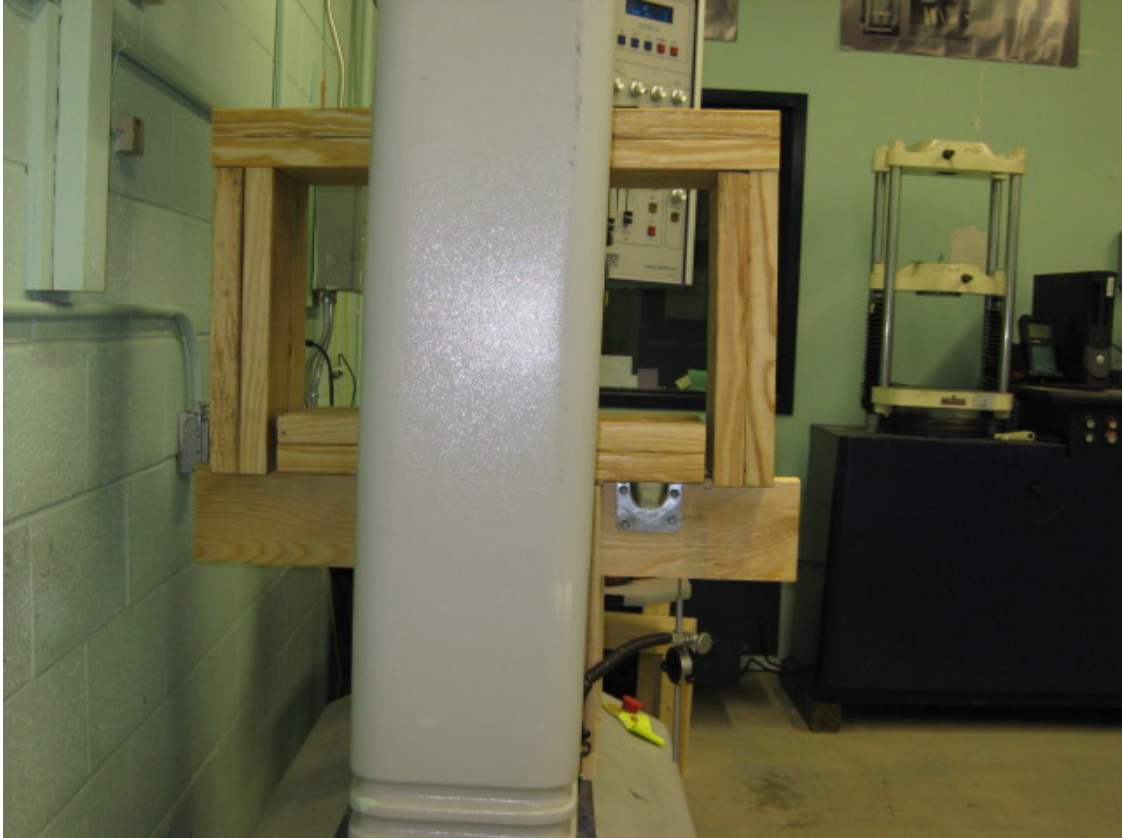
The horizontal member joining the two stems together was made of two wood pieces each with a cross-section of 2 inch x 10 inch. These two pieces were connected together using 2.0 inch nails (Figure 4-10).

Figure 4-10 Test setup for gable end connection

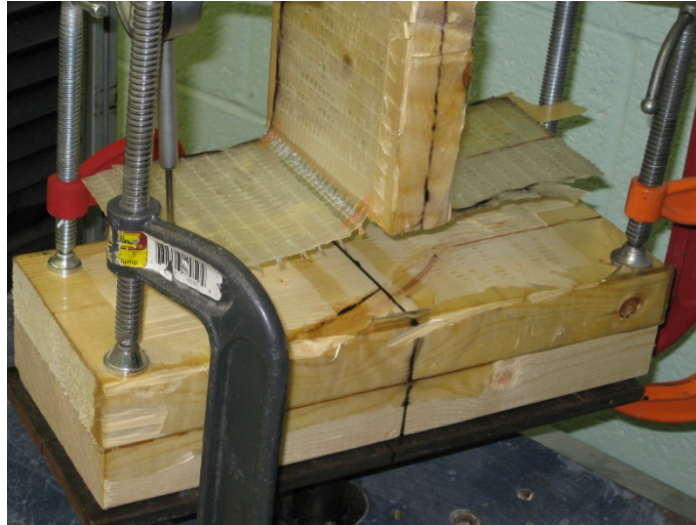
load per connection (two FRP angles per connection) was actually 170 lbs. The failure of configuration-1 was observed to be due to the peeling of the FRP from the top plate with some wood fibers attached to it as shown in the Figure 4-11.

Figure 4-11 Failure mode of Configuration-1

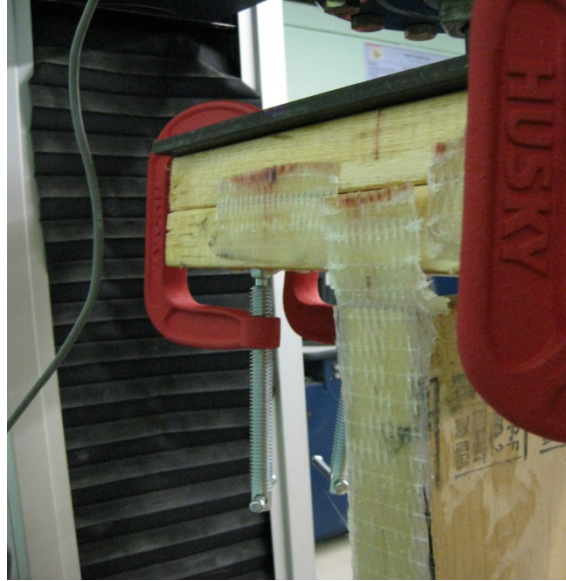
This configuration consisted of a T-shape FRP piece which was applied to the test assembly in a manner that the flange of the T-shape was attached to the double top plate and the web of the T-shape was attached to the stud. The FRP ties were attached to the front and rear side of the top and bottom connections providing two connections per specimen. The area of each T-shape FRP piece was 35.75 inch². The failure of the connection was observed at 4,050 lbs before the 0.125 inch deflection limit was reached. The factored ultimate load per connection (two T-shaped FRP pieces per connection) was found to be 1350 lbs. The failure mode of configuration-2 was determined to be shear failure from the double top plate with some wood fibers attached to it, as shown in Figure 4-12.

Figure 4-12 Failure mode of configuration-2

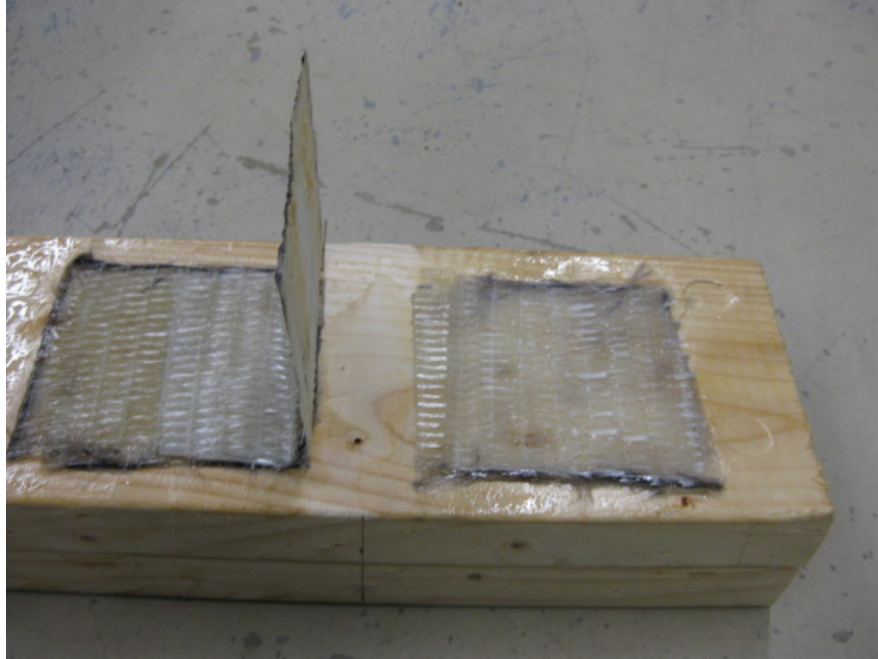
and the FRP angle connection was 54 sq inch. The failure of the connection was observed at 1560 lbs before the 0.125 inch deflection limit was reached. Therefore the factored ultimate load per connection mechanism was 520 lbs. The failure mode of configuration-1 was shear failure on one side of the stud and peeling of the upper layer of FRP on the opposite side as shown in Figure 4-13.

Figure 4-13 Failure mode of configuration-4

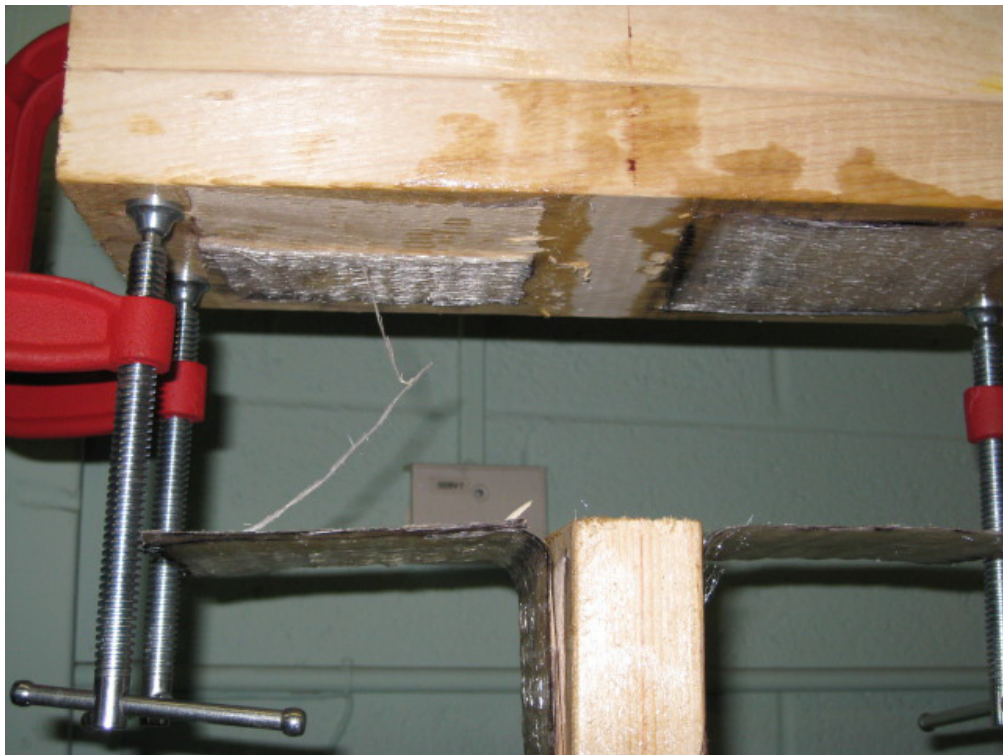
inch deflection limit was reached. Therefore, the factored ultimate load per mechanism (Two FRP connection in each mechanism) was 76.7 lbs. The failure mode of configuration-5 was peeling of the upper layer on the one side and peeling of the upper layer with the partial rupturing of the bottom layer as shown in Figure 4.14. By placing the double layer on the stud shear failure was restricted but there was no increase in the ultimate load capacity.

Figure 4-14 Failure mode of configuration-5

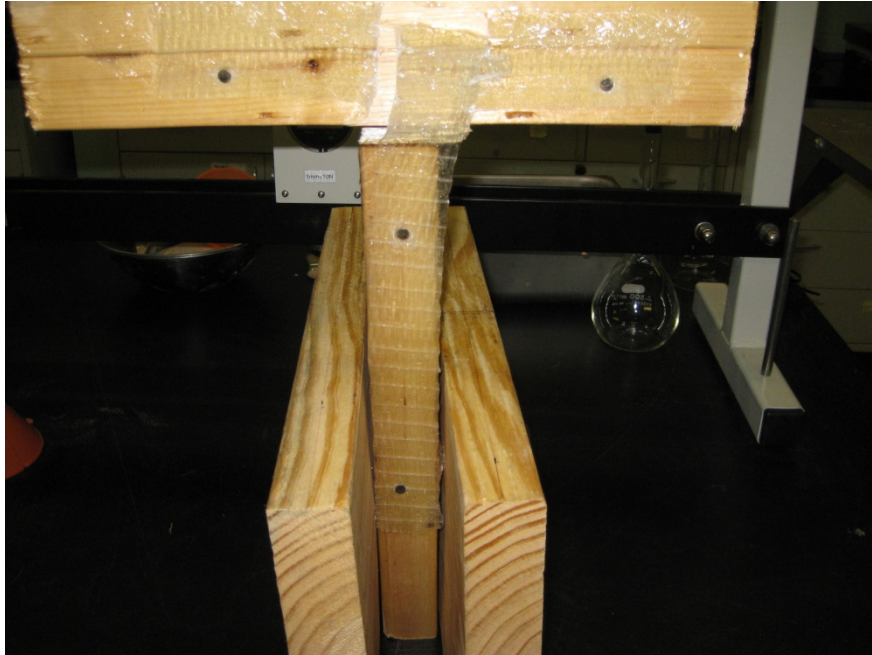
Configuration-2 was further tested with the nails (Figure 4-15) to know the effect of nailing through the FRP ties as plywood sheathing should be attached at the exterior face of the stud using nails thus puncturing the FRP ties. The failure mode of configuration-2 with nails was same as the previous test done without the nails. The failure load showed only 2.7 % decrease.

Figure 4-15 Failure mode of configuration-2 (with nails)

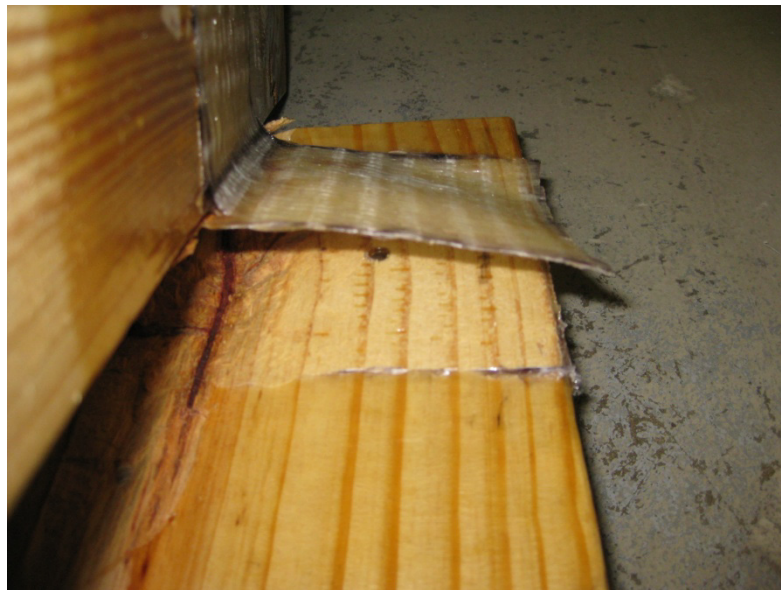
and the bottom chord such that the 4 inch length of FRP was attached on the double top plate and the rest was attached to the bottom chord of the truss (joist). The area of angle connection was 38 sq inch. The failure of the connection was observed at 2020 lbs before the 0.125 inch deflection limit was reached. Therefore, the factored ultimate load per clip was 336 lbs. The failure mode of configuration-2 was peeling from the double top plate as shown in Figure 4-16.

Figure 4-16 Failure mode of configuration-1

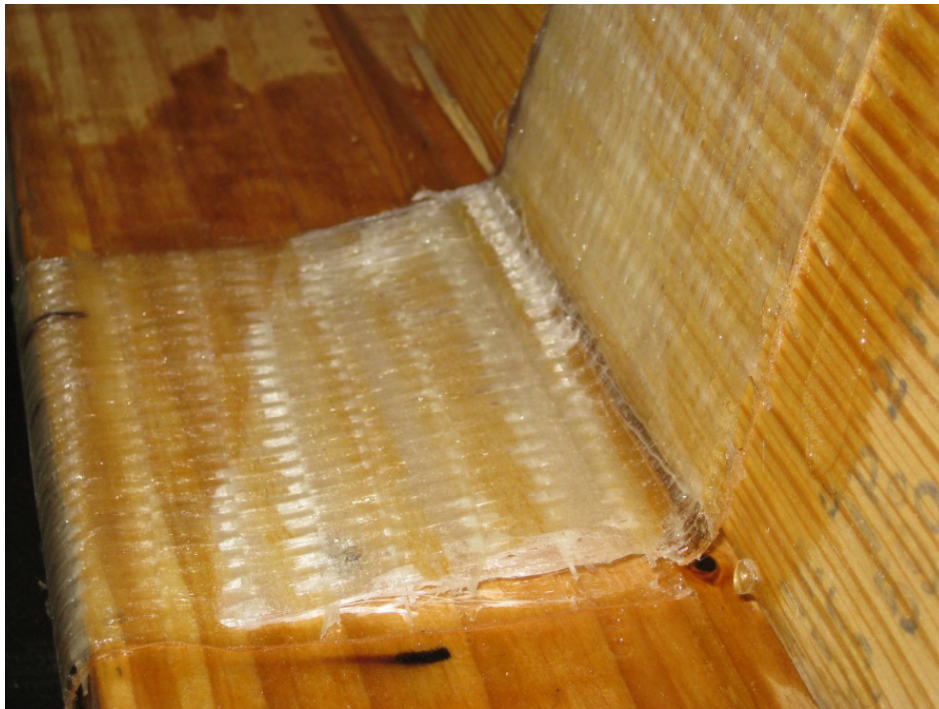
of angle connection was 56 sq inch. The failure of the connection was observed at 2900 lbs before the 0.125 inch deflection limit was reached. Therefore, the factored ultimate load per clip was 483 lbs. The failure mode of configuration-2 was the peeling of FRP from the double top plate as shown in Figure 4-17.

Figure 4-17 Failure mode of configuration-2

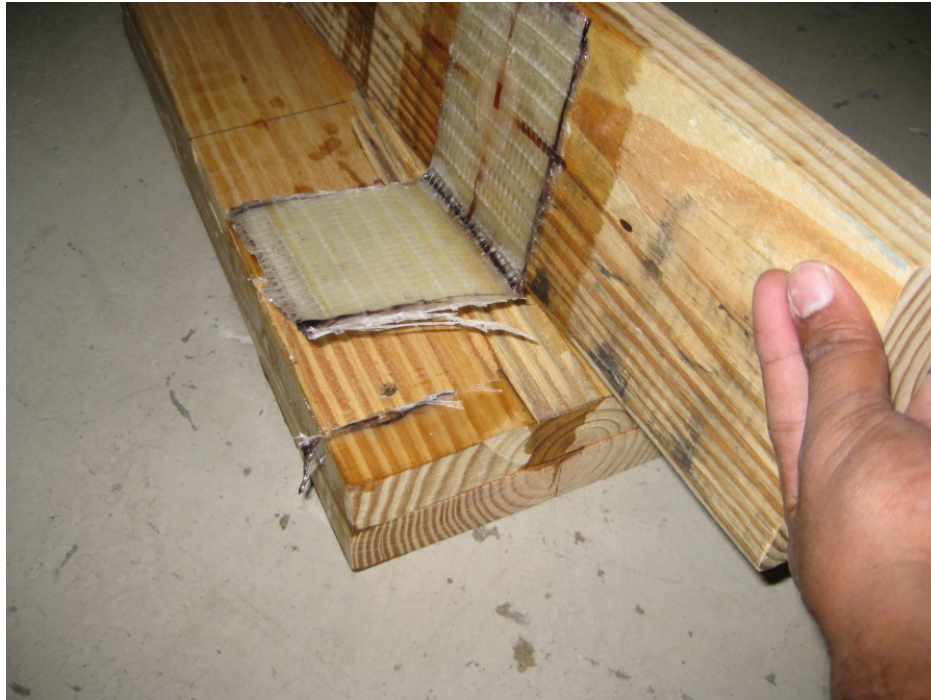
factored ultimate load per connection was 663 lbs. The failure mode of configuration-3 was the peeling of FRP from the double top plate as shown in Figure 4-18.

Figure 4-18 Failure of configuration-3

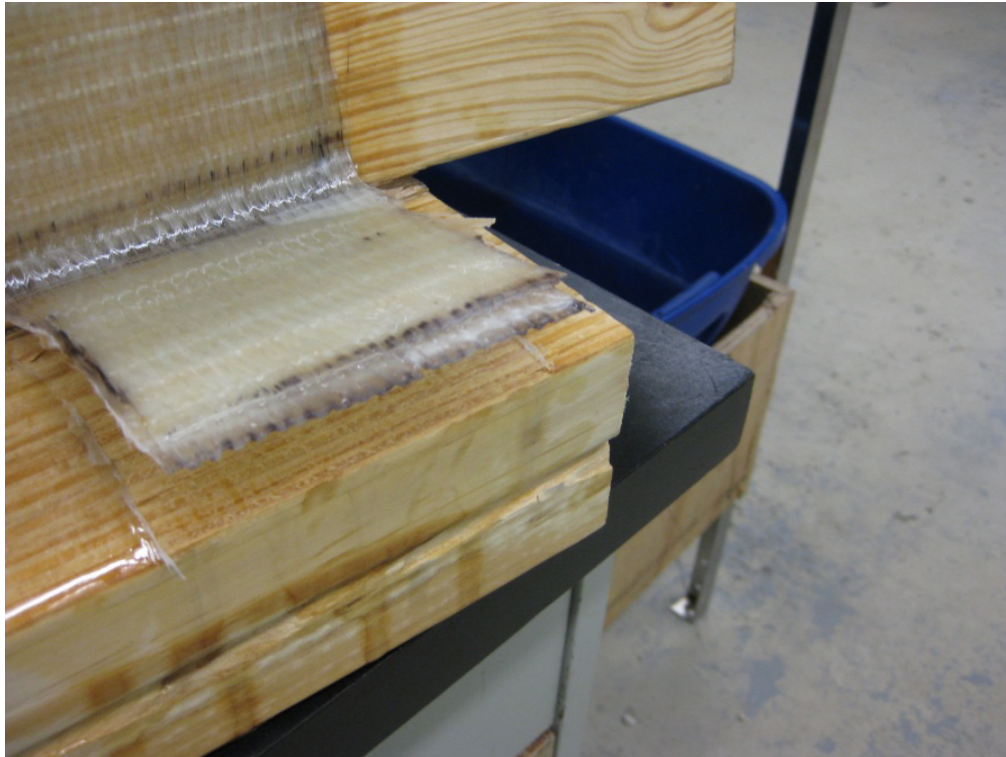
Configuration-4 was a modification of configuration-3, and involved placing an additional layer on the shear face as well. This FRP connection was applied in such a manner that before applying the folded angle FRP a 4 inch x 4 inch piece of FRP was placed on the peeling face (double top plate) and 4 inch x 5 inch piece of FRP was placed on the shear face (joist). The area of angle connection was 72 sq inch. The failure of the connection was observed at 4650 lbs before the 0.125 inch deflection limit was reached. Therefore, the factored ultimate load per clip was 775 lbs. The failure mode of configuration-3 was the peeling of FRP from the double top plate as shown in Figure 4-19.

Figure 4-19 Failure mode of configuration-4

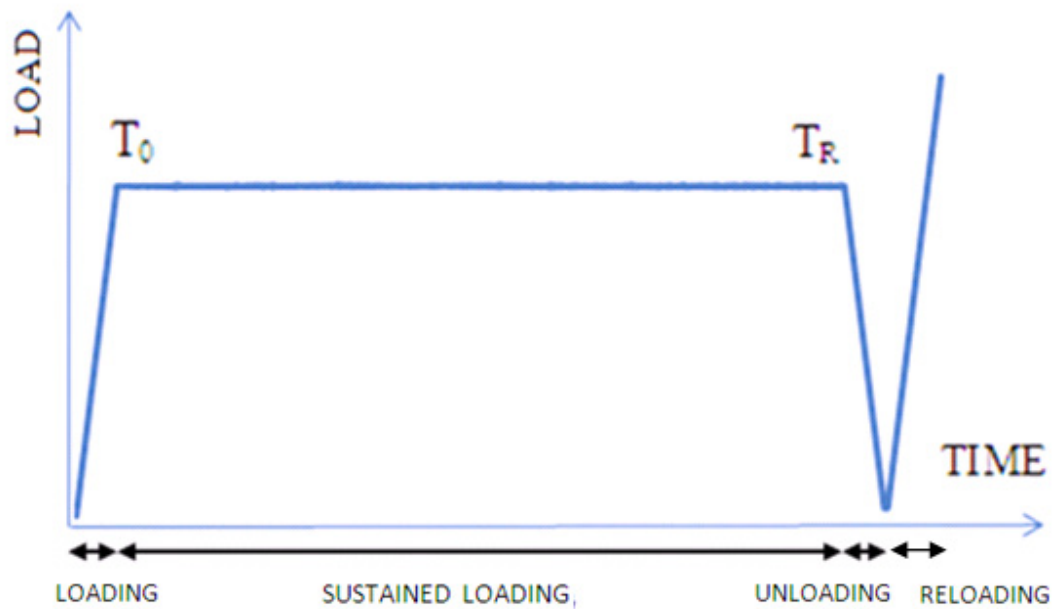
The goal of this testing was to check the short-term creep deformation of the FRP ties during 3 hours of sustained high wind force. This creep testing did not involve the effect of physical aging, temperature and long-term creep deformation. In this research each specimen was tested for three different stress ratios (nominal stress to the ultimate stress) which were 50%, 75% and 85% of the minimum failure load from the three static tests. Total 9 tests were performed with each connection, 3 tests being performed for each stress ratio. These tests were performed in accordance with ASTM D-6815-02A. According the ASTM 6815-02A the loading rate for creep test specimen should be such that the average time to attain the sustained stress level does not exceed the average time to failure of the monotonic loading test. Rate of loading was kept 3.5 lb/sec as it did not exceed the average time to failure of the monotonic loading test. The load history (Figure-4-20) was such that after time T_0 the specimen was subjected to the sustained load for up to 3 hours. Specimens that survived up to 3 hours were unloaded at T_R and loaded with a rate of 3.5 lb/sec till failure to investigate the residual ultimate strength.

Figure 4-20 Load History for creep test

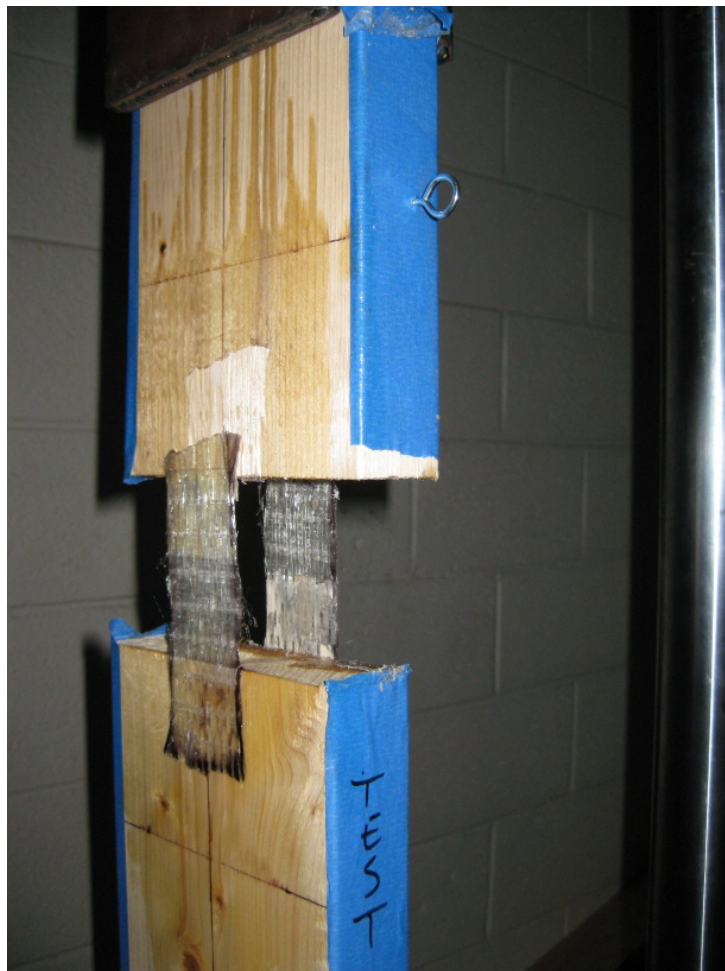
Figure 5-1 Failure mode of shear connection test.

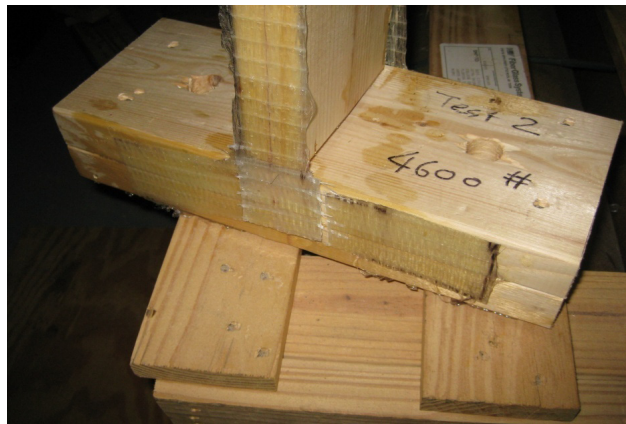
Figure 5-2 Mode of failure for stud to top plate connection

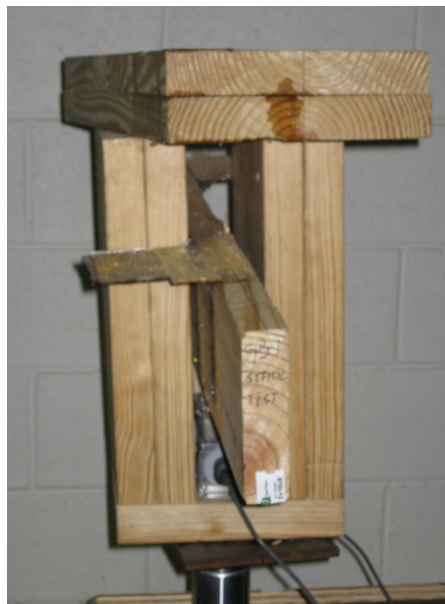
Figure 5-3 Failure mode of Gable end connection
