Evaluation of Organic Protective Coatings as Corrosion Prevention for The Interior of Subsea Pipelines in Sour Gas Service

EVALUATION OF ORGANIC PROTECTIVE COATINGS AS CORROSION
PREVENTION FOR THE INTERIOR OF SUBSEA PIPELINES IN SOUR GAS
SERVICE

MASTER OF SCIENCE

MATERIAL SCIENCE AND ENGINEERING

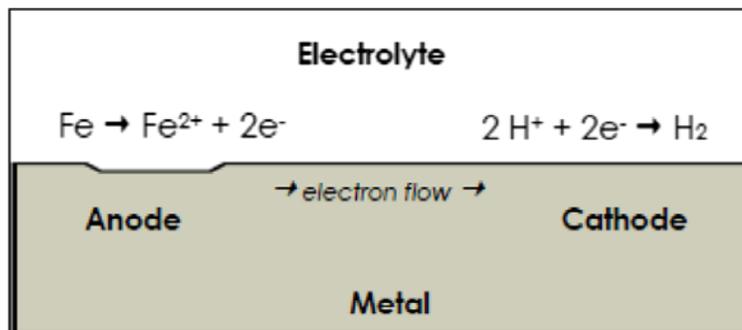
Figure 2: Corrosion Process [18].

Corrosion is an electrochemical process acknowledged by the tendency of a metal to return to its original mineral state. In order for corrosion to occur, the following four elements must always be present: 1) Anode; 2) Cathode; 3) Electrolyte; and 4) Metallic Pathway for electronic conduction. The electrolyte is the liquid medium through which dissolved ions conduct electricity by diffusing to and from the electrodes. In practice, most electrolytes are based on water solutions that contain dissolved ions which carry positive and negative charges. The anode is defined as the part of metal that corrodes by losing electrons thereby producing positively charged ions in the electrolyte. The electrons flow through the metal (or via an external circuit) to the cathode, which is defined as the less active area on the metal where electrons are consumed. Thus, the latter site is protected from corrosion. The metallic pathway between the anodic and cathodic areas enable electrons to flow from the anode to the cathode. Figure 2 is a schematic illustration of the corrosion process of metals [7].

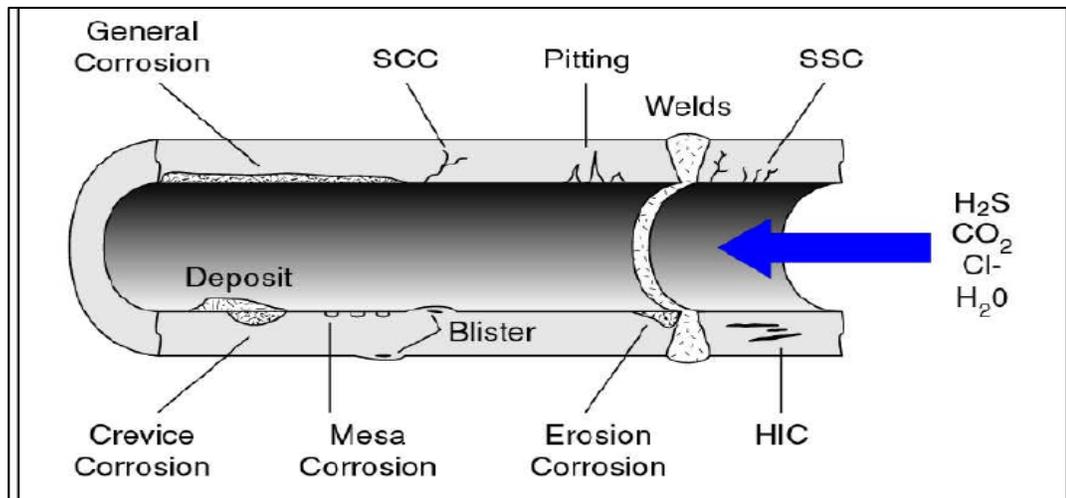
Figure 3: Corrosion Mechanisms in a Pipeline [19].

When the extracted natural gas is a wet sour gas, which contains on a molar basis up to 8% CO₂ and 5% H₂S, a predominantly sour corrosion regime can be anticipated. On the other hand, the external environment surrounding the subsea pipelines consists of shallow to medium water depth in which a typical marine type corrosion phenomenon occurs. The different forms of corrosion that may occur internally in a pipeline system is schematically illustrated in Figure 3 [7].

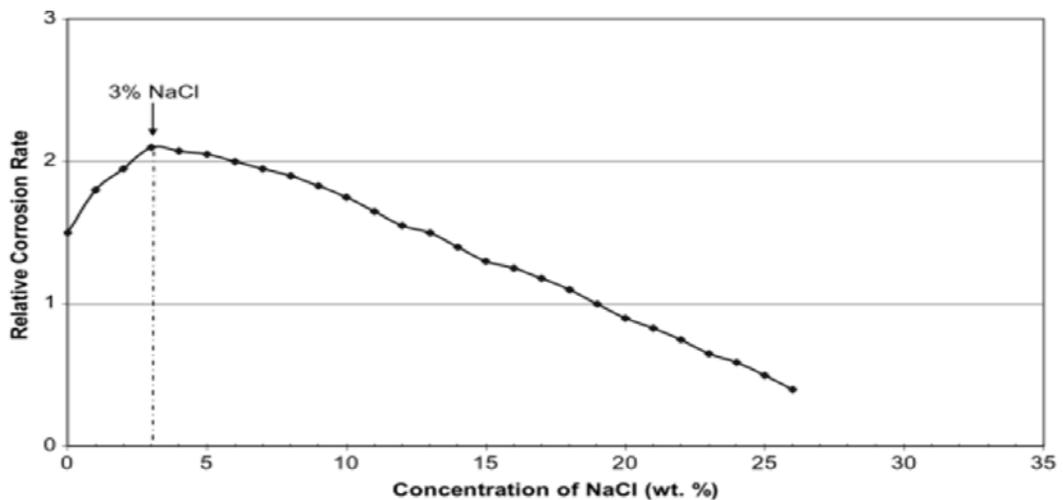
Figure 4: Corrosion rate of Fe in aerated solution at room temperature as a function of NaCl [7].

Figure 4 illustrates the change in the corrosion rate of iron at room temperature immersed in air-saturated distilled water as a function of Cl ion concentration added in the form of NaCl. It can be observed that the corrosion rate increases as the concentration of NaCl increases up to 3% NaCl. In pure distilled water, the oxygen concentration is very high as well as the solution resistance, which means that the solution conductivity is low and as a result the corrosion rate is also low. When NaCl is added to the solution it increases its conductivity, which lead to an increase in the corrosion rate. In addition, the solution conductivity reaches adequate levels for the oxygen effect to become dominant at around 3% NaCl. If the concentration of NaCl is increased above 3%, the amount of oxygen dissolved in the solution decreases, which lead to a decrease in the corrosion rate. Furthermore, chloride ions lead to the formation of localized pitting corrosion by destroying the oxide surface layers.

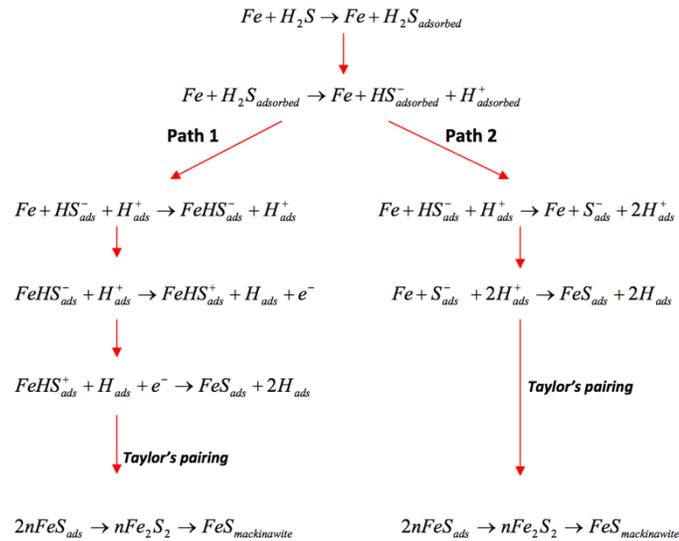
Figure 5: Mechanism for iron dissolution in aqueous solutions containing H₂S

Furthermore, another probable mechanism for iron dissolution in aqueous solutions that contain H₂S is based on the formation of mackinawite film as shown in Figure 5, which was proposed by Sun et al [2,7,12].

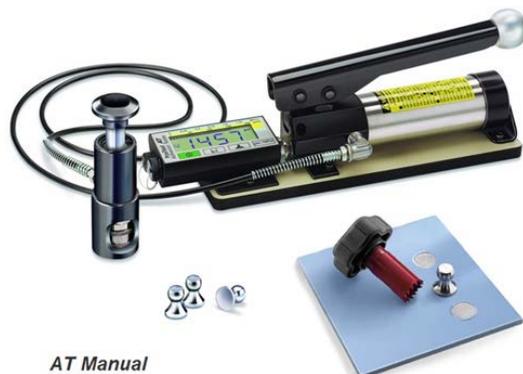
Figure 6: Pull-Off Adhesion tester.

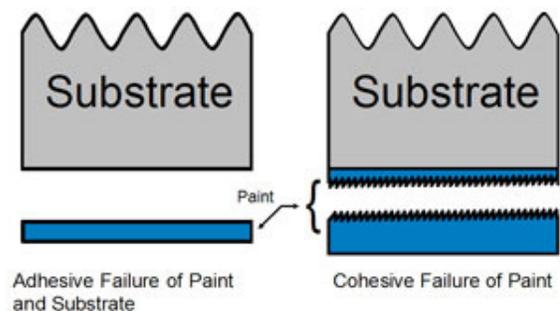
Figure 7: Adhesive and cohesive failure of coating systems [23].

- 1) Adhesive Failure: failure at the coating/substrate interface
- 2) Cohesive Failure: failure within the coating film or the substrate
- 3) Glue Failure: failure within the glue

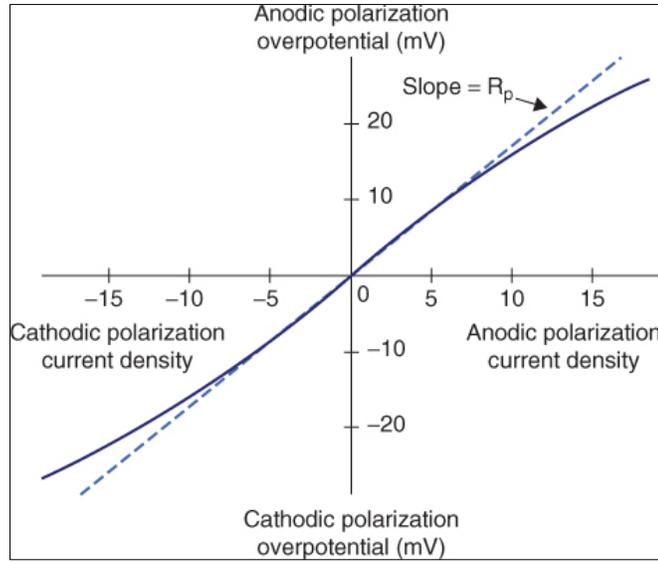
Figure 8: Applied Potential vs. Resulting Current [27].

polarization is applied in order not to interfere with the natural corrosion process. The applied potential is plotted versus the resulting current as displayed in Figure 8 [26,27].

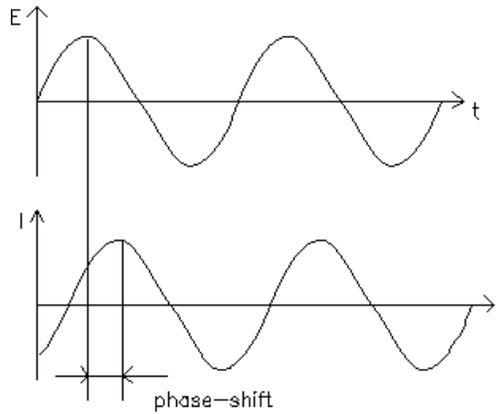
Figure 9: Sinusoidal current response to the applied AC potential in a linear system [29].

In linear systems, the current response to the applied sinusoidal potential will be a sinusoidal at the same frequency but shifted in phase as shown in Figure 9 [26,27].

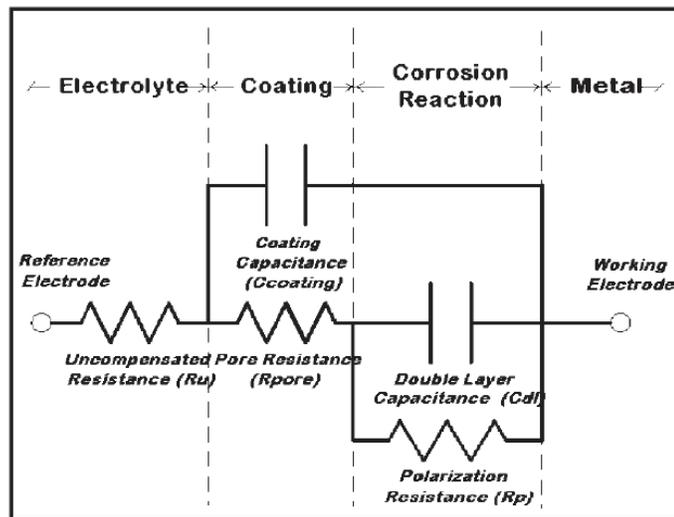
Figure 10: The equivalent circuit of an organic coating on a metallic substrate [26].

From Table 2 it can be observed that the impedance of a resistor does not have an imaginary component and thus the generated current through the resistor stays in phase with the applied voltage throughout the resistor. In contrast, the capacitor has an imaginary impedance component and therefore, the generated current through the capacitor has a phase shift of 90 degrees with respect to the applied voltage. The following Figure 10 illustrates the equivalent circuit of an organic coating on a metallic substrate [26].

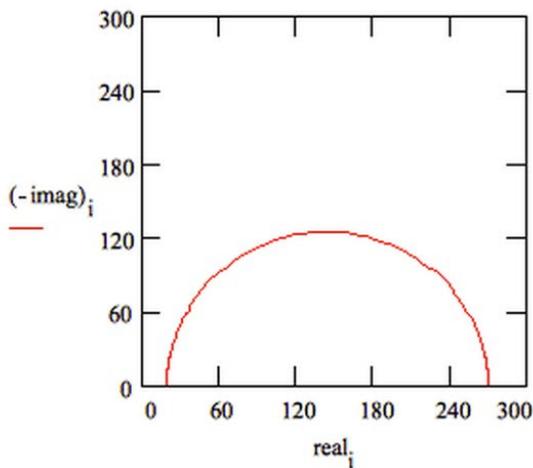
Figure 19: Nyquist Plot for Randles cell [29].

During the time of exposure, the electrolyte may penetrate the coatings through the micropores and as a result the pore resistance is decreased. Figure 19 illustrates the Nyquist plot for a coating that is developing a low pore resistance and it can be observed that it consists of a semi-circle like the Randles cell. The value of the solution resistance (R_s) can be estimated from the interception with the X-axis at the high frequency zone in the left region of the plot. In contrast, the interception with the X-axis at the low frequency region represents the sum of the pore resistance and the solution resistance ($R_{po} + R_s$). The Bode plot for the Randles cell is displayed in Figure 20. It should be noted that the phase angle does not reach 90° as is the case for pure capacitors.

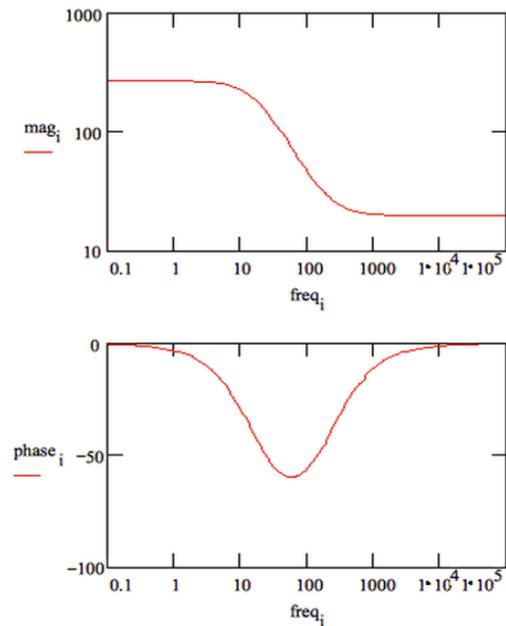
Figure 20: Bode Plot for Randles cell [29].

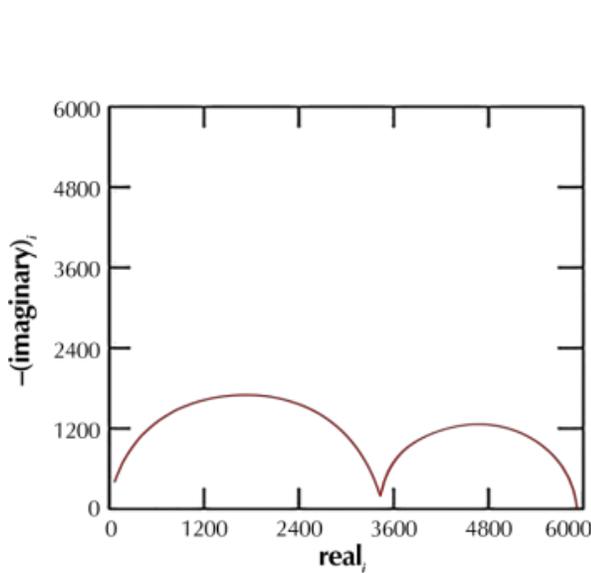
Figure 21: Nyquist Plot for a degraded coating [29].

As the electrolyte continues to penetrate through the micropores of the coating, corrosion may occur in certain areas of the metal substrate in contact with the electrolyte. The Nyquist plot for a degraded coating is shown in Figure 21, and two semi-circles are observed that represent the two time constants. The semi-circle on the left at high frequency represents the coating capacitance while the one on the right at low frequency represents the double layer capacitance. The Bode plot for the same degraded coating is illustrated in Figure 22 and a significant drop is noticed in the total impedance of the coating at low frequency.

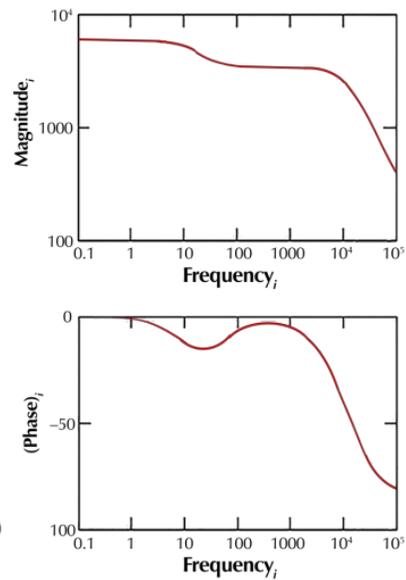
Figure 22: Bode Plot for a degraded coating [29].

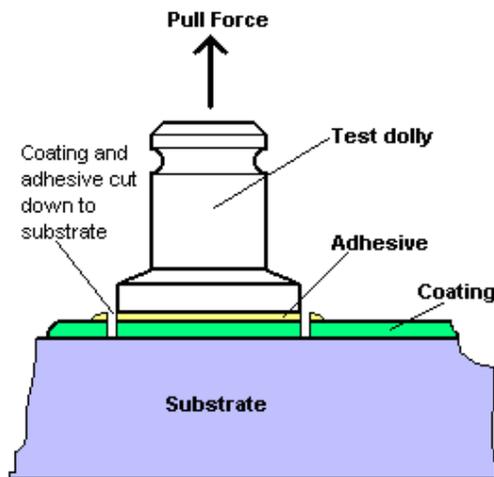
Figure 23: Test dolly glued on a coated substrate [31].

Figure 23 illustrates a test dolly glued on a coated substrate. The coating and adhesive are cut down to the substrate in circular shape around the test dolly. Afterwards,

the test dolly is pulled and the force required to detach the coating from the substrate is recorded. According to literature, the test results may be affected by several factors such as temperature, glue mixing, preparation of the coated panels the actual performance of the test.

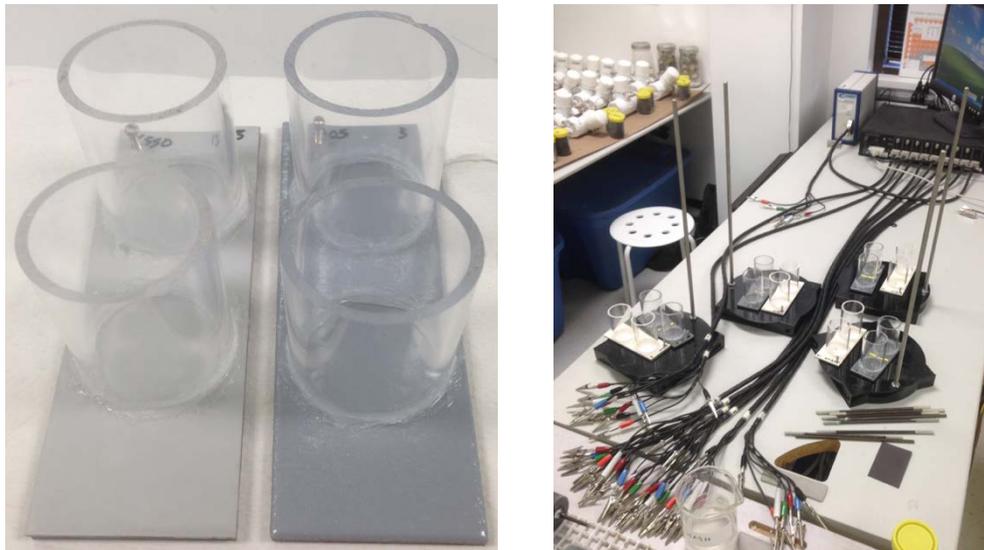
Figure 25: Acrylic tubes glued on coated panels

Figure 26 displays the Gamry Electrochemical Multiplexer ECM8 with eight possible connections to coated panels for conducting EIS testing. Figure 25 shows two coated test panels with the acrylic cylinders glued on both panels.

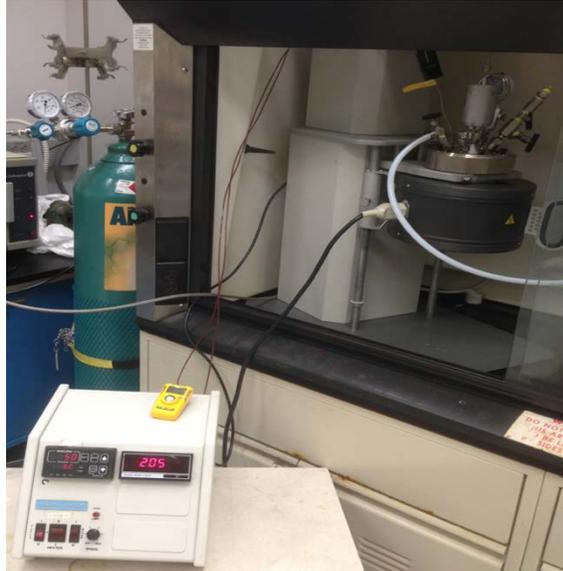
Figure 29: Parr Bench Top Reactor and Temperature Controller.

Parr Bench Top Reactor (Series 4525) which is shown in Figure 29 was used to simulate the sour gas environment. A 1000 mL autoclave with a maximum pressure rating of 1900 psig was employed to conduct the test at a maximum temperature of 350 °C. A Parr Model 4842 Temperature Controller was used to control and monitor the autoclave temperature.

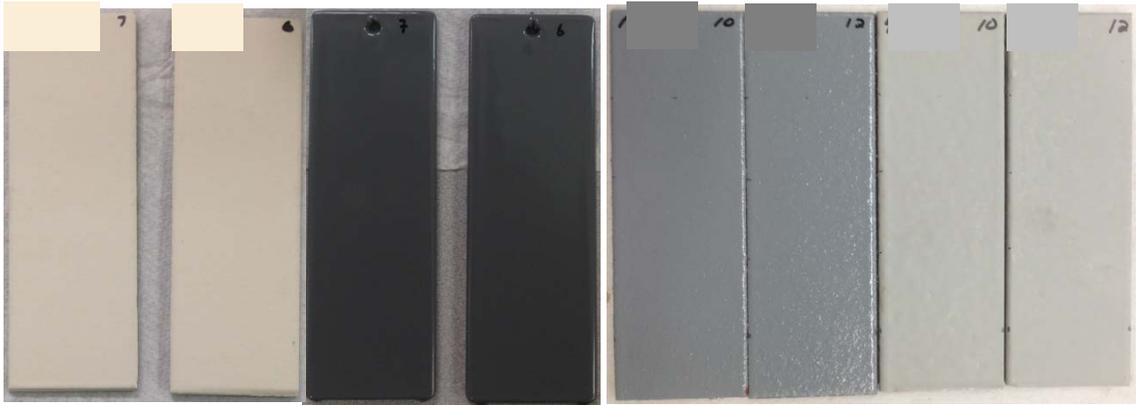
Figure 31: Phenolic Epoxy & FBE as received.

Figures 31 and 32 displays the as-received coated panels of the four products. Furthermore, Figures 33 and 34 illustrate the four products with the applied pinhole (3 mm Diameter Hole). The depth of the pinholes is measured by the use of Vernier Caliper.

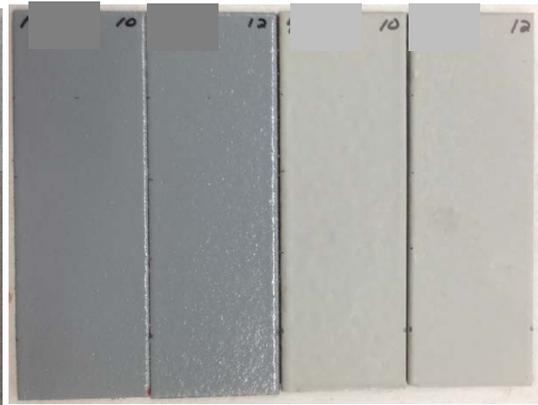
Figure 32: Amine Novolac & Novolac Epoxy as received.

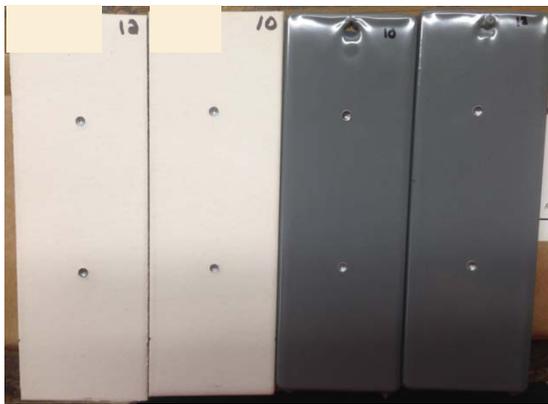
Figure 33: Phenolic Epoxy & FBE with defect.

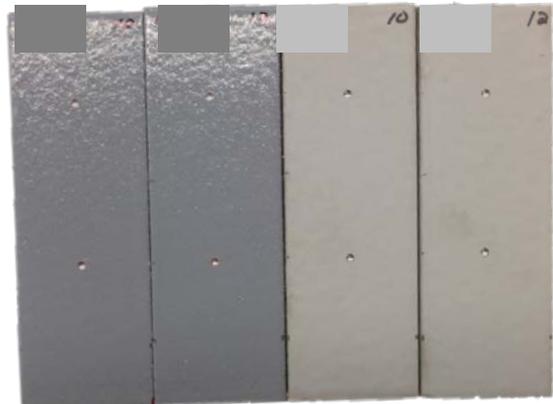
Figure 34: Amine Novolac & Novolac Epoxy with defect.

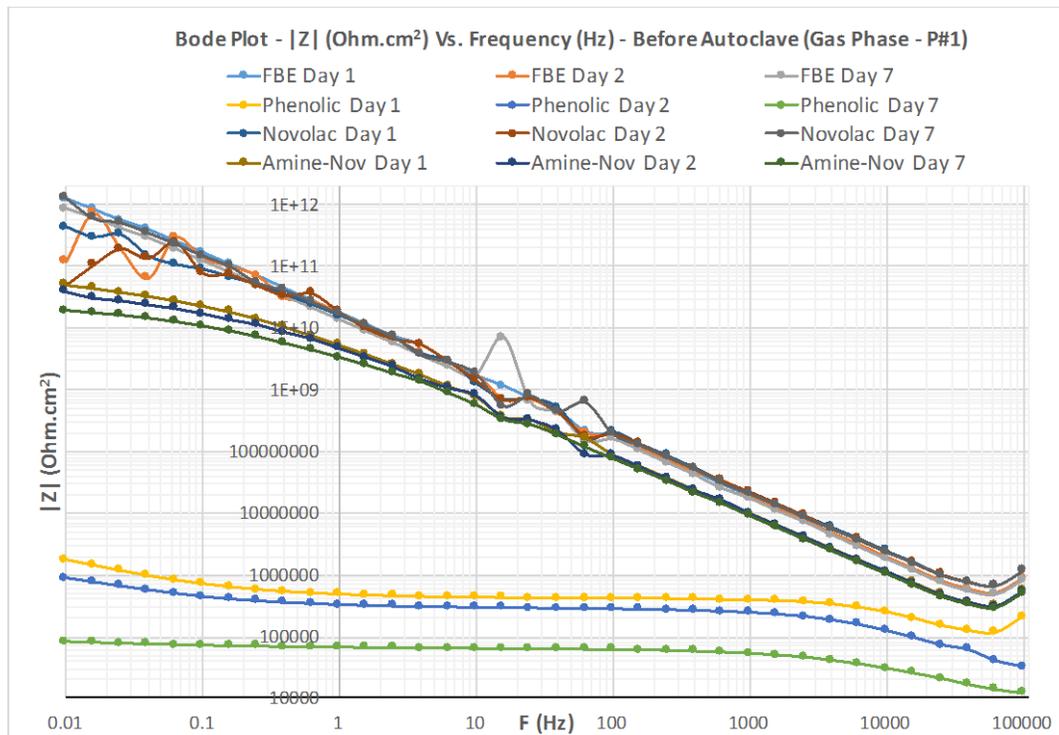
Figure 35: Bode Plot of all coatings for panel #1 in the gas phase.

The Bode plot results of the as-received coatings for panel #1 in the gas phase is shown in Figure 35. All the results were replicated and the Bode plot results of all coatings for panel #3 in the gas phase is included in the appendices. From the Bode plot it can be observed that the measured impedance for both the FBE and Novolac coatings were high significantly in the lower ranges of frequency and remained steady over the seven days of EIS testing. Also, the Amine Novolac coating had excellent impedance however, it decreased with time whereas the Phenolic coating had very low impedance compared to the other 3 coatings and it decreased over time. Figure 36 displays the Bode plot for panel #1 in the liquid phase. The impedance results of the liquid phase were very close to the results of the gas phase since measurements were taken before the autoclave test.

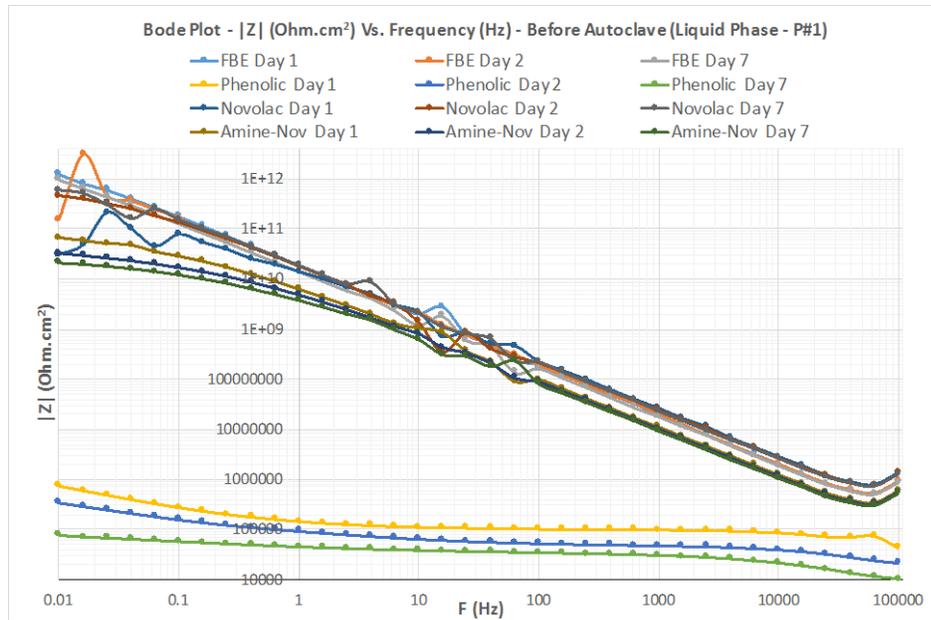
Figure 36: Bode Plot of all coatings for panel #1 in the liquid phase.

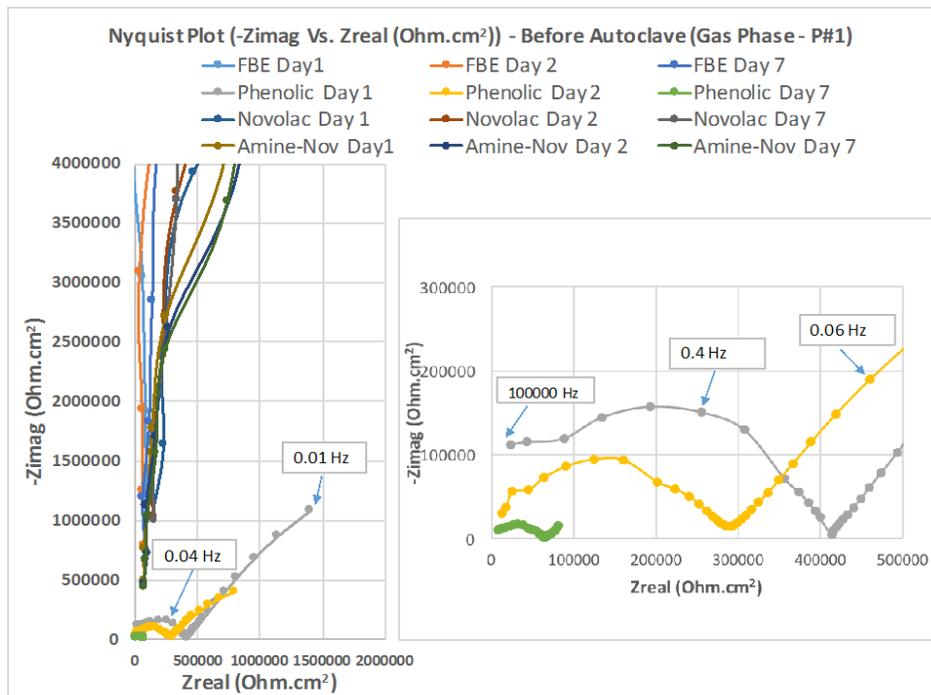
Figure 37: Nyquist Plot of all coatings for panel #1 in the gas phase.

Figure 37 shows the Nyquist plot for panel #1 in the gas phase. It can be noted that both the FBE and Novolac coatings behaved like almost perfect capacitors and this behavior was represented by a vertical line in the Nyquist Plot. Additionally, the Amine Novolac

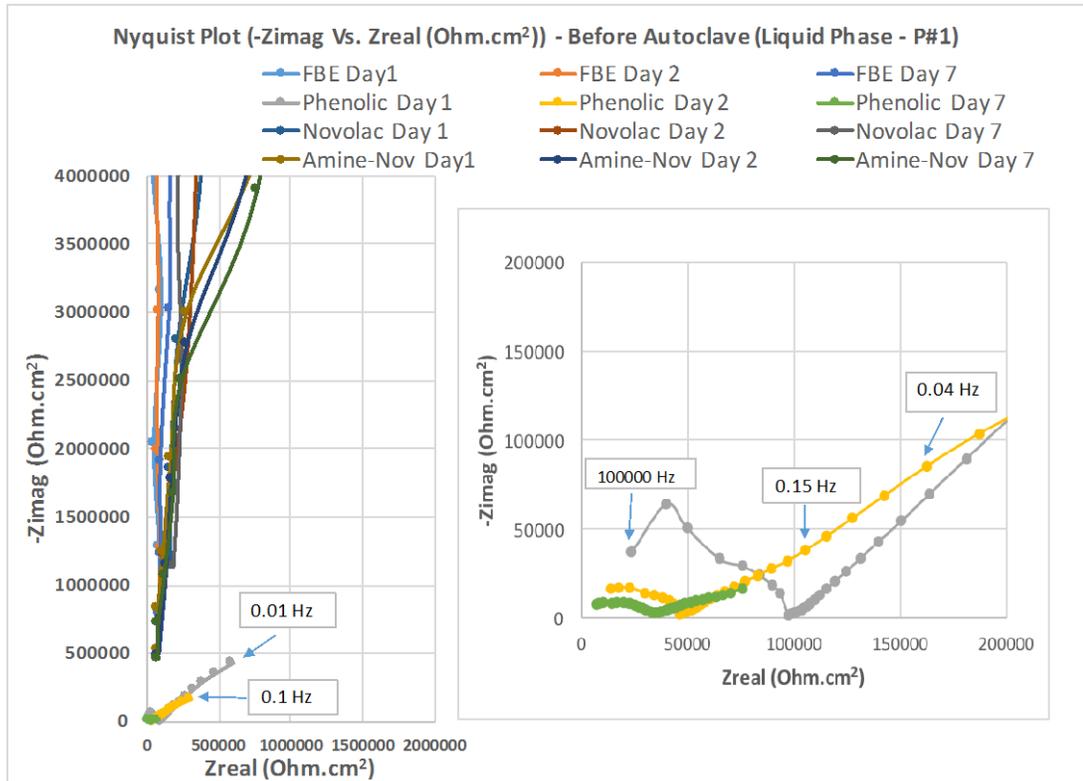
Figure 38: Nyquist Plot of all coatings for panel #1 in the liquid phase.

coating showed capacitive behavior and had high impedance. In contrast, the Phenolic coating had low impedance and the pore resistance significantly decreased over time. The decrease in pore resistance (R_{po}) indicate that the electrolyte penetrated through the coating and reached the metal surface. This behavior of a degraded coating is usually represented with two semi-circles in the Nyquist plot which was the case for the Phenolic coating. Figure 38 demonstrates the Nyquist plot for panel #1 in the liquid phase and it can be observed that the results were similar to the gas phase results. The FBE and Novolac coatings behaved like capacitors and the Amine Novolac coating had also high impedance. While the Phenolic coating behaved like a degraded coating with two semi-circles in the Nyquist plot and had low impedance which decreased over time.

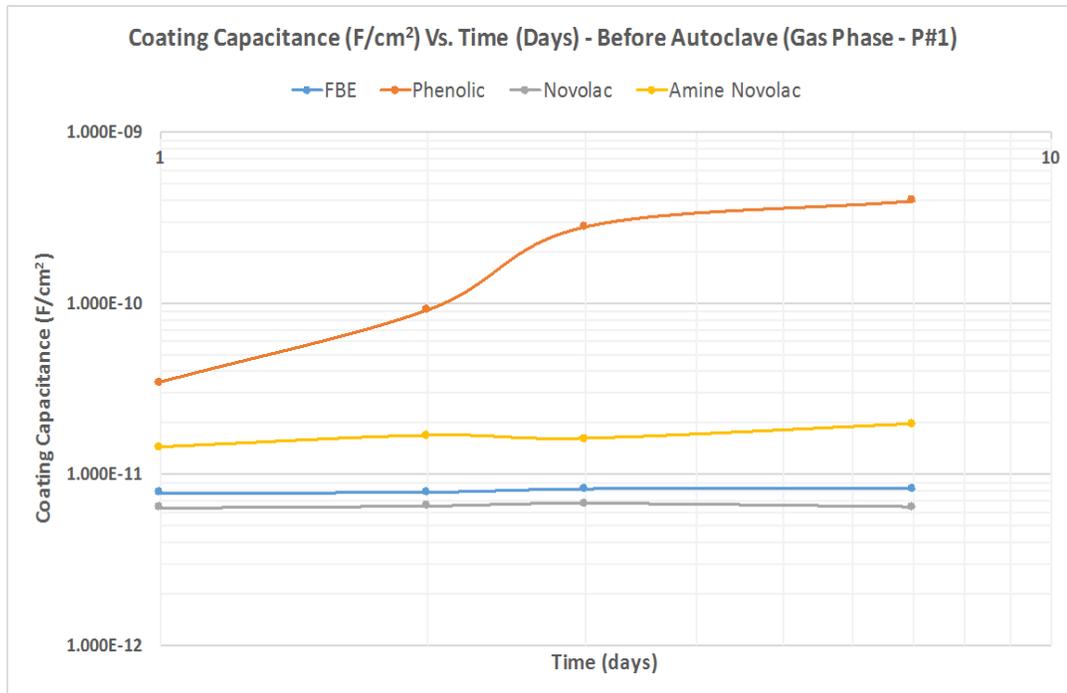
Figure 39: Coating Capacitance (F/cm^2) for panel #1 in the gas phase.

The EIS results of the as-received coatings were fitted to the appropriate electrical equivalent circuit (EEC) and the coating capacitance (C_c) and pore resistance (R_{po}) of each coating were determined over the week of EIS testing. The coating capacitance is a measure of the water and electrolyte ingress in the coating. Figure 39 displays the capacitance of each coating for panel #1 in the gas phase. The FBE and Novolac coatings exhibited low coating capacitance which indicated that there was no significant water absorption by both coatings. Additionally, the coating capacitance of the Amine Novolac was also low yet, it slightly increased over time. On the other hand, the Phenolic coating had relatively low capacitance over the first few days however, it increased with time which suggested that water and ions may have penetrated the coating through the pores. Figure 40 illustrates the coating capacitance for panel #1 in the liquid phase. The results were very similar to the results of the gas phase and the Phenolic capacitance increased with time.

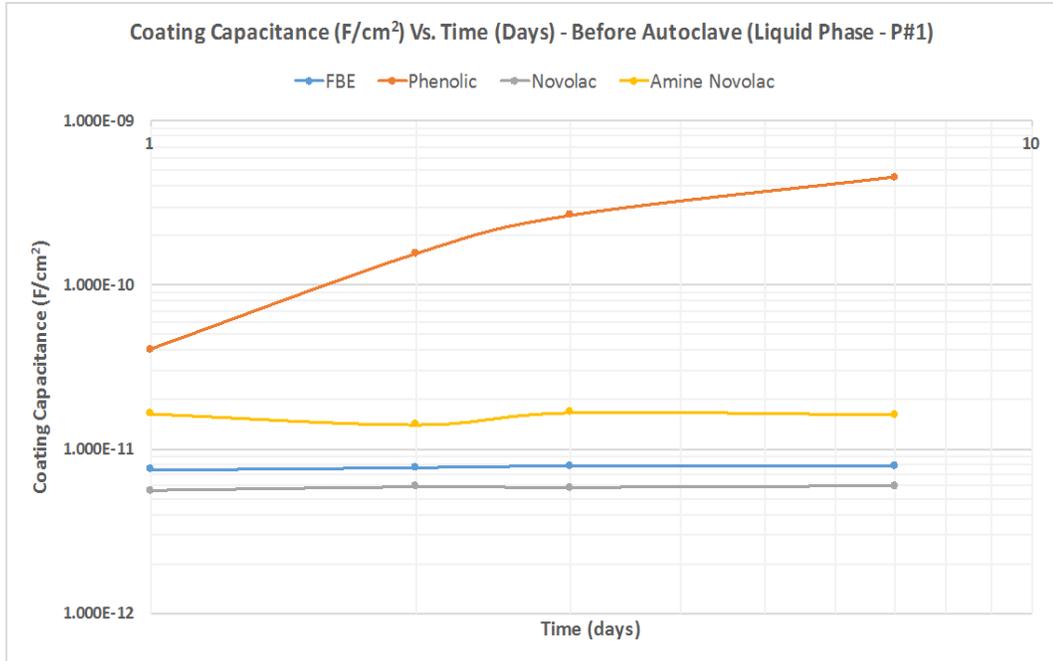
Figure 40: Coating Capacitance (F/cm²) for panel #1 in the liquid phase.

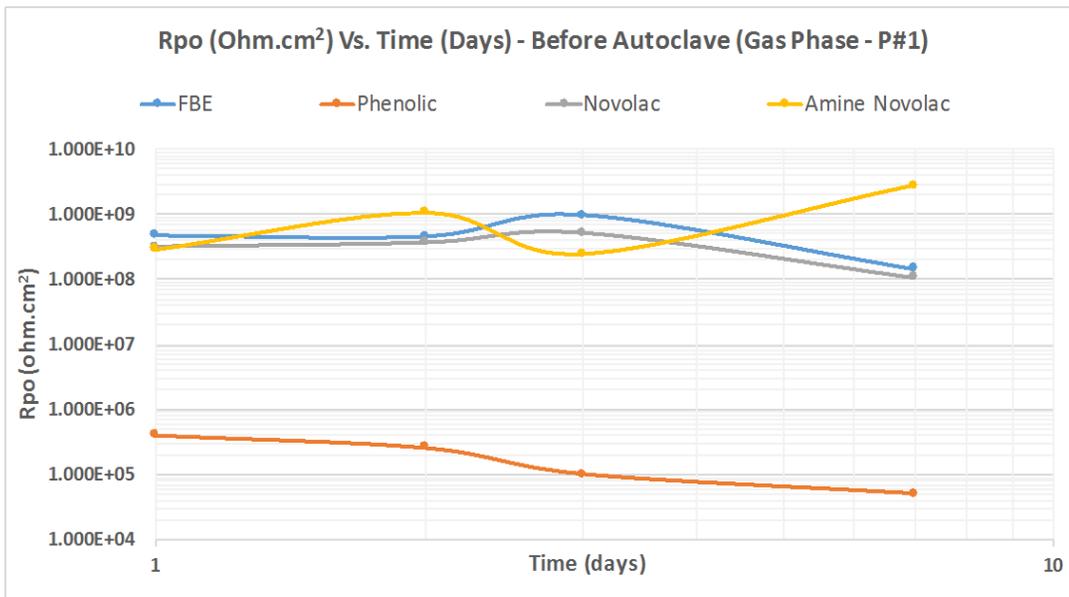
Figure 41: Pore Resistance (R_{po}) for panel #1 in the gas phase.

Figure 41 demonstrates the determined pore resistance (R_{po}) of all coatings for panel #1 in the gas phase over the week of EIS testing in 3% NaCl solution. It can be observed that the FBE and Novolac coatings had high pore resistance which implied that the micropores of both coatings had high ability to resist the flow of current and electrolytes.

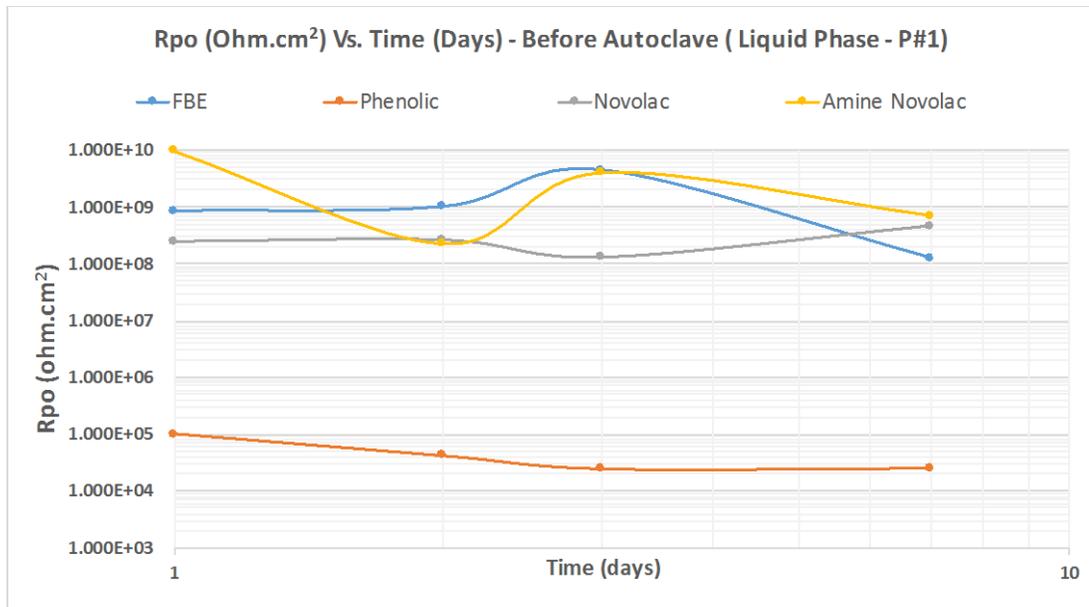
Figure 42: Pore Resistance (Rpo) for panel #1 in the liquid phase.

In addition, the Amine Novolac coating had high pore resistance over the time of exposure which indicated that the Amine Novolac was considered a high performance coating before exposure to the sour gas environment. On the other hand, the Phenolic coating exhibited low pore resistance and it decreased over time which implied that the electrolyte may have penetrated through the coating layers and reached the metal surface. Figure 42 displays the determined pore resistance (Rpo) of all coatings for panel #1 in the liquid phase and it can be observed that the trends are similar to the gas phase trends.

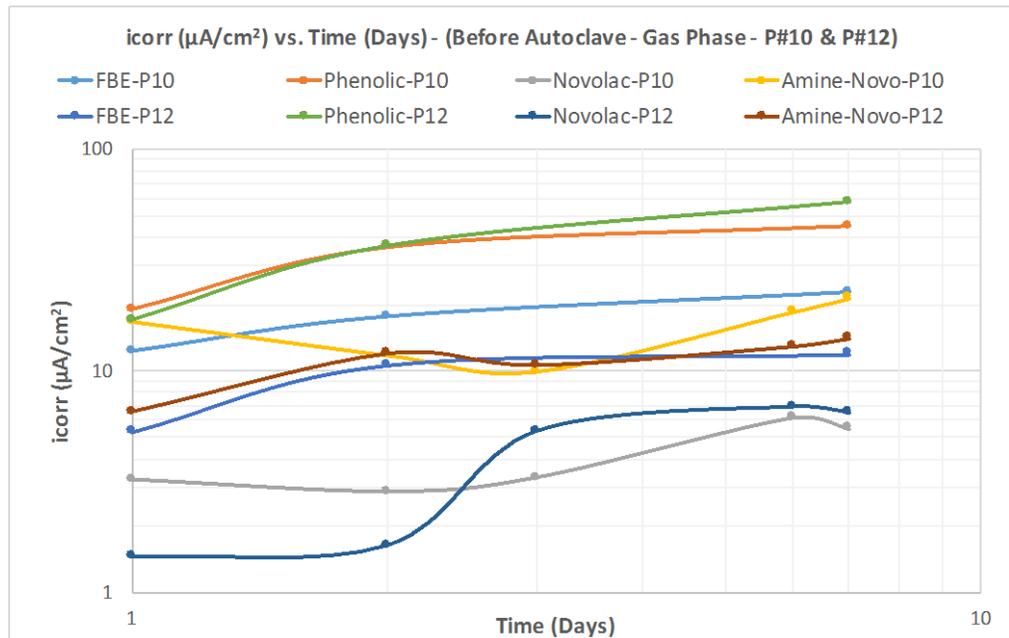
Figure 43: i_{corr} vs. Time for panels #10 & #12 in the gas phase.

The LPR measurements were conducted to the artificially damaged coatings (3 mm diameter hole) to determine the corrosion current density (i_{corr} , $\mu\text{A}/\text{cm}^2$). Figure 43 displays the Linear Polarization Resistance (LPR) results of all coatings for panels #10 and #12 in the gas phase before the autoclave test. The Phenolic coating had the highest corrosion current density (i_{corr}) and it increased with time. The FBE and Amine Novolac coatings had similar values of i_{corr} with a slight increase over time. In contrast, the

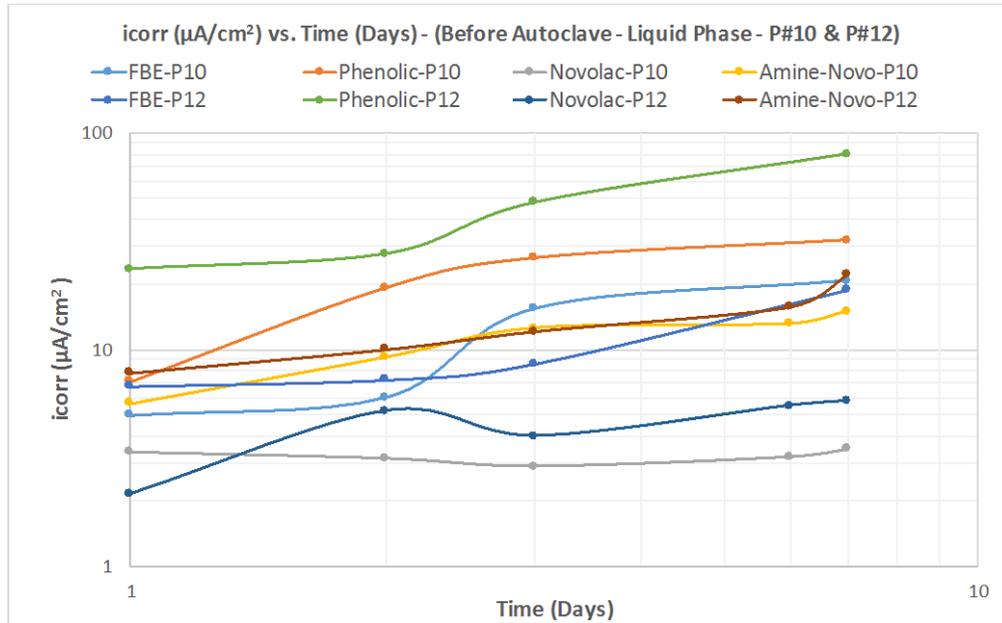
Figure 44: icorr vs. Time for panels #10 & #12 in the liquid phase.

Novolac coating had the lowest icorr and it remained stable over a week of exposure to 3% NaCl electrolyte solution. The LPR results for panels #10 and #12 in the liquid phase are shown in Figure 44 and the results are very similar to the gas phase results.

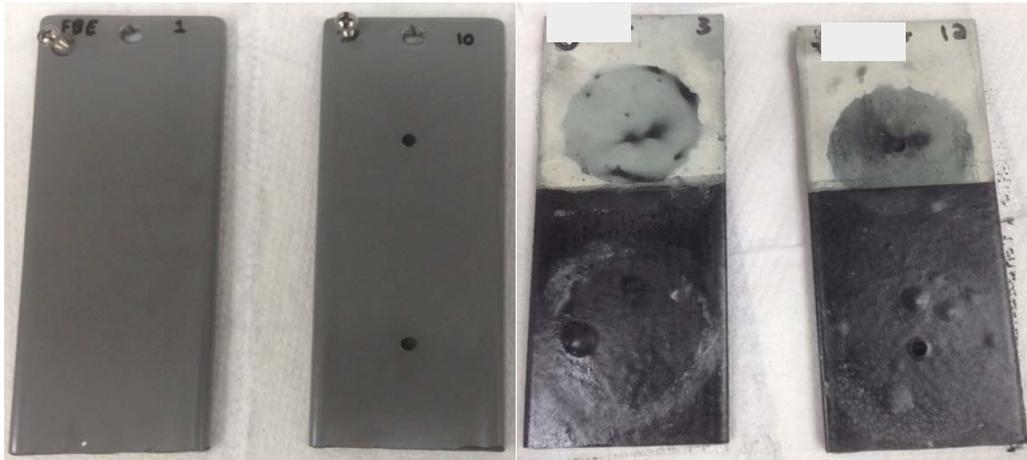
Figure 45: FBE and Phenolic Epoxy coated panels after the autoclave test.

blisters were observed in the liquid phase than in the gas phase for both coatings. The formation of blistering is usually attributed to the breakdown in the protective nature of the coating. Moreover, blisters indicate that the coating may have lost adherence from the steel which may lead to water accumulation and corrosion might occur. On the other hand, the FBE and Novolac coatings did not experience any blistering which suggested that both coatings had excellent adhesion properties after exposure to the sour environment.

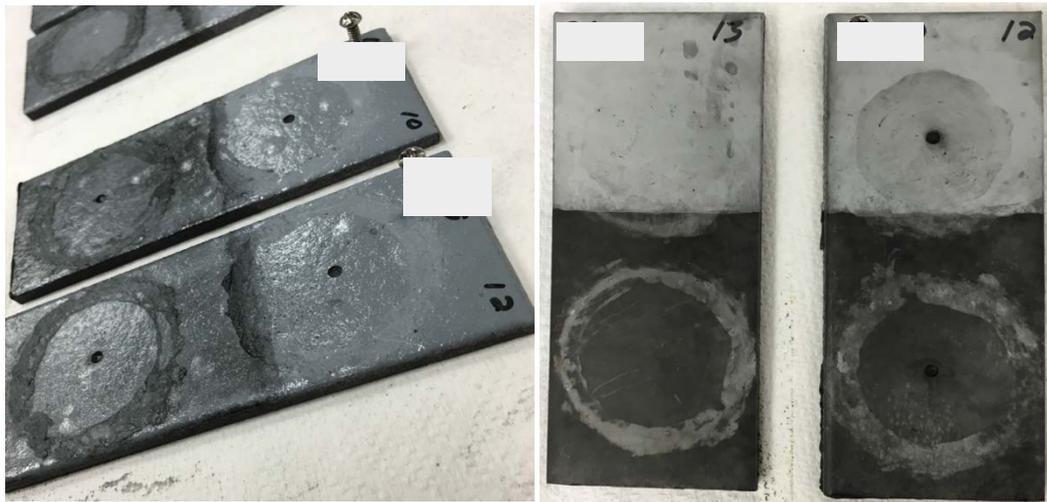
Figure 46: Amine Novolac and Novolac Epoxy coated panels after the autoclave test.

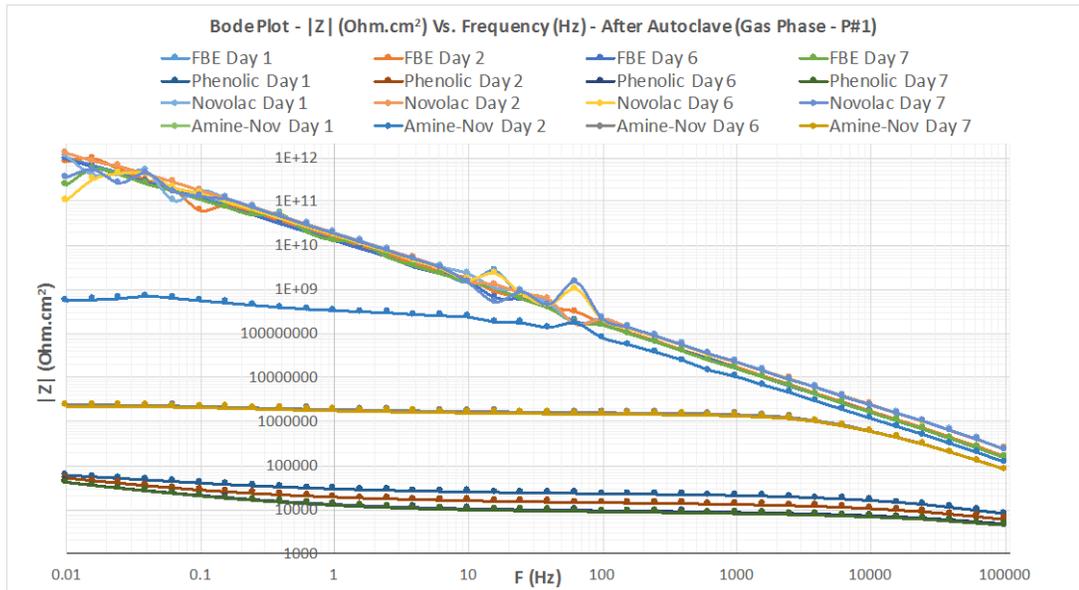
Figure 47: Bode Plot of all coatings for panel #1 in the gas phase.

The Bode plot results of all coatings after the autoclave test for panel #1 in the gas phase is illustrated in Figure 47. It can be noticed that the measured impedance for both the FBE and Novolac coatings remained significantly high even after being exposed to the sour environment as well as stable over the week of EIS testing in 3% NaCl solution.

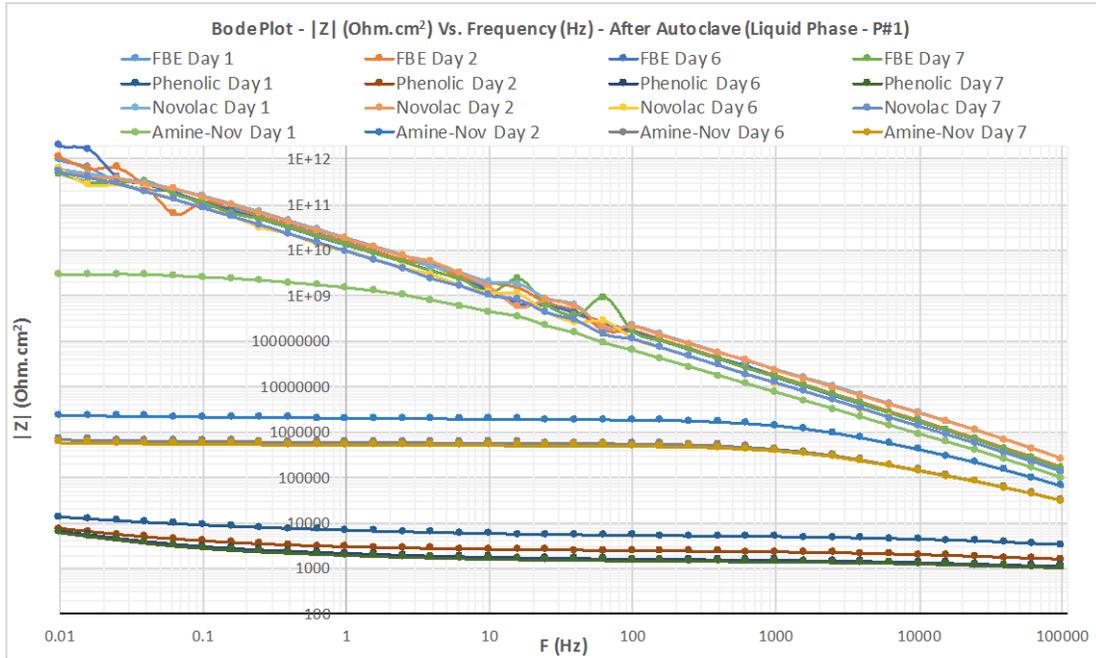
Figure 48: Bode Plot of all coatings for panel #1 in the liquid phase.

Furthermore, it can be observed that the Phenolic and Amine Novolac coatings had lower impedance in the liquid phase as compared to the gas phase.

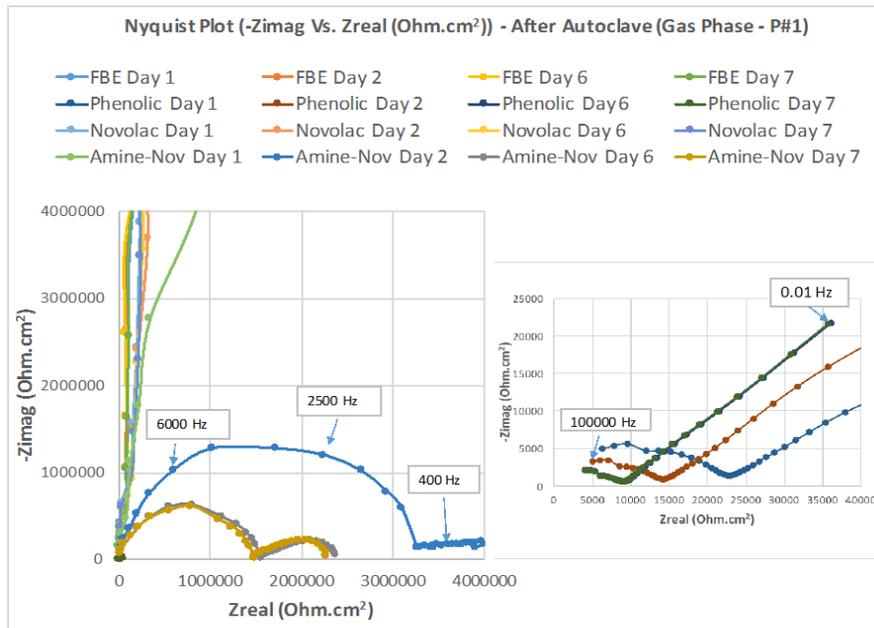
Figure 49: Nyquist Plot of all coatings for panel #1 in the gas phase.

The FBE and Novolac coatings continued to behave like pure capacitors and exhibited

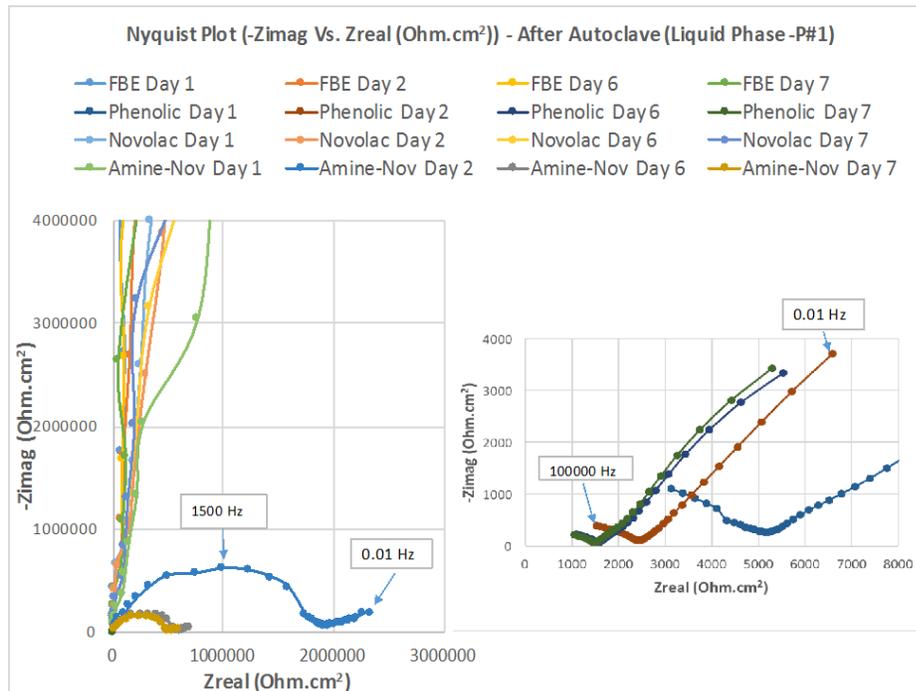
Figure 50: Nyquist Plot of all coatings for panel #1 in the liquid phase.

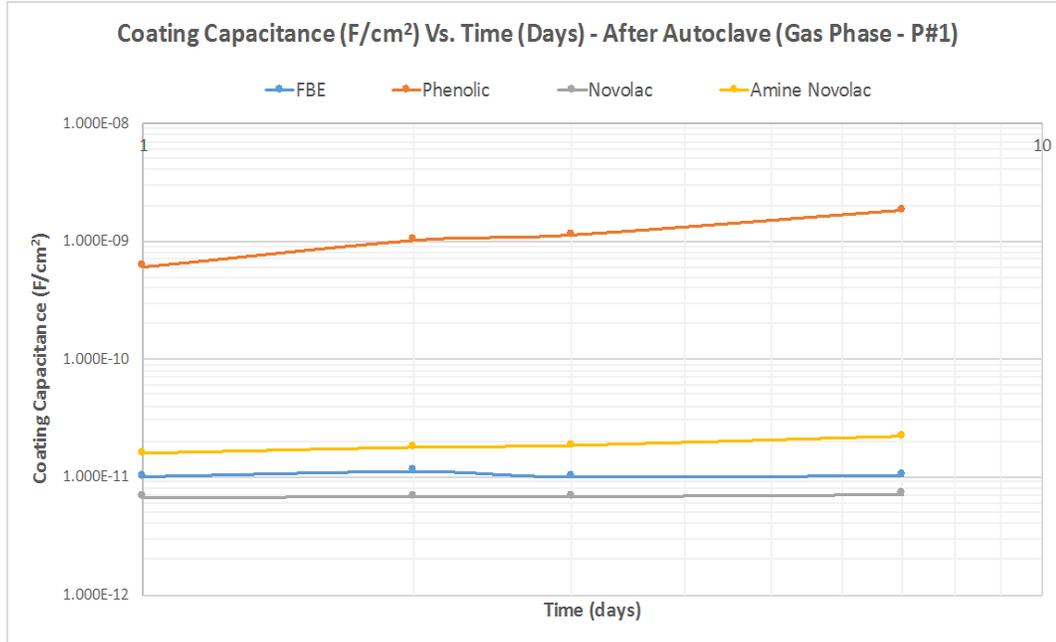
Figure 51: Coating Capacitance (F/cm²) for panel #1 in the gas phase.

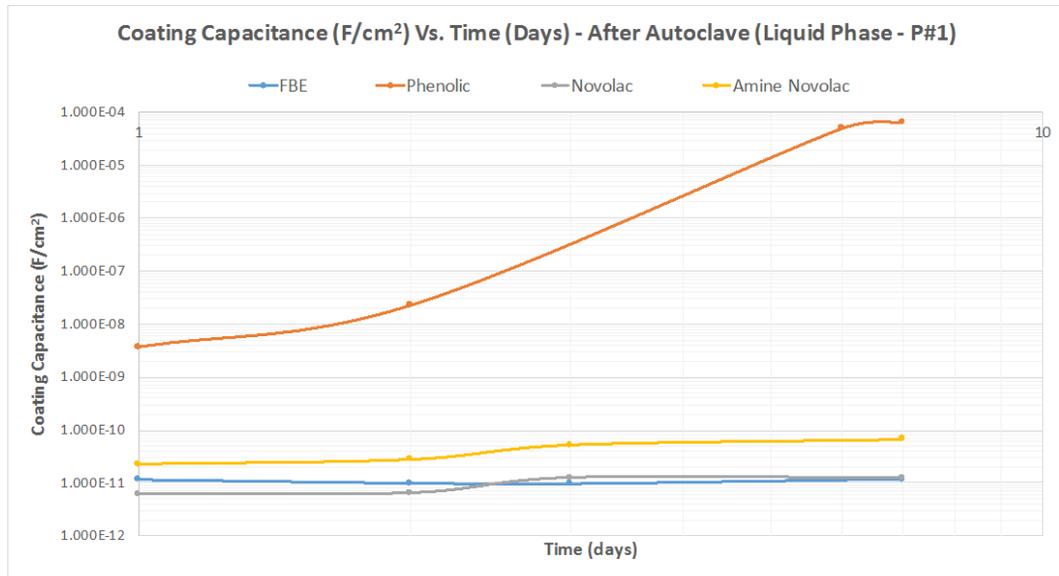
Figure 52: Coating Capacitance (F/cm²) for panel #1 in the liquid phase.

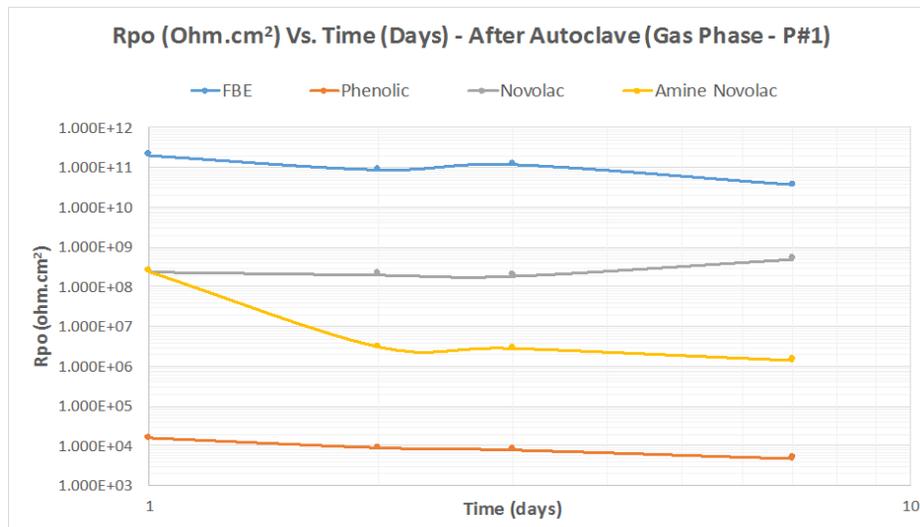
Figure 53: Pore Resistance (R_{po}) for panel #1 in the gas phase.
