Evaluation of Organic Protective Coatings as Corrosion Prevention for The Interior of Subsea Pipelines in Sour Gas Service

EVALUATION OF ORGANIC PROTECTIVE COATINGS AS CORROSION
PREVENTION FOR THE INTERIOR OF SUBSEA PIPELINES IN SOUR GAS
SERVICE

MASTER OF SCIENCE

MATERIAL SCIENCE AND ENGINEERING

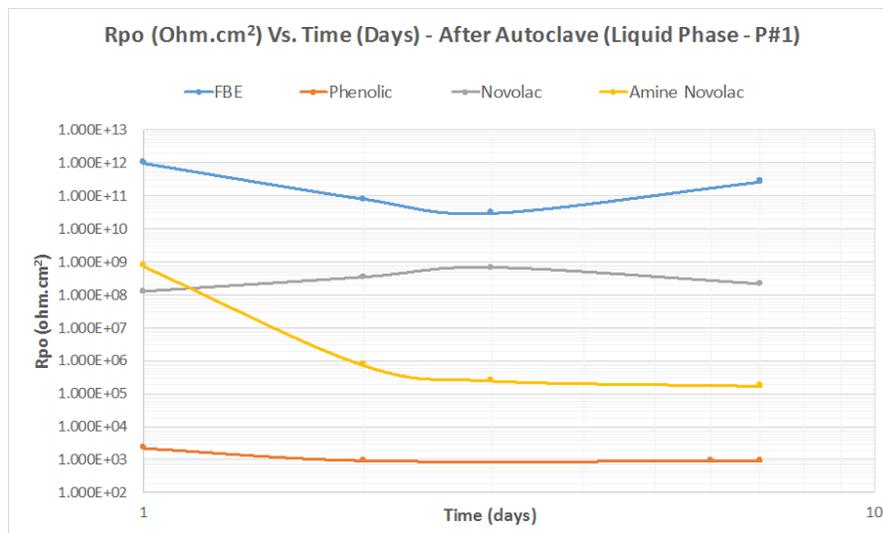
Figure 54: Pore Resistance (Rpo) for panel #1 in the liquid phase.

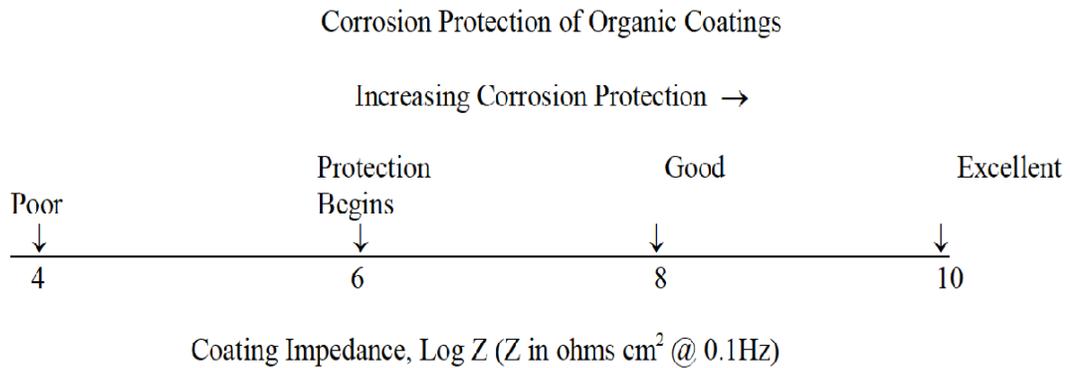
Figure 55: Logarithmic Coating Impedance Scale [32].

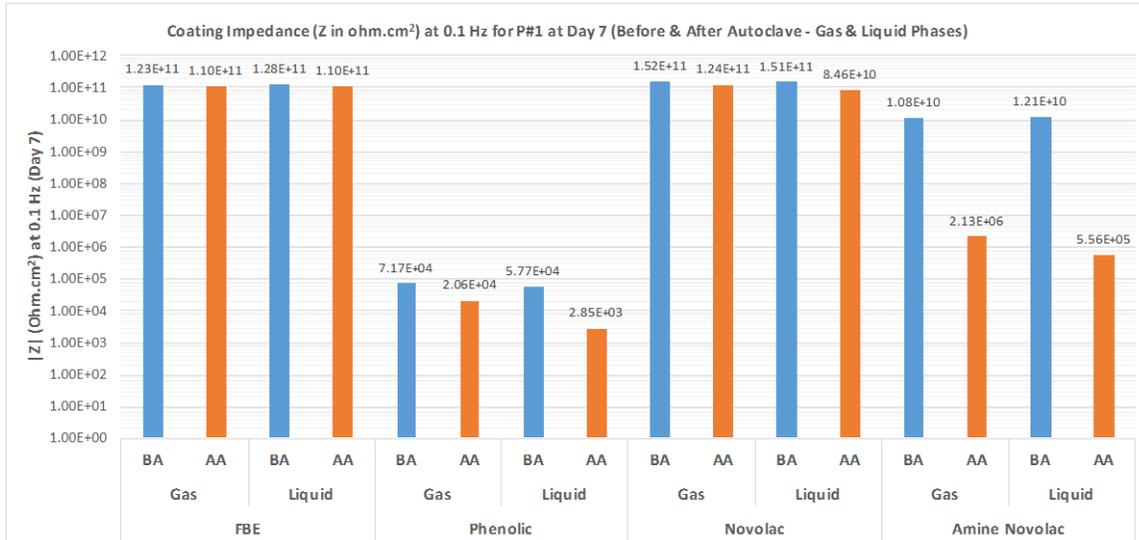
Figure 56: Coating Impedance (ohm.cm²) at 0.1 Hz for panel #1 in gas/liquid phases before/after autoclave.

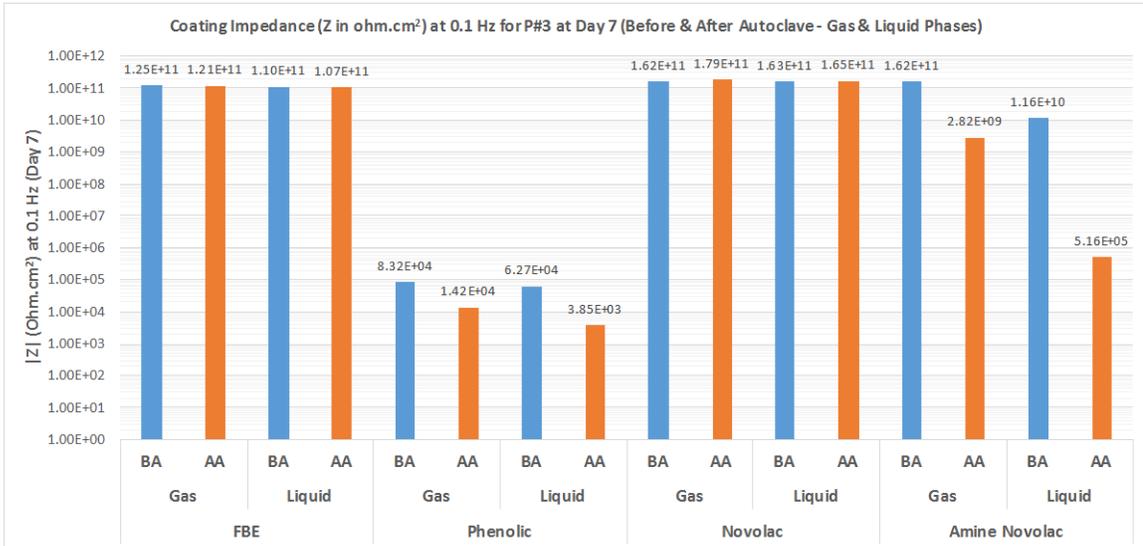
Figure 57: Coating Impedance (ohm.cm²) at 0.1 Hz for panel #3 in gas/liquid phases before/after autoclave.

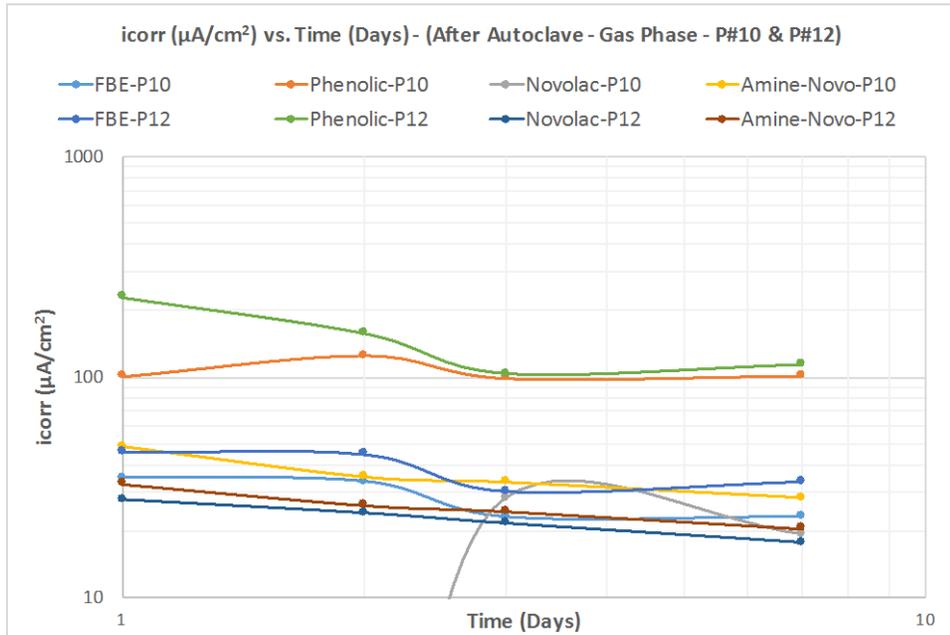
Figure 58: i_{corr} vs. Time for panels #10 & #12 in the gas phase.

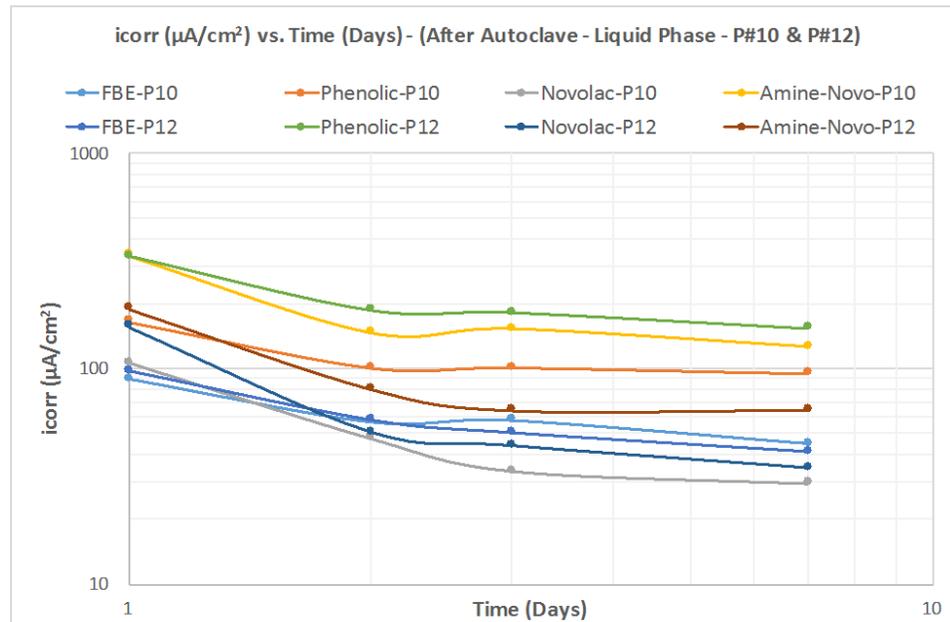
Figure 59: i_{corr} vs. Time for panels #10 & #12 in the liquid phase.

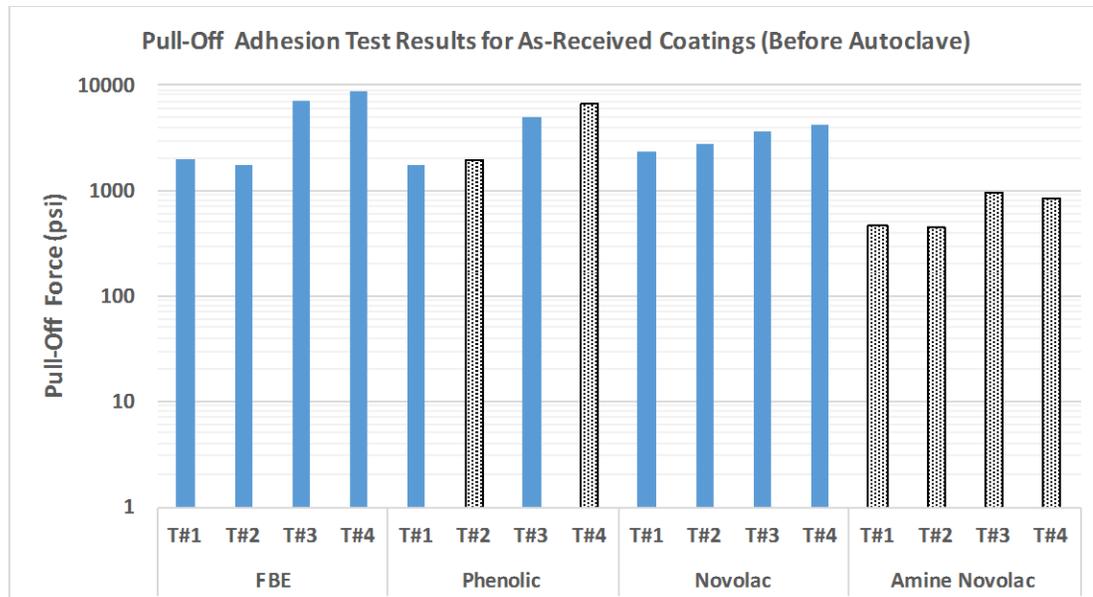
Figure 60: Pull-Off Adhesion Test results for as-received coatings before autoclave.

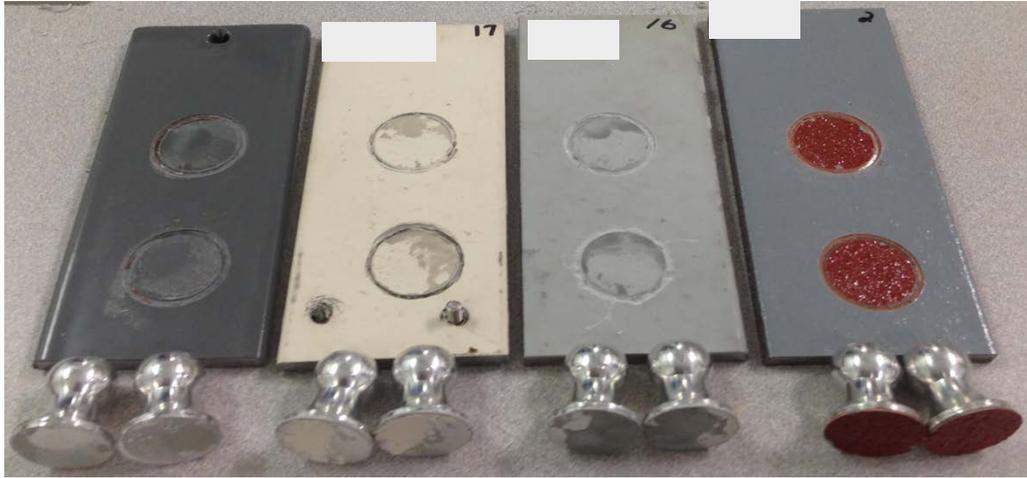
Figure 61: FBE, Phenolic, Novolac, and Amine Novolac coated panels after the pull-off test.

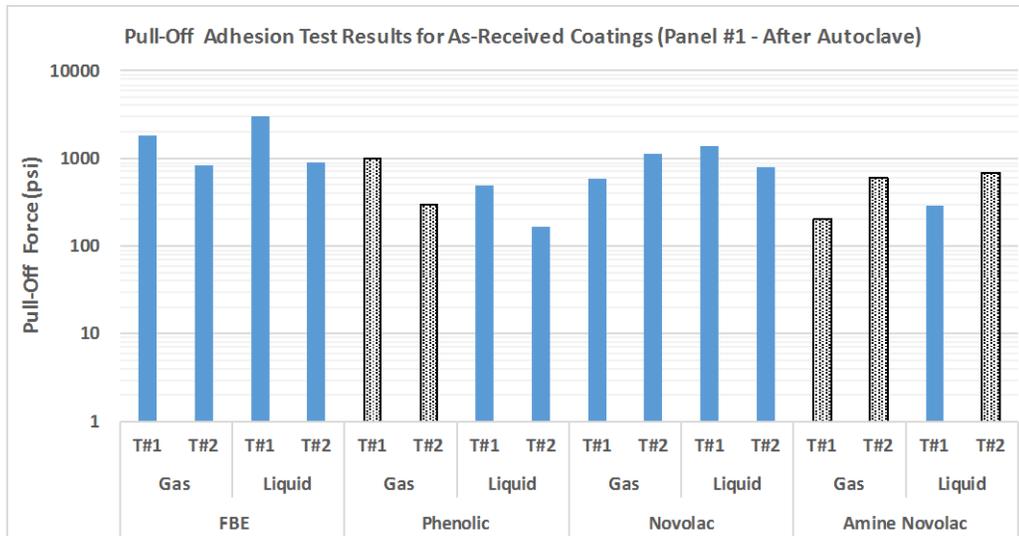
Figure 62: Pull-Off Adhesion Test results for panel #1 after autoclave.

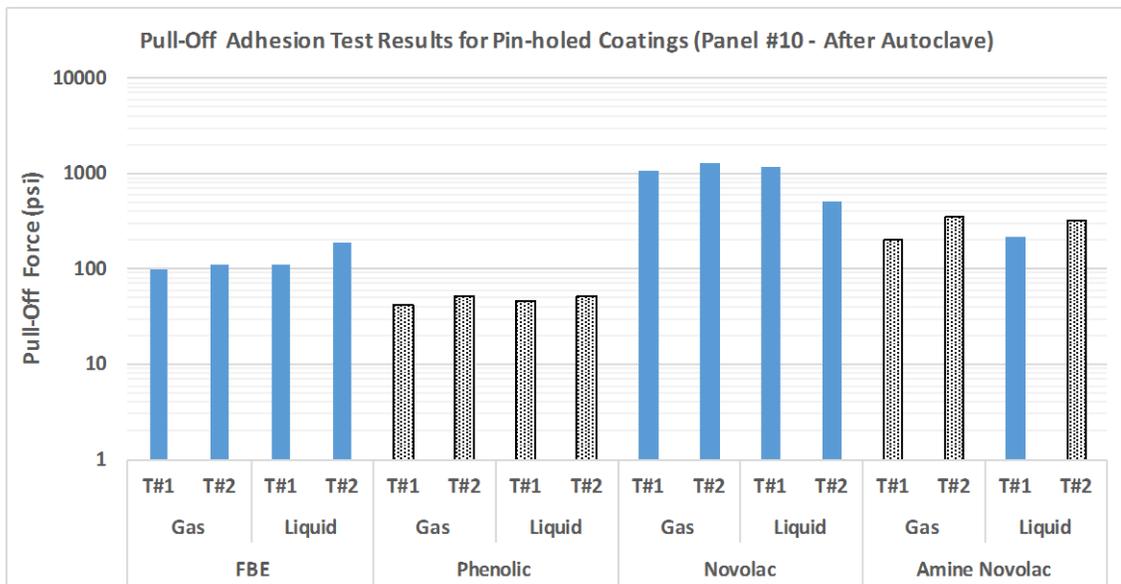
Figure 63: Pull-Off Adhesion Test results for panel #10 after autoclave.

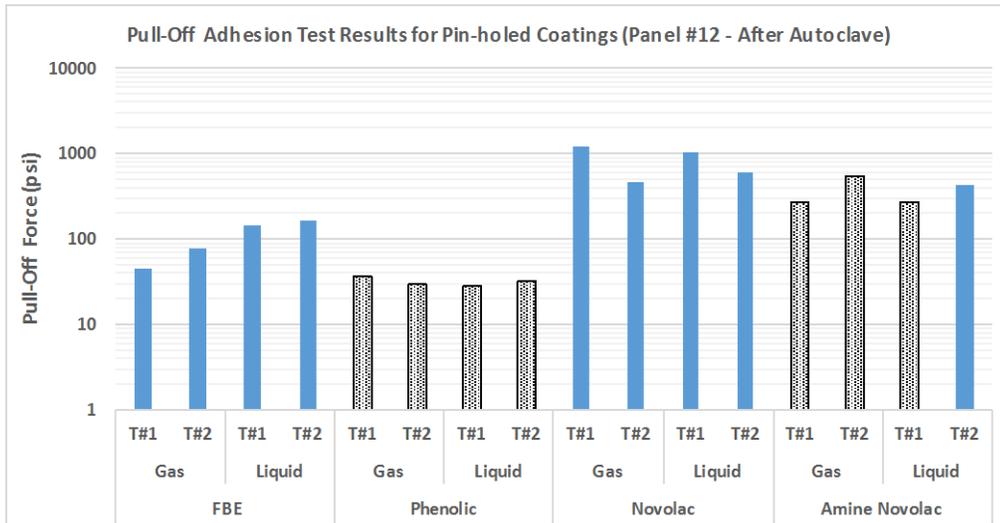
Figure 64: Pull-Off Adhesion Test results for panel #12 after autoclave.

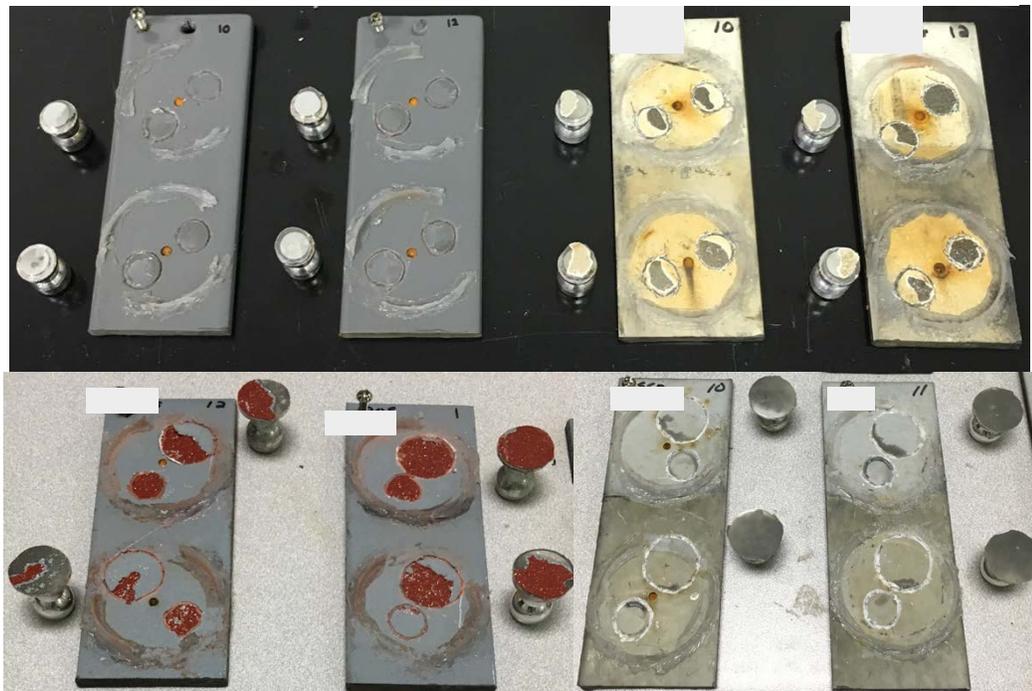
Figure 65: FBE, Phenolic, Amine Novolac, and Novolac coated panels after the pull-off test.

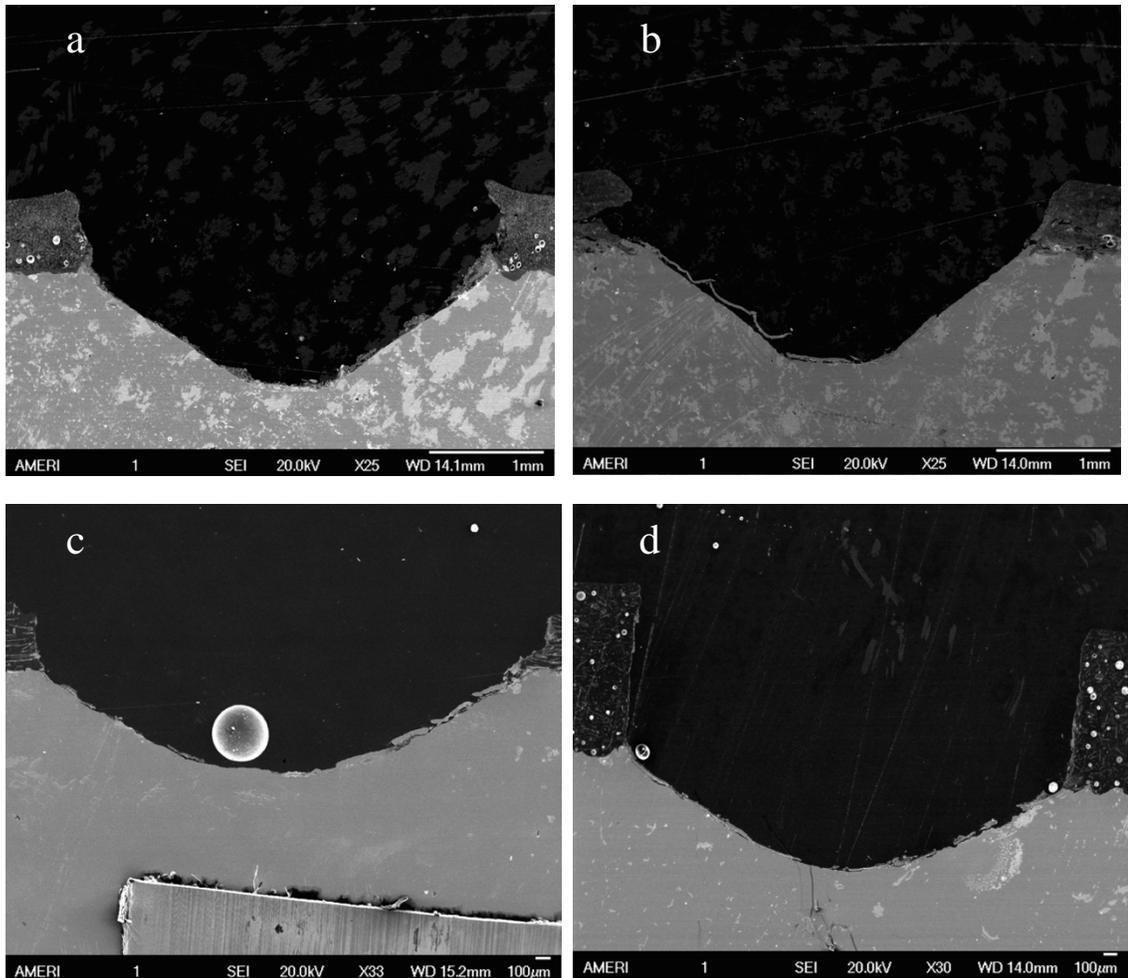
Figure 66: SEM images of the cross-sectional area of the pinholes. (a) FBE (b) Phenolic (c) Amine Novolac (d) Novolac.

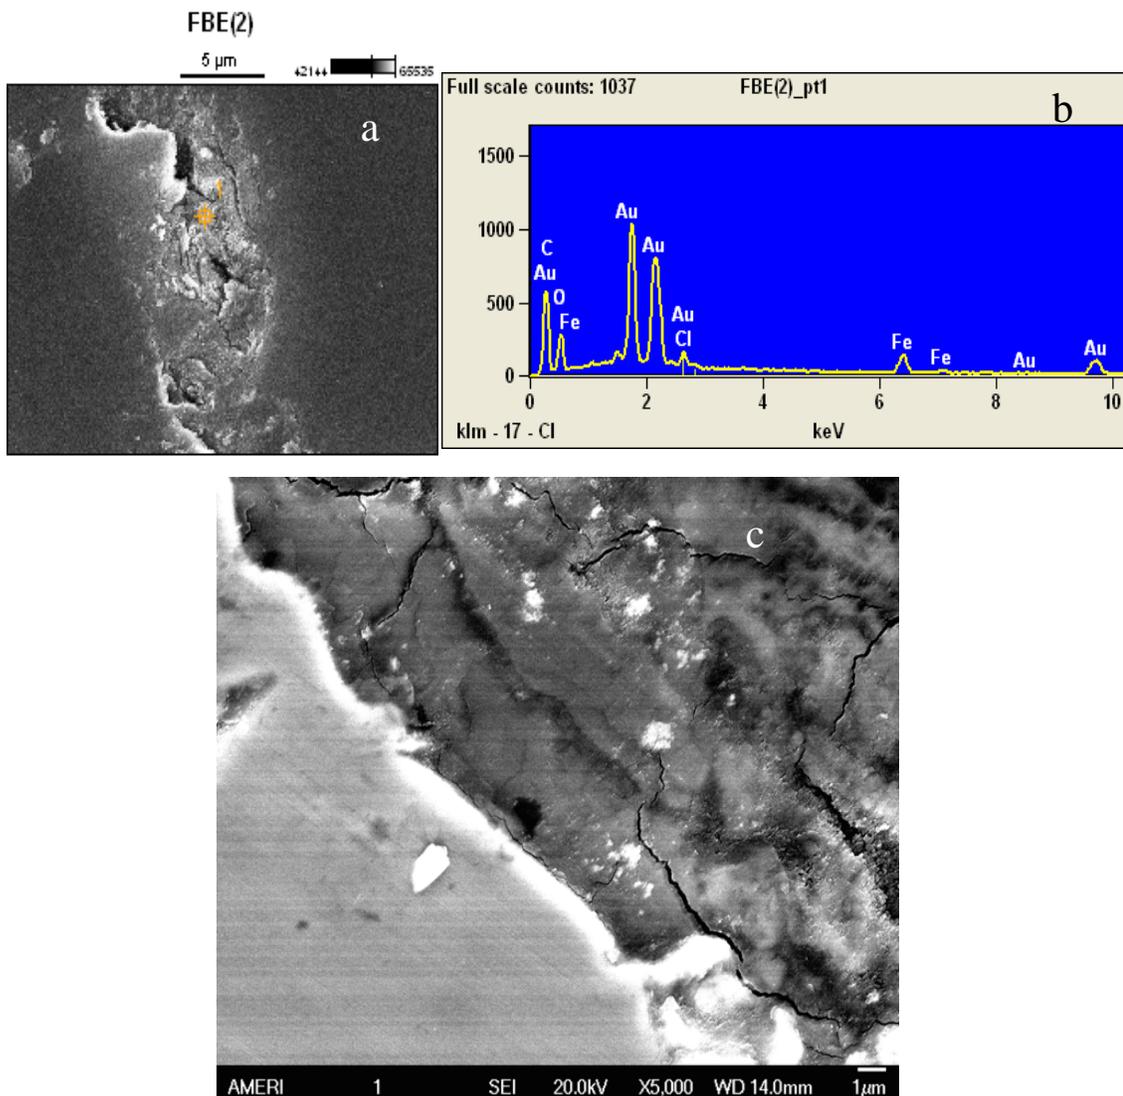
Figure 67: (a) and (c): SEM image of corrosion products in pinhole. (b) EDS spectrum illustrating the elemental composition of the region marked in (a).

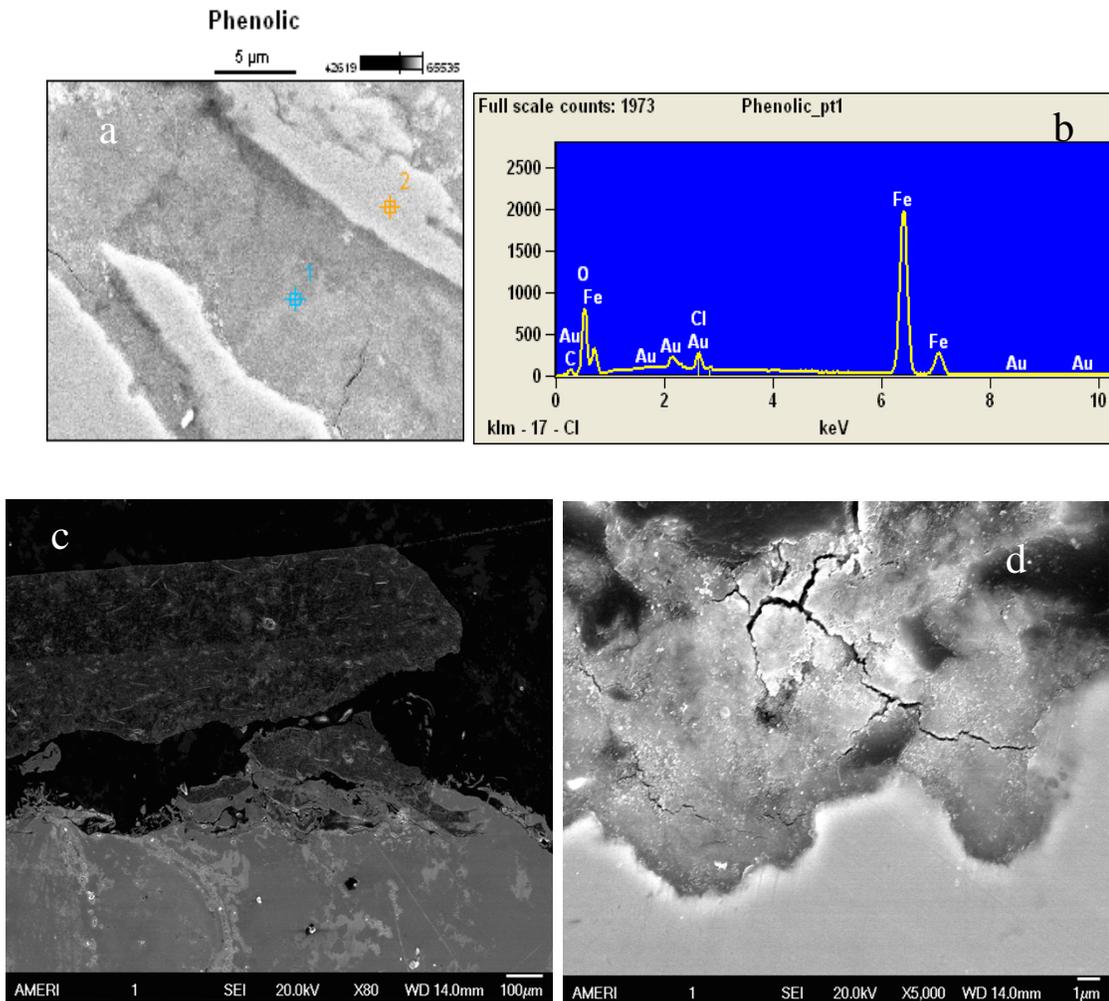
Figure 68: (a), (c) and (d): SEM image of corrosion products in pinhole. (b) EDS spectrum illustrating the elemental composition of the region marked in (a).

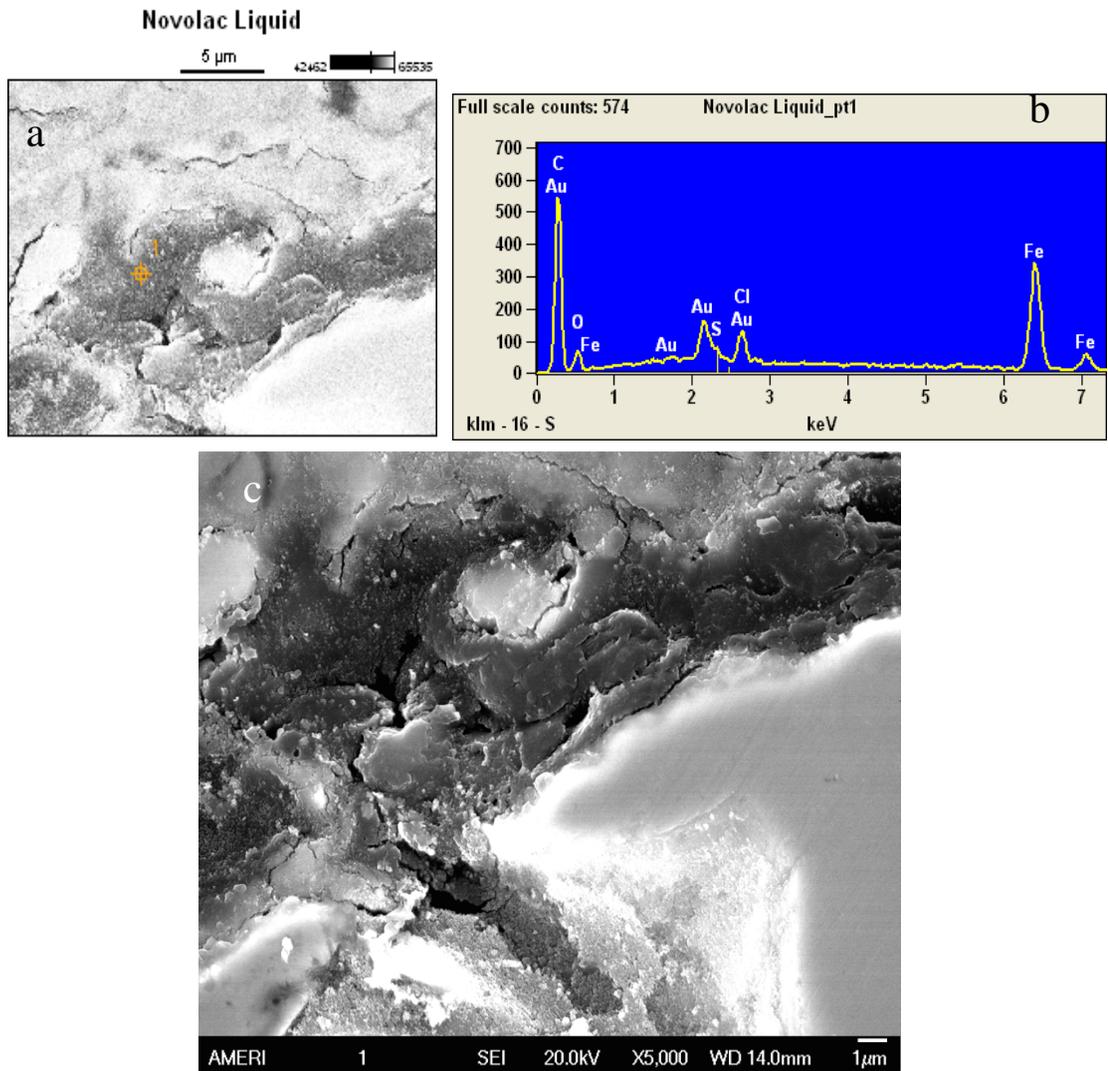
Figure 69: (a) and (c): SEM image of corrosion products in pinhole. (b) EDS spectrum illustrating the elemental composition of the region marked in (a).

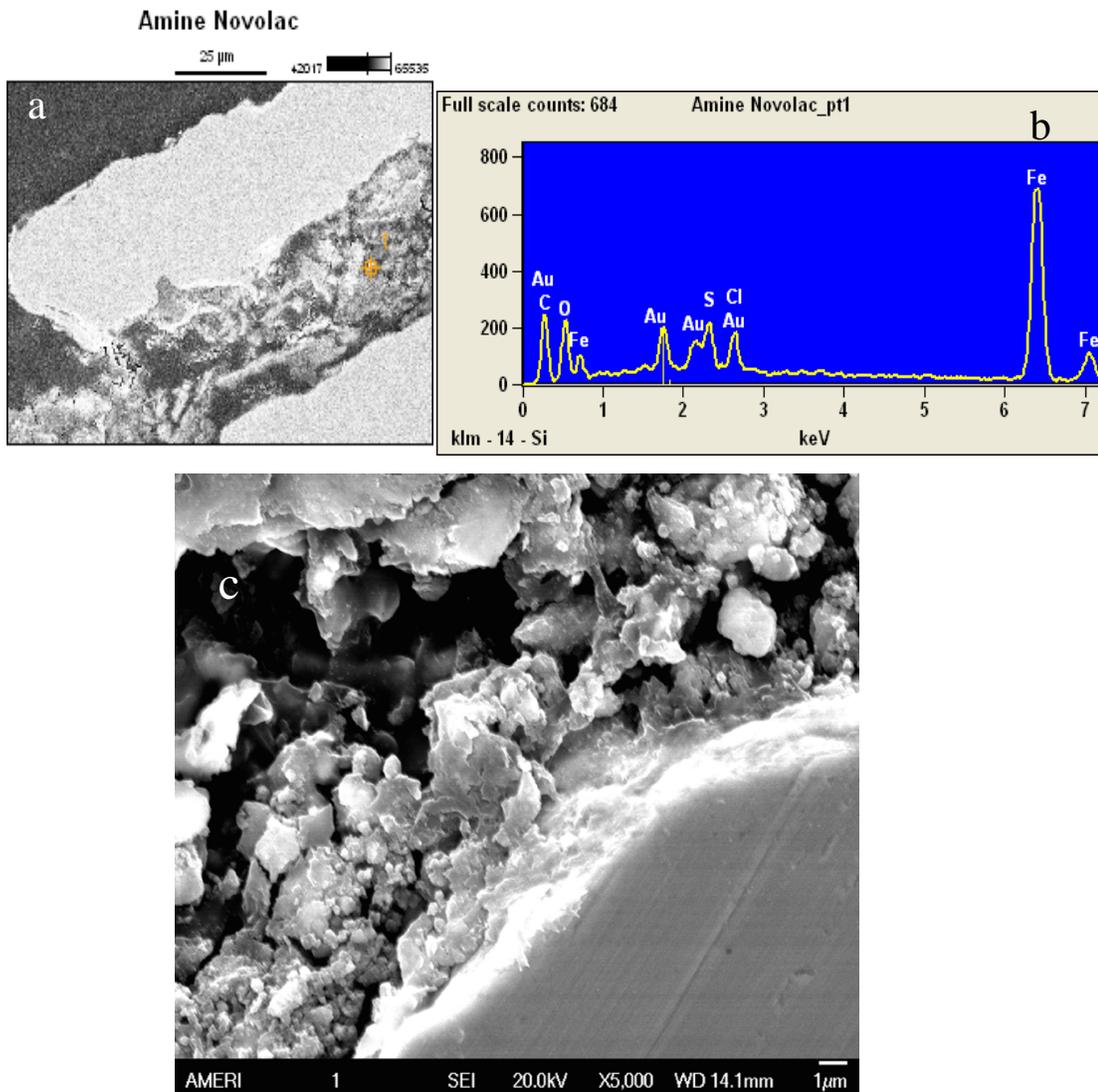
Figure 70: (a) and (c): SEM image of corrosion products in pinhole. (b) EDS spectrum illustrating the elemental composition of the region marked in (a).

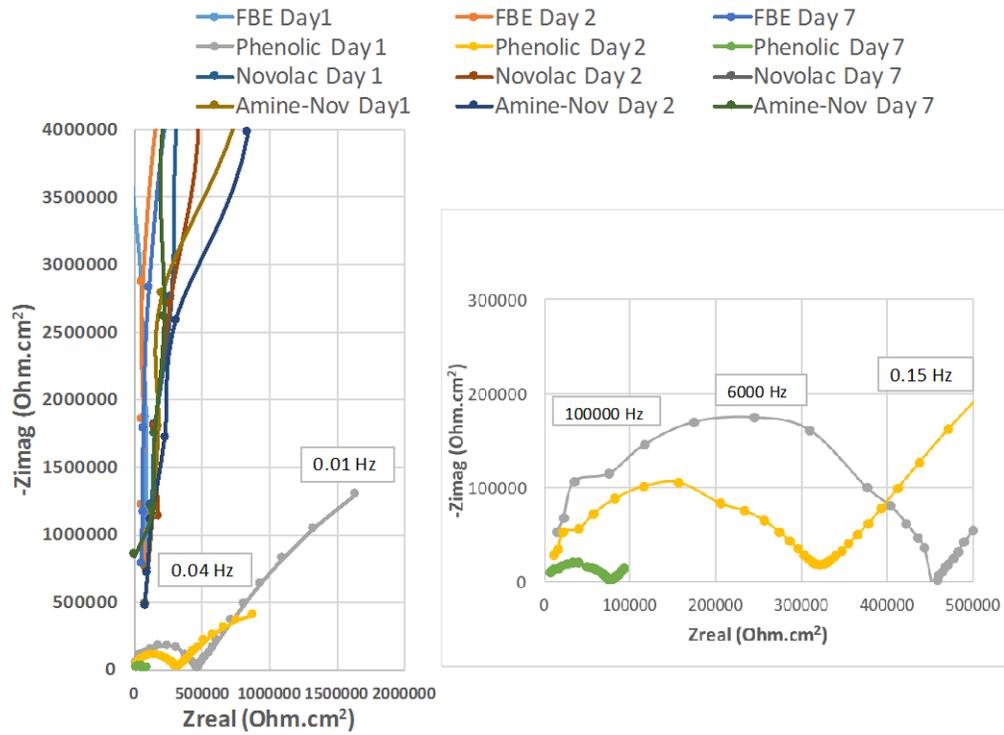
Nyquist Plot (-Zimag Vs. Zreal (Ohm.cm²)) - Before Autoclave (Gas Phase - P#3)

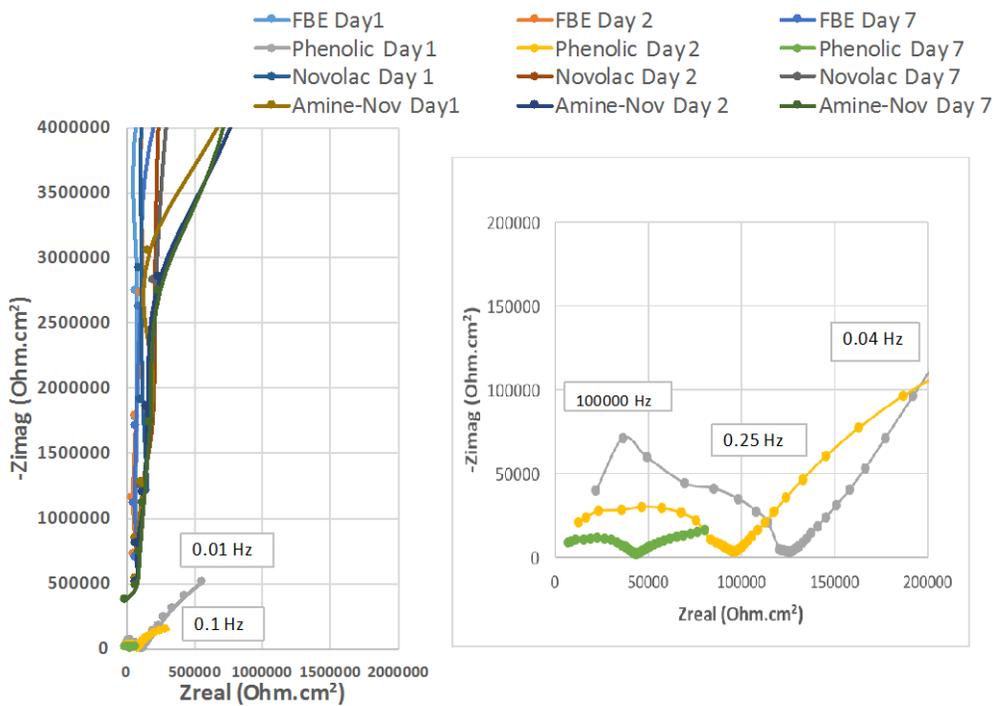
Nyquist Plot (-Zimag Vs. Zreal (Ohm.cm²)) - Before Autoclave (Liquid Phase - P#3)
