On the Role of the Pore Water Chemistry of Deficient Post-Tension Grout to Promote Steel Corrosion

A thesis submitted in partial fulfillment of the

MASTER OF SCIENCE

ENVIRONMENTAL ENGINEERING

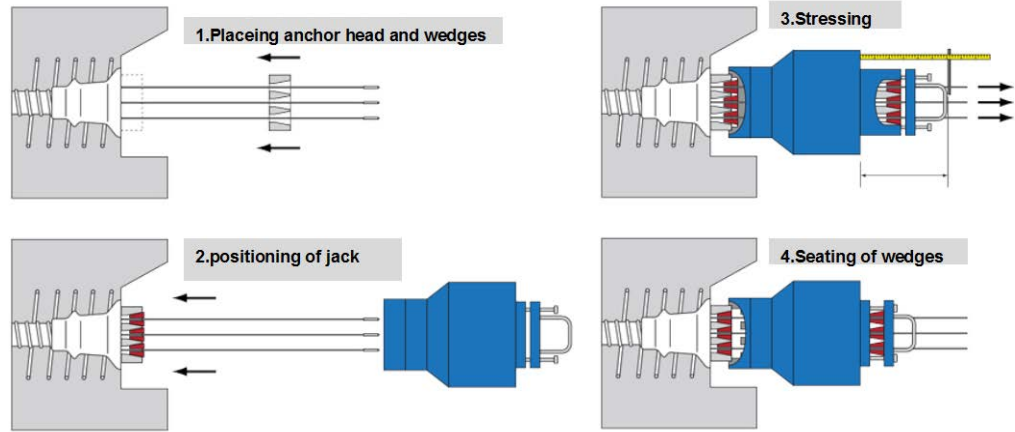
Figure 1.1: Illustration of Post Tensioning Process (Post-Tensioning Institute, 2000)

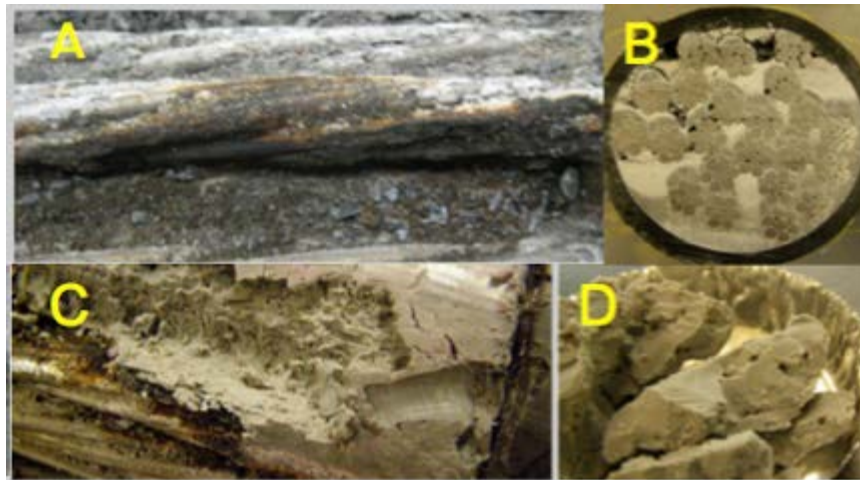
Figure 2.1: Photos of Failed Tendons; A-Corroded strand, B -Different layers of deficiency in tendon, C- Corroded strands in deficient grout, D-, Deficient grout, Courtesy by FDOT

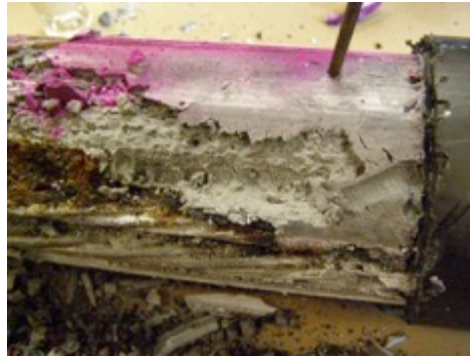
Figure 2.2: Corrosion of Strand Embedded in Deficient Grout. Pink color shows phenolphthalein indicator sprayed on grout surface. Courtesy by FDOT

The severe corrosion of the steel occurred at locations with deficient grout. The deficient grout was not consistently associated with void, bleed water and enhance chloride content. In the most severe manifestation of the deficient grout, the grout remained unhardened (Figure 2.1 and 2.2) with a putty-like consistency and becomes friable upon drying. In nearby regions, the deficient grout had a white color and had a chalky consistency. The deficient grout material had as much as 80% moisture content. Pore-water pH, was generally greater than 12 and the pH in the soft grout with nearby corrosion was sometimes greater than 13. No consistent indication of carbonation being the primary corrosion mechanism was observed. The total chloride content was low to moderate but may be enhanced in the deficient grout due to capillary transport during the grout segregation process. Severe corrosion and deficient grout was associated with high free sulfate

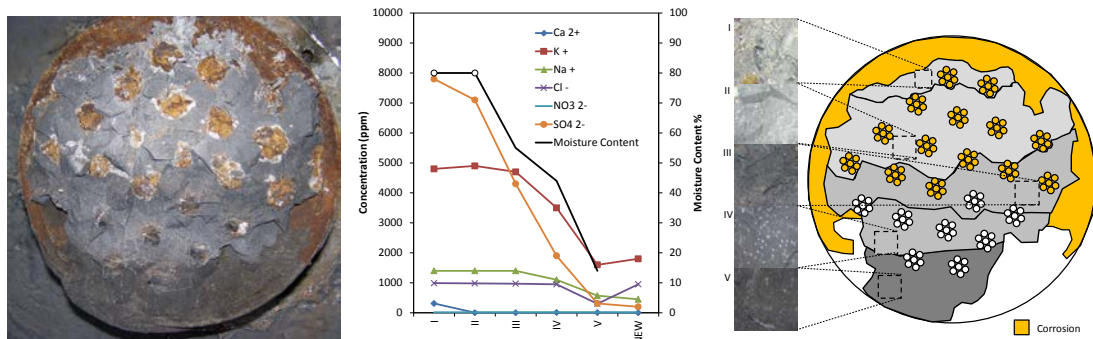
Figure 2.3: Visual and Chemical Makeup of Stratified Deficient Grout at an Anchor Cap. (Lau et al., 2013)

Similar to the deficient grout found in the Ringling Causeway, the extracted deficient grout there had high sulfate ion concentrations (ranging from 1,000 to 12,000 ppm) relative to extracted hardened grout (10 to 200 ppm).

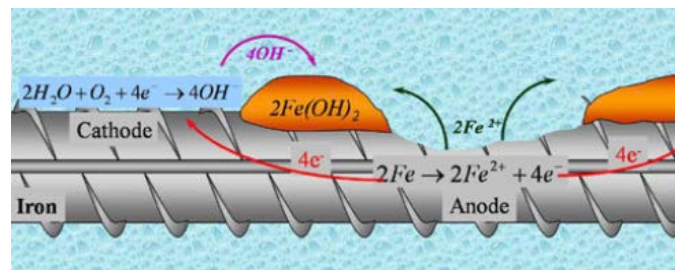
Figure 2.4: Schematic of Steel Corrosion Acting as an Anode and Cathode (PCA)

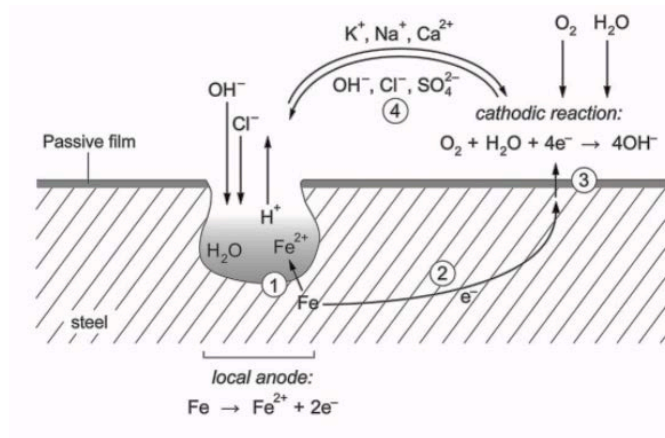
Figure 2.5: Schematic Illustration of Chloride Induced Pitting Corrosion and Reaction, Steps: 1. Anodic iron dissolution; 2. Flow of electrons through metal; 3. Cathodic reduction reaction; 4. Ionic current flow through the electrolyte.

As a result of the deoxygenation-acidification mechanism, and having the large cathodic and small anodic area, a macro-cell is established. When the anodic and cathodic half-cell reactions are spatially separated, anodic iron dissolution preferentially takes place in the acidic deaerated pit environment, while cathodic oxygen reduction proceeds on the alkaline, aerated external metal surfaces.

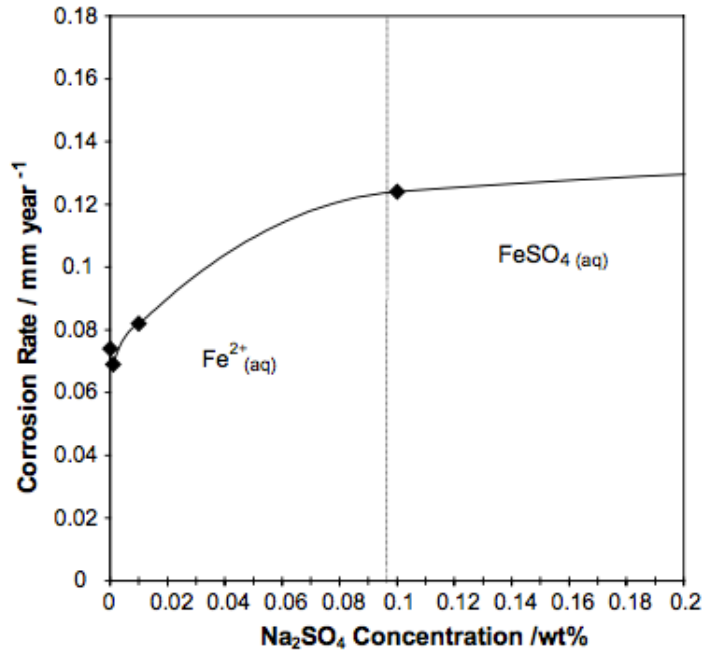
Figure 2.7: Corrosion Rate of Mild steel as a Function of Na₂SO₄ Concentration (Arzola et al., 2003)

As shown in Figure 2.7, It is clear that when the predominant species is FeSO_4 , the corrosion rate increases significantly. As pointed out by Arzola the effect of sulfate ion on the rate of oxidation of iron in mildly alkaline solutions results from its ability to form soluble complexes with either Fe^{2+} or Fe^{3+} . Sulfate ions accelerate the active dissolution of iron. Iron dissolves in sulfate solutions at a high rate when sulfate concentration exceeds 550 ppm in certain pH of the water. This implies that a supersaturated solution allowing precipitation of a non-protective film occurs.

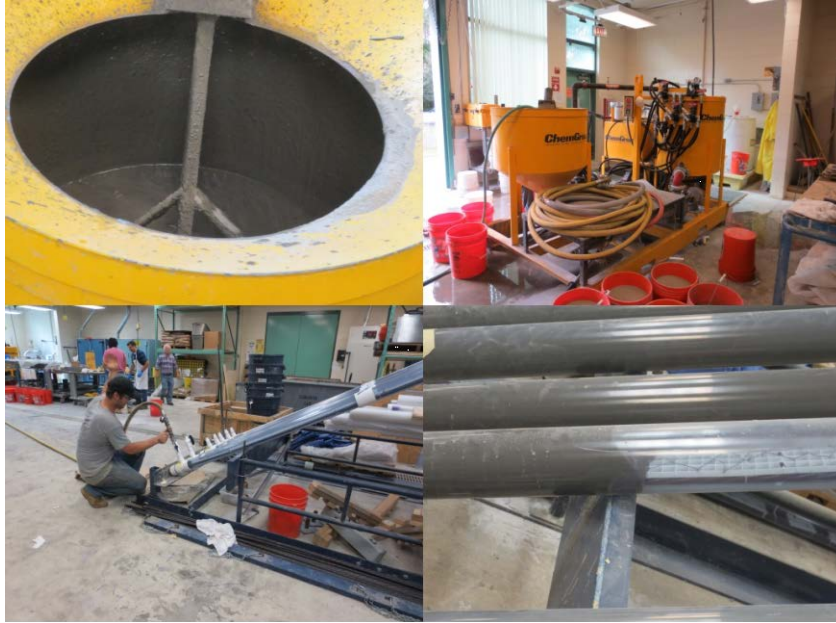
Figure 3.2. Grout Batching, Mixing, and Pumping Sequence

Corrosion behavior of steel in expired Grout was measured in large mock up tendons followed by Modified incline tube test (MIT). All MIT samples were cast with expired grout materials in non-ideal conditions in order to promote grout deficiencies. Only one grout product was utilized in these experiments (Grout A). All grout materials used were past marked expiration dates and at least excess 15% mix water over manufacturers recommended high end limit was added. Batching and mixing was conducted at the State Materials Office (SMO) using a high shear grout plant (Figure 3.2).

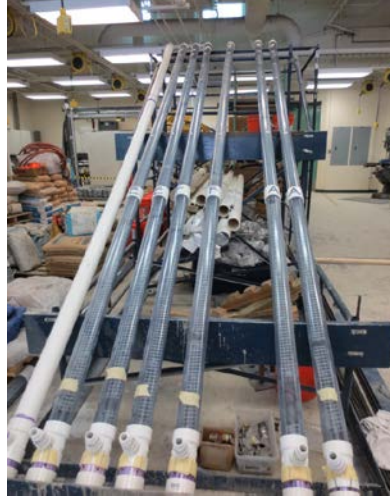
Figure 3.3: Photos of 15 ft. Lab Casted Mock up Tendons (Modified Incline Tube Test (MIT))

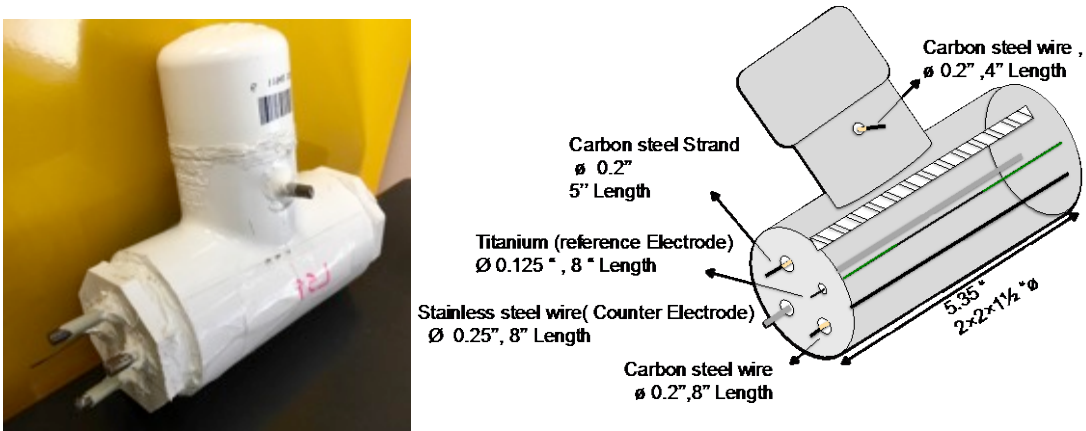
Figure 3.4: Schematic of INT Test Samples

The PVC tee was expected to facilitate volume displacement of the deficient grout material to the tee header and allow discrete testing and sampling of the deficient grout materials. The test is called here as Inverted Tee test (INT). The control set of the samples casted with as received Grout A and B, using the manufacturer recommended mix water content containing different sulfate concentration (0 ppm, 2000 ppm, 20,000 ppm). After 1-2 days from casting, the samples were sealed either with Sikadur epoxy or permanent PVC cap.

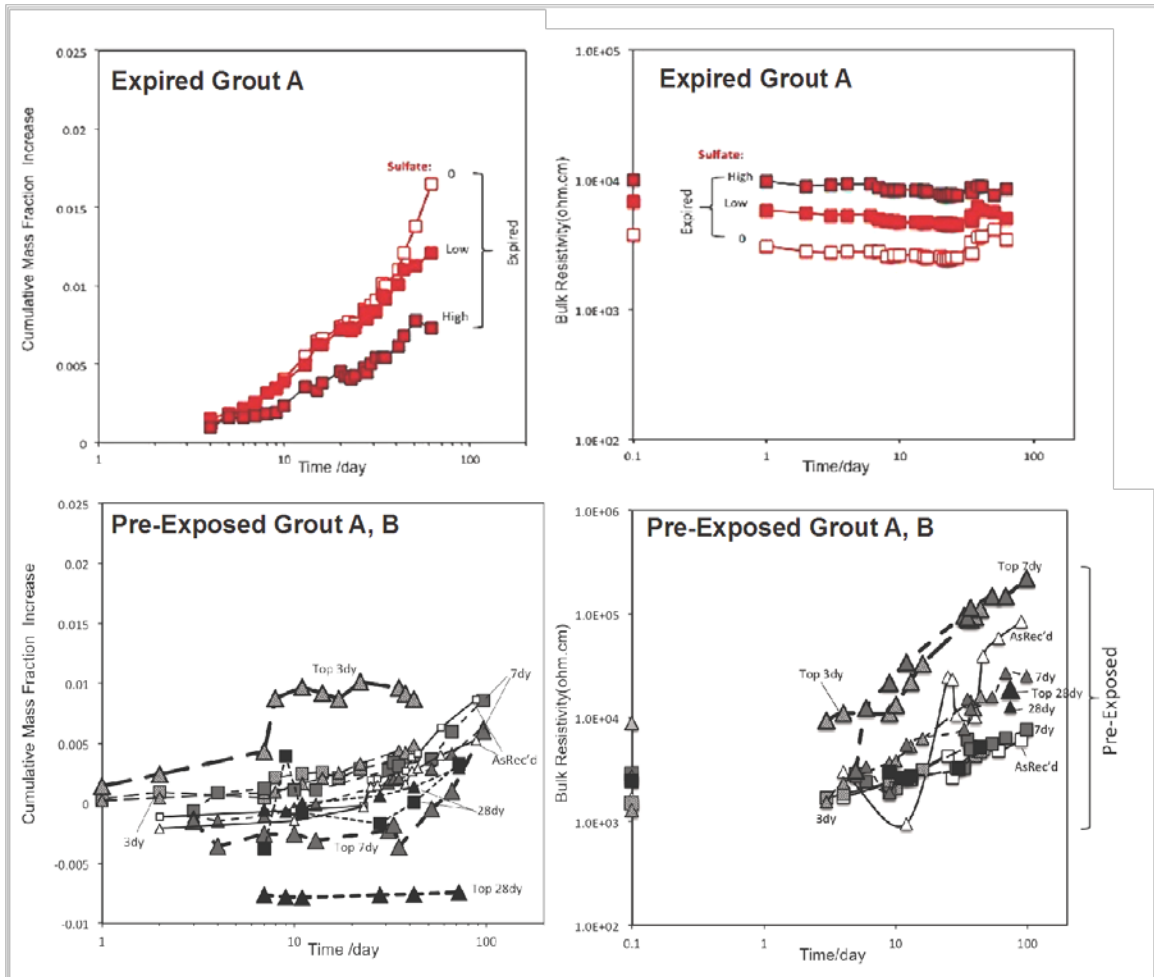
Figure 4.5: Moisture Uptake and Grout Wet Resistivity for Grout Cylinder Test
 (Square: Grout product A. Triangle: Grout product B)
 (Med Sulf: 20,000ppm/High Sulf: 150,000 ppm)

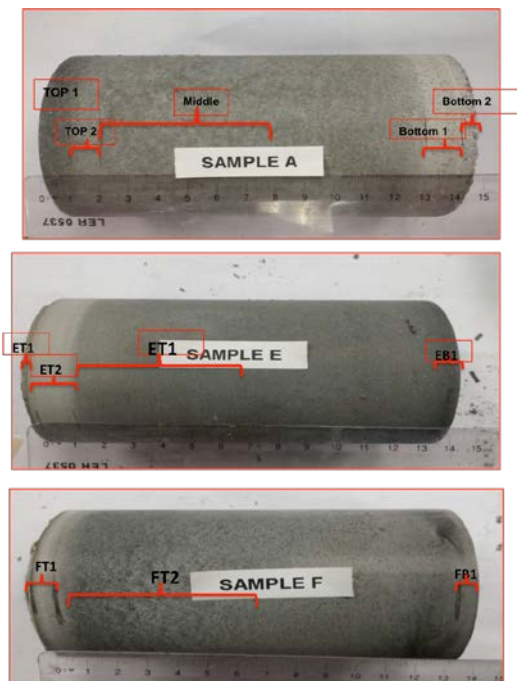
Figure 4.6: Photos of Stratified Layer in Expired Grout Samples Collected from the Outflow of Pumped Grout in Modified Incline tube test (MIT)

The expired grout samples all showed varying layers along the 6-inch height (Figure 4.6). Although none of the layers had the degree of deficiency as observed in the field, the textures of the layers (especially at the top) were synonymous with grout segregation. Representative samples of those layers were collected for sulfate analysis (Figure 4.7). As a comparison, field samples were also collected for sulfate analysis with the three leaching method (Figure 4.8).

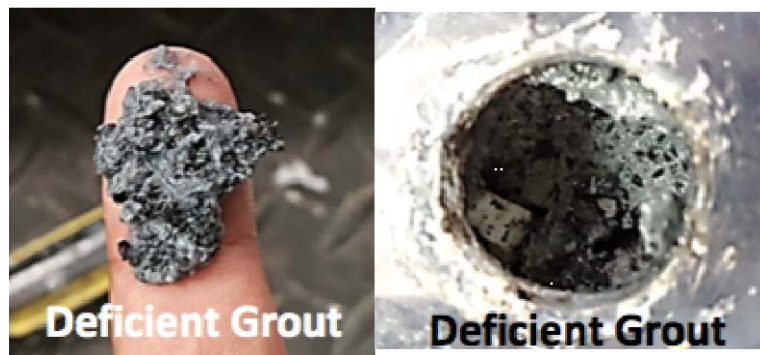
Figure 4.12: Photos of Deficient Grout from MIT Test. (The location showed was adjacent to a probe location at ~0.3 ft. from the top of sample A)

Severe material segregation was observed in the elevated portion of MIT test (Figures 4.12-13). Variability of the level of segregation was observed in different samples. It was apparent that the elevated portion of the zero and medium sulfate samples (A and E) had higher segregation as exhibited by having higher content of soft material.

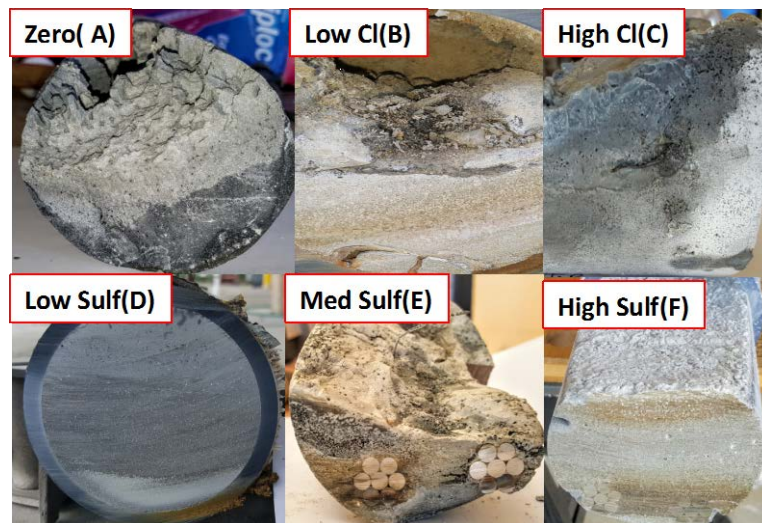
Figure 4.13: Photos of Deficient Grout in the Elevated Portion of MIT Test

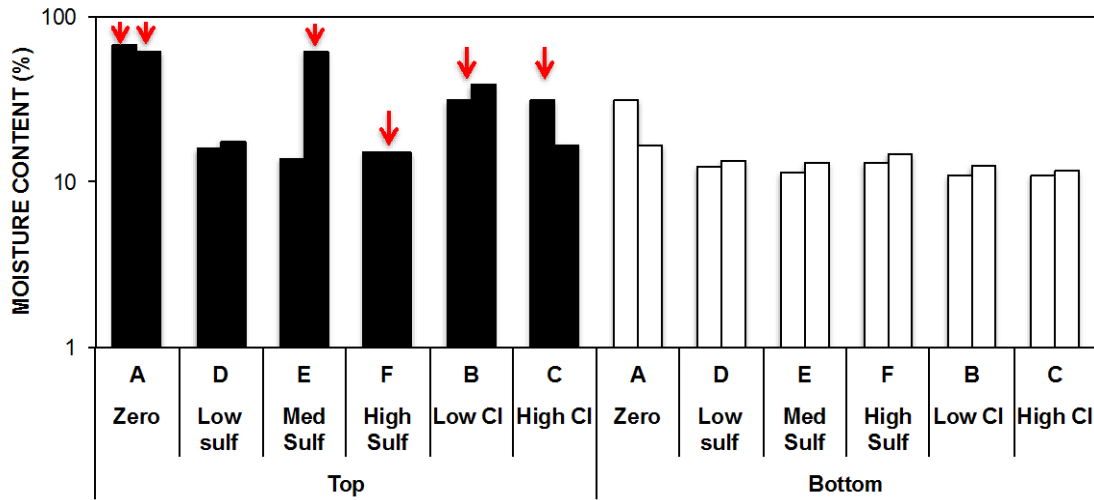
Figure 4.14: Moisture Content of the Grout from MIT Test Samples (red arrows show where corrosion occurred)

Figure 4.14 show moisture content analysis of grout for MIT test samples. Mostly all the elevated portion in MIT test samples had higher moisture content than the bottom section. The moisture content of segregated grout samples with zero and medium sulfate additives (A and E) were as high as 70-80%.

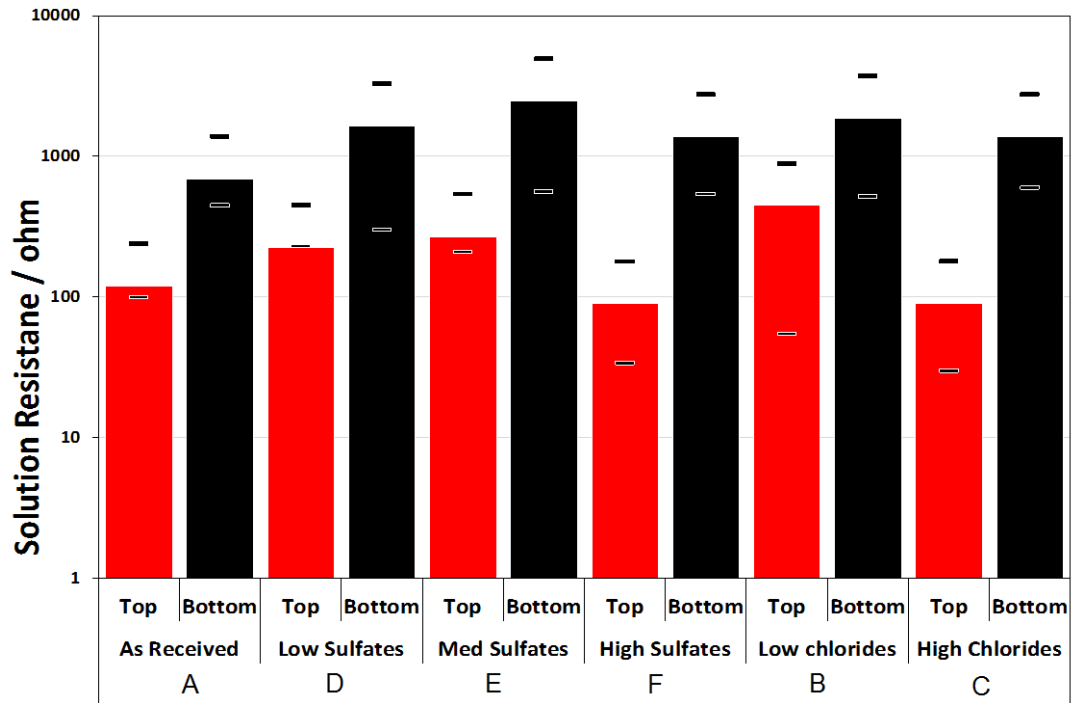
Figure 4.15: Solution Resistance of Grout from MIT Test Samples

Solution resistance measurements are shown in Figure 4.15; variability in the measurements is shown with high and low dash marks. Lower solution resistance was observed in all the elevated portion of MIT test samples, while all the bottom section had higher solution resistance.

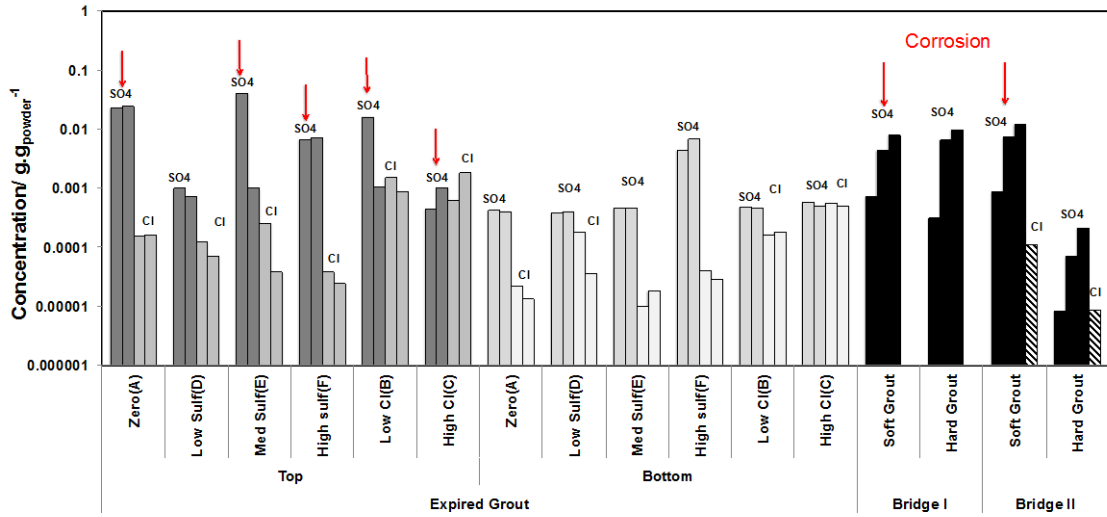
Figure 4.16: Sulfate and free Chloride Concentration of Grout from MIT Test Samples (red arrows show where corrosion occurred)

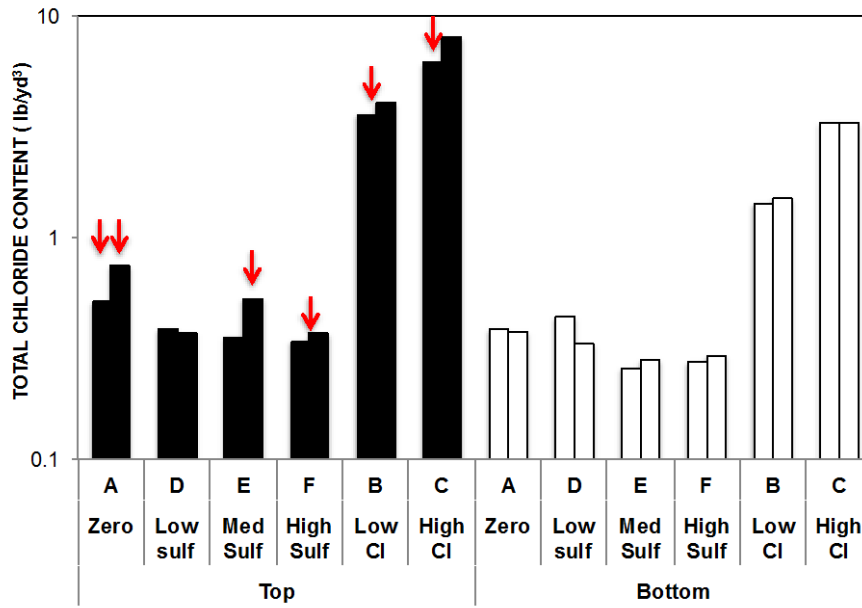
Figure 4.17: Total Chloride Content of Grout from MIT Test Samples (red arrows show where corrosion occurred)

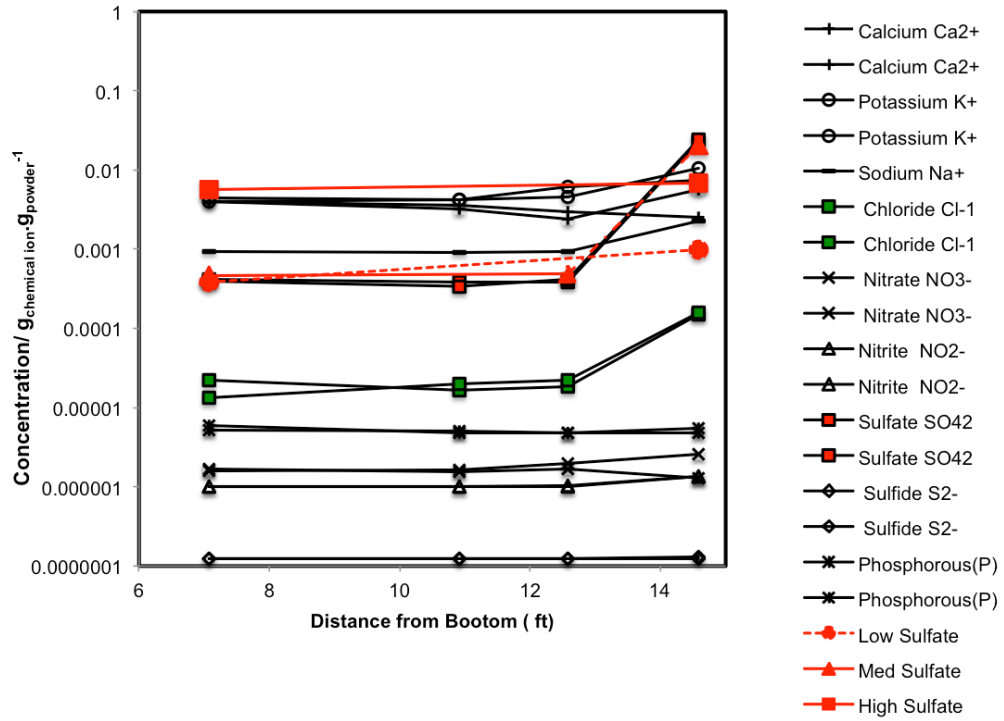
Figure 4.18: Chemical Characteristic Profiles along 15 ft. of MIT Tests (Case A)

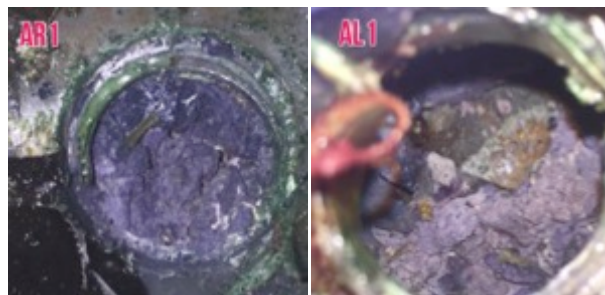
Figure 4.20: Photos of pH Results for the First Corrosion Probe Located at 0.5 ft. from the Top of MIT Test Samples with Zero Additives (A)

The results of pH tests from the ex-situ leaching method are shown in Figure 4.19. Results showed that the pH was typically greater than 12. For the grout sample with zero additives (A), the leaching method resulted in a pH lower than 11; however testing with the pH indicator showed pH greater than 11(Figure 4.20). The results for all other test locations sprayed with pH indicator are shown in Appendix A.

Modified incline tube test (MIT): In MIT test samples, the pH was reported to be in range of 12.5 -13. Zero samples (Case A) with highest moisture content and less cement ratio had pH of less than 10.5. Which is really close to carbonation limits, (Figure 4.19). However, the same sample was sprayed with pH indicator and pH measurements did not give any color indication of drop in pH. The pH was reported to be around 11. (Figure 4.20) All top section of big tendons had higher

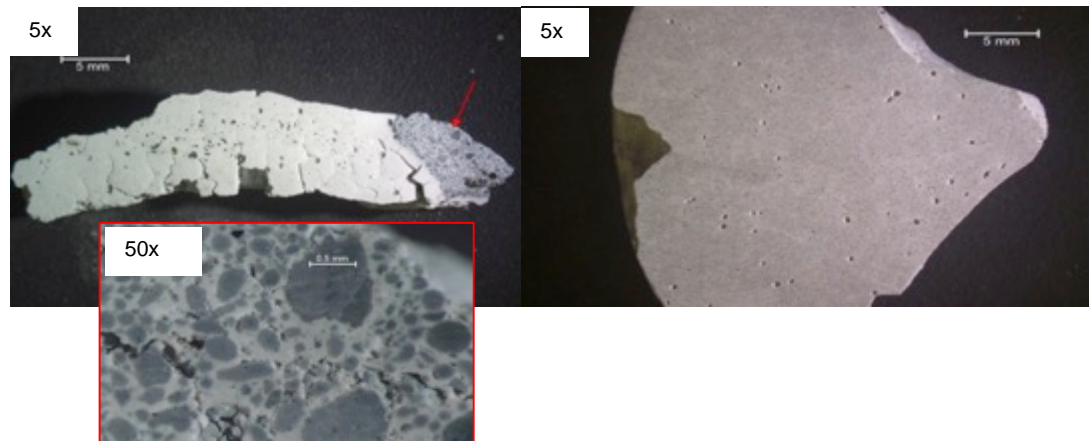
Figure 4.23: Micrograph of Segregated Top and Bottom section in MIT test Samples with no Additives (Case A), at 5x, 50 x Magnification

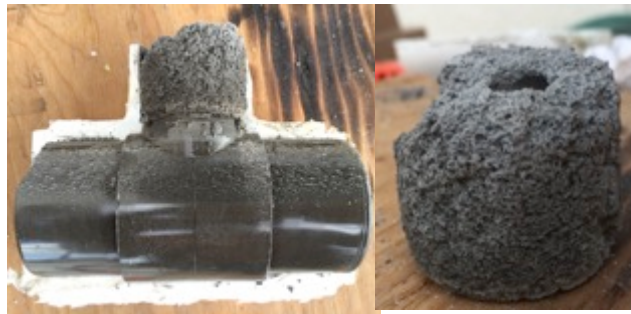
Figure 4.29: Photo of the Prototype for INT Sample Cast with Pre-exposed Grout B

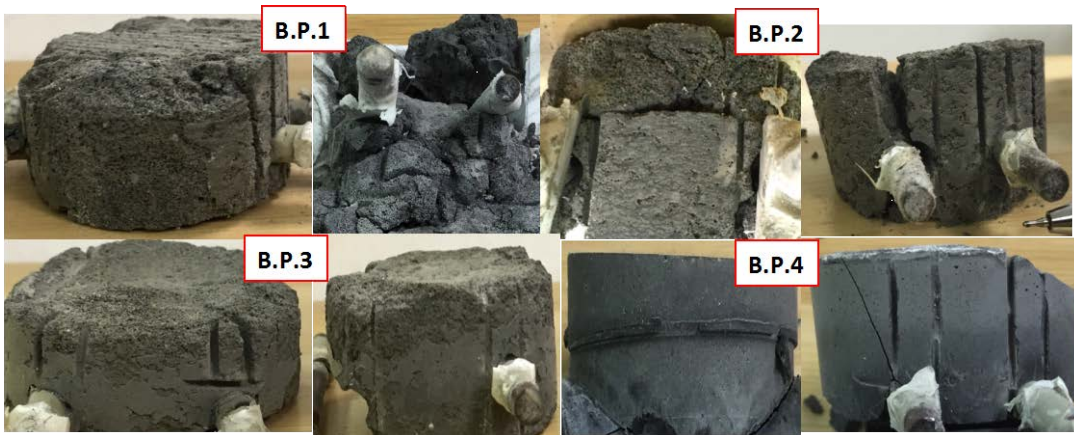
Figure 4.30: Photos of segregated grout in Tee header from INT Test Samples Cast with Pre-Exposed Grout B (Cases B.P.1-4)

Similar grout deficiency was observed in MIT and INT test samples cast with Grout A. Figures 4.27-28 show the surface of deficient grout in the tee header after one and 300 days from casting for different set of samples. Samples with pre-exposed Grout B also showed segregated porous material in tee header (Figure 4.29-30). As shown in Figure 4.31, the tee body was entirely filled with hardened grout for all samples (Grout A and B).

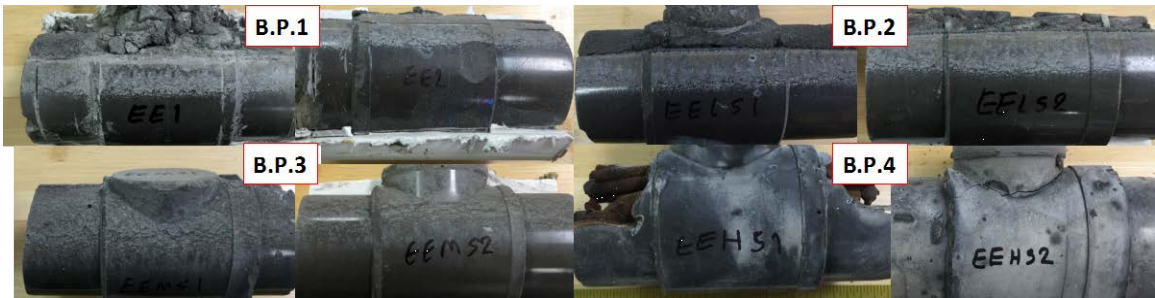
Figure 4.31: Photos of Grout in Tee Body from INT Test Cast with Pre-Exposed Grout B (Cases B.P.1-4)

Inverted Tee test (INT): Small -scale samples from the INT test which were cast with 32 days exposure and 20 % extra water did show some differentiation at tee header compared to the grout in the tee body. The bottom section of both Grout A and B formed hard material with dark color (Figure 4.31,4.34.4.38). Segregated grout typically formed in the PVC tee header. Pre-exposed Grout B formed friable weak material at the top section (Figure 4.29,4.30). Pre-exposed Grout A samples also were visually differentiated (Figure 4.32-33) .As shown in Figure 4.35 and 4.36, varying severity of material separation were observed depending on the sulfate and chloride level .Generally enhanced level of segregation was observed in samples with zero additives(A.P.1) as well as low to medium sulfate

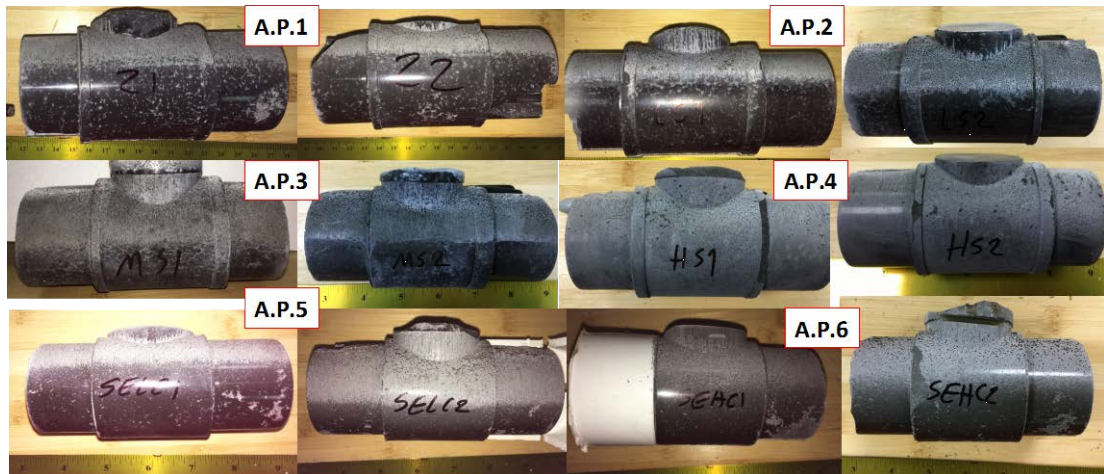
Figure 4.34: Photos of Grout in Tee Body from INT Test Cast with Pre-Exposed Grout A (Cases A.P.1-6)

INT samples with pre-exposed Grout A (A.P.1-6) showed variable level of segregation in the different case. As shown in Figures 4.32-33 the grout in tee header mostly consist of soft material while uniformly hard material formed in the tee body (Figure 4.34). The extent of grout segregation in cases with zero and medium sulfate concentration (A.P.1 and A.P.3) was greater than others.

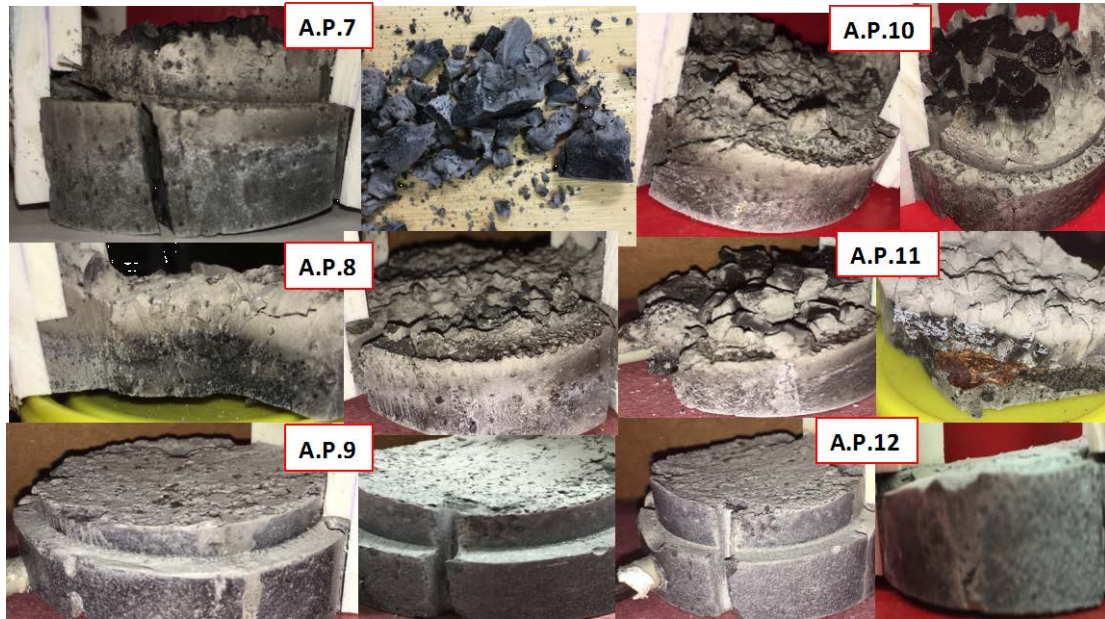
Figure 4.36: Photos of Segregated Grout in Tee Header from INT Test Cast with Pre-Exposed Grout A (Cases A.P.7-12)

Figure 4.35 shows the surface of the deficient grout in tee header after 300 days from casting for cases A.P.7-12. Varied level of grout segregation was observed in the tee header, depending on the sulfate and chloride concentration (Figure 4.36), It was clear that cases A.P.7-8 and A.P.10-11 had higher segregation as exhibited by having higher content of soft material. Overall the soft material at tee header formed 4 layers with different characterization (Figure 4.37). Like other cases described in the previous section, uniform hard material formed in the tee body (Figure 4.38).

The samples with high-admixed sulfate concentration (case A.P.4, A.P.9 and A.P.12) formed a harder material at the top section. Bleed water (5 to 10 ml) with pH of 12.86 accumulated in the ones without chloride additives (A.P.4). Even though this excess water was present here, the grout did not form the soft deficient grout seen in the other cases (Figure 4.33, 4.36).

highly friable material characteristic of corrosive deficient grout observed elsewhere (Figure 4.36). With that in mind, the electrochemical characteristics were indicative of low corrosion conditions (Figure 4.56). Like other cases, the corrosion current density, albeit at relative low values, were differentiated by the segregated layers. The OCP for steel in both the tee header and body was $\sim -200\text{mV}_{\text{CSE}}$. Corrosion current densities were less than $0.01\mu\text{A}\cdot\text{cm}^2$. It was apparent that the levels of chloride located within the grout layers in these samples did initiate corrosion development.

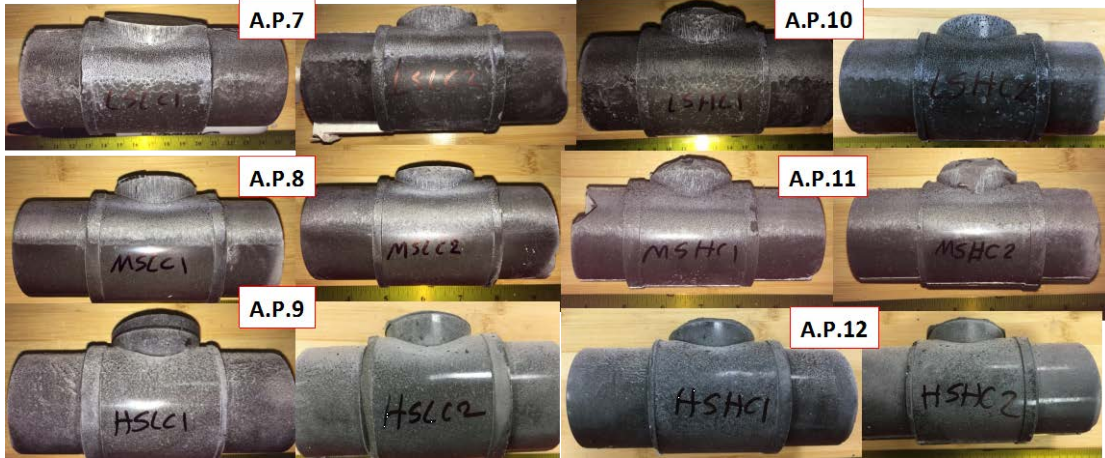
Figure 4.38: Photos of grout in Tee Body from INT test cast with Pre-Exposed Grout A (Cases A.P.7-12)

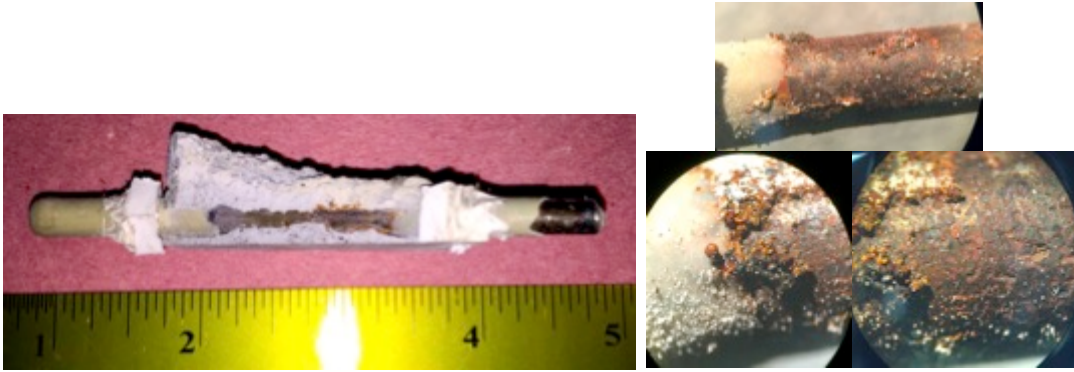
Figure 4.59: Photos of Corroded Wire in Segregated Part of INT Test Samples (Case A.P.3)

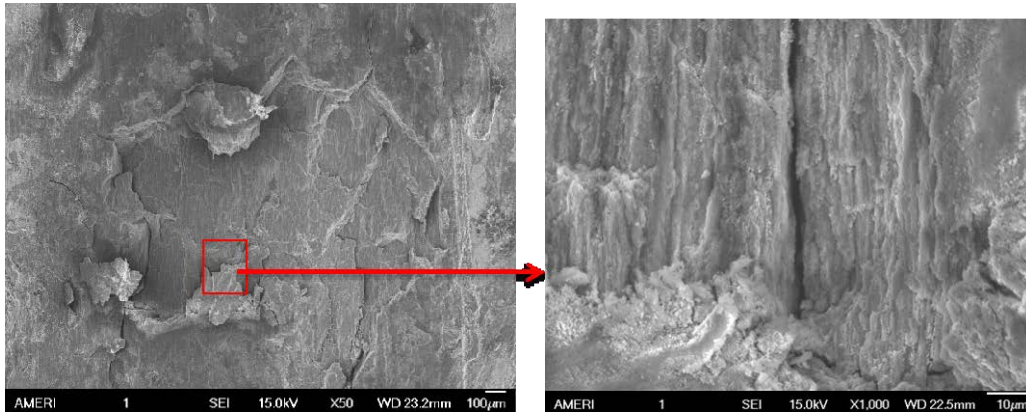
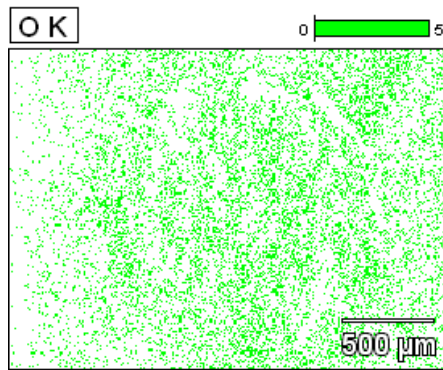
Figure 4.64: SEM Micrograph and EDS Elemental Maps on Pitting Corrosion for Corroded Wire in (Case A.P.11.1)

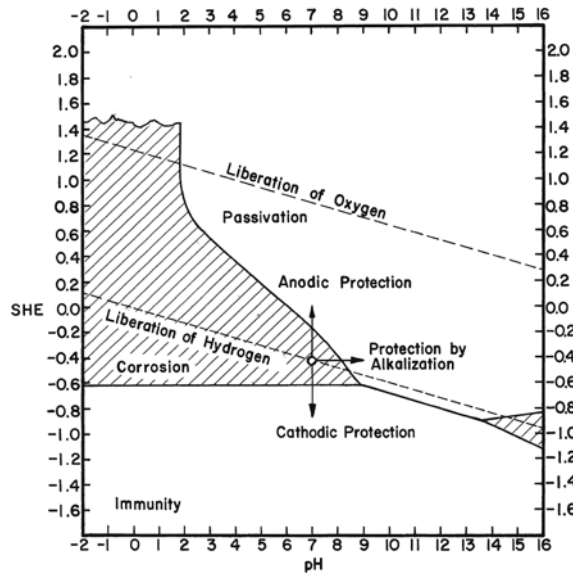
Figure 5.1: Pourbaix Diagram for Iron (Jones, 1993)

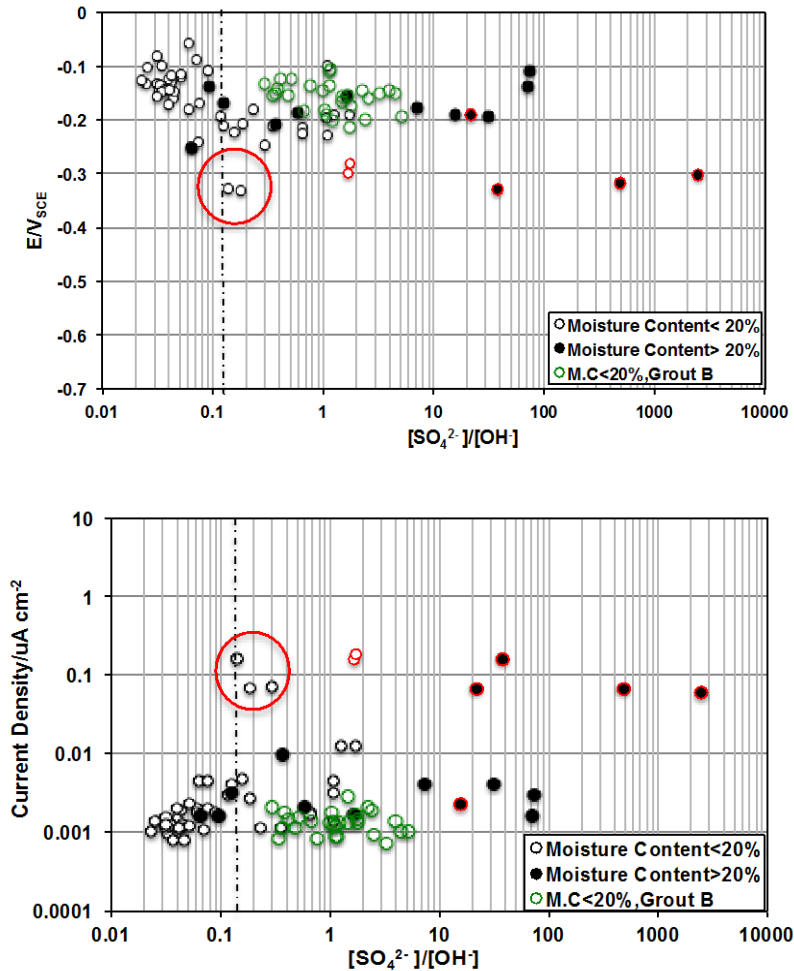
Figure 5.5: Sulfate /Hydroxyl Threshold Value Based on Corrosion Potential and Current Density. (Corrosion occurred in points with red outline)
