# Evaluation of Redundancy of Twin Steel Box-Girder Bridges

EVALUATION OF REDUNDANCY OF TWIN STEEL BOX-GIRDER BRIDGES

DOCTOR OF PHILOSOPHY

CIVIL ENGINEERING

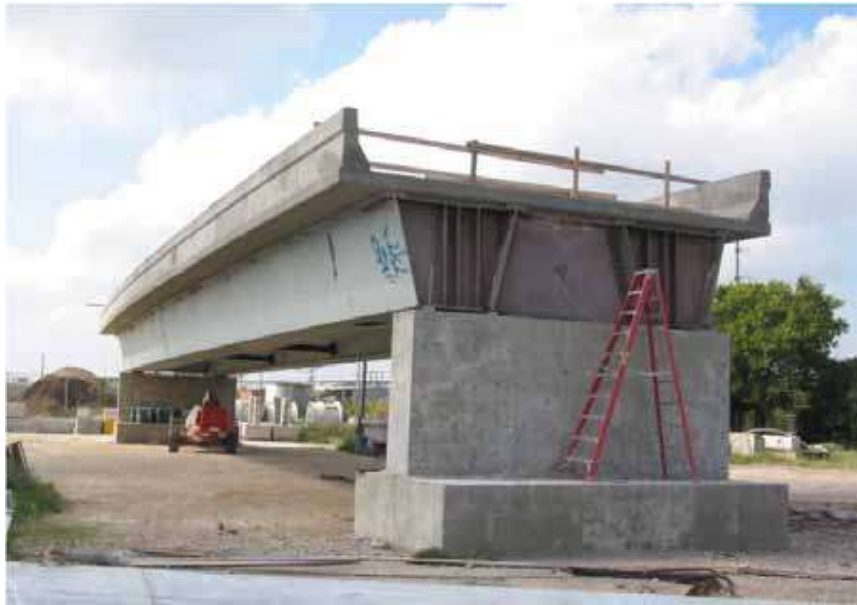
constructed with expansion joints that limit the contribution of the railing to the load-carrying capacity of the bridge. The bridge had a horizontal curvature and the fractured girder was the outside girder that has the maximum internal forces. Therefore, it is observed that the situation of a real-life bridge cannot be worse than this bridge from redundancy standpoint. Figure 1-1 shows a picture of this test bridge before conducting the tests.

**Figure 1-1 FSEL twin box-girder bridge (Source: FHWA Report No FHWA/TX-10/9-5498-1).**

The full-scale bridge test of this research project revealed the intrinsic redundant behavior of twin box-girder bridges, despite the fact that the test was conducted in the worst-case scenario from the point of view of redundancy. The tested bridge was a simple-span bridge and therefore it had no redundancy due to continuity of its superstructure. All external diaphragms of this bridge were removed. The railings of the bridge were

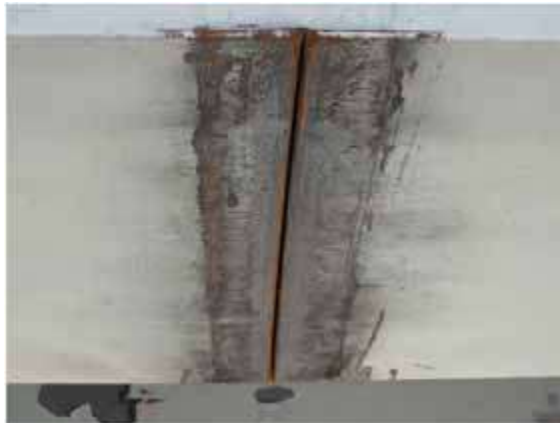
**Figure 1-3 Bottom flange cut after the explosion (Source: FHWA Report No FHWA/TX-10/9-5498-1).**

Three different tests were conducted on this bridge. In the first test, the bottom flange of the exterior girder was suddenly failed using an explosive to simulate a sudden fracture while an equivalent HS-20 load was positioned above the fractured girder and in the worst possible location. Figure 1-2 illustrates the bridge during the explosion and Figure 1-3 shows the bottom flange cut after the explosion. The response of the bridge during and after this test was satisfactory and its maximum deflection was less than 1 in.

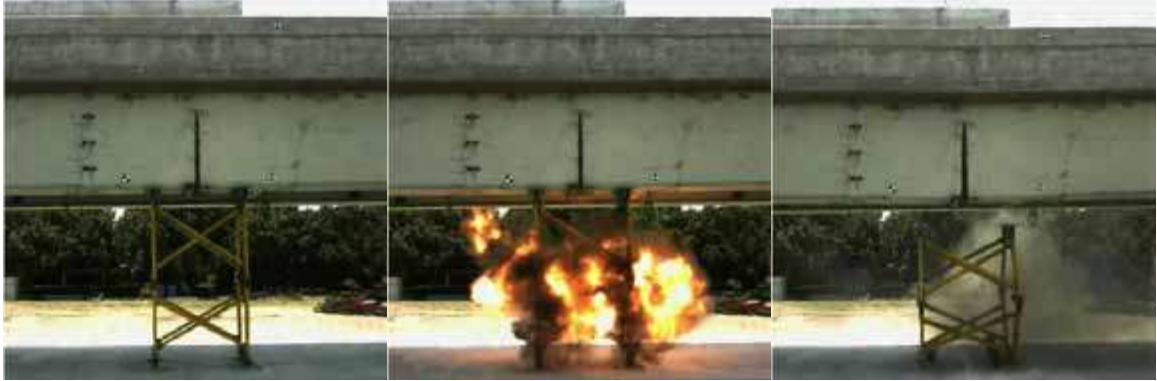
In the second test, the bridge and equivalent HS-20 truck loading were supported by means of a scissor jack while about 83% of the webs of the cracked girder were manually cut. The scissor jack was then removed suddenly using an explosive charge attached on the jack. This simulated the sudden nature of the crack. Figure 1-4 shows the supporting scissor jack before, during, and after the explosion. Again, the bridge safely sustained the load with a maximum deflection of 7 in.

**Figure 1-4 FSEL second bridge fracture test (Source: FHWA Report No FHWA/TX-10/9-5498-1).**

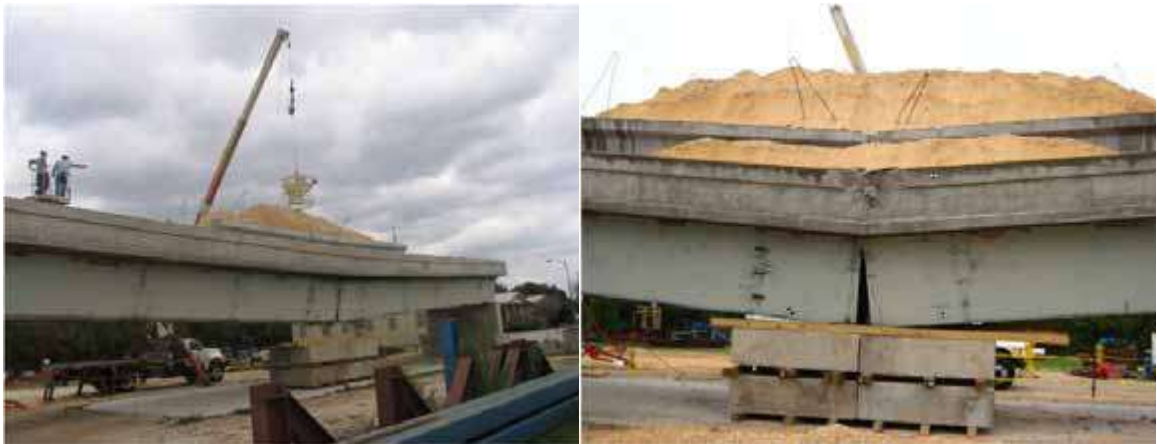
The third test was a static test to measure the load capacity of the damaged bridge. In this test, the load on the bridge was increased incrementally until the bridge was not able to carry more loads. In this test, the bridge carried 363 kips of load which, considering the extent of the damage, was a remarkable capacity. Figure 1-5 shows the incremental loading of the bridge and also the bridge in its collapsed mode.

**Figure 1-5 FSEL third bridge fracture test (Source: FHWA Report No FHWA/TX-10/9-5498-1).**

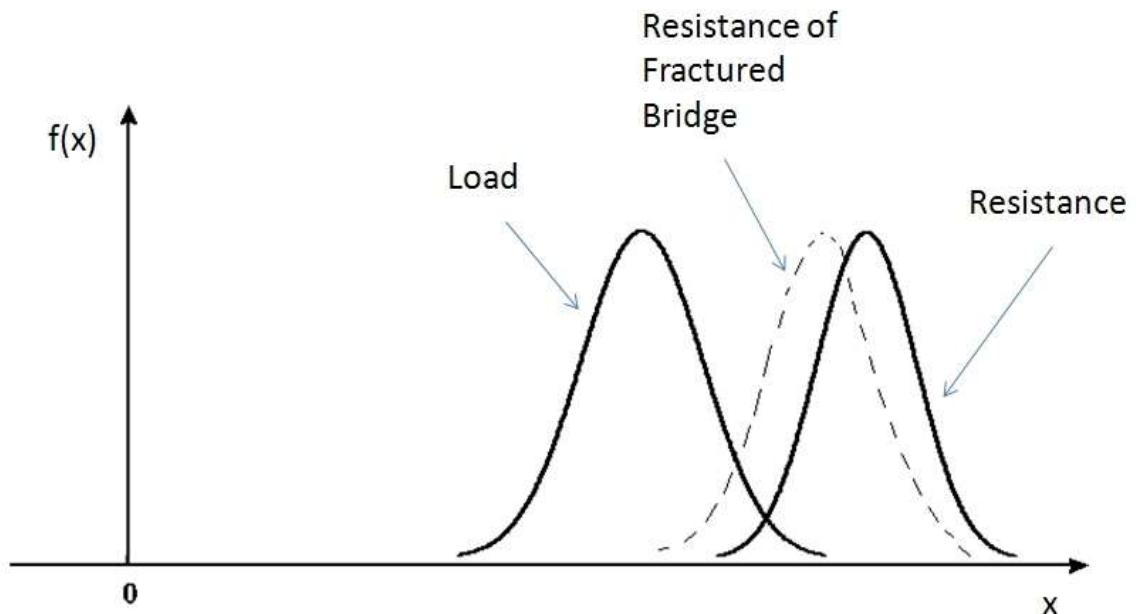
**Figure 2-1 Probability density functions of load and resistance of damaged and undamaged bridges.**

The determination of the load level that damaged two steel box-girder bridges must resist could be established by first establishing the level of safety (beta index) for damaged bridges that is agreeable by owners. This safety level could be established by consensus or through analysis of bridges that are agreed to be redundant (Ghosn and Moses, 1998). Once the safety level is established, the PDF of load could be shifted to the left or right until the overlapping area under the two PDFs results in a desired safety level. This process will establish the position of PDF for load, which in turn will establish the load level that damaged two steel box-girder bridges must resist.

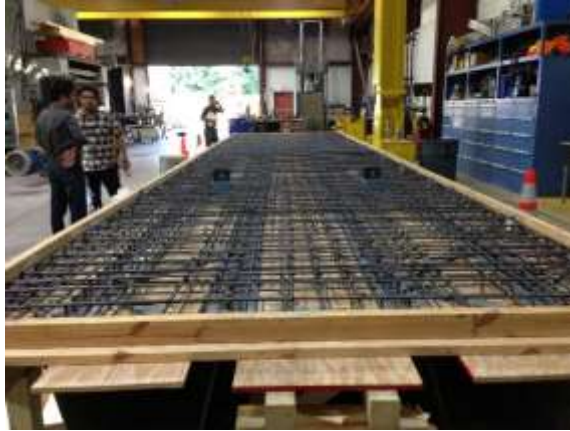
**Figure 3-8 Complete specimen ready for casting.**

After the fabrication was completed, two steel girders and five external cross-frames were assembled at the shop to check for any fit-up issue. Then, they were disassembled and shipped to FDOT Structures Laboratory to complete the remaining construction works. At FDOT Structures Laboratory, the girder and cross-frames were reassembled and then the formworks and the reinforcements were installed as shown in Figure 3-8. The instrumentations were also installed. Details on the instrumentation plan are discussed in the next section.

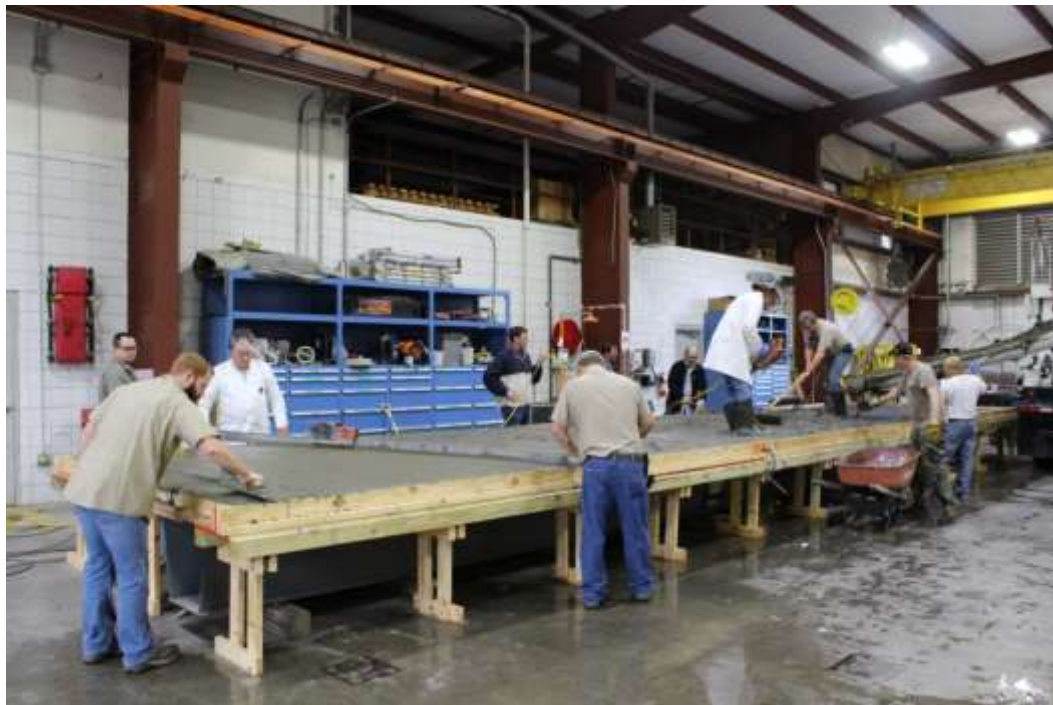
The bridge deck was casted using class II concrete mix with 28-day strength of 4,500 psi, 3 in. slump and 0.75 in. maximum aggregate size. This is also the type of concrete that is used by FDOT in other construction projects. The casting process is shown in Figure 3-9. After the concrete got hardened, the entire specimen was relocated to a final position and ready for testing as illustrated in Figure 3-22.

**Figure 3-9 Casting the concrete deck.**

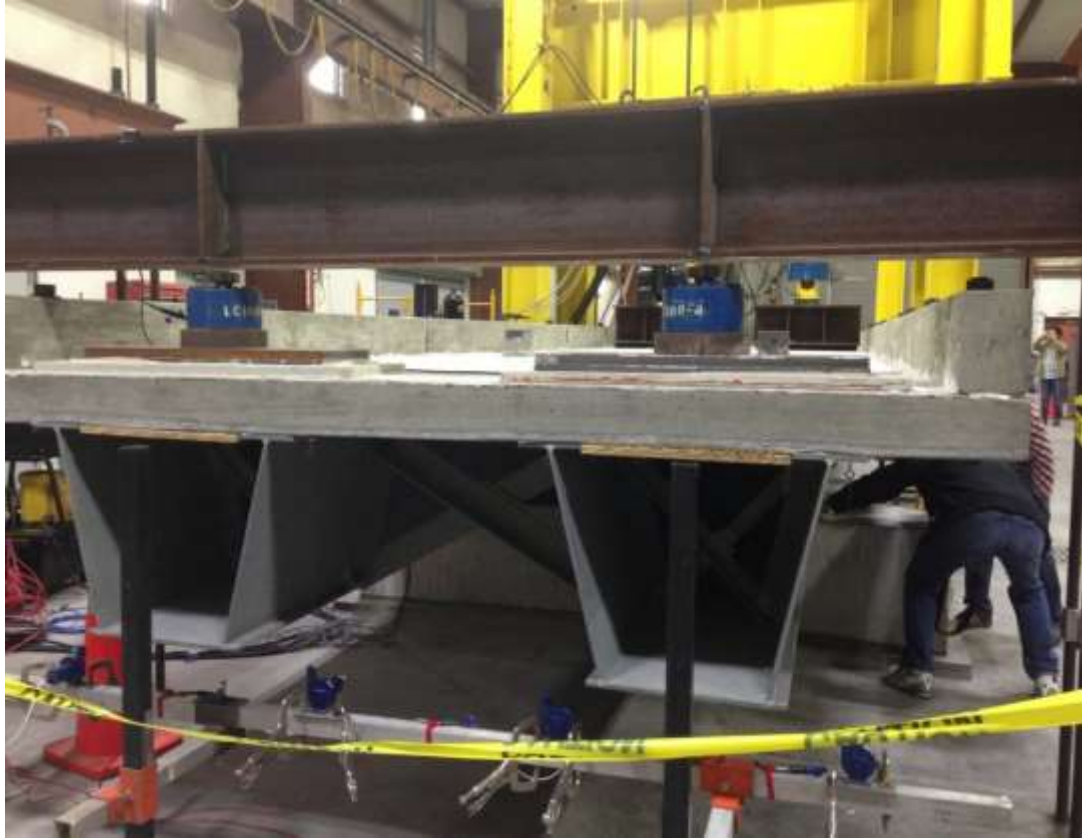
**Figure 3-20 Setup for continuity effect.**

conditions, a unique specimen configuration was devised so that both cases can be studied. The total length of the specimen is 41 ft comprising a 31-ft main span and a 10-ft second span as shown in Figure 3-19. The support, which is closer to the second span, is labeled as the south support. The one further away from the second span is labeled as the north support. The second span was configured so that it may act as a free cantilever in the non-loaded or non-anchored state. But when it is restrained to move vertically at its free end, the bridge will become a continuous structure with two spans. The restraining system at the cantilever end is composed of a transverse stiff I-beam anchored to the strong floor through two steel rods as shown in Figure 3-20. Two load cells were placed between the deck and the I-beam. As the load cells are in contact with the I-beam, the anchoring forces that will prevent the cantilever end from moving upwards are recorded. The I-beam can be raised out of the way to remove the restraint.

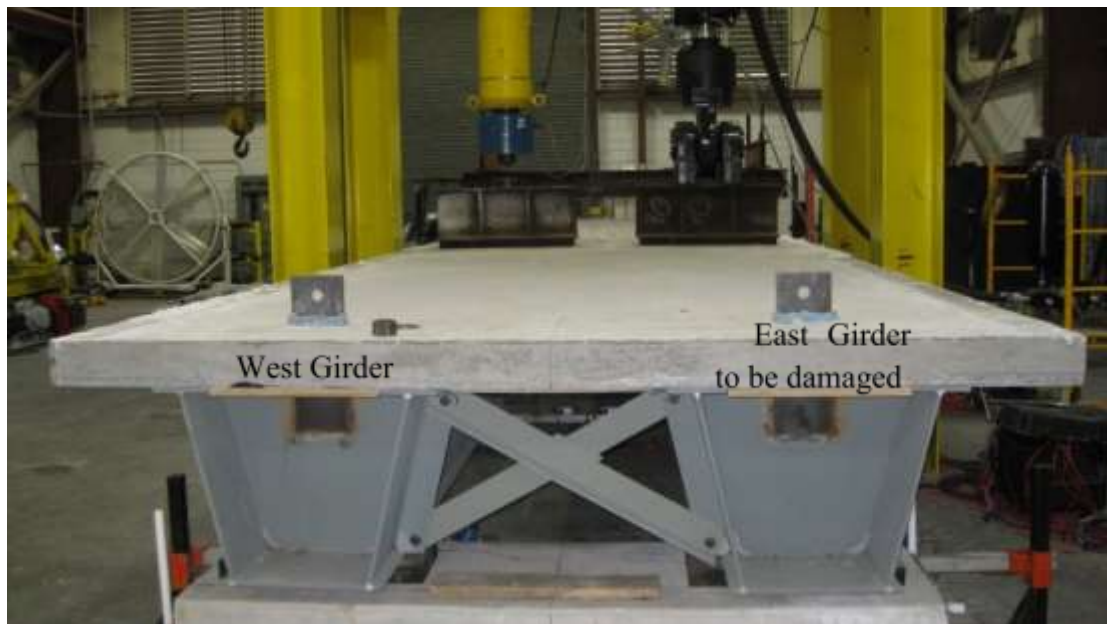
Figure 3-22 Specimen with complete loading setup.

Loading system used for this experiment included a FDOT loading frame of 130-in. width, two actuators, a loading beam (stiff I-beam) and steel reinforced elastomeric bearing pads as shown in Figure 3-21. One actuator has an 800-kip capacity and the other one has a 450-kip capacity. With this loading setup either one-point loading or two-point loading scenarios can be carried out. Figure 3-22 shows the complete specimen that was ready to be tested.

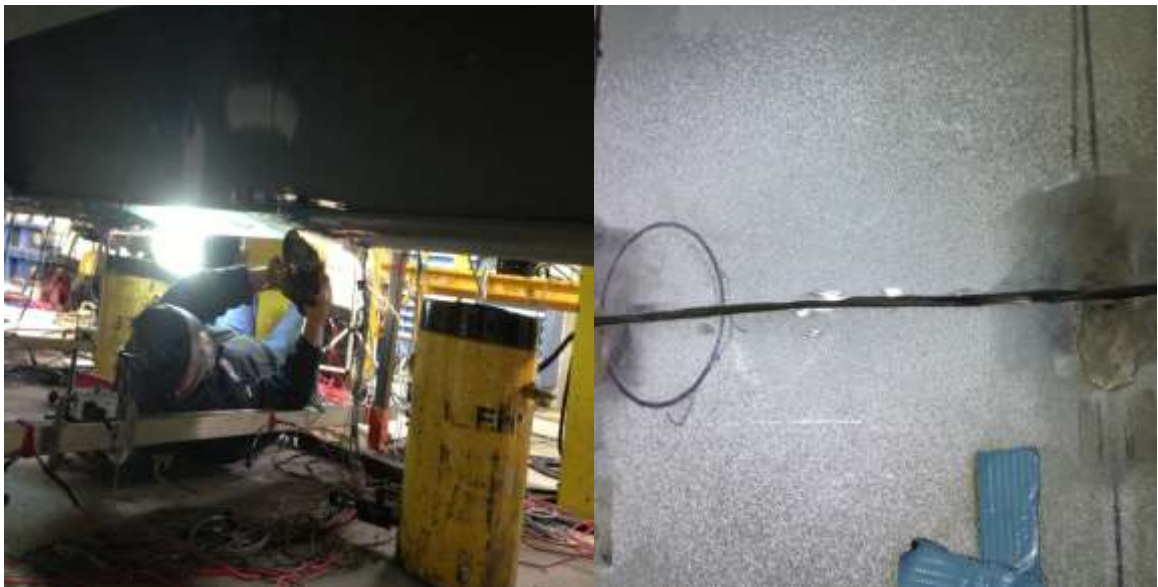
Figure 4-1 Saw cutting of bottom flange in east girder.

In this series of tests, the bottom flange in the EG was fractured at mid-span as illustrated in Figure 4-1. Due to that fracture in bottom flange, the maximum longitudinal strain in EG was now measured from its webs, while maximum longitudinal strain in WG was still measured from its bottom flange. The same six tests that had been carried out for the undamaged bridge were repeated. Again, the effects of each parameter, including rail, continuity, and loading configuration, were investigated based on the responses of the steel box-girders.

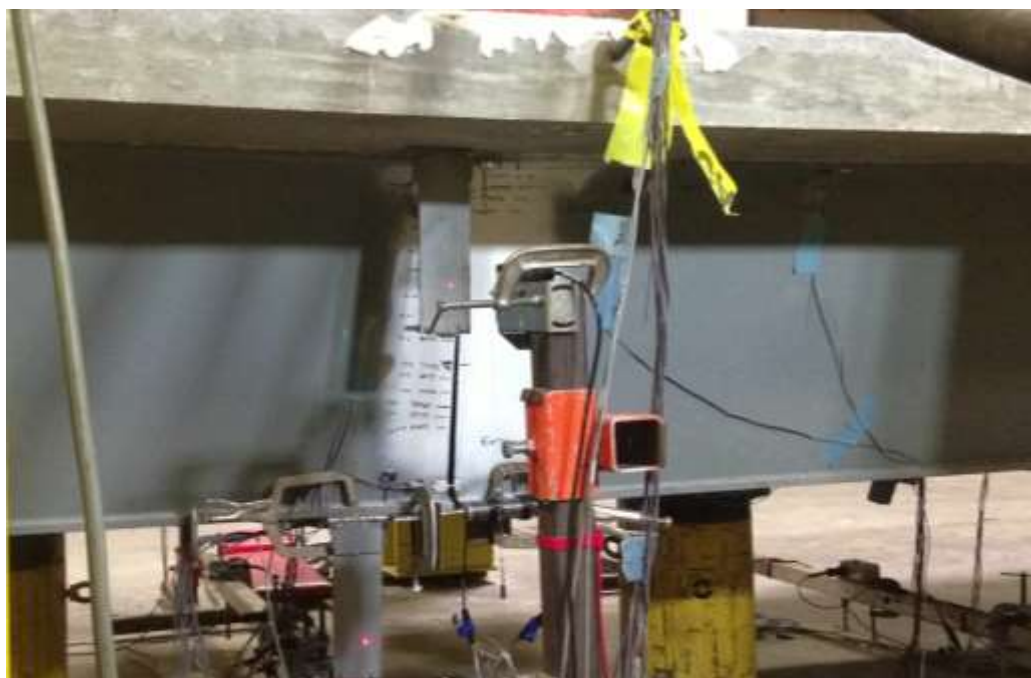
**Figure 4-2 East girder with bottom flange and web fractured in one girder.**

In this testing series, the damage intensity was extended by fracturing the entire webs of EG in addition to the existing fracture in the bottom flange as illustrated in Figure 4-2. It is also important to note that since the web was now fully fractured, the longitudinal strain data in EG at mid-span were lost and not reported here.

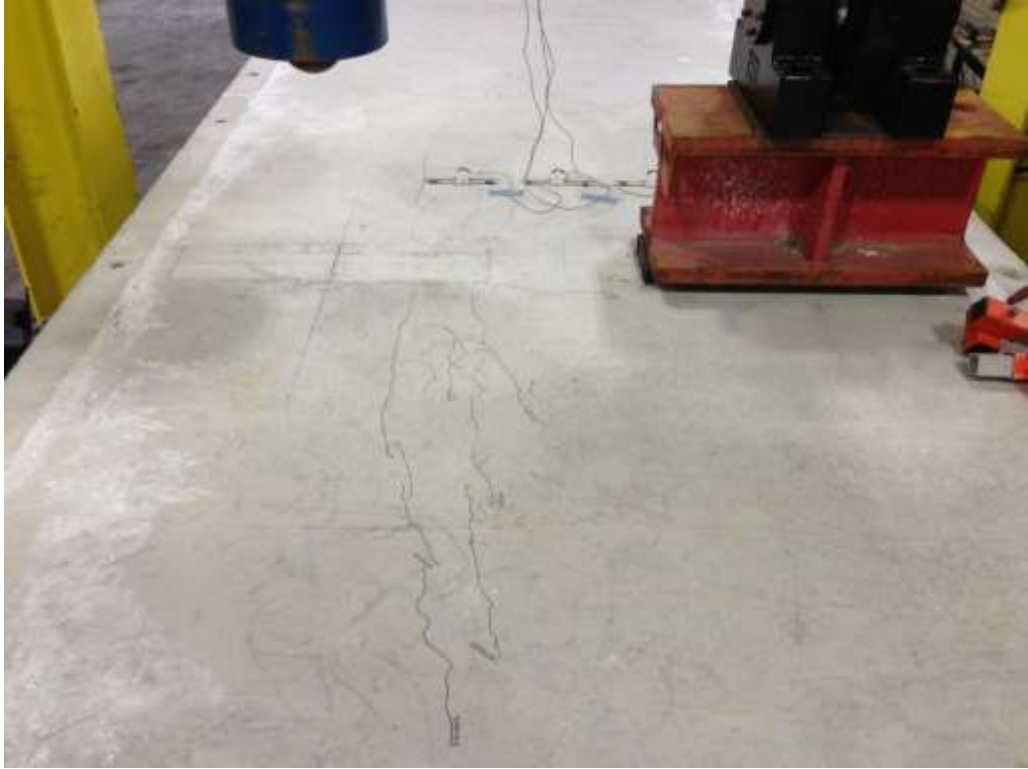
**Figure 4-7 Cracks on the deck surface during cyclic test.**

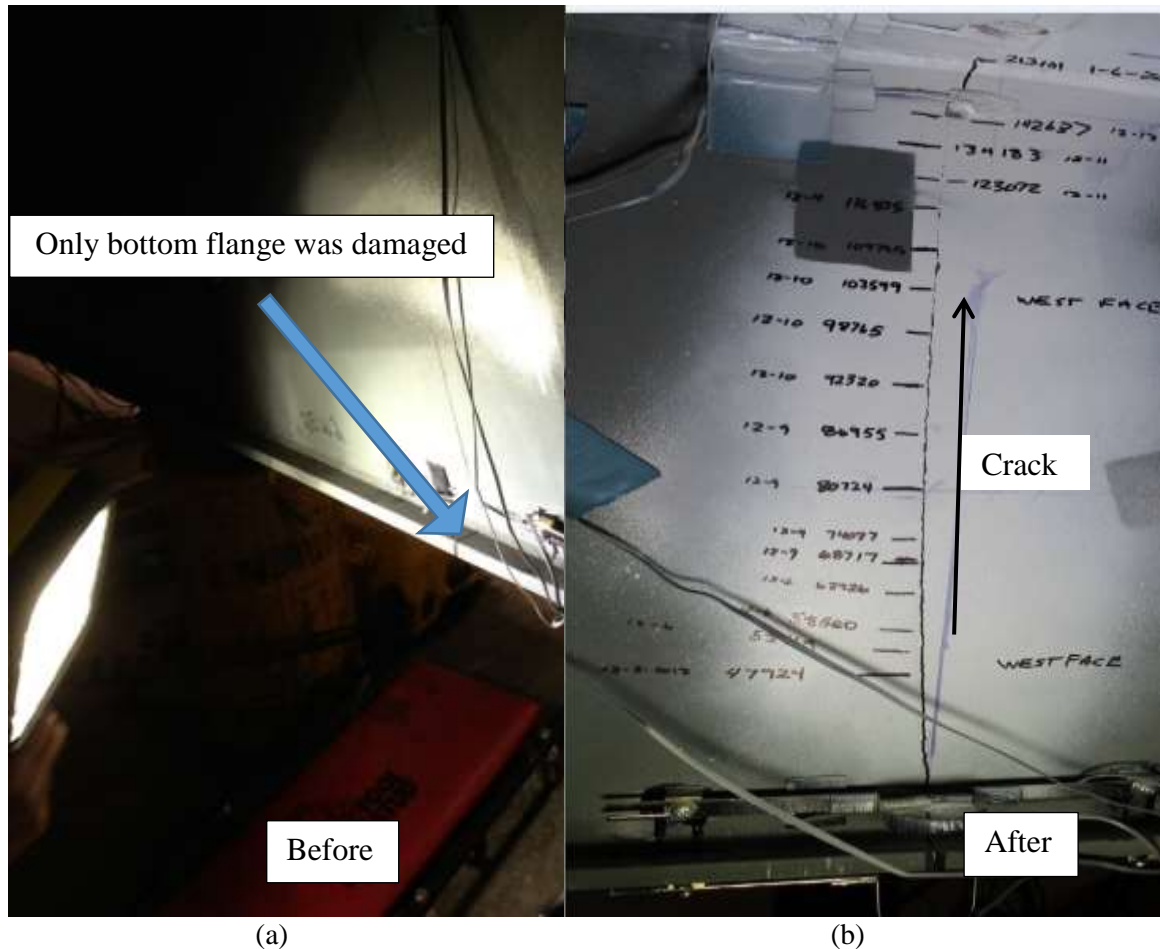
**Figure 4-8 Crack in the damaged girder: (a) before and (b) after the cyclic test.**

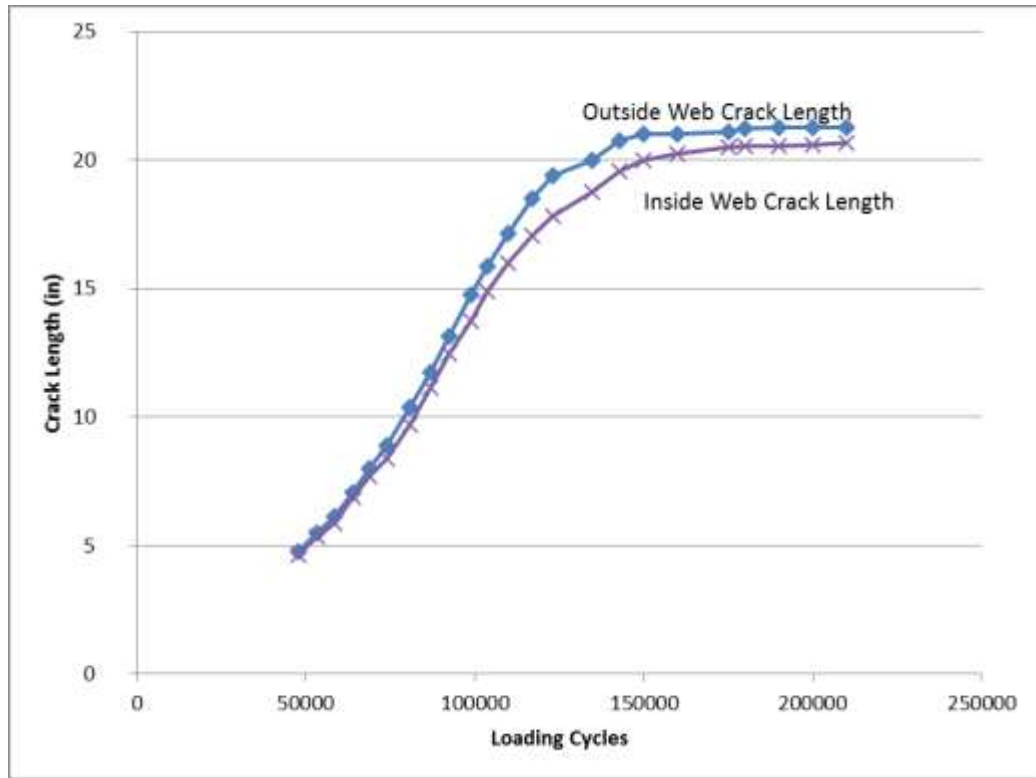
**Figure 4-9 Crack growth in the damaged girder.**

girder to the inside web of the damaged girder. This was consistent with experimental data from elastic tests and FEA results, which showed the outside face of the damaged girder always had higher displacement and stress than the inside face.

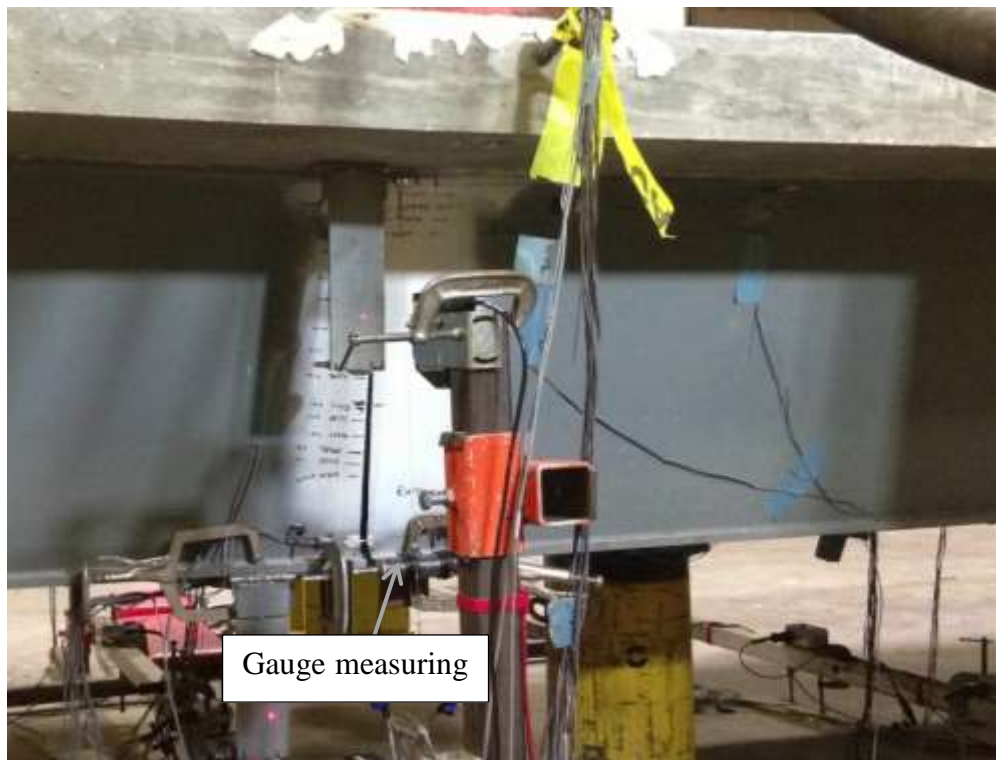
**Figure 4-10 Crack opening measuring gauge on the exterior face.**

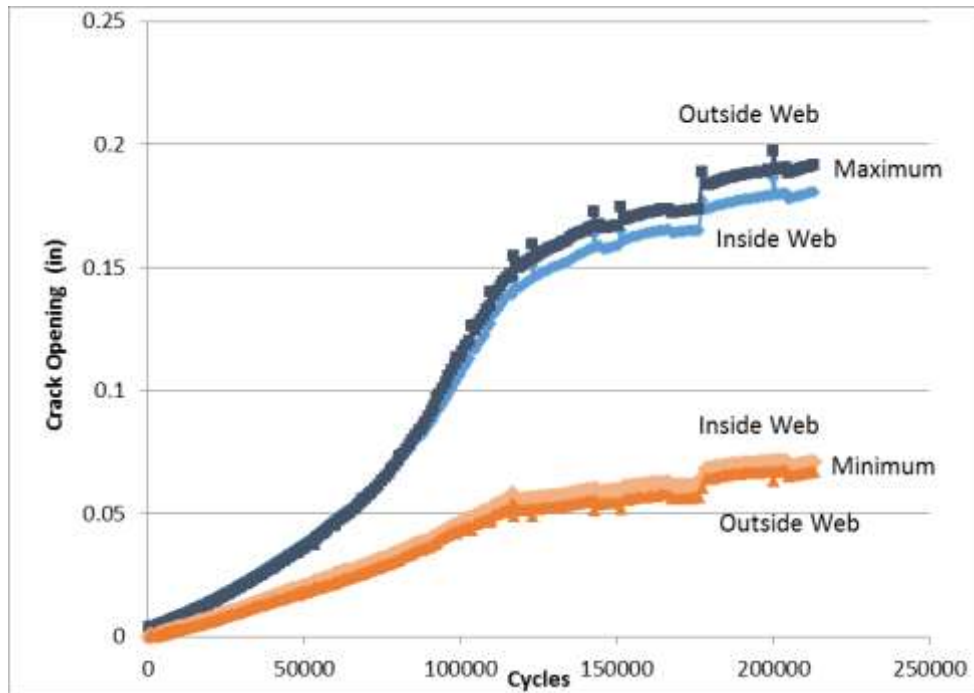
**Figure 4-11 Crack base opening vs. number of loading cycles.**

At the same time, the stiffness of the bridge measured at the fractured location was found to have decreased approximately 54% from 260 kips/in to 120 kips/in.

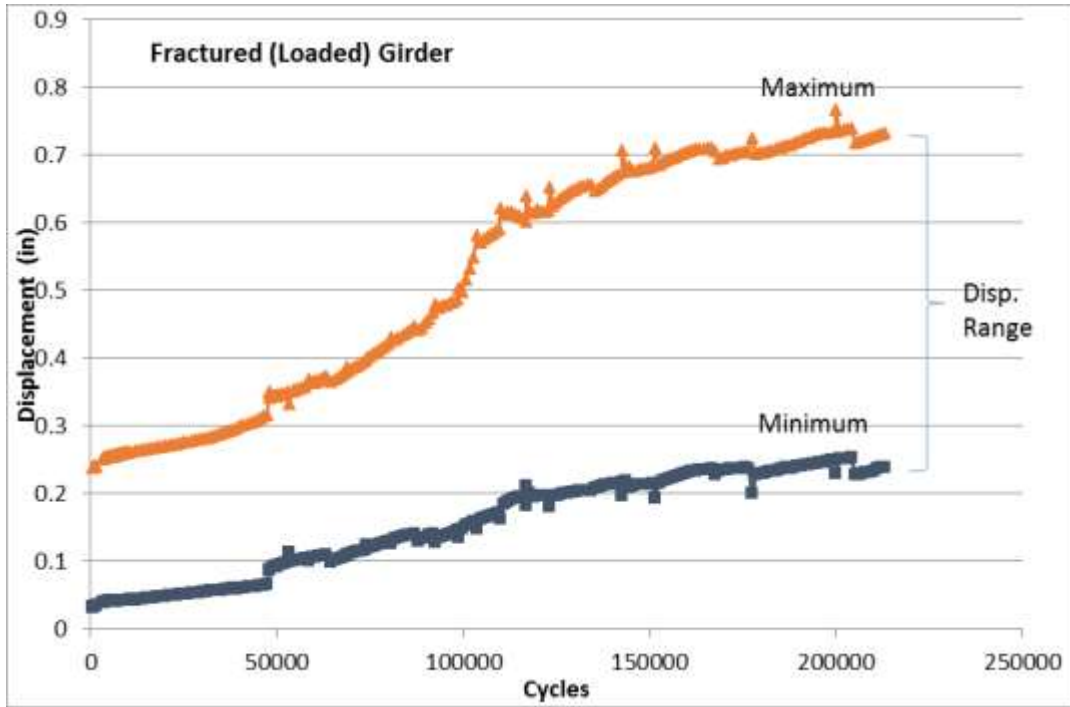
Figure 4-12 Mid-span displacement vs. number of loading cycles in the fractured girder.

The maximum displacement and minimum displacement of the girders were collected for each loading cycle. Figure 4-12 shows how the maximum and minimum displacement of the fractured girder changed over time. The maximum displacement increased from 0.25 in. to 0.7 in. while the minimum displacement also increased from 0.03 in. to 0.24 in. during the test. Figure 4-13 plots the displacement range for both girders (which is equal to maximum displacement minus minimum displacement in each girder) that shows the vertical deflection of each girder in a cycle. Both plots show similar behavior and trends to that of the crack length growth plot.

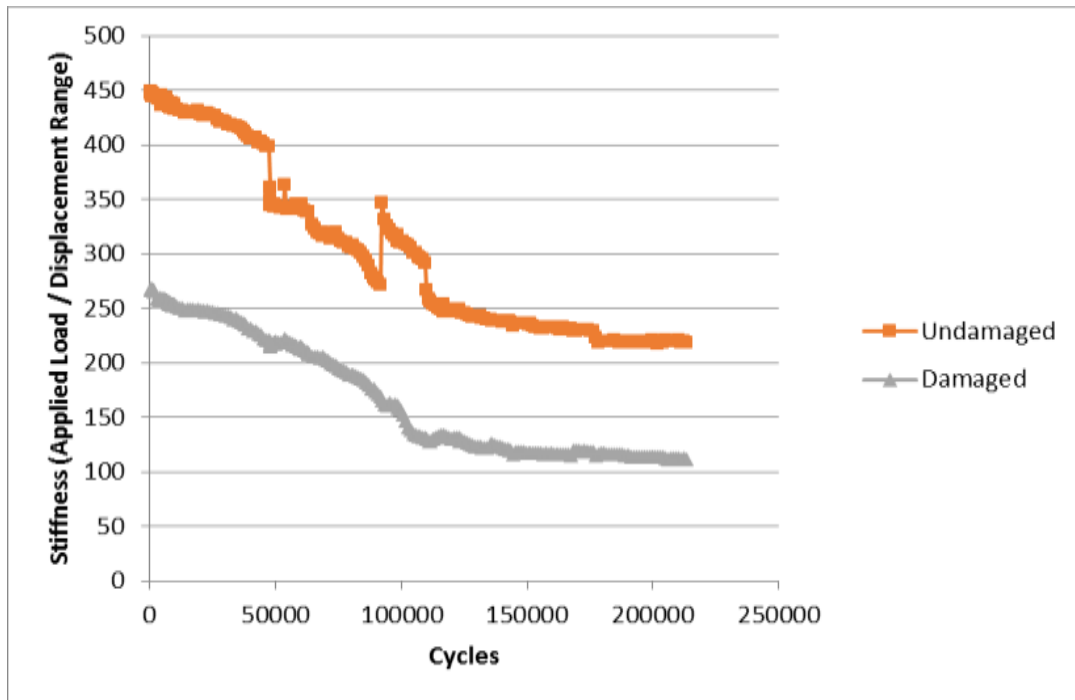
**Figure 4-14 Stiffness of each girder during the cyclic test.**

The stiffness of each girder over time is plotted in Figure 4-14. The stiffness of each girder is calculated by dividing the applied load by the displacement range in each cycle. Since the applied load for each cycle was constant at 60 kips, the stiffness curve was shown inversely proportional to displacement range curve. The damaged girder had a stiffness of 260 kips/in at the beginning of the cyclic test when bottom flange fractured. The stiffness reduced 60%, to 105 kips/in, at the end of the test when the web was completely fractured. Similarly, the stiffness reduction, for the undamaged girder, was around 235 kips/in, which was equivalent to 52% of its initial stiffness.

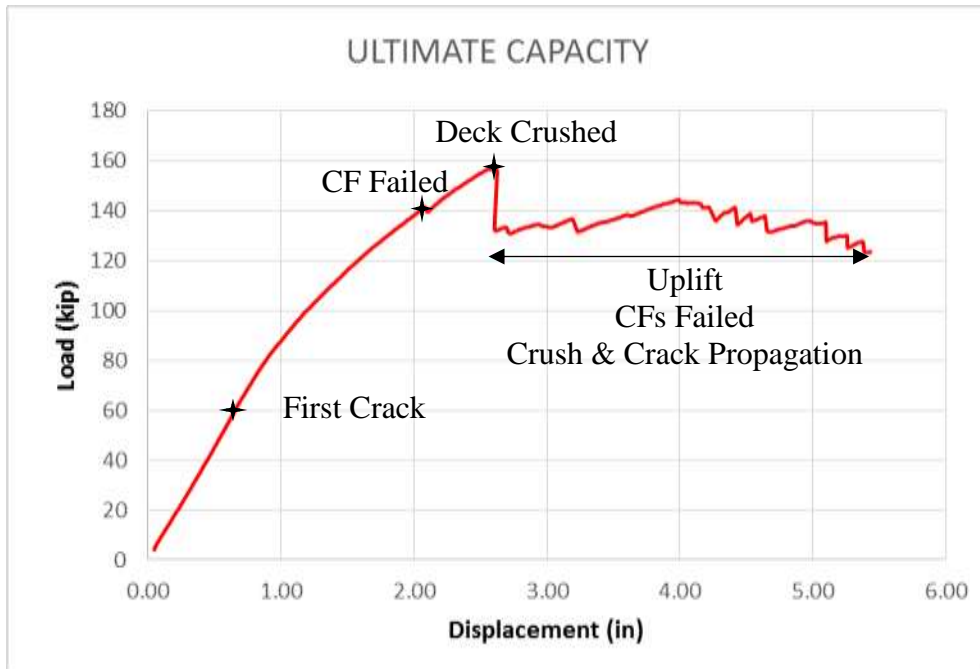
**Figure 4-18 Load vs. deflection curve of the specimen during ultimate load Test A.**

both ends of intact girder. As seen in Figure 4-18, during this loading period, the load fluctuated and reached a local maximum load of 144 kips at 4-in. displacement. It, then, slowly dropped down to 123 kips at 5.5-in. displacement before the test was halted. This sequence of failure suggests that the bridge was trying to transfer the load to the intact girder through an alternative load path after the primary load path had failed. This load-transfer mechanism is discussed further in the following section.

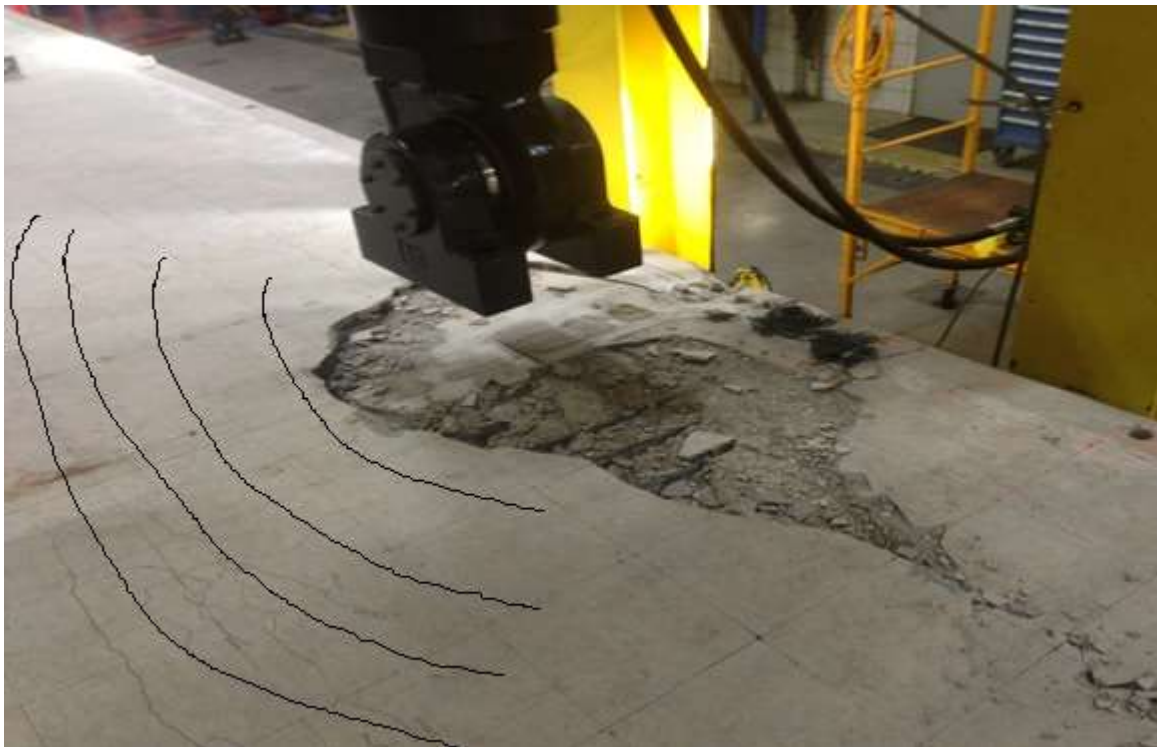
**Figure 4-19 Punching in the top of the concrete surface looking to South.**

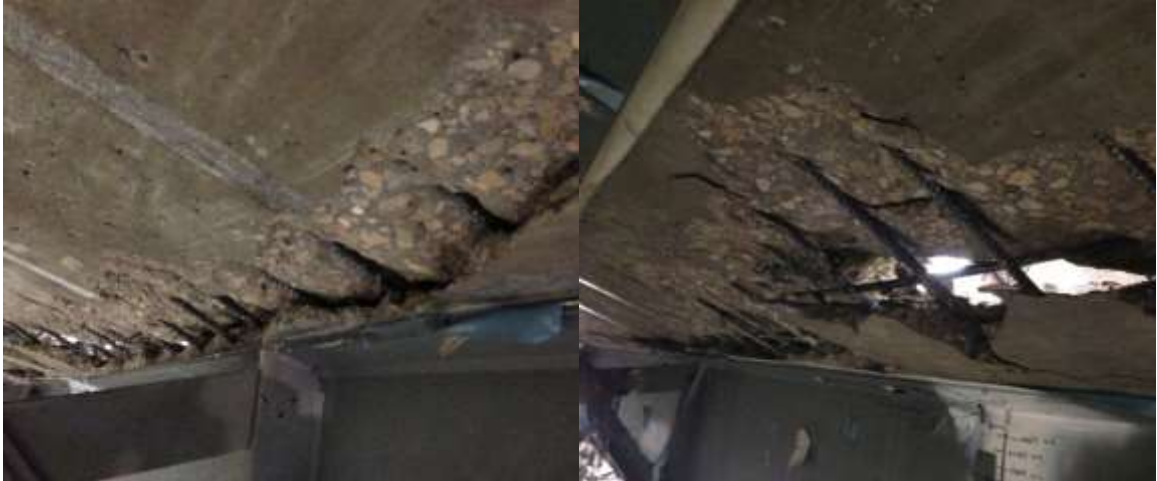
than the south support. It could be due to the presence of the cantilever portion in the south end. This cantilever made the south portion of the specimen measured from the loading point was stiffer than the north portion of the specimen. Eventually, the deck was punched by the loading pad along the inside top flange of the damaged girder when the specimen reached its maximum capacity. The spalling of concrete in the bottom of the deck is illustrated in Figure 4-20.

**Figure 4-20 Punching in the bottom of the deck.**

This same hypothetical situation can be used to examine the failure mechanism near the load point. In this region, the (hypothetical) damaged girder will be below the undamaged. Since the displacement level is being held by the loading beam, the undamaged girder will be pulled downward when the two separate structures are hypothetically re-joined. The effect of the resulting shear force can be seen in Figure 4-20.

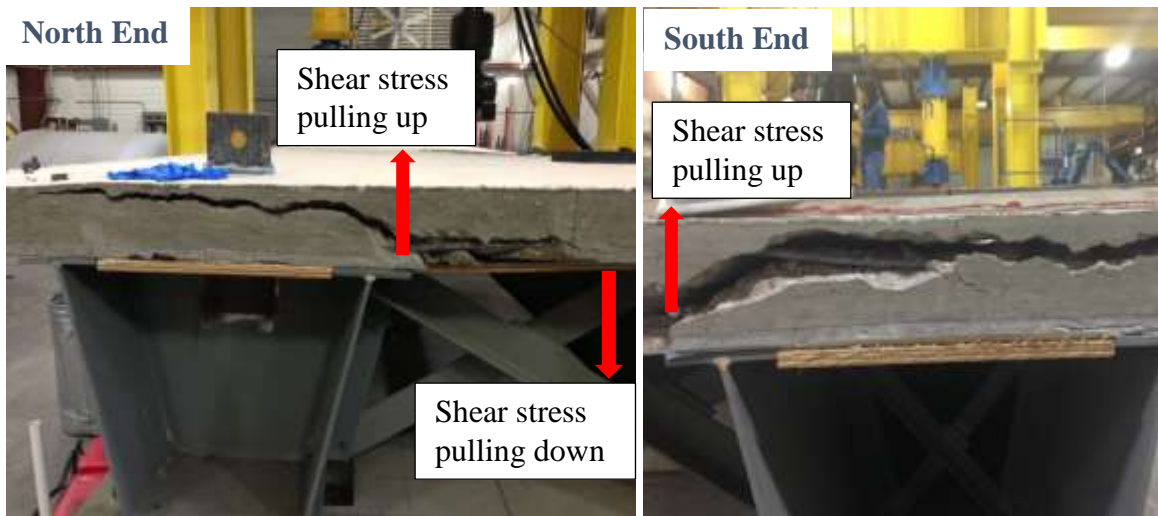
**Figure 4-21 Damage at North end (left) and South end (right).**

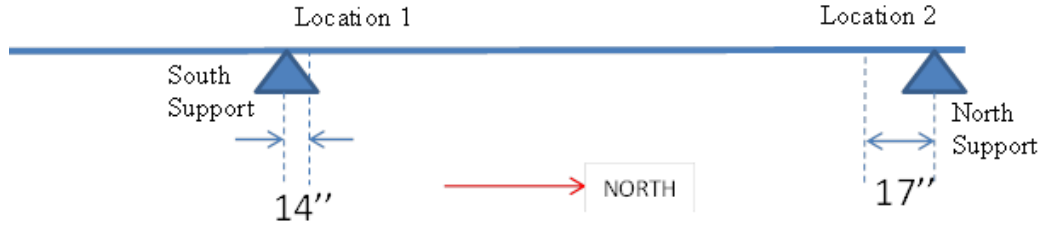
Another important behavior observed was the uplift at supports of the intact girder. Displacements near the supports were monitored at location 1 (14 in. from the bearing line of the South support) and location 2 (17 in. from the north end of steel box girders) as depicted in Figure 4-22. Figure 4-23 and Figure 4-24 plot the vertical displacements at these two locations. These plots show that the intact girder (or the West Girder) began to uplift at the south support shortly at 100 kips before the specimen reached its maximum capacity of 156 kips while the north support was uplifted just right after the maximum

capacity was reached. The final uplifts were measured as 0.48 in. near the south support and 0.11 in. near the north support.

Figure 4-22 Location of potentiometers at supports.

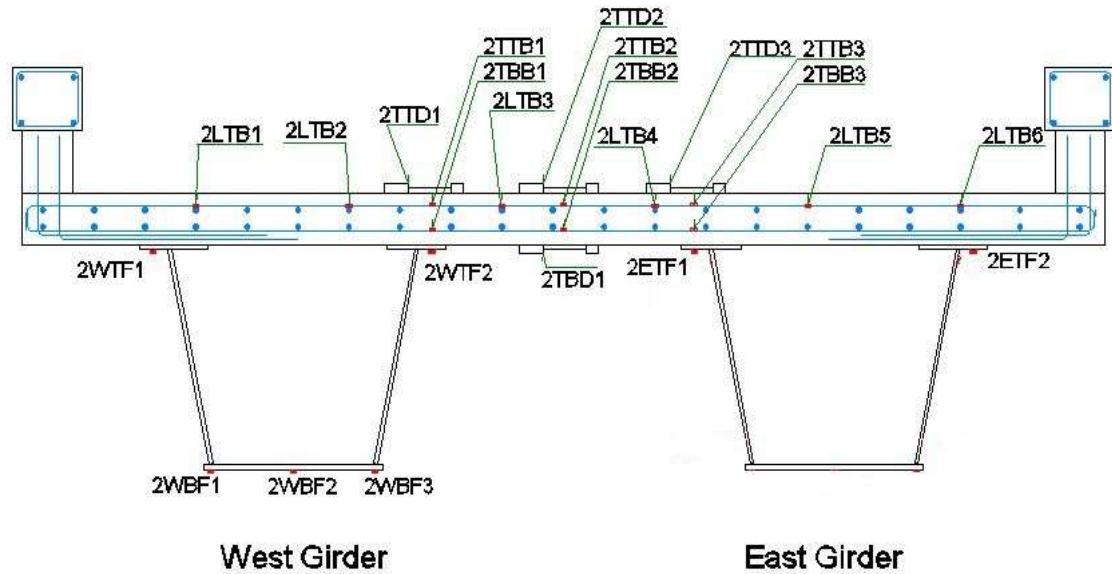
**Figure 4-26 Strain gauges at the mid-span section.**

It is noted that gauges 2TTD1, 2TTD2 and 2TTD3 were shifted away from the mid-span by 1 ft toward the south support to avoid contact with loading pads.

Responses in transverse rebars at mid-span were measured from six strain gauges 2TTB1, 2TBB1, 2TTB2, 2TBB2, 2TTB3 and 2TBB3 (see Figure 4-26 for their locations.) All of the strains in the transverse rebars were positive or in tension except at gauge 2TBB3, located near the damaged girder as illustrated in Figure 4-30. However, gauge 2TTB2, which was located at the center of the cross-section, had its strain fluctuating around zero. This suggests that the gauge 2TTB2 was an inflection point in the deflected shape of the cross-section. The plot also suggests that the strains at gauges 2TTB1 and 2TTB3 were much higher than that of other gauges. Gauge 2TTB1 had a strain of  $2600 \mu\epsilon$  suggesting the transverse re-bar yielded at this location, which is the inside top flange of the intact girder.

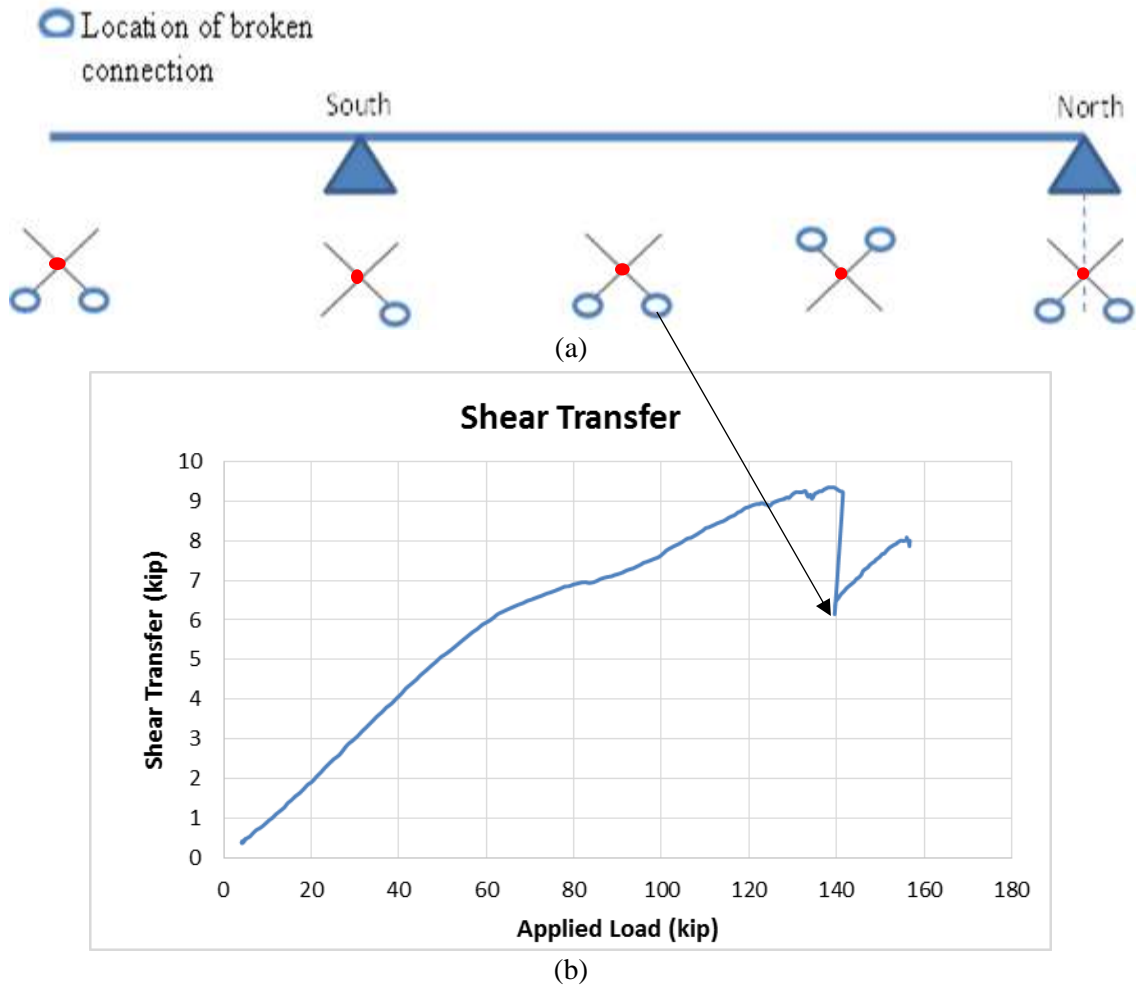
Figure 4-33 Shear transferred through one cross-frame in Test A.

Since the deck and external cross-frames were found to be two major components that transferred the load from damaged girder to undamaged girder, it is interesting to quantify how much load was transferred through these components. It is important to note that there were only two external cross-frames in the main span of the specimen. Each of them is located 5 ft away from the mid-span. Figure 4-33b shows the amount of shear force transferred (vertical direction) in one external cross-frame. The shear transferred through this cross-frame only plotted until the maximum capacity of the specimen was obtained. The first shear drop was approximately 3 kips at 2.1-in. displacement with 140 kips of applied load, and it was due to the failure of bottom connection of the tension brace. It should be noted that even though the capacity of the cross-frame dropped 3 kips, the capacity of the specimen decreased only 1 kip as seen in Figure 4-18. The difference could be due to the fact that the calculated shear drop of 3 kips was based on the assumption that the strain profile was linear along each brace as shown in Figure 4-15b. It should be noted that after one connection failed, this cross-frame should have lost its load-resisting capability completely. However, the welded connection between two L-angle braces as shown by the red dot in Figure 4-33a enabled this tension brace to continue carrying more forces until another failure in the bottom connection of the compression brace. Therefore, after the failure of the first connection in the tension brace, the data in cross-frames were no more unreliable.

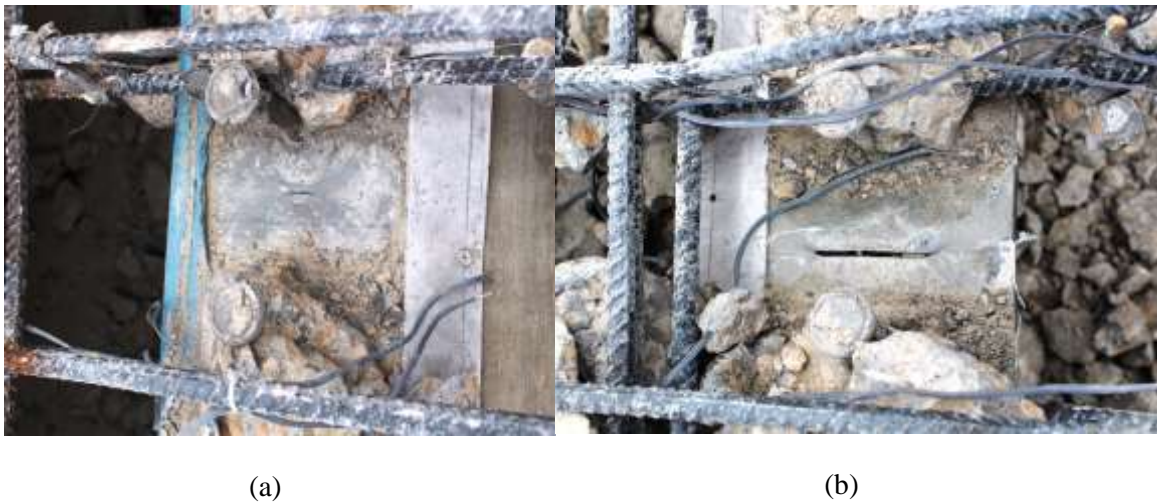
**Figure 4-34 Damage in (a) the inner top flange, (b) the outer top flange of the damaged girder.**

already expected, and this damage almost cut the damaged girder into halves as illustrated in Figure 4-34.

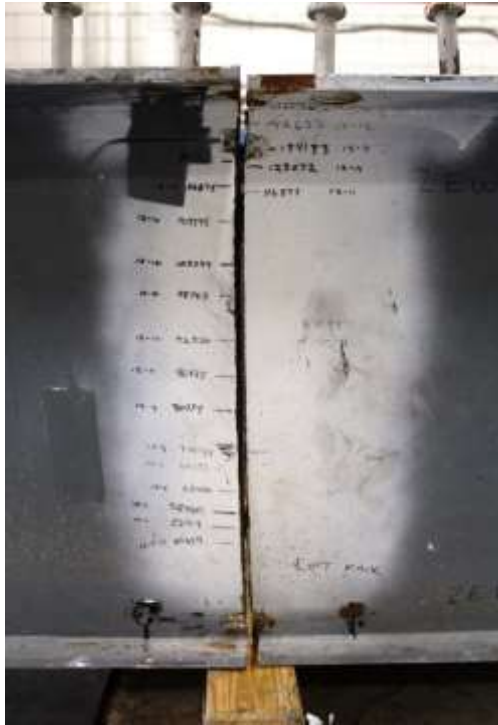
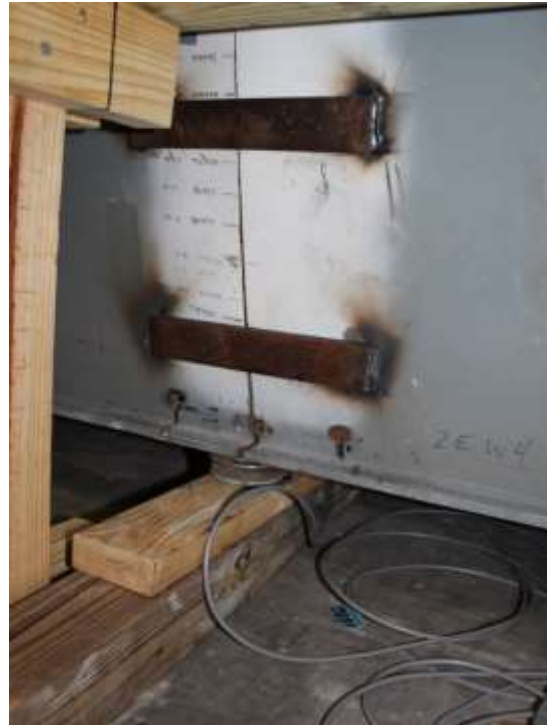
(a) Before aligned

(b) After aligned

**Figure 4-35 Alignment of two fractured segments.**

Eventually, it was decided that this damaged girder should be cut into two halves to make the reconstruction of the specimen easier. The results of FEAs showed that the effect of having the damaged girder cut completely into two separate pieces is negligible. However, misalignment of two fractured segments, as shown in Figure 4-35a, brought up some difficulties during the reconstruction process. In order to fix it, the bolts connecting the external cross-frames were loosened, and then the slop in the bolt holes were used to shift the girder segments into better alignment. Then the cross-frame bolts were tightened up again. Finally, scab plates were used to bring these two segments closer as much as possible. Figure 4-35b illustrates the damaged girder with the welded scab plates. Please note that once the deck was cast, these scab plates were removed. After aligning the fractured segments, the new specimen was reconstructed as it had been previously. Figure 4-36 shows the complete specimen after the reconstruction.
