# Evaluation of Redundancy of Twin Steel Box-Girder Bridges

EVALUATION OF REDUNDANCY OF TWIN STEEL BOX-GIRDER BRIDGES

DOCTOR OF PHILOSOPHY

CIVIL ENGINEERING

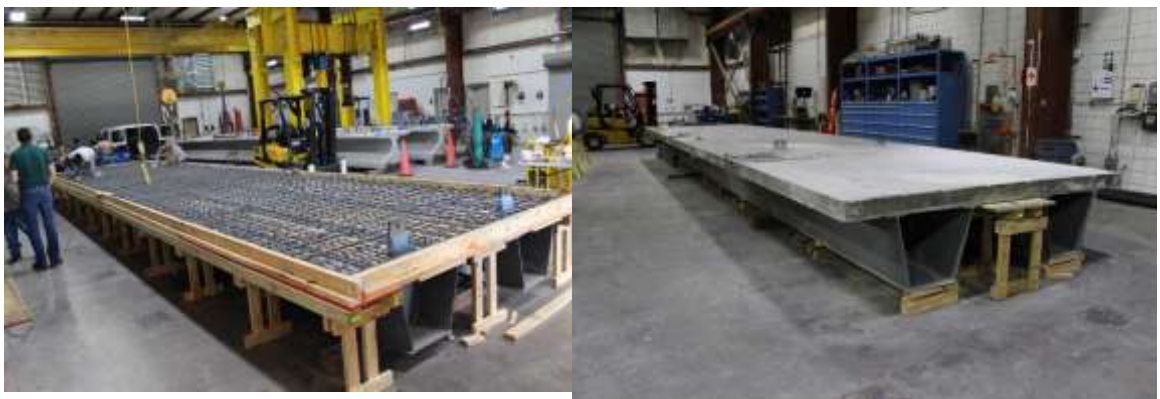
**Figure 4-36 The reconstructed specimen before (left) and after casting (right).**

Eventually, it was decided that this damaged girder should be cut into two halves to make the reconstruction of the specimen easier. The results of FEAs showed that the effect of having the damaged girder cut completely into two separate pieces is negligible. However, misalignment of two fractured segments, as shown in Figure 4-35a, brought up some difficulties during the reconstruction process. In order to fix it, the bolts connecting the external cross-frames were loosened, and then the slop in the bolt holes were used to shift the girder segments into better alignment. Then the cross-frame bolts were tightened up again. Finally, scab plates were used to bring these two segments closer as much as possible. Figure 4-35b illustrates the damaged girder with the welded scab plates. Please note that once the deck was cast, these scab plates were removed. After aligning the fractured segments, the new specimen was reconstructed as it had been previously. Figure 4-36 shows the complete specimen after the reconstruction.

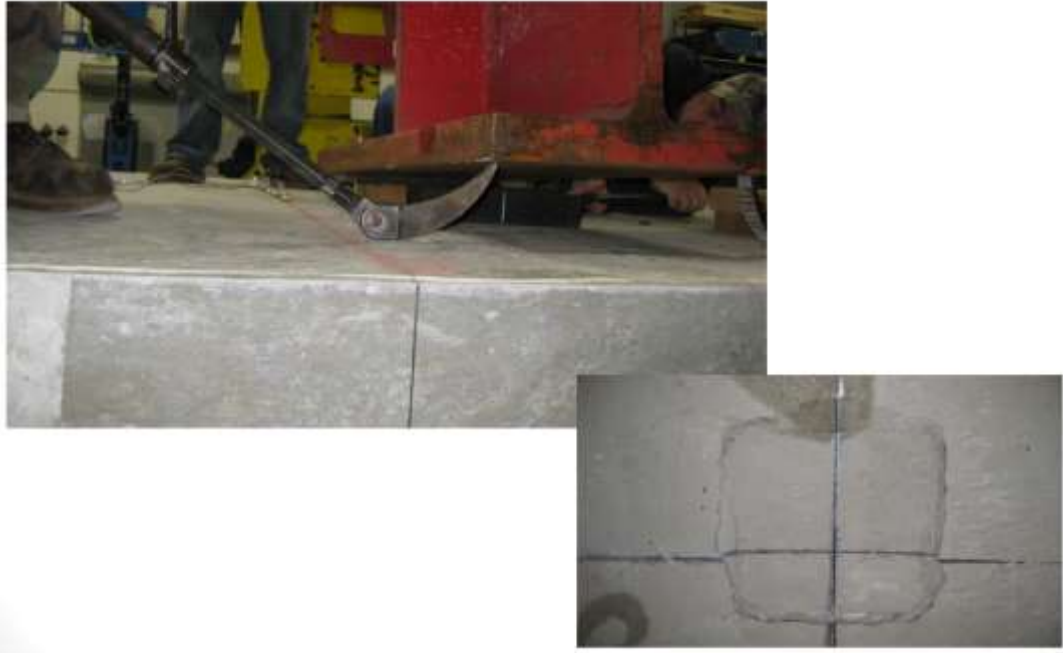
Figure 4-49 Punching damage in test C.

loading configuration was very small, with less than 2 kips before the deck was punched through.

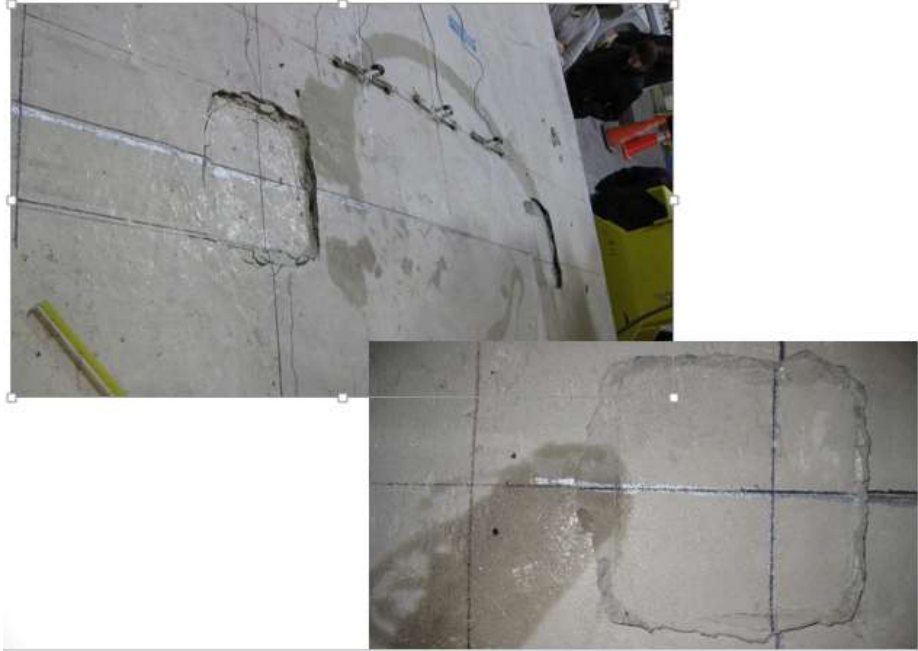
**Figure 4-61 Punching damage in Test D.**

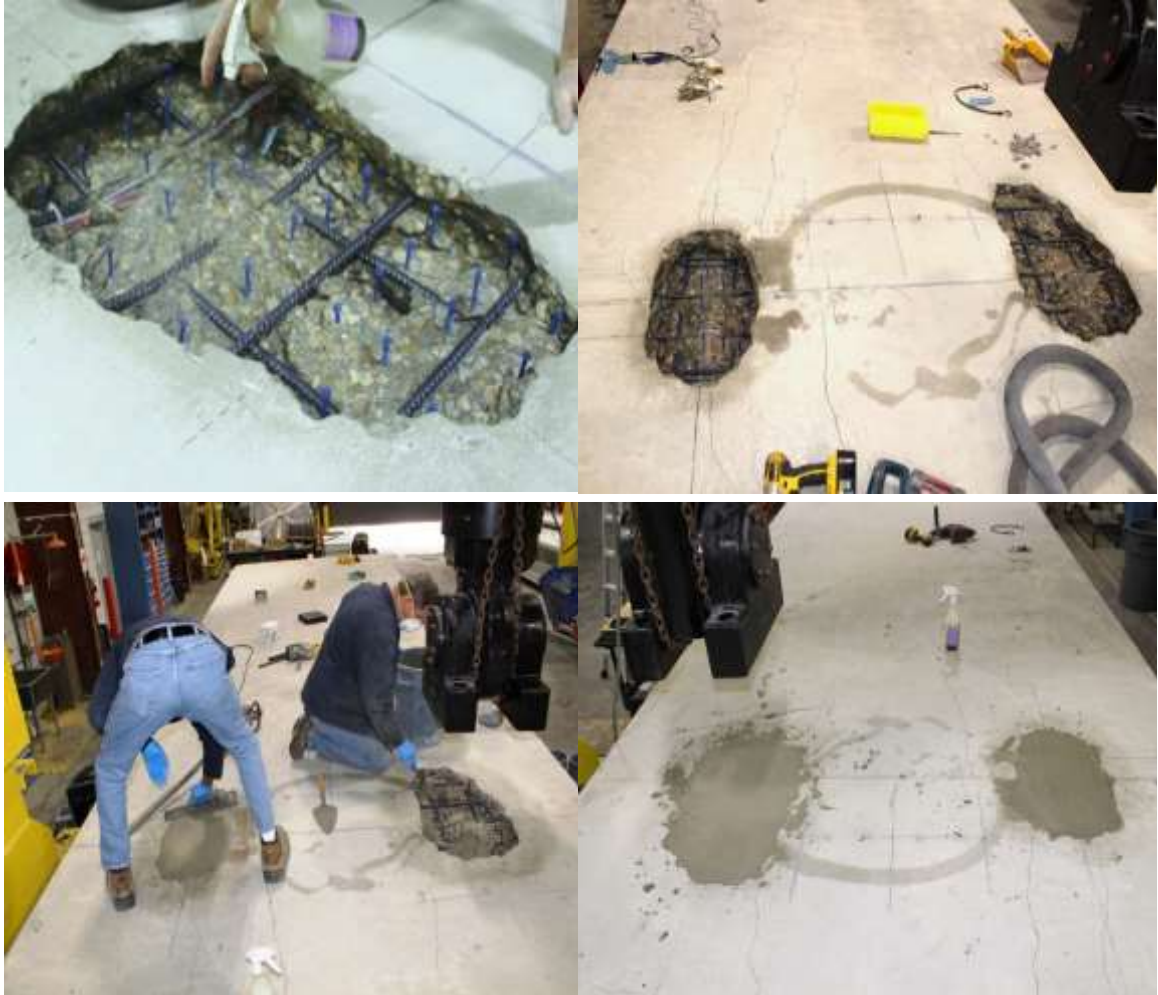
**Figure 4-70 Repair of punching shear damage from Tests C and D.**

After completing Tests C and D, a decision was made to repair damage due to punching in the deck before carrying out one last ultimate test in which the specimen was loaded under a truck footprint. In order to repair these damages, first of all, spalling concrete fragments were removed around punched square holes. Then tapcons were drilled into the concrete to act as shear studs. After that, an attempt was made to get a saturated surface dry (SSD) condition in the holes. The main material used for the repair was MasterEmaco T302, a two-component polymer-modified cement-based repair mortar with an integral corrosion inhibitor. The expected compressive strength for this composition is 6,000 psi. Once the mortar mix was thoroughly mixed, the moistened concrete fragments were added in, since no pea gravel was available on hand at that time. Then, the mortar mix was poured into the holes and then vibrated in order to get the best possible penetration. Once the repair patch was troweled, moist cure bags were placed over the repair areas. Some pictures taken during the repair are shown in Figure 4-70.

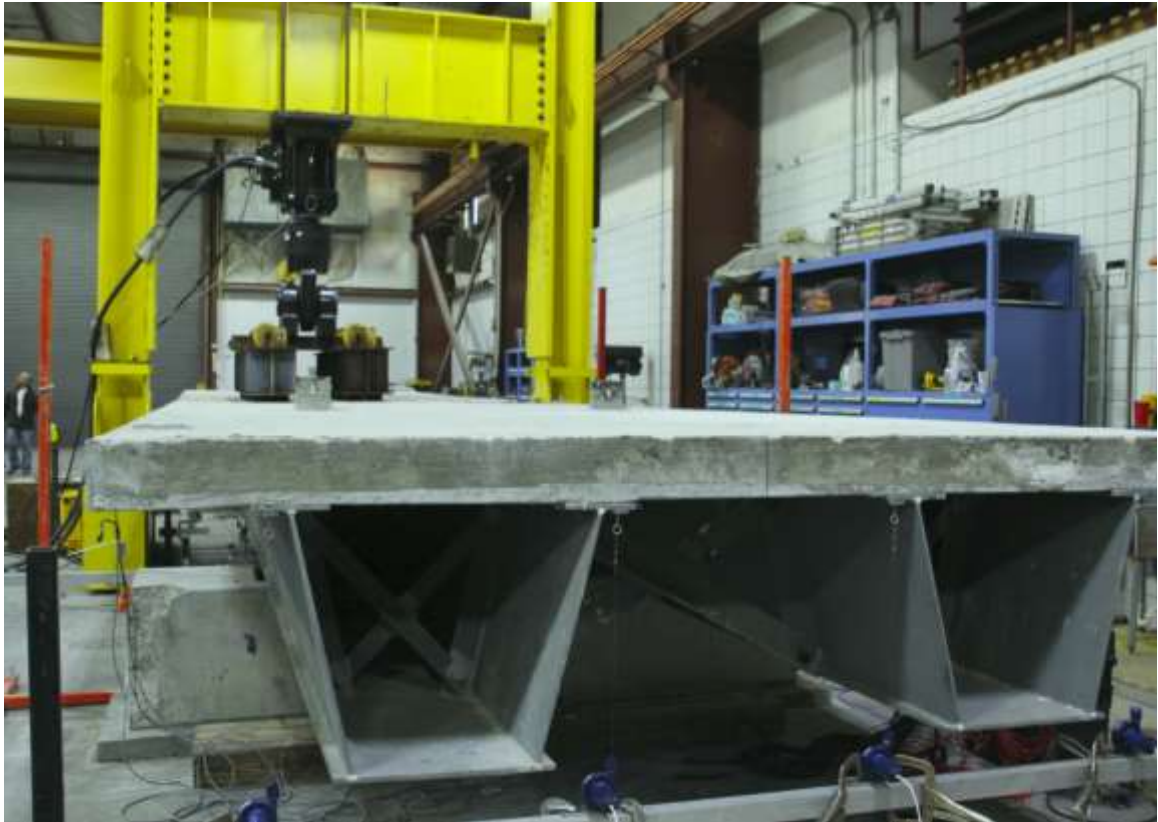
In this test, the load was applied through four loading pads in order to simulate the truck footprints. The loading pads were the same as in previous tests with a dimension of 10 in. x 10 in. The distance between north wheels and south wheels was 72 in., while the distance between west wheels and east wheels was 27 in. from center to center. The west wheels were placed at the center of cross-section while the east wheels were at the center of damaged girder. The schematic description of Test E loading set up is shown in Figure

4-71. The purpose of this test was to investigate whether the same failure mode of punching shear will be obtained, under truck-load configuration.

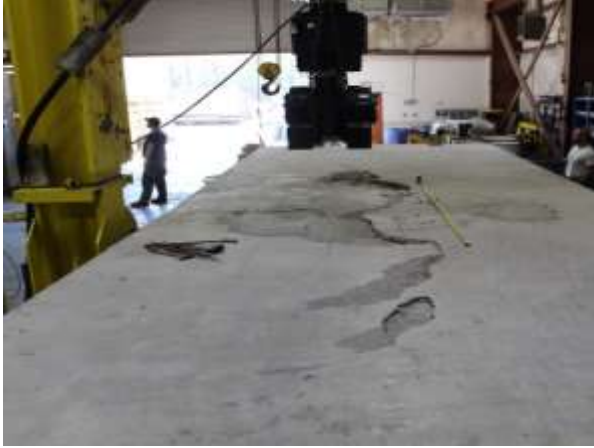
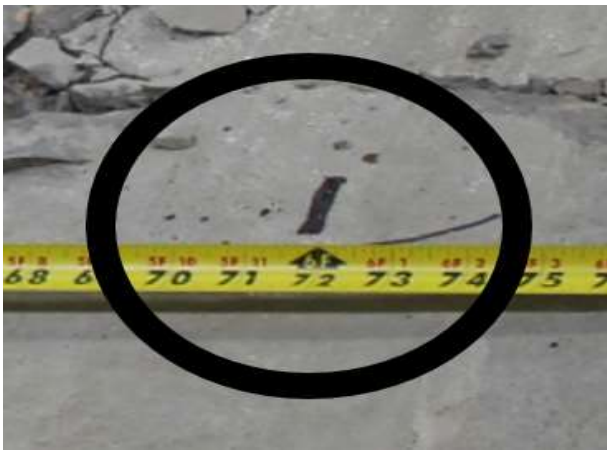
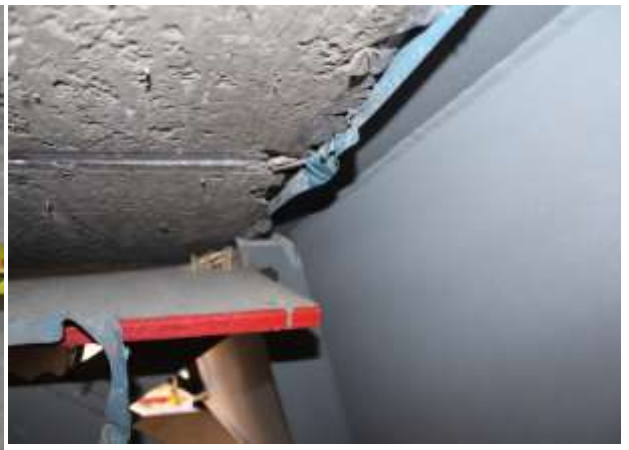
In this test, the specimen carried up to 235 kips of load before it failed abruptly as shown in Figure 4-73a. It should be noted that this is the total load distributed to all four loading points and the deflection is measured from the mid-span location, not under the loading points. The initial stiffness of bridge under this loading condition was approximately 103 kips/in which was similar to its initial stiffness under Tests A and D where the load was applied toward to the damaged girder. The intact girder responded almost linearly in the entire test. The damaged girder responded linearly up to 150 kips when the first cracks were noticed especially along the west loading points. As the load continued to increase, the initial cracks formed around the south-west loading point and north-west loading point propagated toward each other in the longitudinal direction as well as toward the intact girder in the transverse direction as shown in Figure 4-72a-c. As the load increased, these longitudinal cracks finally met each other and penetrated further into the deck creating a heavy crushing line on the deck at its centerline where the west wheels were placed. Figure 4-72d also shows there was a significant damage occurred along the inside top flange of the intact girder. It was due to the fact that the applied load was distributed to the intact girder and created a significant amount of shear force at the section along the inside top flange of the intact girder. Figure 4-74 illustrated that the concrete deck at the ends was also cracked and almost ripped off, similar to what was observed in Test A. The reasons this happened was explained previously in Test A. By assuming the participation of the damaged girder in resisting the applied load is negligible, this test will resemble to the case where the slab is linearly supported by the undamaged box girder and subjected to multiple concentrated loads over the overhang region of the slab. Overall, the

crack and damage pattern suggested that the specimen failed predominantly in one-way shear failure.

**Figure 4-72 Damage in Test E.**

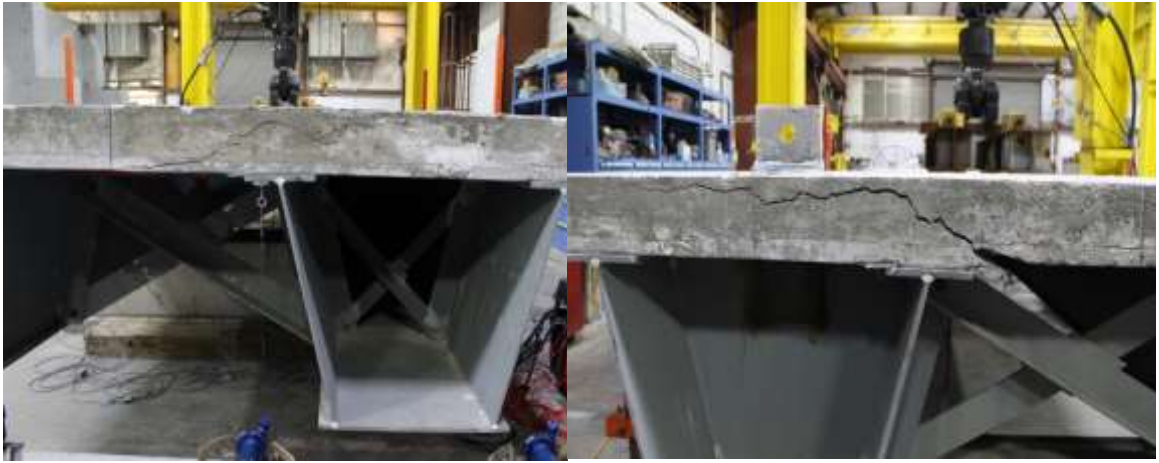
The displacements at Section 5 and at cantilever end are plotted in Figure 4-73b-c. The displacements measured at the cantilever end were about the same for both girders up to 150 kips of load. This suggests that the shear cracks, illustrated in Figure 4-74, might begin at this point of time causing the differential displacement between two girders. The displacements monitored near the supports increased during the entire test as illustrated in Figure 4-75. This indicates no uplift occurred in this test. Shear force captured in the cross-frame at Section 5 was only 7 kips as shown in Figure 4-76. This indicates that the contribution of cross-frame under this loading configuration was also small and the applied load was transferred to the intact girder mainly through the deck. The reason that the specimen experienced a different failure mode in this test than in previous tests and the load was transferred to the intact girder mainly through deck is attributed to the loading configuration that was used in the test. In this test, the specimen was loaded with four points, instead of one, and the loads were placed much closer to the intact girder so that it facilitated transferring the load to the intact girder in both longitudinal and transverse directions.

**Figure 4-74 Shear damage at ends in Test E.**

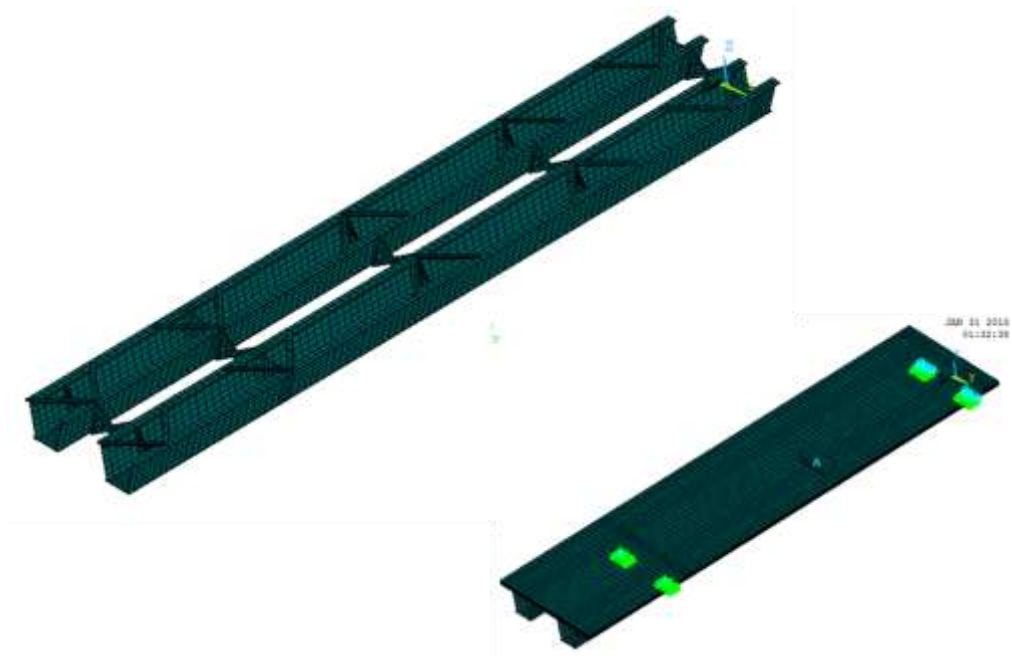
**Figure 5-1 Finite element bridge model.**

of freedom at each node. BEAM188 element is based on Timoshenko beam theory with shear deformation effects included. This element is suitable for analyzing slender structures such as cross-frames and bracings. The concrete deck and rail were modeled using 8-node solid elements, SOLID65 with three translational degrees of freedom at each node. This element is typically used for three-dimensional modeling of solids with or without reinforcing bars. Specially, this particular element has additional cracking and crushing capabilities making it a perfect element for concrete modeling. Figure 5-1 illustrates the complete model of the bridge in ANSYS.

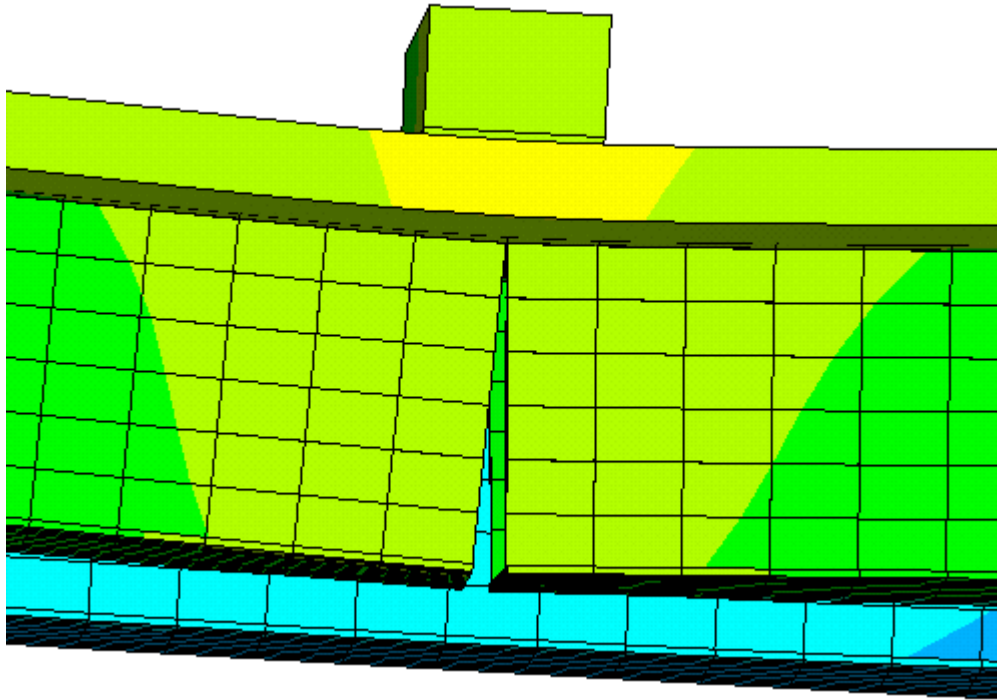
**Figure 5-3 Finite element model with full-web fracture condition.**

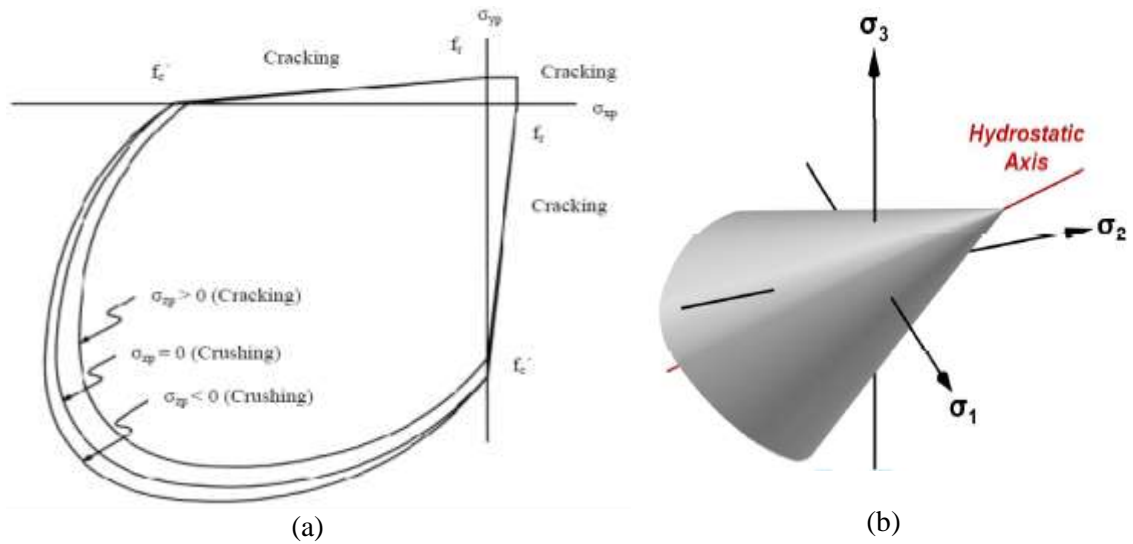
**Figure 5-8 Failure surfaces of concrete under (a) biaxial and (b) triaxial loading states (Willam and Warnke, 1975).**

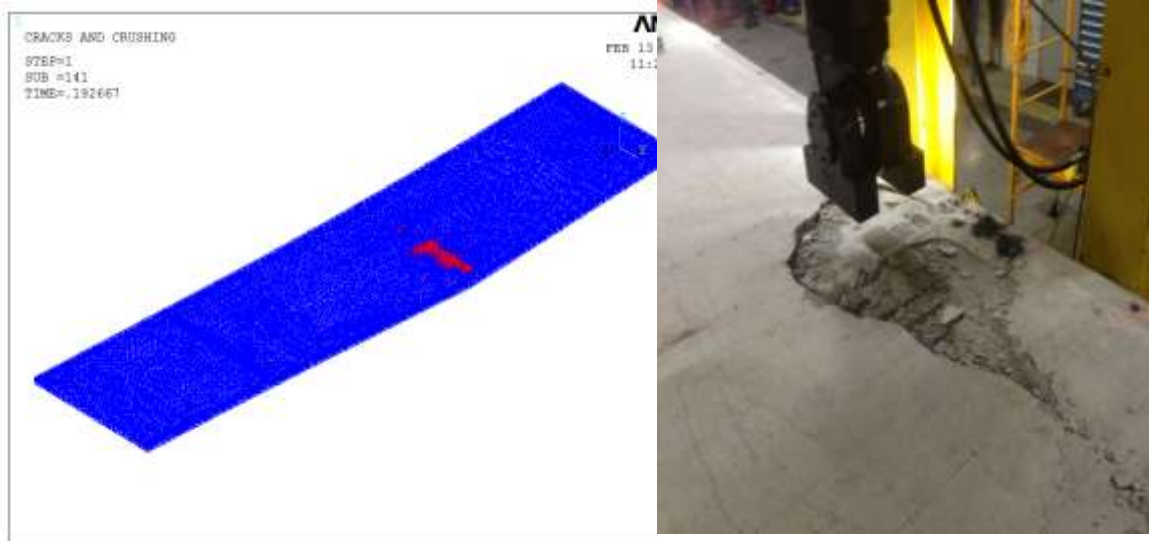
Figure 6-35 Location of concrete crushing in FEA and in experiment.

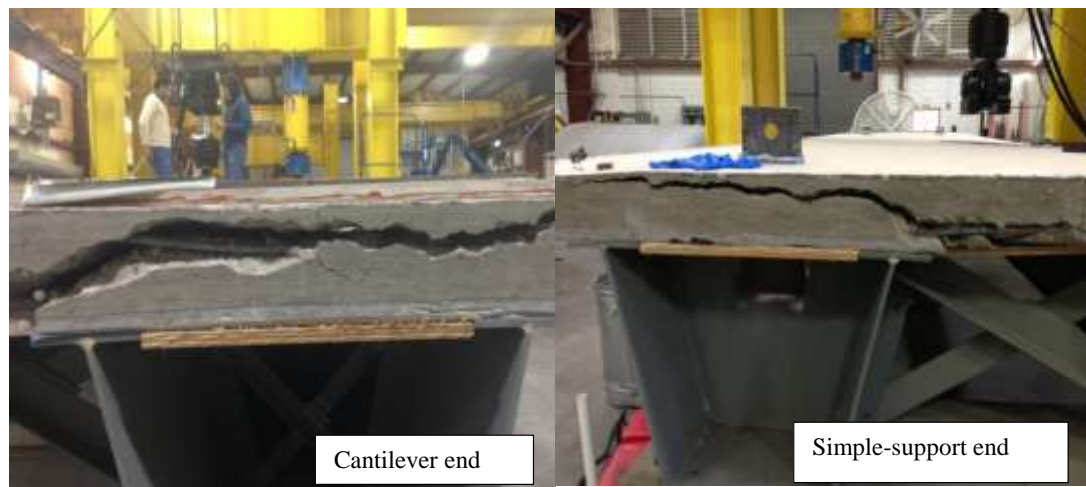
The FEM models provided a good prediction of the location where concrete crushing would occur. Figure 6-35 compares the location of concrete crushing in the analytical model and experiment. Figure 6-36 compared experimental results to finite element analysis results regarding cracks at the ends of specimen. Finite element analysis results in Figure 6-36 predicted the shear cracks and tensile cracks would occur at the ends of the bridge.

Figure 6-36 Shear cracking in south (left) and north (right) supports.

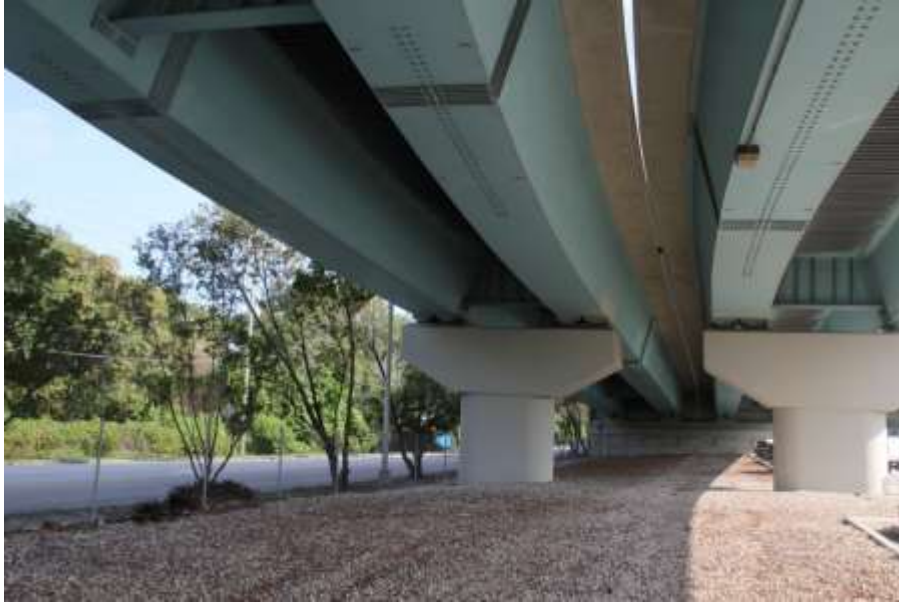
**Figure 7-1 First two spans of the ramp bridge - underneath view.**

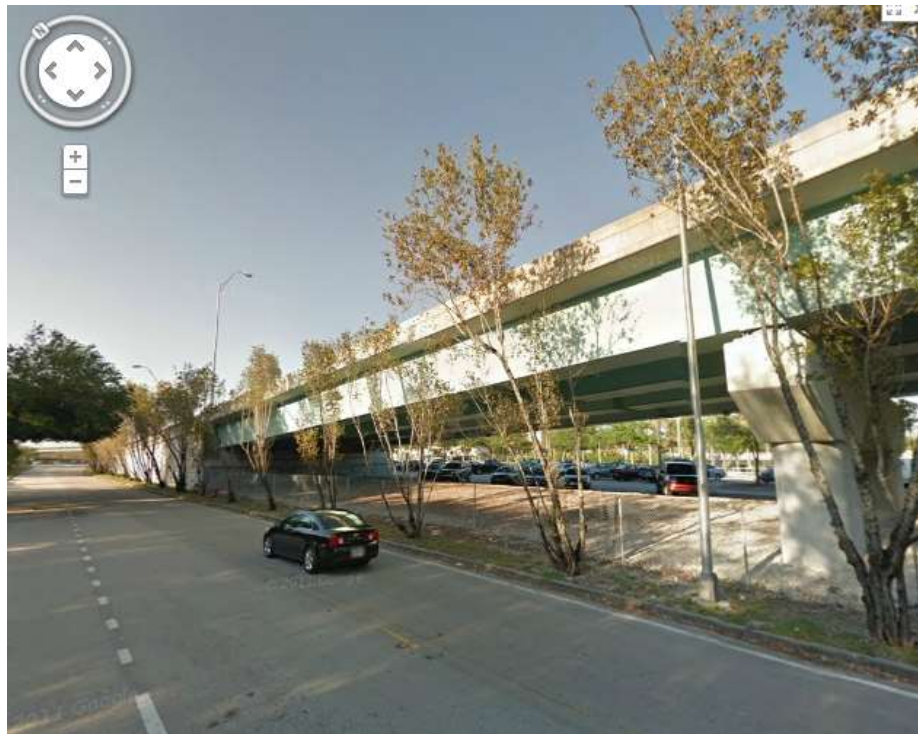
**Figure 7-2 First span of the ramp bridge 860600 - elevation view from west.**

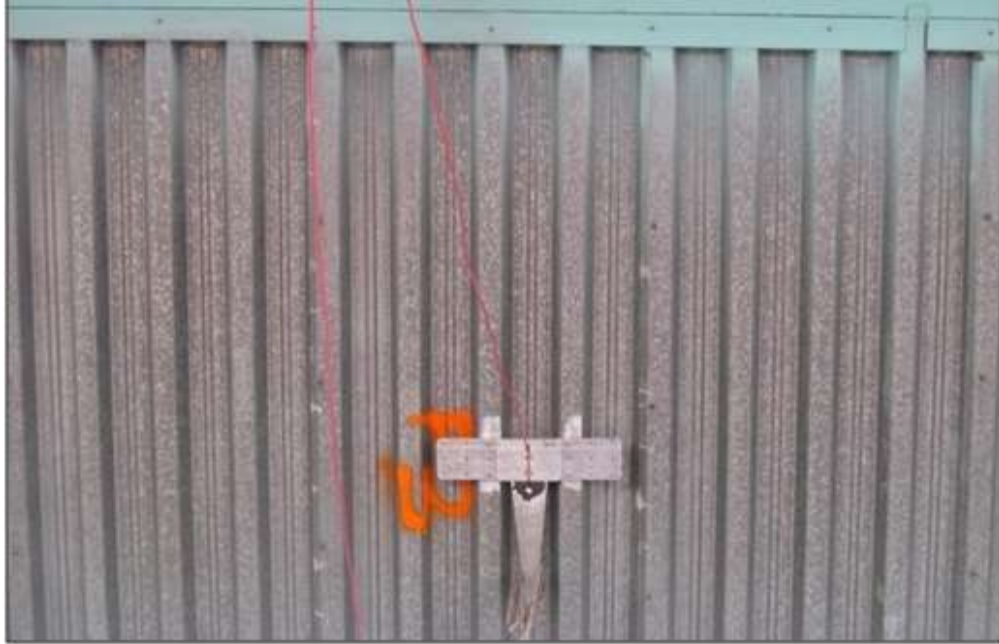
Location 1 is in the first span at a distance of 85 ft from the first pier. At this location, there are four potentiometers, two of them below the edges of the bottom flange of the west box-girder, one in middle of the concrete deck between the steel girders and the other one below the west edge of the EG. Figure 7-7 displays the arrangement of the potentiometers in the first span. The gauge and channel ID's (in parentheses) of these displacement sensors are shown in Figure 7-8. A typical photo of the assembly of these displacement sensors is in Figure 7-9. As stated earlier to measure the displacement of the concrete deck between the girders, a sensor is attached to it. As the structural insulated panel (SIP) is used for the concrete, the transducer should be attached to the SIP form

instead of the concrete face. Figure 7-10 shows the transducer attached to formwork below the concrete slab.

**Figure 7-10 Displacement sensor on SIP form below concrete deck.**

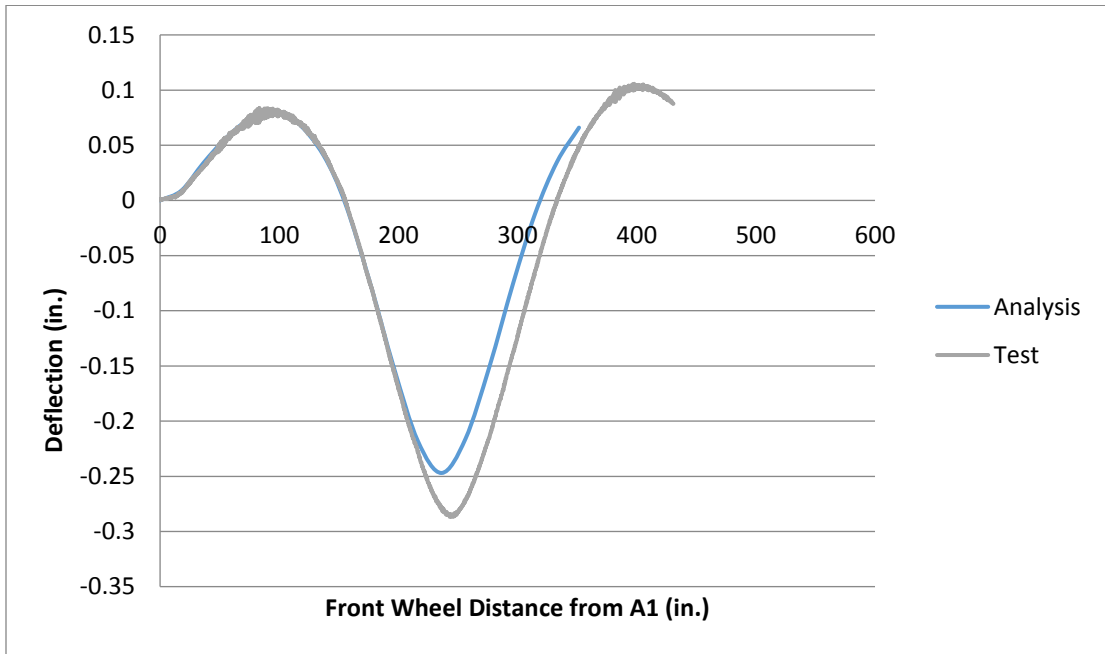
In general, the results of field testing were in good agreement with the results of finite element analysis. In this section, some of the results of finite element analysis of the bridge under loading scenarios are compared to the field test data. The selected loading scenarios include scenario-3 which has Truck-1 on path-3, scenario-5 which has Truck-2 on path-1 and Truck-1 on path-3 and loading scenario-7 which has Truck-1 followed by Truck-2 on path-1. Figure 7-27 through Figure 7-32 compare the deflection of the girders in first and second spans due to application of selected loading scenarios.

Figure 7-28 Vertical deflection of west edge of WG: 225.5 ft from north abutment, Truck-1 on path-3.

| Figure 7-28 Vertical deflection of west edge of WG: 225.5 ft from north abutment,<br>Truck-1 on path-3. .... | 214 |

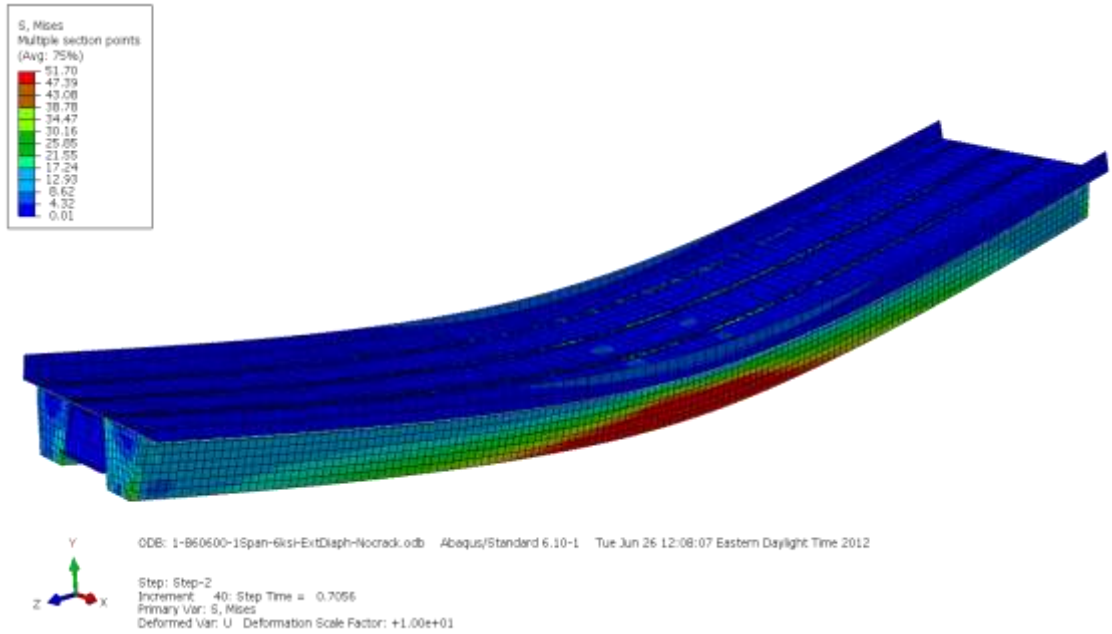
**Figure 8-7 Von Mises stresses in single-span bridge under maximum moment, undamaged condition.**

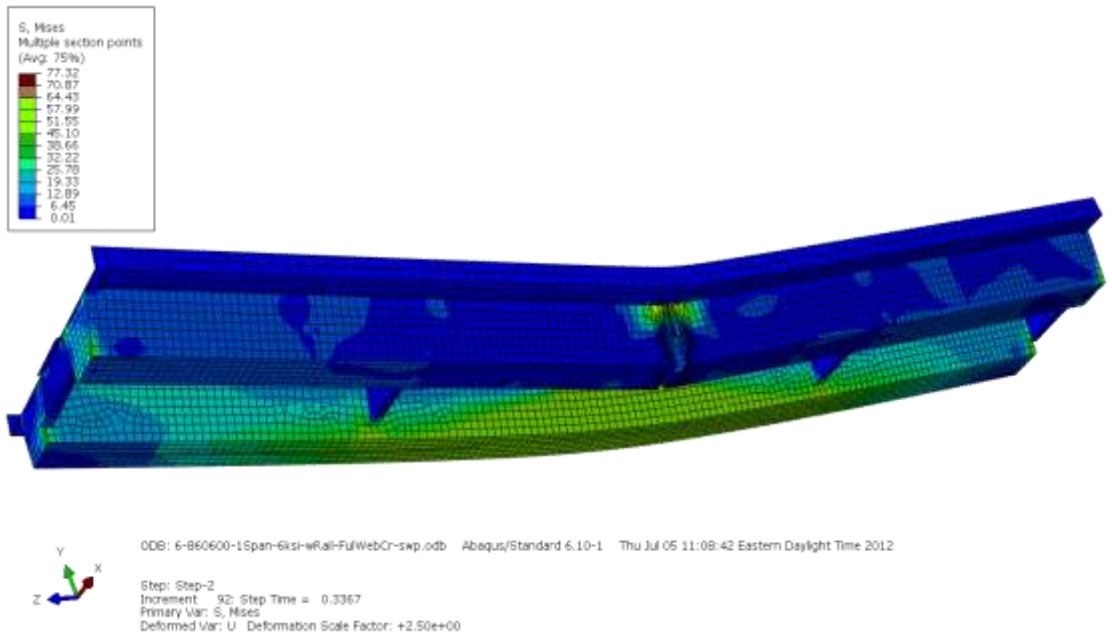
**Figure 8-8 Von Mises stresses in single-span bridge under maximum moment, full-web cracked condition.**

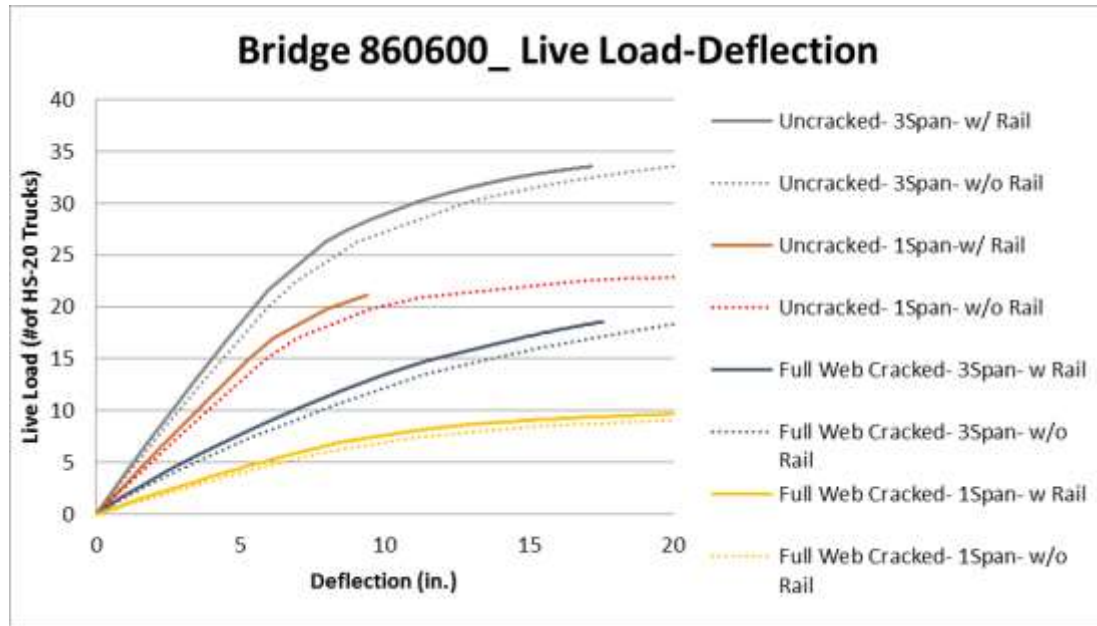
**Figure 8-9 Load vs. vertical deflection of single- and three-span bridges with different conditions.**
