# Corrosion Degradation Mechanism of CBPC Coating System for Highway Bridge Steel Components

CORROSION DEGRADATION MECHANISM OF CBPC COATING SYSTEM FOR  
HIGHWAY BRIDGE STEEL COMPONENTS

DOCTOR OF PHILOSOPHY

CIVIL ENGINEERING

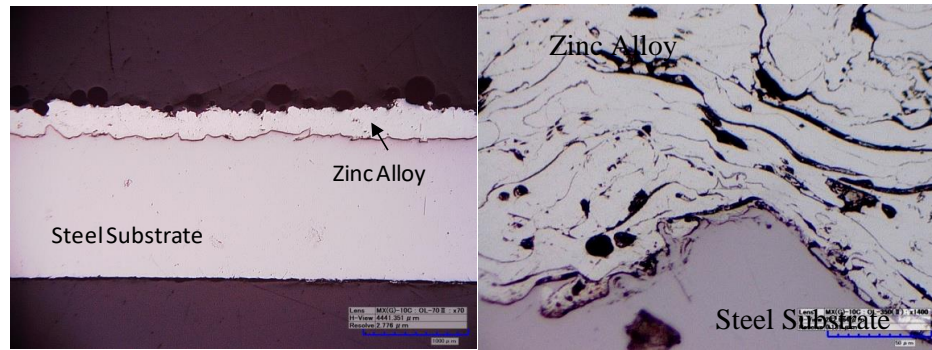
**Figure 2.1. Thermal Spray Coating.**  
(Figure by Lau and courtesy of FDOT.)

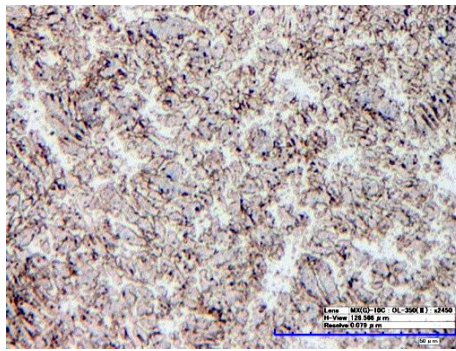
**Figure 2.2. Hypereutectic Microstructure of ZnAl15.**  
(Figure by Lau and courtesy of FDOT.)

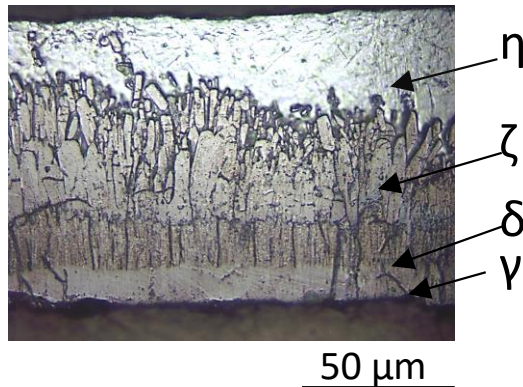
**Figure 2.3: Microstructure of Hot Dip Galvanizing.**

Batch hot-dip galvanizing (HDG) has been the most commonly used method of protecting steel products from corrosion for over 200 years (Zhmurkin, 2009). In this process an adherent, protective coating of zinc or zinc alloy is developed on the surfaces of iron and steel products by immersing them in a bath of molten zinc (Dallin, 2012). The galvanized steel develops a thick zinc-iron alloy coating with layers of different alloy composition (Figure 2.3); the properties of these layers are given in Table 1(Dallin, 2012).

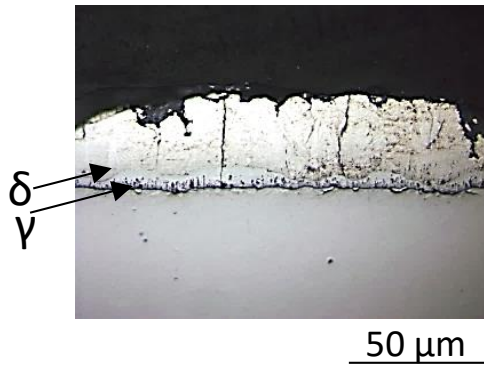
**Figure 2.4: Microstructure of TDG.**

The coating process involves vapor diffusion of zinc into steel. The process creates a zinc/iron alloy by penetrating the surface on steel. The steel components and zinc powder are rotated within a closed cylinder inside of an oven and heated to a temperature of  $710^{\circ}$  -  $1092^{\circ}$  F ( $320^{\circ}$  to  $500^{\circ}$  C) (ASTM, 2008). Zinc sublimation occurs at  $500^{\circ}$  F and by penetrating the steel, produces Zn/Fe alloy. This process results in the formation of iron-zinc gamma (solid Zn ions inside Fe substrate), delta ( $\text{Fe}_{11}\text{Zn}_{40}$ ), and zeta ( $\text{FeZn}_7$ ) layers, excluding the external eta layer of pure free zinc (ASTM, 2008). The coating metallurgy of zinc in thermal diffusion galvanizing (TDG) is analogous to hot dip galvanizing but the longer heat cycle associated with TDG allows much deeper penetration of zinc into the steel substrate. The thickness of the eta (pure zinc) in TDG is significantly thinner than in Hot Dip Galvanizing. The eta layer has much less corrosion resistance than the zinc/iron phases. The zinc/iron phases (zeta, delta, and gamma layers) can be thicker in TDG than hot dip galvanizing (Figure 2.4).

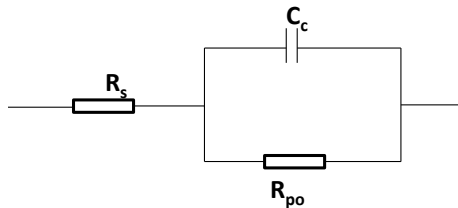
**Figure 2.5: Electrical Equivalent Circuit of an Intact Coating in Contact with an Electrolyte.**

When an intact coating comes in contact with the electrolyte, the solution can enter the pores of that coating. The pore resistance,  $R_{po}$  decreases with the passage of electrolyte intrusion. Initially the pore resistance is considered as infinite. The entire system is represented in equivalent circuit as shown in the Figure 2.5 where  $R_s$  is the solution resistance and  $C_c$  is coating capacitance.

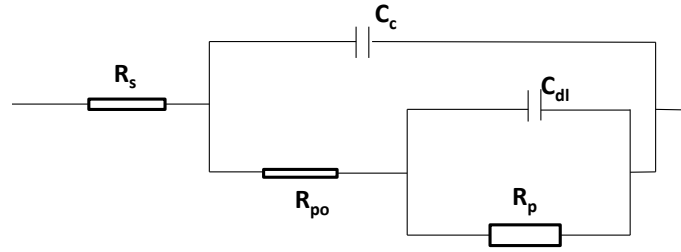
**Figure 2.6: Electrical Equivalent Circuit of a Coating in Contact with an Electrolyte by Considering the Base Property of the Steel.**

A new phase is included with this equivalent circuit when corrosion reactions can take place at the metal electrolyte interface as shown in the Figure 2.6. This circuit incorporates a capacitor characterizing the double layer capacitance of the metal/solution interface,  $C_{dl}$ , and a resistor element describing the polarization resistance,  $R_p$ , both proportional to the active metallic area in contact with the electrolyte and

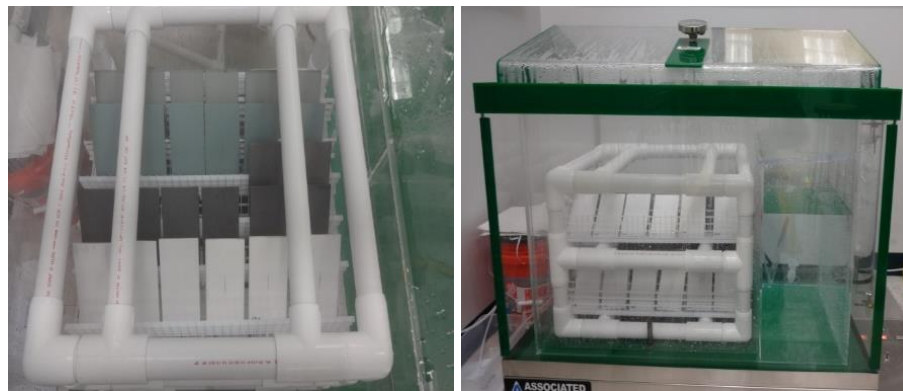
**Figure 3.2. Test setup for Salt Fog Exposure.**

A salt-fog chamber conforming to ASTM B117-03 was setup as shown in the Figure 3.2. Tests included exposure in a salt fog chamber with use of 5% NaCl saturated salt solution for at least 2200, 5800 hours and 14600 hours to evaluate the effects of the various aggressive exposure conditions on the integrity of the coating and corrosion of the steel coupons. The salt-fog chamber temperature was maintained  $\sim 32^{\circ}\text{C}$ . The samples were placed at a  $\sim 40^{\circ}$  inclination with support along the bottom edge of the coupon and along an edge at the upper third of the sample. Corrosion development was photo-documented with time. The replicate panels were removed at previously mentioned duration from environmental exposure to identify degradation of the coating by physical testing and other material testing as discussed in section 3.4.

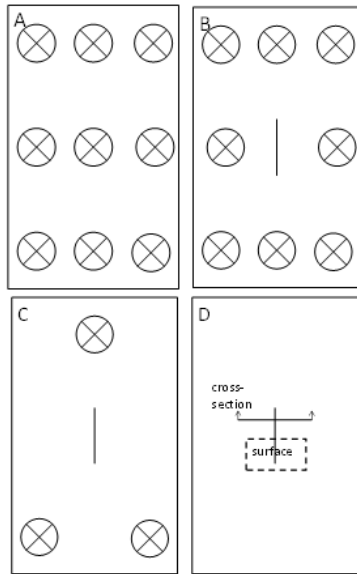
**Figure: 3.5 Sample Testing Surface Locations.**

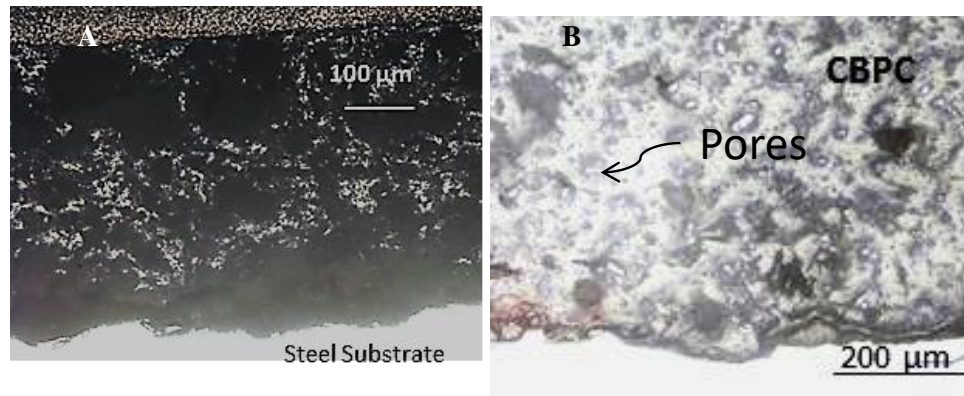
**Figure: 4.1 CBPC Coating on Steel Cross-Section Micrographs.**  
A) Rough Surface. B) Presence of Pores.

textures with a layer between the ceramic and steel substrate. That intermediate layer did not appear to be continuous throughout the steel-to-ceramic coating interface. As will be described later, imaging with SEM also did not consistently reveal a continuous intermediate layer on the steel substrate.

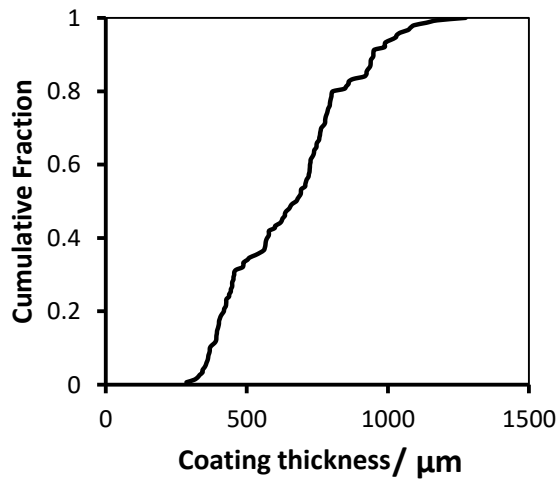
**Figure 4.2: CBPC Sample Coating Thickness.**

Although variability in the thickness of the CBPC coating was observed, the as-received pull-off strengths were not greatly affected by coating thickness. All pull-off testing of coatings in the as-received condition had removal of the CBPC coating and had strengths less than 1400 kPa as shown in Figure 4.3. The coating was typically separated at the coating/steel substrate but some residue of the CBPC typically remained on the steel substrate. It is noted that the pull-off strength may not directly indicate efficacy in corrosion mitigation. However, this parameter is expected to give insight on material performance after exposure in aggressive environments such as coating degradation or disbondment that may possibly be important in corrosion development.

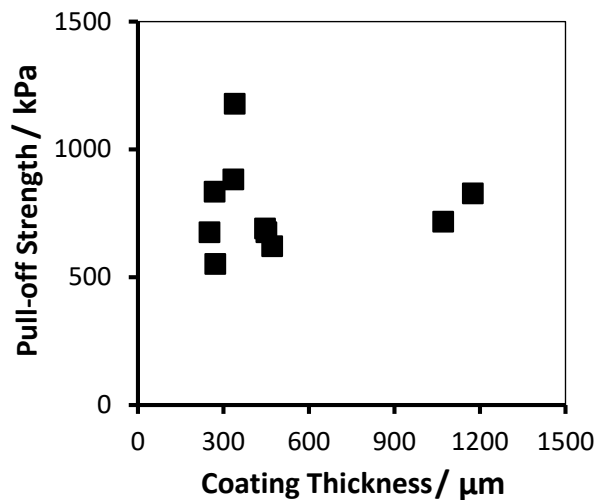
**Figure 4.3: CBPC Coating Pull-off Strength.**

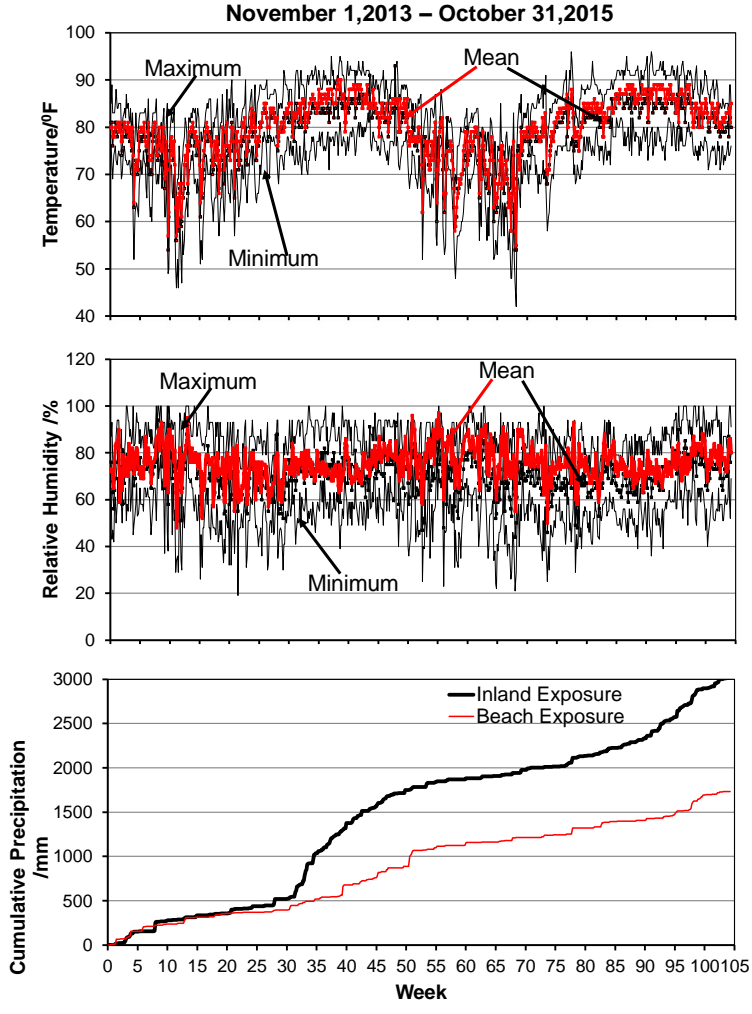
**Figure 4.4: Environmental Conditions at Outdoor Test Sites.**  
 Black (Inland). Red (Beach).

times were proposed to identify coating degradation and corrosion development with time. Coated steel coupons were initially installed on November 1, 2013. Sets were removed on February 28, 2014; on June 30, 2014 and on November 03, 2015. Record of environmental parameters of the test sites is shown in Figure 4.4. Temperature and relative humidity at the two outdoor test sites were comparable but the precipitation data for inland site was higher than the beach site. Samples were exposed to salt-fog conditions with 5% NaCl solution according to ASTM B 117 for 2200, 5800 or 14600 hours to evaluate the effects of the aggressive exposure conditions on the integrity of the coating and corrosion durability of the steel coupons. Visual comparisons of the sample coating conditions and degree of corrosion were made. Assessment of coating thickness and coating adhesive strength before and after exposure were also made. The coating pull-off strengths and thicknesses were meant to evaluate changes due to test exposure conditions and not necessarily to prescribe quantitative values to degradation.

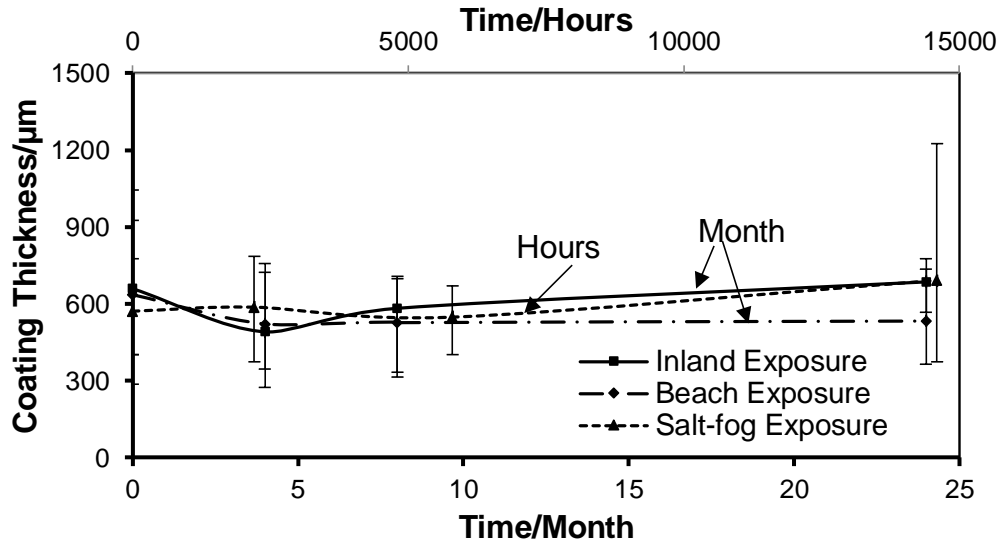
**Figure 4.6: After Exposure Coating Thickness of CBPC Coating.**

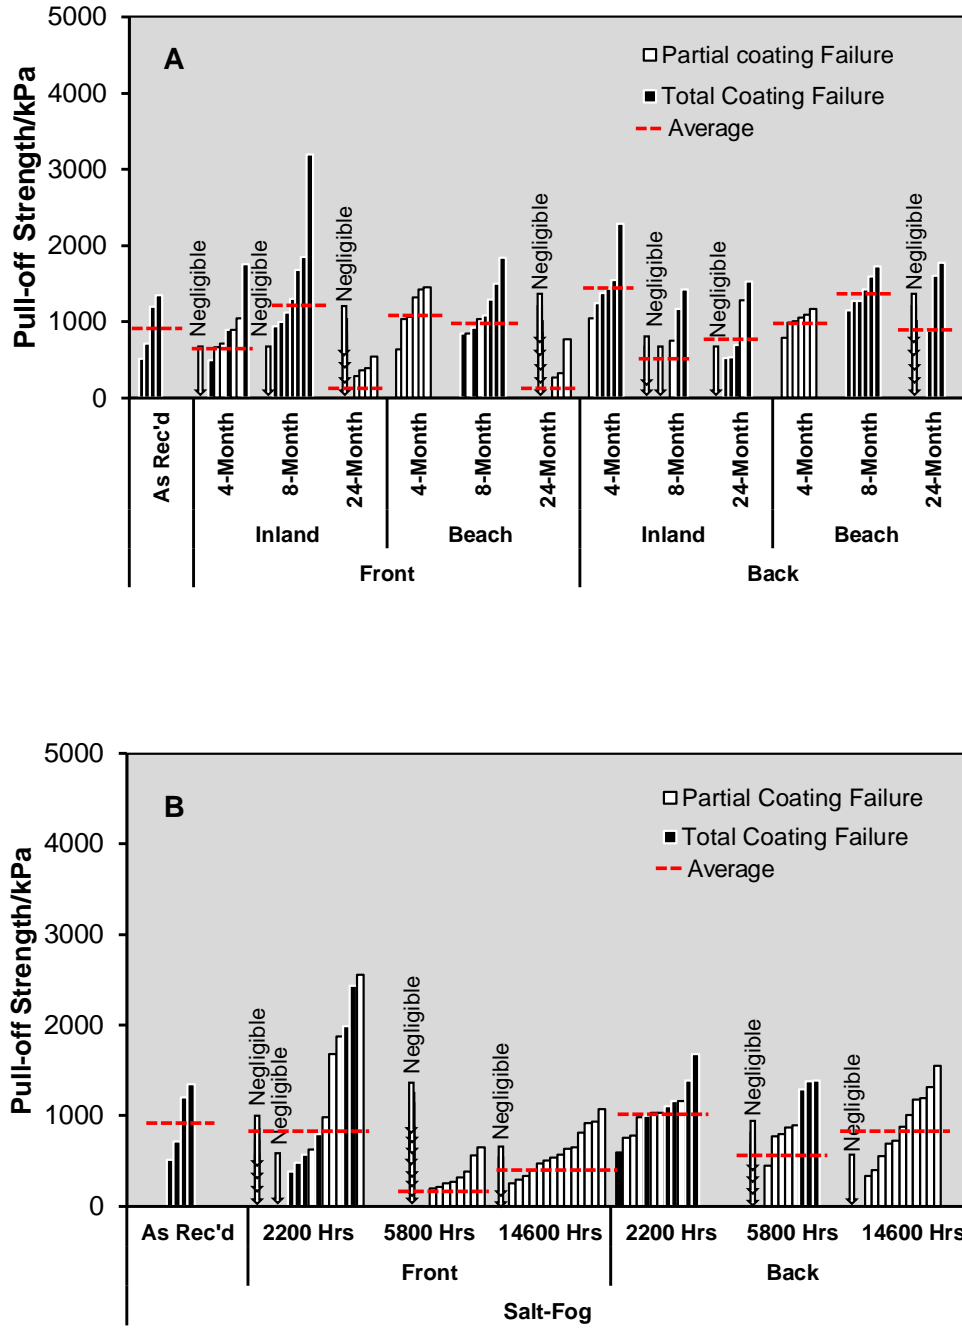
**Figure 4.7: Pull-off Strength of CBPC Coating.**  
**A) Outdoor Exposure B) Salt-Fog Exposure.**

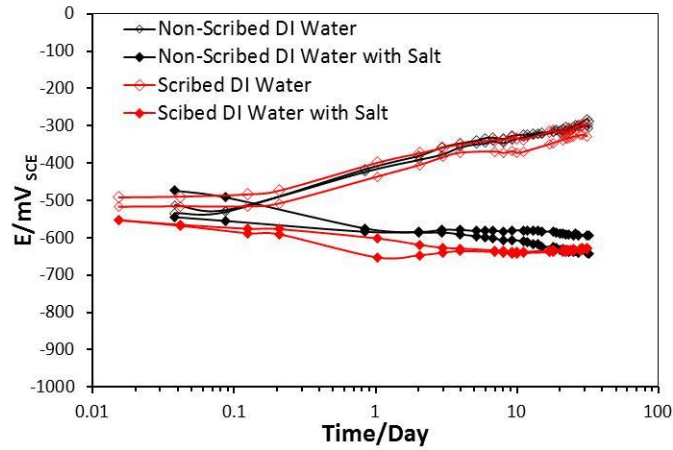
**Figure 4.10: OCP for CBPC Coating in Wet Exposure.**

gradually increased to  $\sim -300$  mV<sub>SCE</sub>. The shift to more noble potentials with time indicated a trend towards passive-like conditions. The role of any intermediate alloy layer on the corrosion activity was not ascertained. The samples (scribed and non-scribed) in chloride solution maintained active corrosion conditions throughout the 30-day test period. The corrosion currents determined from LPR measurements (Figure 4.11) were consistent with the trends described by the OCP measurements. As expected, moderate to high corrosion currents were initially observed in all test conditions. The corrosion current declined from  $\sim 15$   $\mu$ A to  $\sim 4$   $\mu$ A with time in chloride-free solution. For samples immersed in chloride solution, the corrosion current ( $\sim 15$  to  $100$   $\mu$ A) remained constant throughout the test period. Of note, the absence of intentional surface coating defects did not result in mitigation of corrosion when immersed in chloride solution. The OCP measurements for the non-scribed samples, similar to the scribed samples, were indicative of active conditions throughout the test. Even so, the corrosion current for the scribed samples was initially assumed to be higher than the non-scribed samples since nominally  $0.13$  cm<sup>2</sup> of steel was directly exposed at the scribe defect, and the CBPC coating was intact for the as-received condition. On the contrary, greater corrosion currents were measured for the non-scribed conditions.

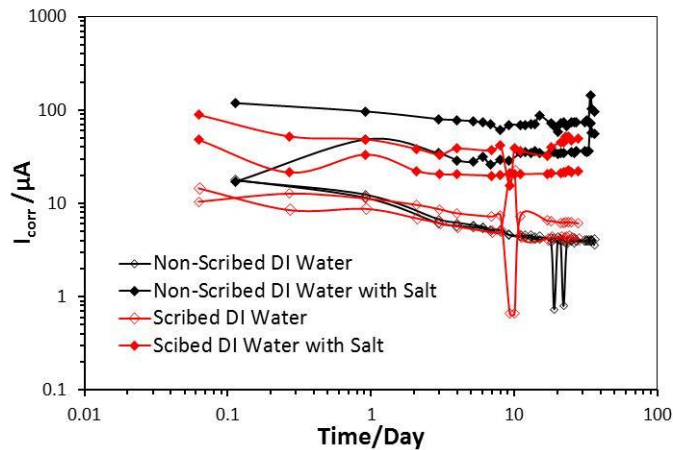
**Figure 4.11: Corrosion Current for CBPC Coating in Wet Exposure.**

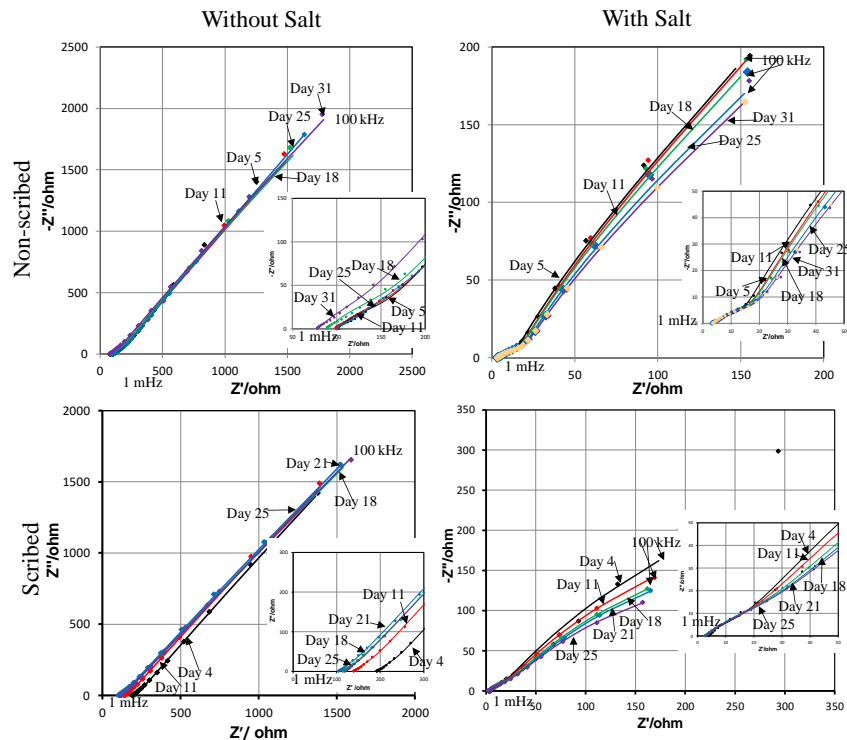
**Figure 4.12: Nyquist Diagram for Non-scribed and Scribed CBPC Samples in Neutral pH with and without Chloride Solution (Representative Diagram).**

resistance was observed for non-chloride solution throughout the immersion period, but an increasing trend was identified for chloride solution. The constant pore resistance with time for the coating in chloride-free solution corroborates previous discussion on early saturation of the coating pores with solution, but does not capture any possible physical degradation of the coating. Assessment of coating permeability is in progress. The increase in pore resistance with time for the coated steel immersed in chloride solution was thought to be due to formation of hydration product within the pores or coating defects, as seen in Figure 4.9. The pre exponential term of the coating capacitance was also resolved from impedance analysis but the pre exponential term have to be transferred to coating capacitance to describe the coating degradation. This part is elaborated in chapter five.

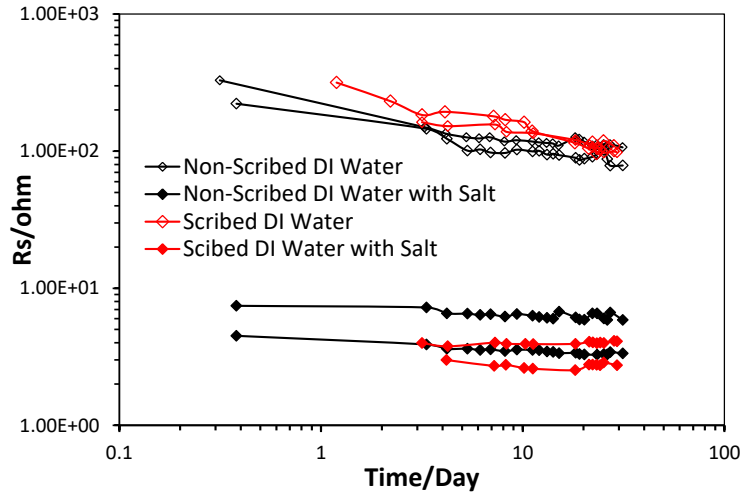
**Figure 4.13: Solution Resistance for Non-scribed and Scribed Samples.**

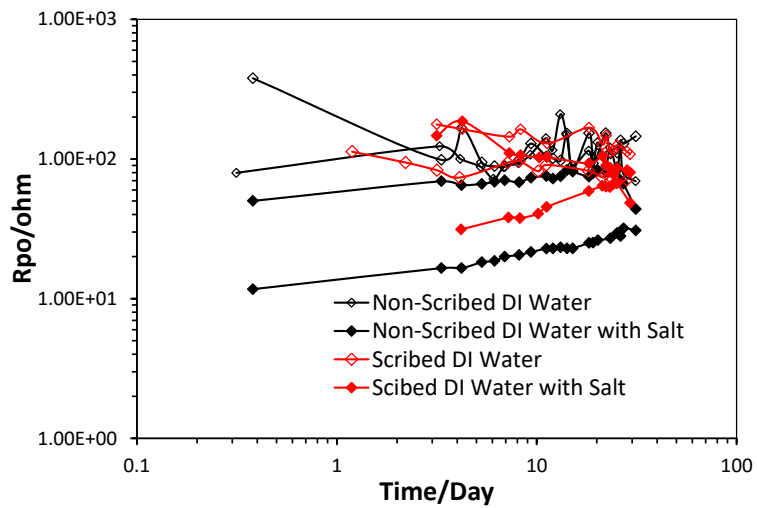
**Figure 4.14: Coating Pore Resistance Non-scribed and Scribed Samples.**

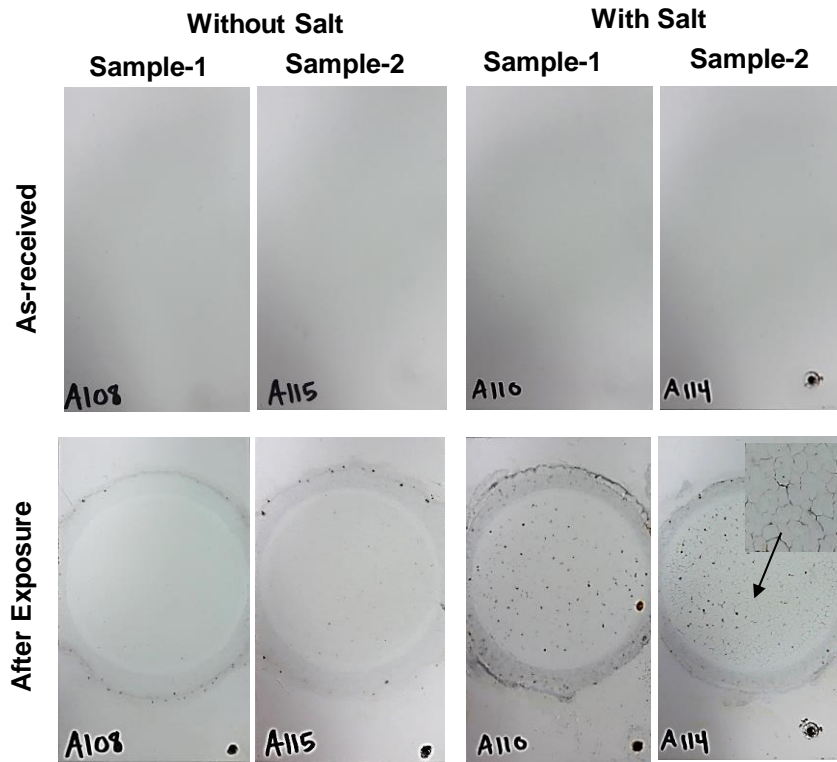
**Figure 4.15: Coating Degradation after Wet and Dry Exposure.**

fracturing may be due to formation of some hydration product of magnesium and phosphate that may act to either limit the extent of cracking or fill free spaces. However, as shown in Figure 4.16, surface scouring and crack formation in the body of the coating can be significant regardless of salt presence.

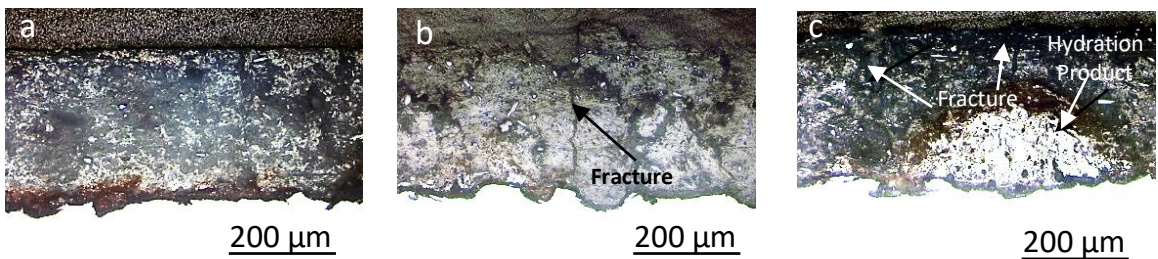
**Figure 4.16: Micrograph of CBPC Samples.**  
a) As-received b) Without Salt c) With Salt

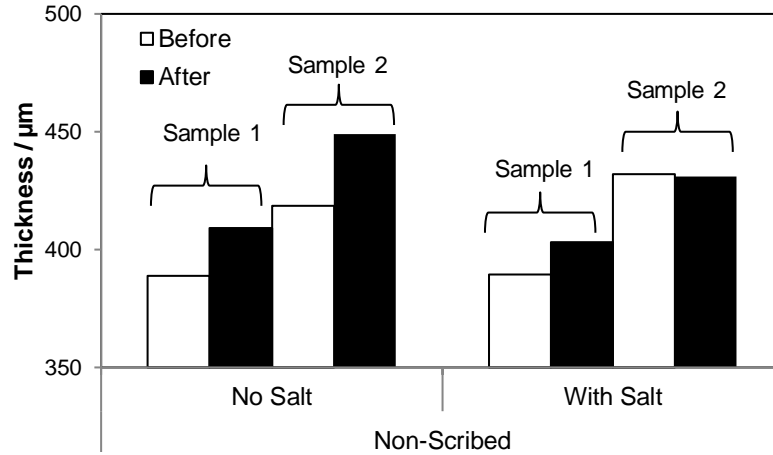
**Figure 4.17: CBPC Coating Thickness after Wet and Dry Exposure.**

The coating thickness increased for majority of the samples exposed to wet and dry exposure after 30 days of testing. It was observed that the increase in thickness was somewhat larger when exposed in test conditions without salt (Figure 4.17). The average increment in coating thickness for salt-free and salt test cases was  $\sim 25 \mu\text{m}$  and  $\sim 7 \mu\text{m}$ , respectively. Pull-off strength was relatively low, less than 2,000 kPa, and generally exposed the metal substrate with minor presence of residual hydrate coating materials for all samples in the as-received condition and in all test conditions (Figure 4.18). Pull-off testing typically resulted in apparent cohesive failure of a layer of coating near the steel interface, possibly related to interfacial products associated with reaction with the base iron (Figure 4.19) and the degraded coating integrity caused by the wet and dry exposures. For the bulk material, the coating may be denser near the steel substrate when the ceramic material initially forms during the spray application. Material layered during subsequent passes was thought to contain higher portions of unreacted constituent materials such as magnesium hydroxide and magnesium phosphate hydrate. Exposure to solution in the testing here would likely lead to subsequent reactions involving these materials including formation of hydrates leading to the increase in coating thickness described above. The expected reduced cohesion in bulk coating layers due to the wet and dry exposures was not well defined by the pull-off testing and was deemed to be due to the overall low cohesive strength.

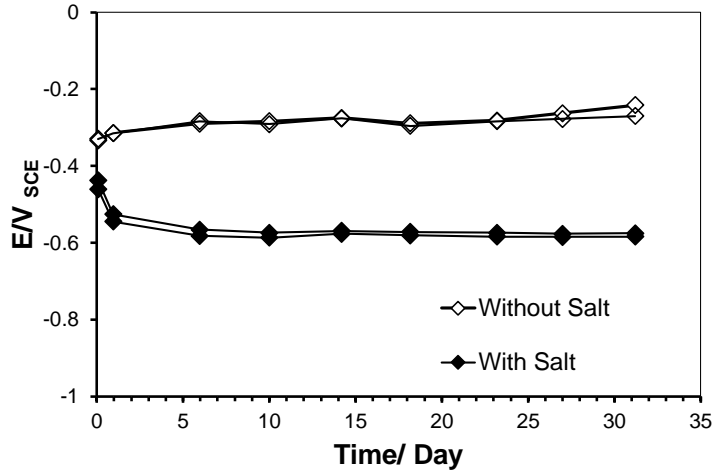
**Figure 4.20: OCP for CBPC Coating during Wet and Dry Exposure.**

The initial open circuit potential (OCP) for non-salt solution was  $\sim -0.3 V_{SCE}$  and the OCP gradually shifted to more novel potential of  $\sim -0.2 V_{SCE}$  during the exposure. The open circuit potential (OCP) was  $\sim -0.4 V_{SCE}$  at the beginning of the test of salt solution (Figure 4.20). The potential increased to  $\sim -0.6 V_{SCE}$  after 5 days of exposure and maintained that OCP for the rest of the exposure. The corrosion current determined from LPR measurement were consistent with the trends described by the OCP measurements (Figure 4.21). High corrosion current of  $250 \mu A$ - $300 \mu A$  was observed for salt solution during the test period. Contrastingly, low corrosion current of less than  $20 \mu A$  observed for non-salt solution and the corrosion current was decreasing during exposure. However, active condition observed at the beginning of the test regardless of the type of solution. The early active condition was due to the characteristics porous nature which facilitated moisture to the steel substrate which were apparently observed in optical micrograph in as-received condition. The observed passive like condition in non-chloride solution was due to the formation of proposed hydrate of magnesium and iron which will be discussed in the section of X-ray diffraction. The increase in thickness and reduction in pull-off strength in outdoor and salt-fog exposure also consistent with the electrochemical nature of the coating. Further, high corrosion current in chloride solution was associated with activity of the proposed iron phosphate hydrated and interaction of water with steel substrate due to the enhancement of the pores for high solubility of bulk magnesium coating in salt solution.

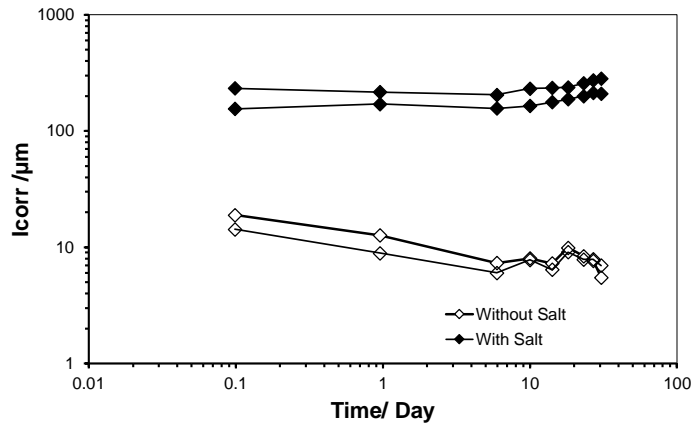
**Figure 4.21: Corrosion Current for CBPC Coating during Wet and Dry Exposure.**

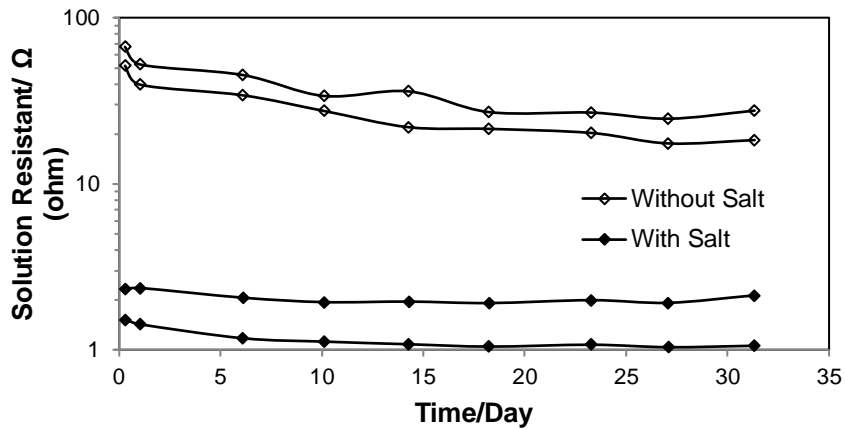
**Figure 4.23: Solution Resistance for Wet and Dry Exposure.**

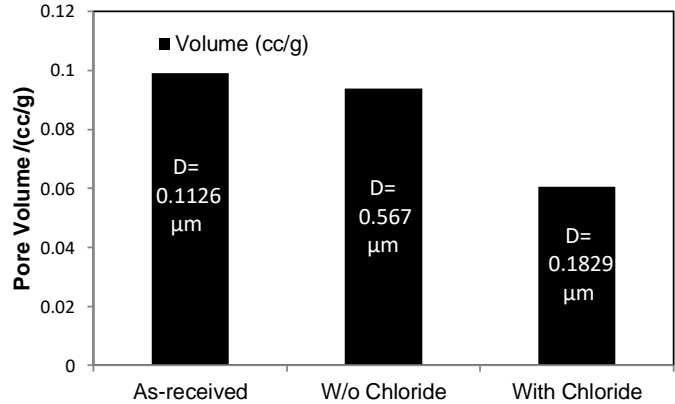
**Figure 4.25: Pore Volume for Modal Diameter.**

for as-received sample 0.0902 cc/g at mode diameter 0.1126  $\mu\text{m}$ , for salt-free solution test sample 0.09388 cc/g at mode diameter 0.567  $\mu\text{m}$  and for salt solution test sample 0.0606 cc/g at mode diameter 0.1829  $\mu\text{m}$ . For the as-received condition, it was apparent that there was a significant volume of pores that had diameter less than 10  $\mu\text{m}$ . When exposed to solution, there was apparent increase in pore volumes greater than 10  $\mu\text{m}$  which would indicate enhancement in pore volume and size due to the environmental exposure. It is noted that the friable degraded bulk material from coupons exposed in salt solutions may have separated from the sample prior to MIP testing.

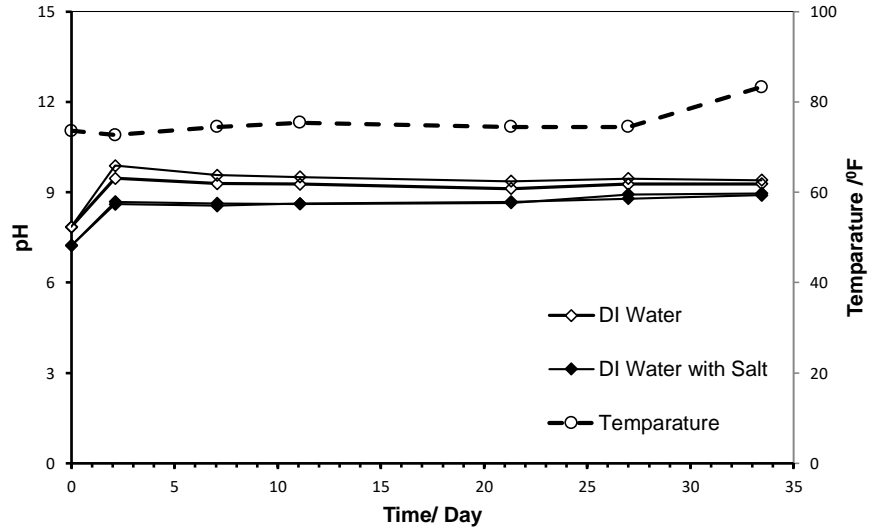
**Figure 4.27: Electrolyte pH for Wet and Dry Exposure.**

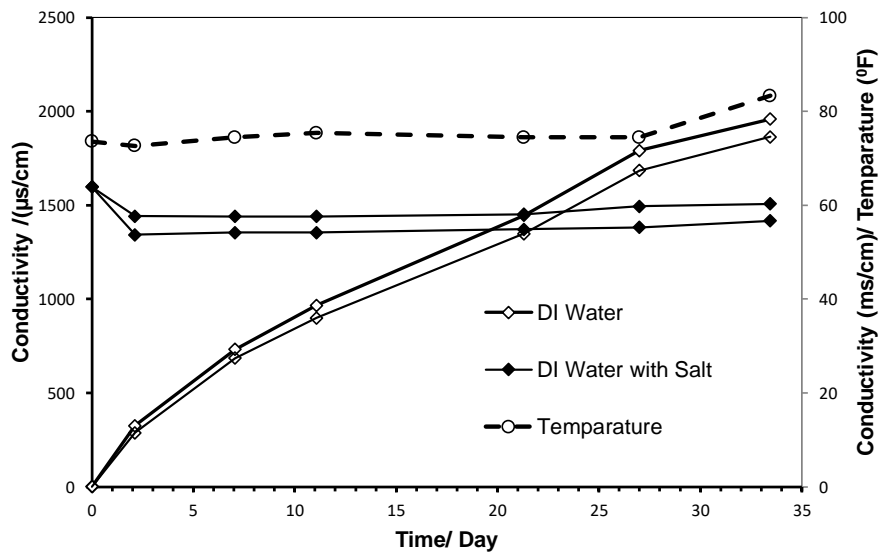
**Figure 4.28: Electrolyte Conductivity for Wet and Dry Exposure.**

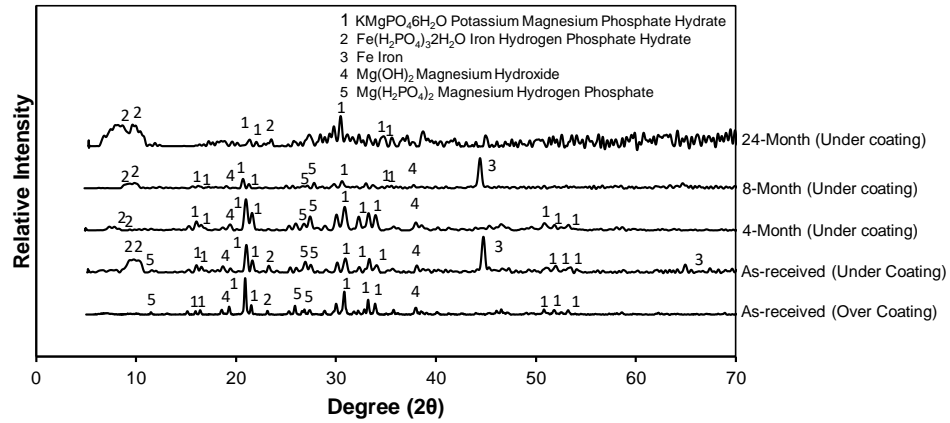
**Figure 4.29: X-ray Diffractogram for Inland Samples.**

The intermediate hydrate layer identified as iron hydrogen phosphate hydrate (Balasubramaniam, 2000) was thought to initially form during coating application involving the phosphoric acid. This layer was thought to provide beneficial corrosion mitigation characteristics (Balasubramaniam, 2000). However, the continued formation of the compound would require iron oxidation that could result in steel corrosion. In some situation, formation of a uniform intermediate hydrate layer may promote barrier protection but aggressive exposure conditions may disrupt this protection. Optical microscopy of samples discussed next provide further examination on the role of the iron phosphate intermediate layers.

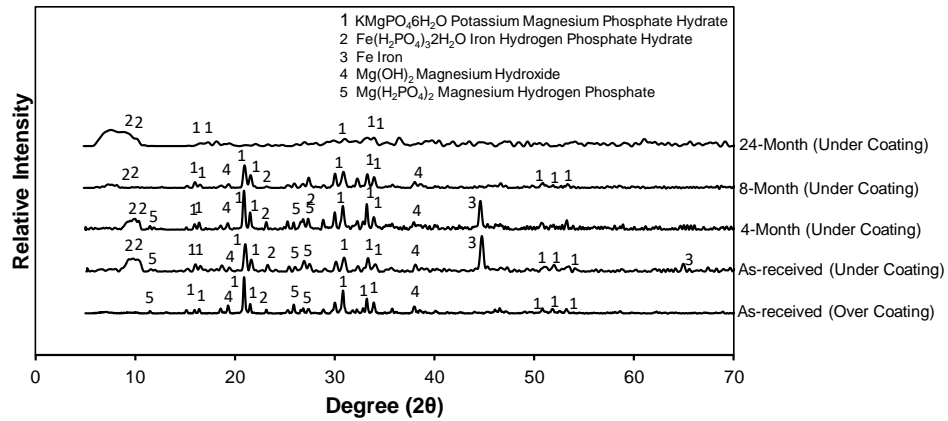
**Figure 4.30: X-ray Diffractogram for Beach Samples.**

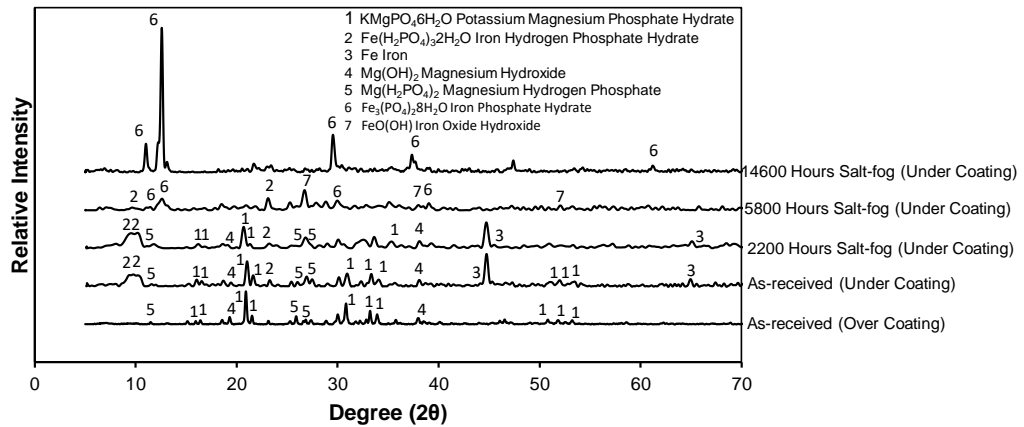
**Figure 4.31: X-ray Diffractogram for Salt-fog Samples.**

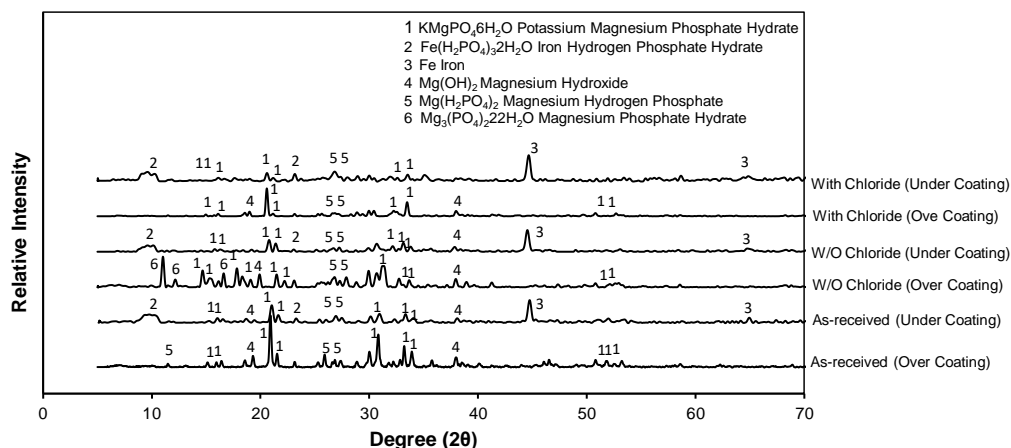
**Figure 4.32: X-ray Diffractogram for Alternate Wet and Dry Exposed Samples.**

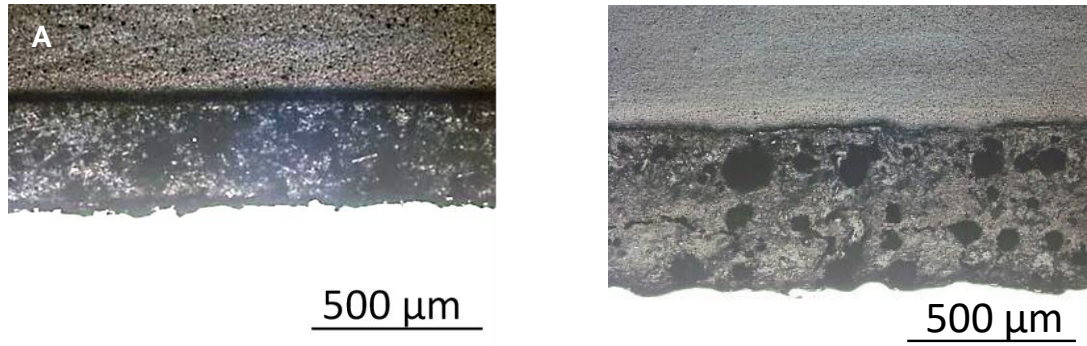
**Figure 4.33: Optical Micrograph after Exposure.**  
 A) As-received and B) Inland Outdoor Exposure after 24-Months.

Optical microscopic evaluation of the exposed samples was done to evaluate the coating and steel substrate condition. Micrographs of samples exposed outdoor for 24 months and salt fog up to 14600 hours are shown in Figure 4.33 and Figure 4.34. In comparison of cross-section from a sample in the as-received condition, it is evident that large pores are initially present in the bulk coating. The coating degradation that accounts for the observed surface chalking and loss of bulk cohesive strength was not well distinguished in the relatively low magnification from optical microscopy. Due to the wide distribution of pores in the bulk coating, SEM images will be presented in the next section to describe further coating degradation.

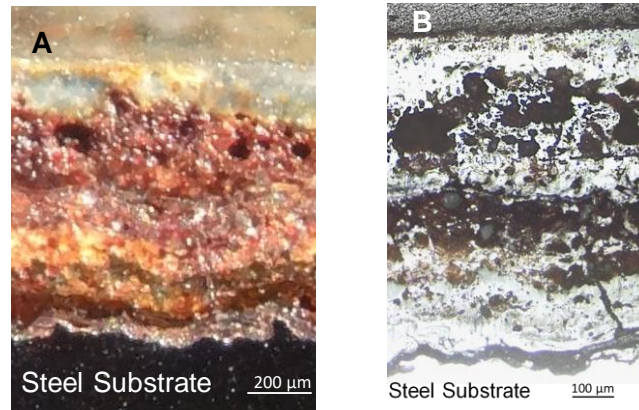
**Figure 4.34: Optical Image after 5800 Hours Salt-fog Exposure.**

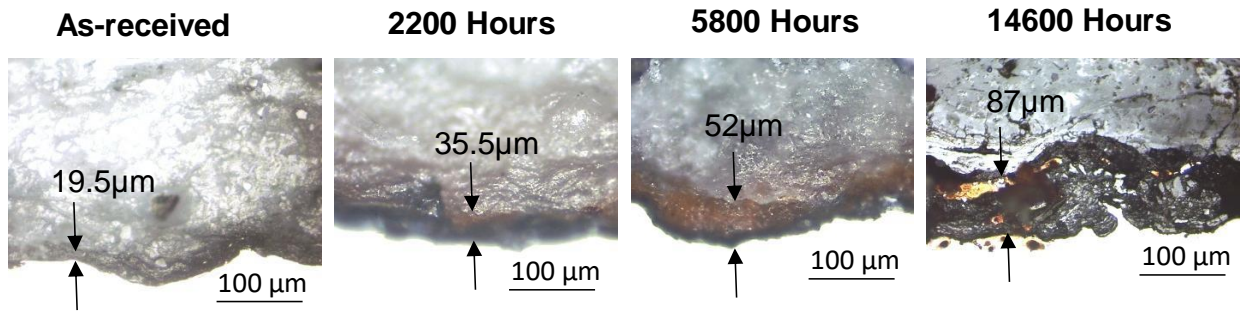
**Figure 4.35: Optical Micrograph of CBPC Coating at Salt-fog Exposure.**

of the intermediate hydrate product discussed earlier are seen in Figures 4.35 and Figure 4.36. Figure 4.35 shows that there is a general increase in the thickness of the intermediate layer with longer times of exposure. The enhanced porosity could facilitate moisture to produce the intermediate hydrate product by reacting with the steel substrate. In Figure 4.35, cross section of a sample exposed in outdoor conditions for 24 months that formed a coating blister shows a layer that was identified by XRD to be iron hydrogen phosphate hydrate, like the intermediate hydrate layers observed elsewhere (Balasubramaniam, 2000). The extent of steel consumption occurring under the coating at the blister site was not consistent with the general lack of external steel rust accumulation as described earlier for the most of the samples. It was apparent that the layer here formed in relation to apparent significant corrosion of the steel substrate. The steel consumption at the blister site under the hydrate layer is disconcerting as there are apparent conditions where coating corrosion mitigation is compromised. The lack of visible iron rust accumulation in the scribe defects of samples exposed in aggressive salt-fog environments also did not account for the level of hydrate product formation as observed in cross-section micrographs such as in Figure 4.37. It is apparent that the role of the intermediate hydrate layer requires further scrutiny to identify conditions where the coated system may be susceptible to steel corrosion. Though it was thought that intermediate iron phosphate hydrate could provide some level of corrosion mitigation, some instances indicated possibility of steel substrate corrosion.

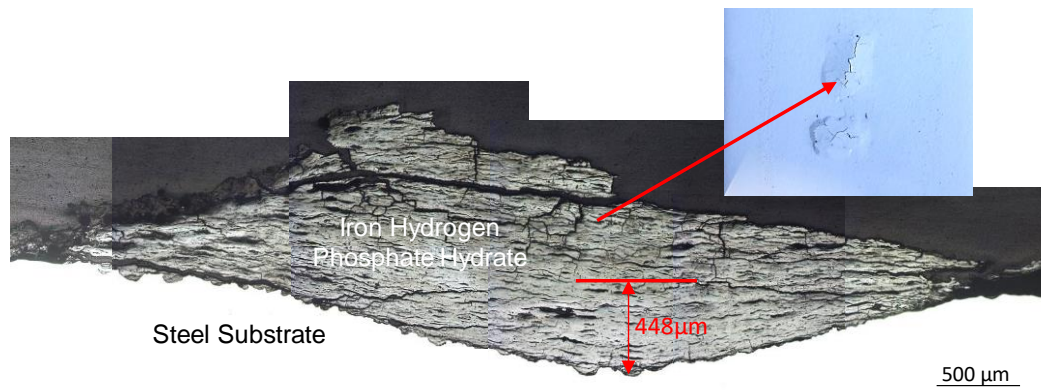
**Figure 4.36: Optical Micrograph of 24-Month Outdoor Exposed Samples.**

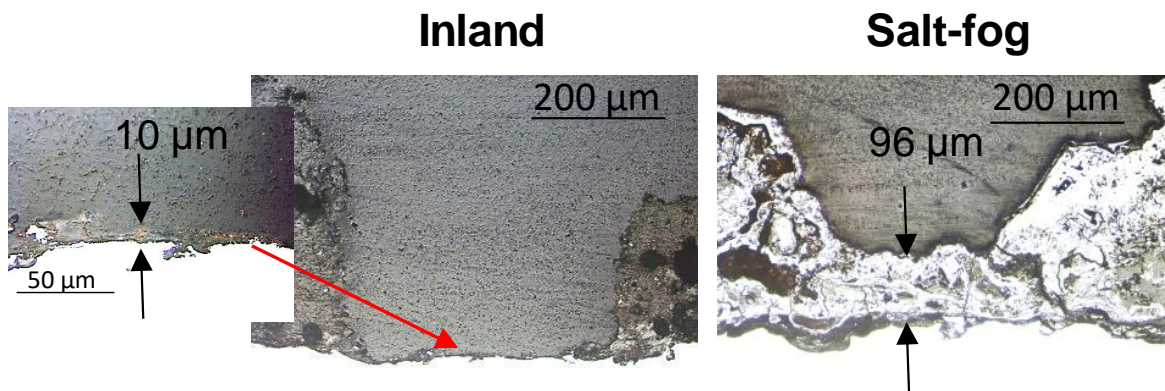
**Figure 4.37: Optical Micrograph of CBPC Coating at Scribed Location.**

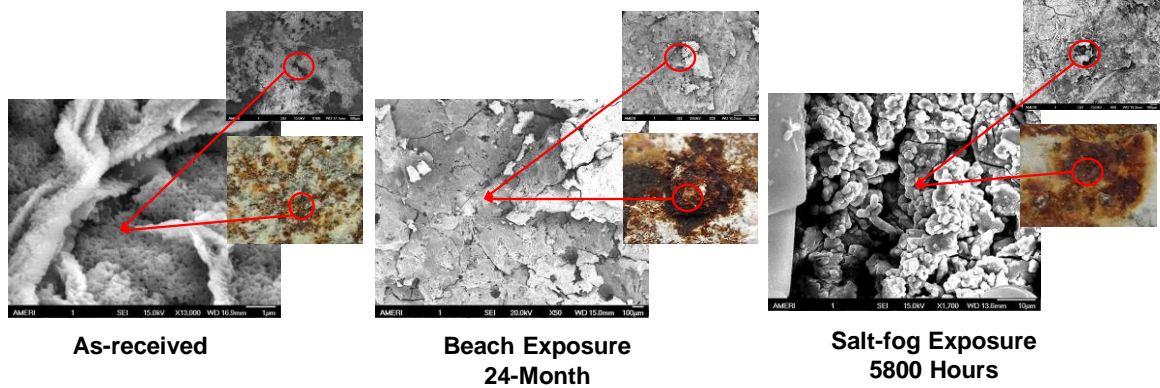
**Figure 4.38: SEM Picture on the Surface of the Coated Steel.**

be opined that though there was an apparent protection of iron phosphate hydrate layer, it was not continuous to provide enhance protection of the steel substrate.

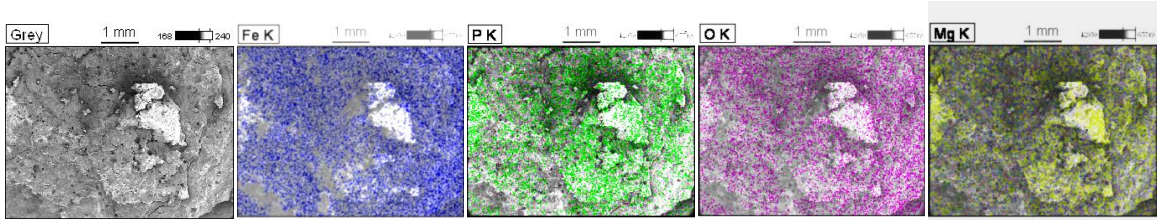
**Figure 4.39: EDS Analysis for 24-month Beach Exposed Sample.**

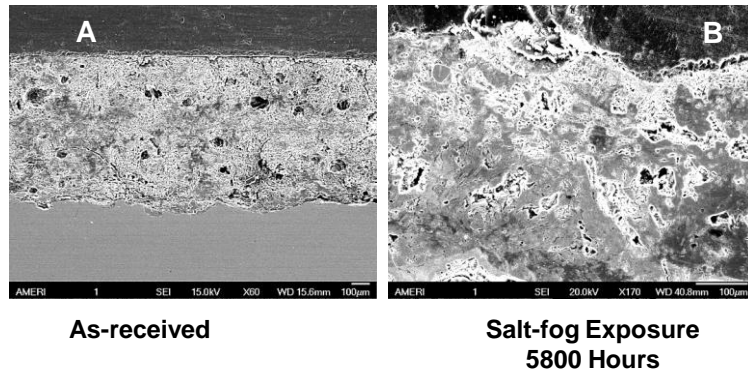
**Figure 4.40: SEM Cross Section of CBPC Coating.**  
 A) As-received. B) 5800 Hours Salt-fog Exposed.

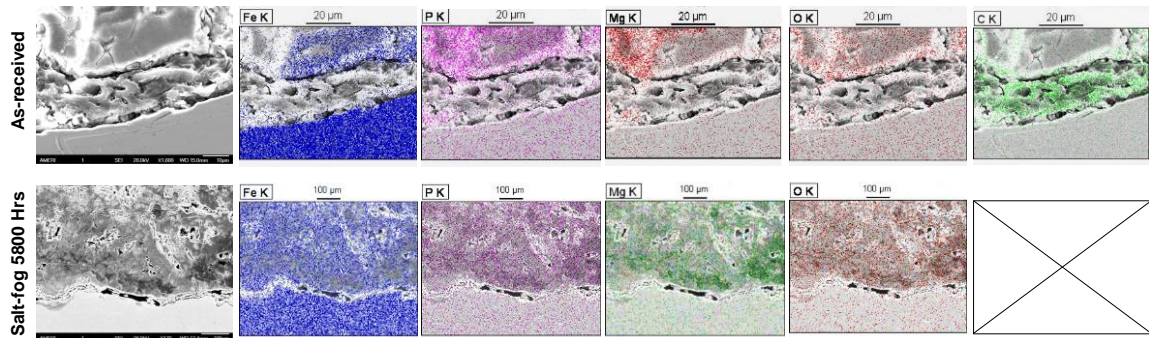
**Figure 4.41: EDS Analysis on Cross Section of the Exposed Samples.**

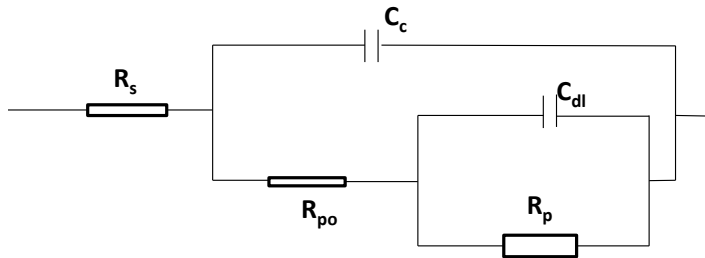
**Figure 5.4: Equivalent Circuit for Double CPE.**

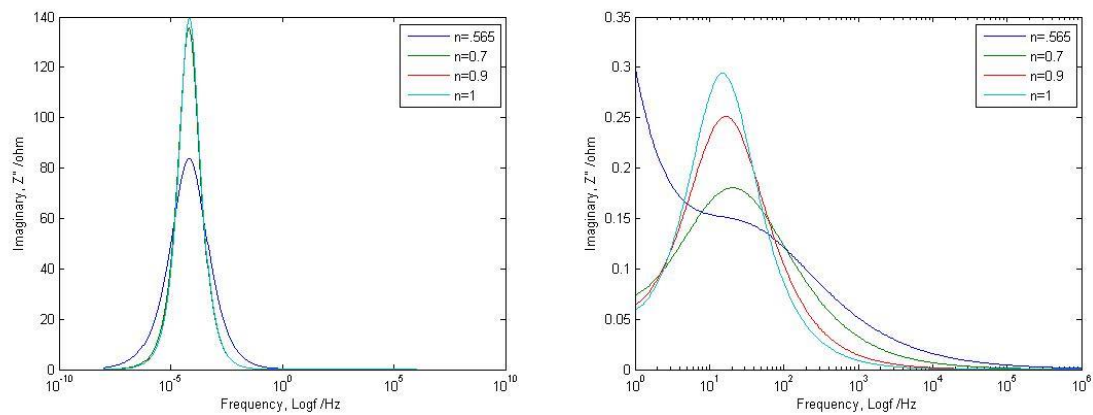
**Figure 5.7 Frequency Dependence of Impedance for CBPC Coating.**

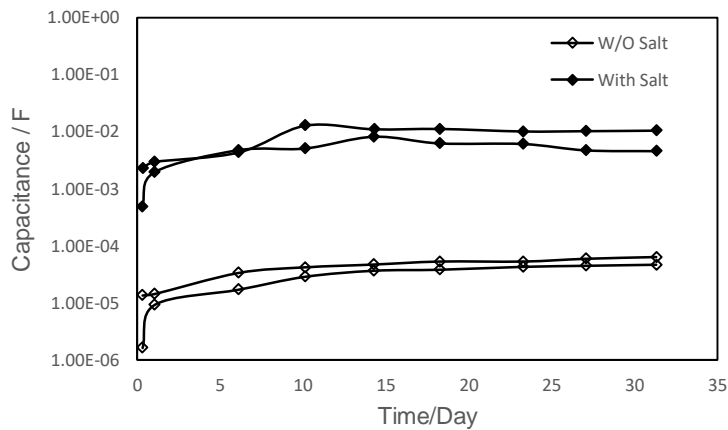
**Figure 5.9: CBPC Coating Capacitance.**

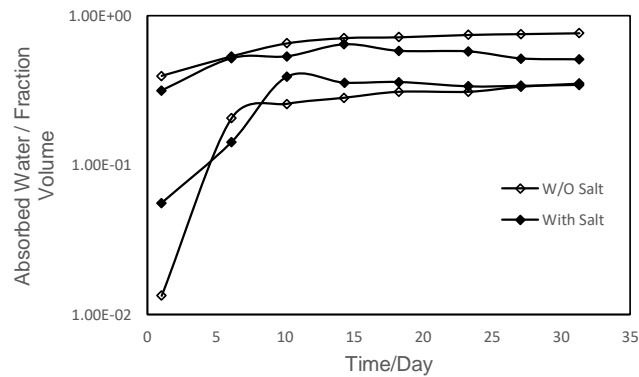
**Figure 5.11: Water Absorption of CBPC Coating.**

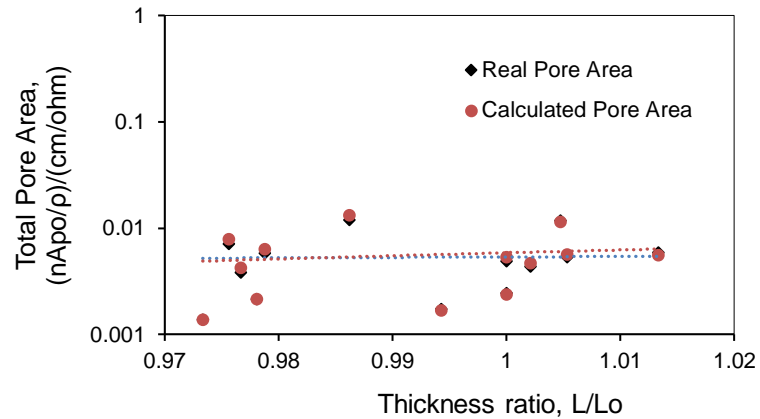
**Figure 5.15: Calculation of Coating Pore Area**
