# Corrosion Degradation Mechanism of CBPC Coating System for Highway Bridge Steel Components

CORROSION DEGRADATION MECHANISM OF CBPC COATING SYSTEM FOR  
HIGHWAY BRIDGE STEEL COMPONENTS

DOCTOR OF PHILOSOPHY

CIVIL ENGINEERING

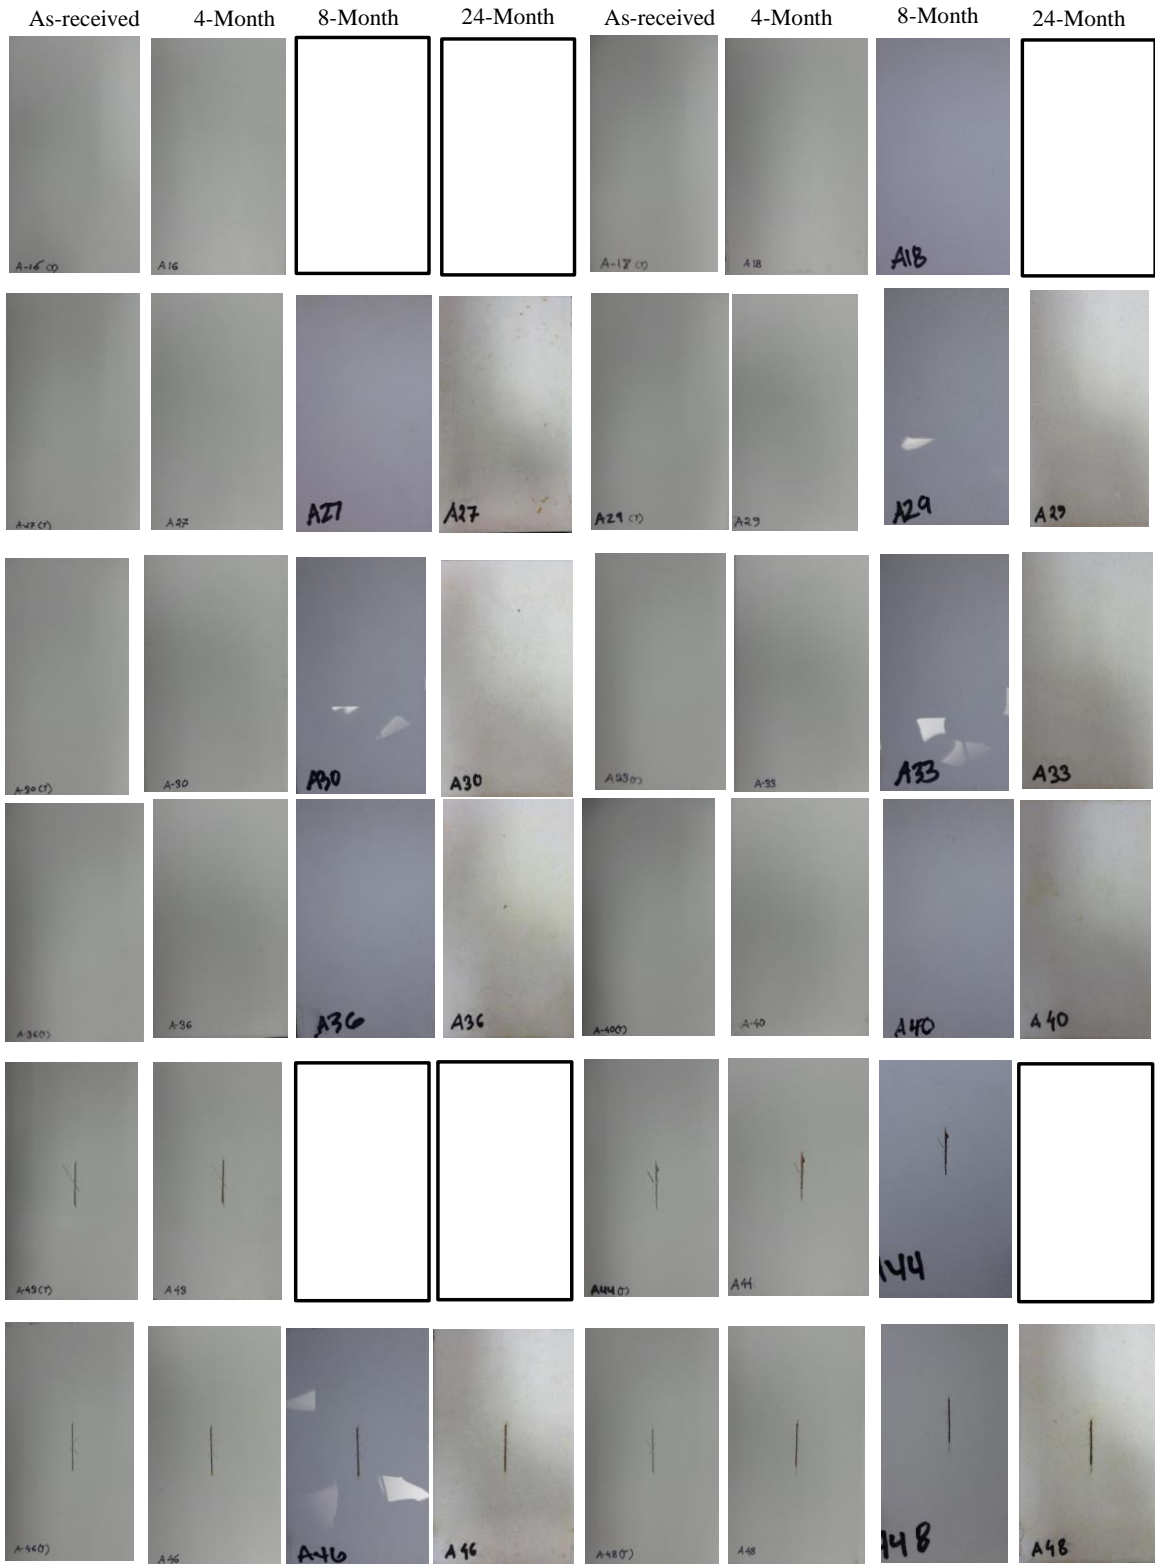
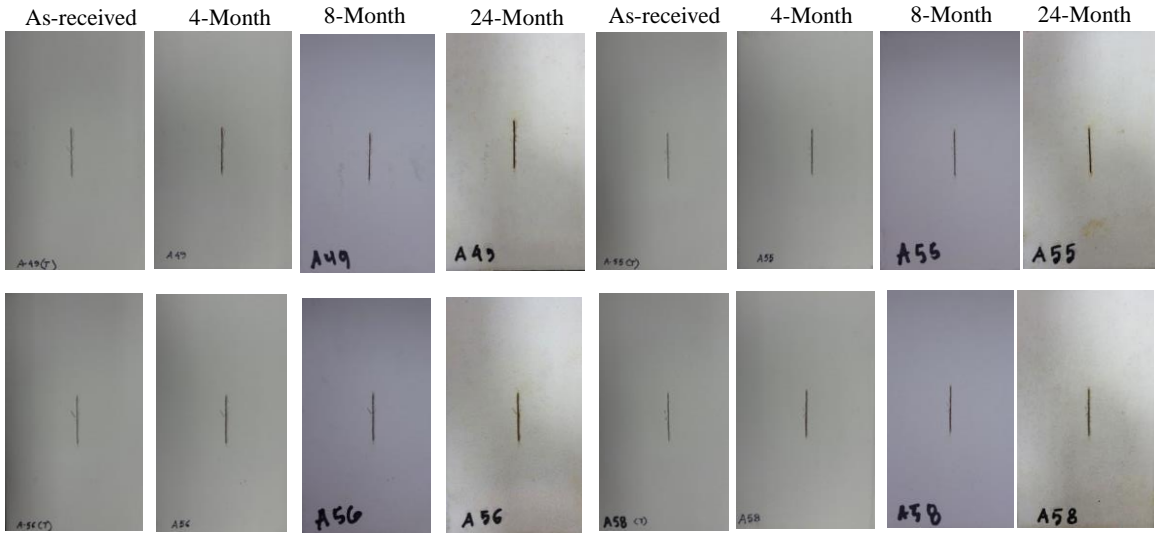
Figure A1: CBPC Samples Exposed at Inland Test Site

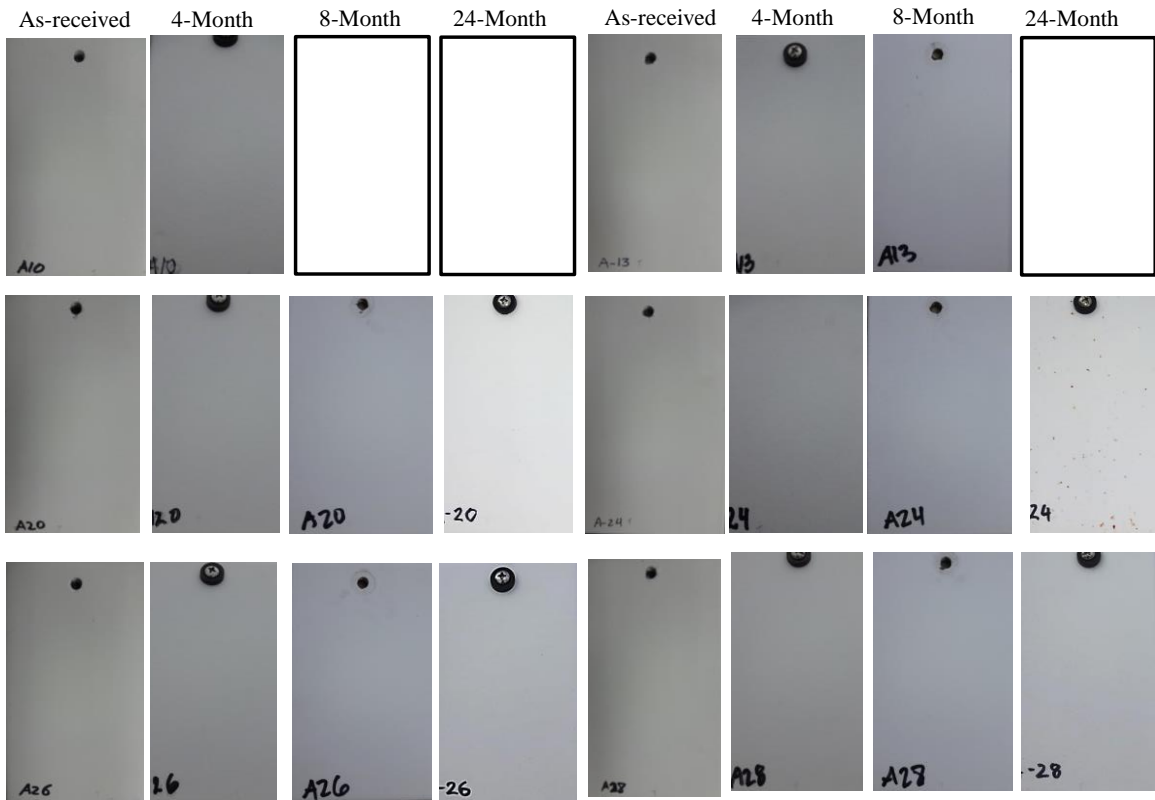
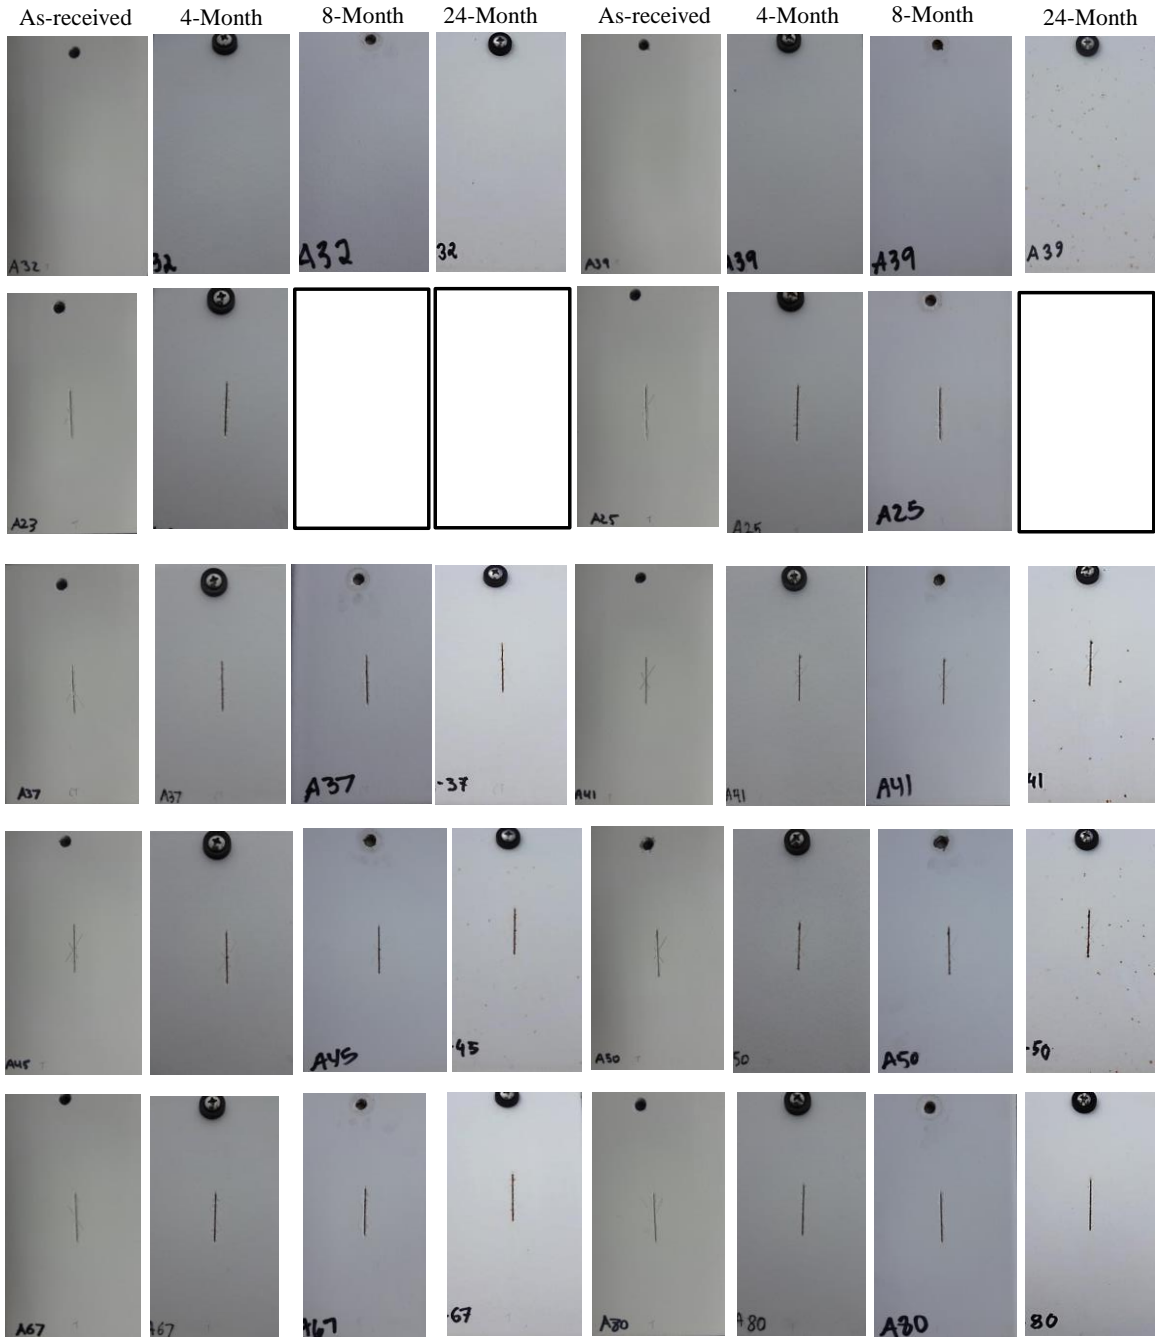
**Figure A2: CBPC Samples Exposed at Beach Test Site**

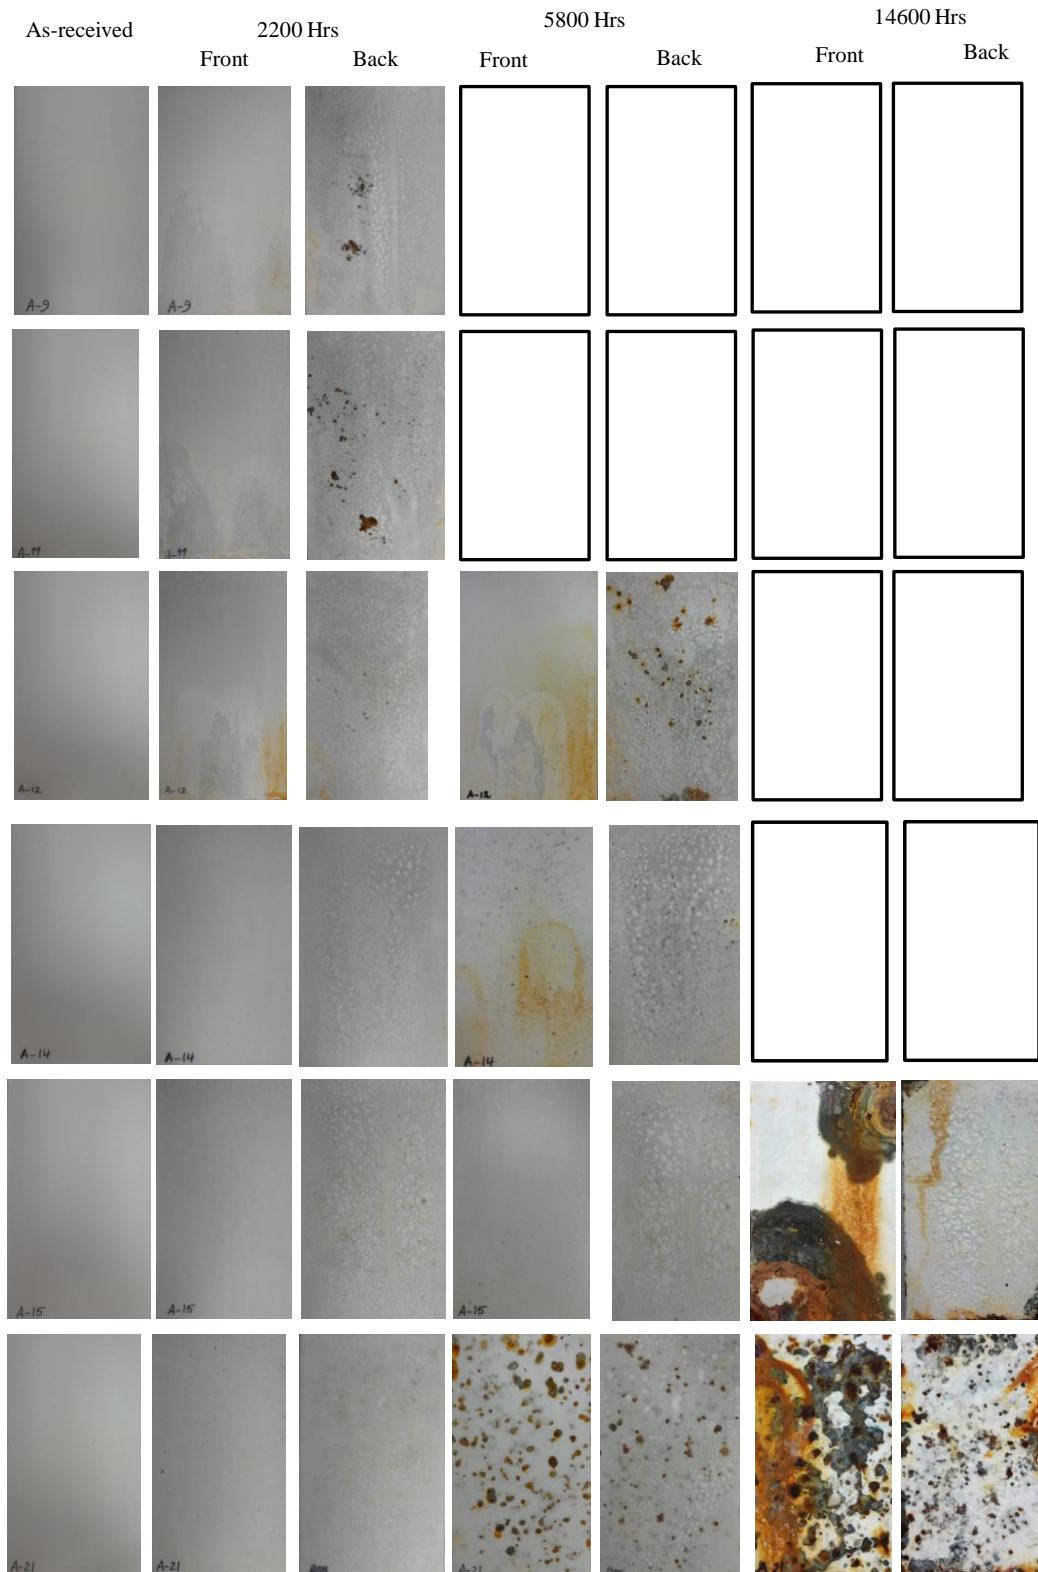
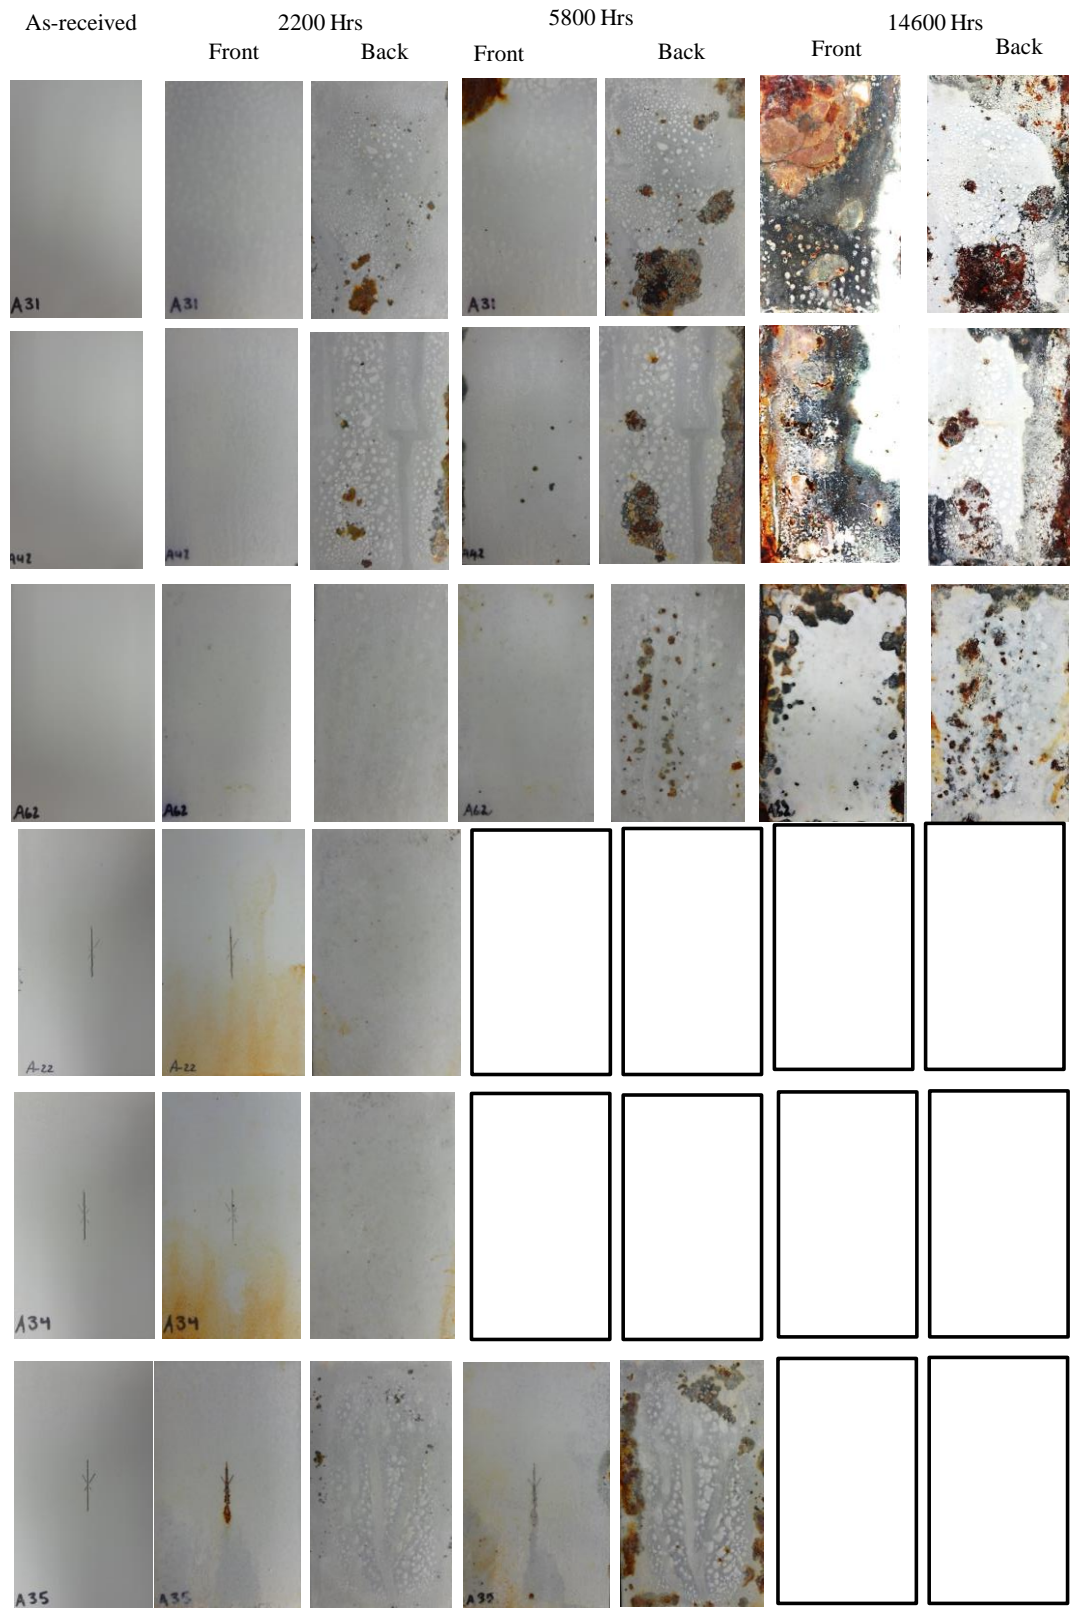
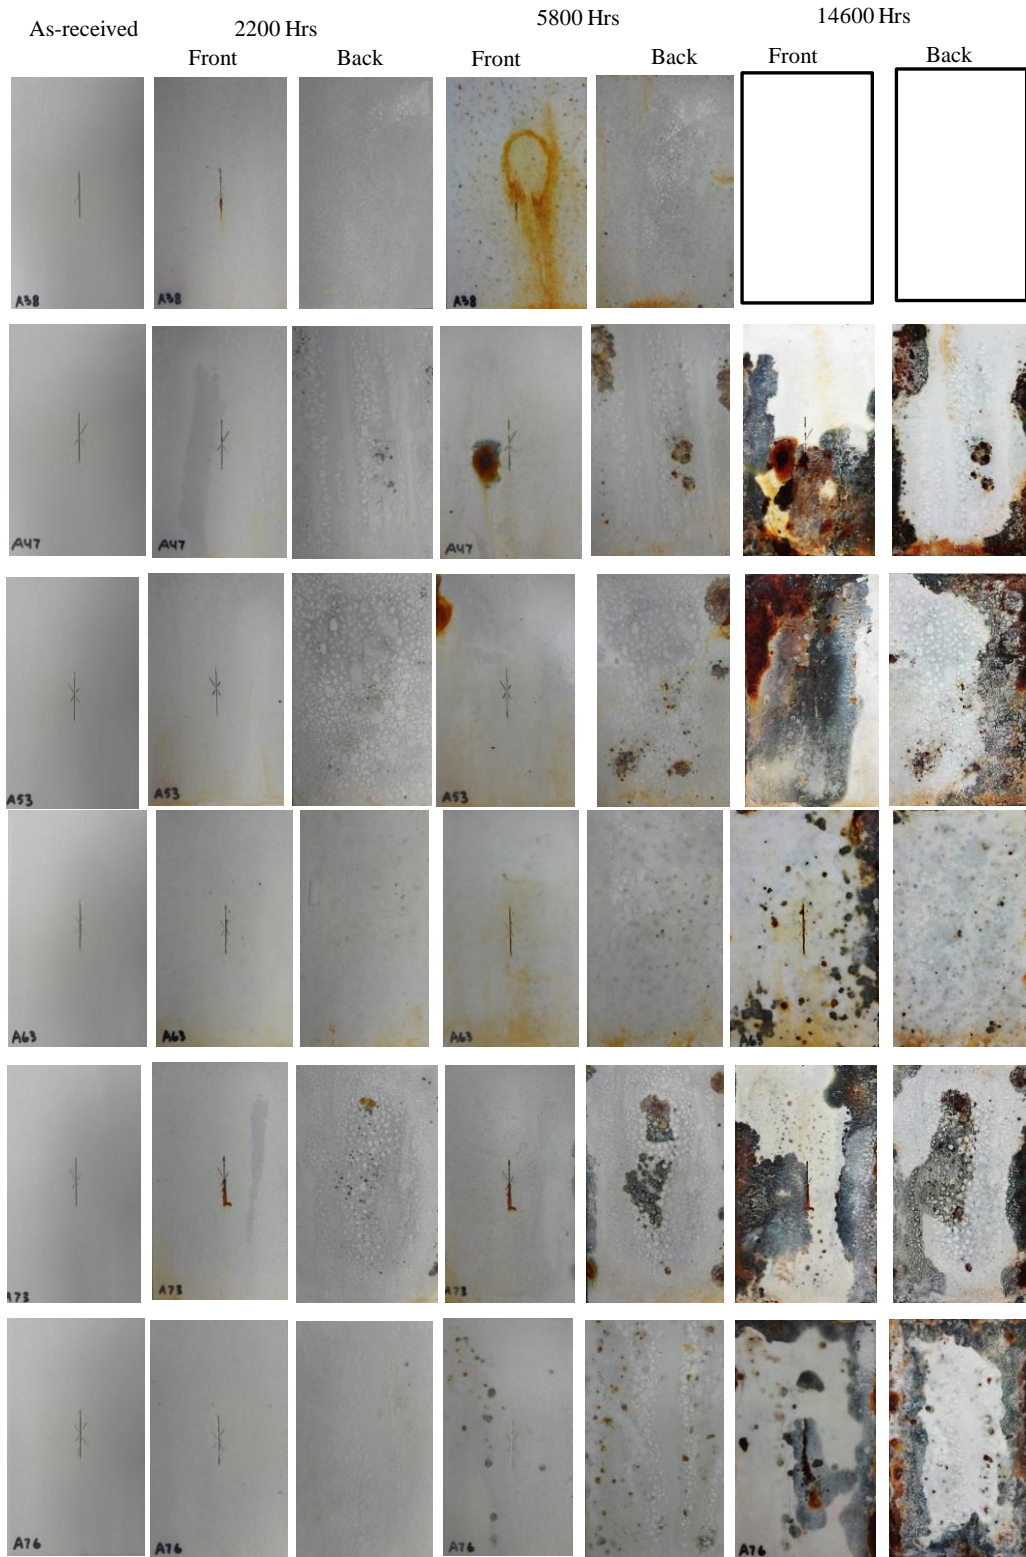
**Figure A3: CBPC Samples Exposed at Salt-Fog**

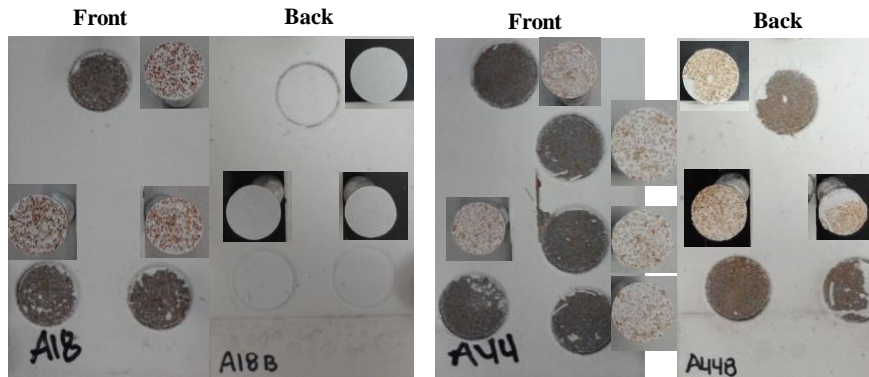
**Figure A5: Exposed Substrate after Pull-off Strength of Inland Samples after 8-Month**

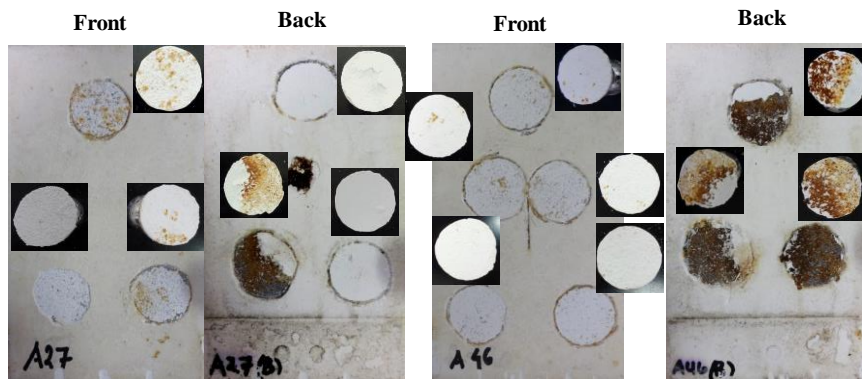
**Figure A6: Exposed Substrate after Pull-off Strength of Inland Samples after 24-Month**

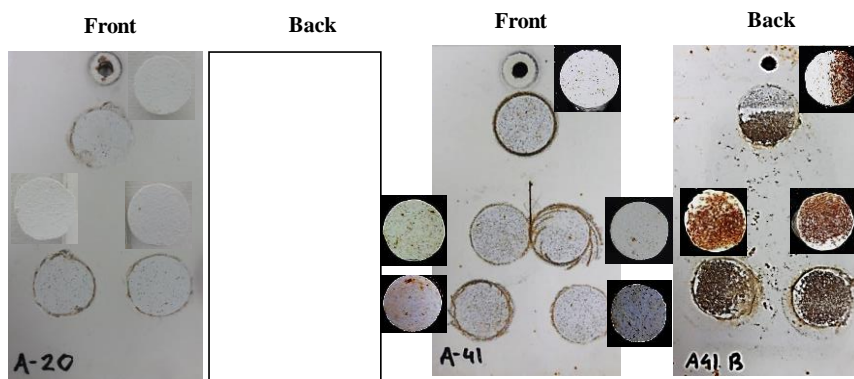
**Figure A9: Exposed Substrate after Pull-off Strength of Beach Samples after 24-Month**

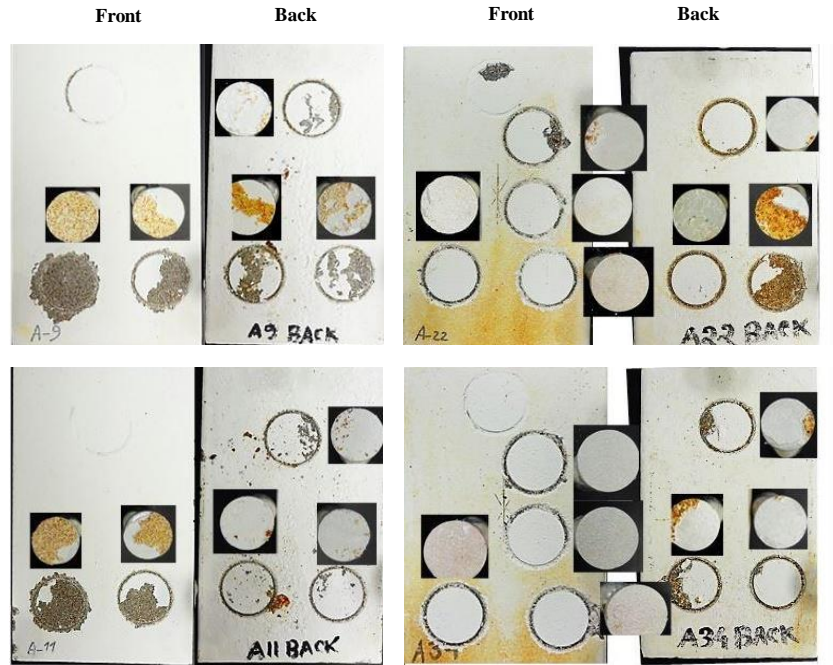
**Figure A10: Exposed Substrate after Pull-off Strength of Salt-Fog Samples after 2200- Hours**

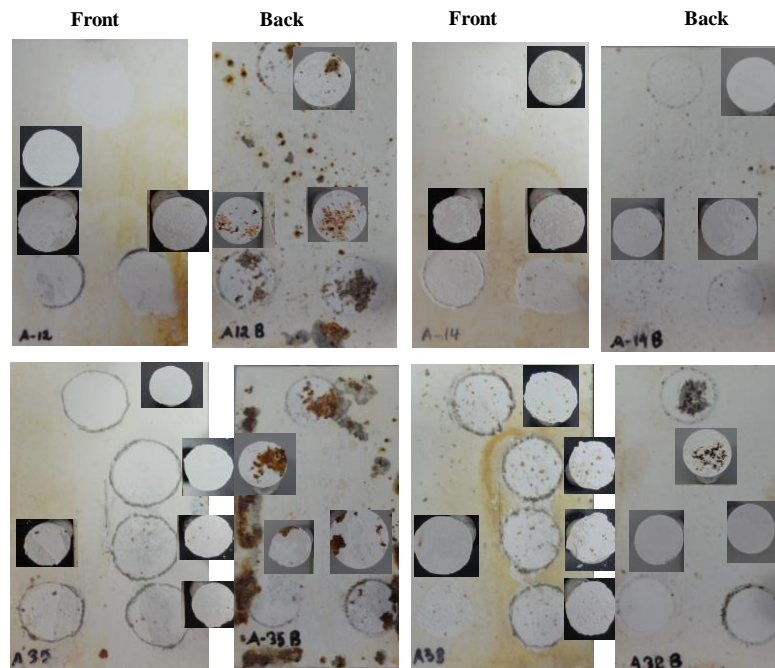
**Figure A11: Exposed Substrate after Pull-off Strength of Salt-Fog Samples after 5800- Hours**

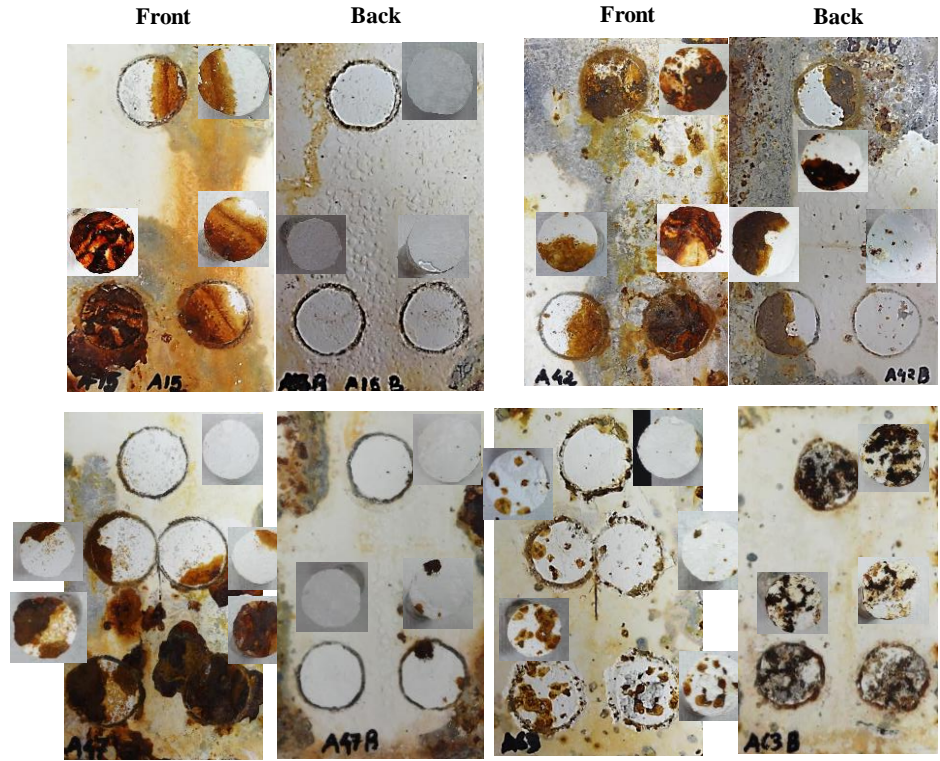
**Figure A12: Exposed Substrate after Pull-off Strength of Salt-Fog Samples after 14600-Hours**
