Use of UHPC Stay-In-Place Shells in Bridge Column Construction for Accelerated Bridge Construction

USE OF UHPC STAY-IN-PLACE SHELLS IN BRIDGE COLUMN CONSTRUCTION
FOR ACCELERATED BRIDGE CONSTRUCTION

A thesis submitted in partial fulfillment of the

CIVIL ENGINEERING

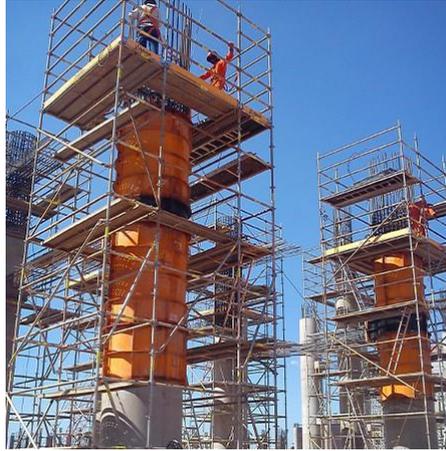
Figure 1-1 Work on circular columns using formwork and scaffolding.

The most common method for supporting the self-weight of wet concrete and its fluid pressure, machines, and workers is the use of conventional formwork and scaffolding. In order to gain access to the structure under construction, conventional scaffolding is typically used. Figure 1-1 shows scaffolding and formwork in bridge site. However, placing and erecting the formwork and scaffolding components usually take time, leading to an increase in construction cost and traffic congestions. Furthermore, possible failure of formwork and scaffolding should be considered due to the unexpected site conditions and deviations from the original design [1]. A common cause of the failure of formwork and scaffolding is the underutilization of hardware, due to rushing of the erection process [2]. If the failure of formwork occurs during a concrete pour, concrete might start to leak, leading to possible structural collapse, injuries or fatalities. Several interviews had been conducted in order to determine the most common formwork and falsework failures which include lack of planning, stripping of formwork, falling objects, floor collapse and material mishandling [3]. Another cause of formwork failure is due to possible human errors or crushing of wooden surface where the heavy loads are located if appropriate bearing surface of joints is not provided. According to the “*Use and Re-use of Formwork: Safety Risk and Reliability Assessment*” report, the formwork being re-used is not factored into its design which leads to possible degradation of its structural capacity when exposed to different loads [4].

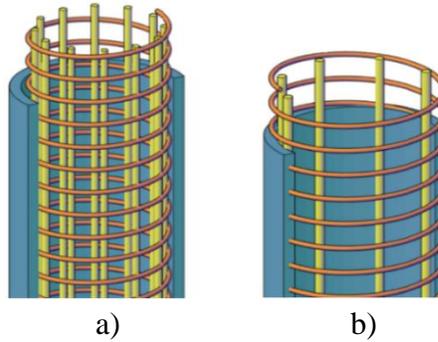
Figure 2-1 Location of the reinforcement: a) first specimen, b) right specimen.

Once axial and lateral loads have been applied to a conventional reinforced concrete column, together with the moisture ingress through concrete, corrosion of the reinforcement starts, causing the expansion of steel bars and crack formation, resulting in the concrete to spall off. The area of the existing column section then starts to decrease, together with its lateral load capacity. To prevent the spalling of column concrete and reduction of the design strength, a prefabricated UHPC shell was incorporated and two specimens were tested at Florida International University. No reinforcement was embedded inside the UHPC shell for the first specimen, whereas a steel cage was only placed in the normal concrete core. Since the UHPC is cast first, the UHPC surface is smooth, therefore, the friction between the conventional concrete and the shell might be reduced, causing material slippage due to the excessive lateral loads. Due to this possible issue, the second specimen was envisioned. The second specimen consisted of longitudinal reinforcing bars partially embedded in the UHPC shell, while being shared with the column concrete and the transverse reinforcement (spirals) was fully embedded in the UHPC shell. This detail was envisioned to prevent possible slippage, causing better interaction and bonding between two materials. Figure 2-1. Show schematics for the first and second specimens.

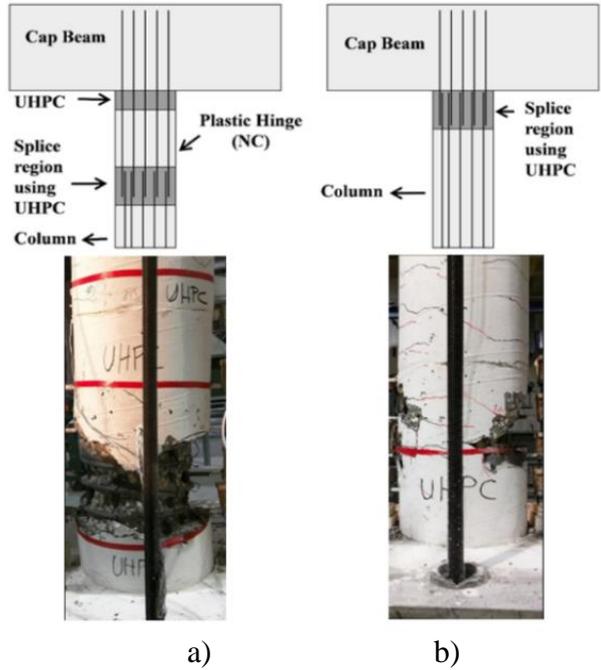
Figure 2-2 Connecting prefabricated bridge columns using UHPC and spliced reinforcement: a) seismic connection, b) non-seismic connection [20].

The UHPC shell is connected to adjoining elements (footing or cap beam) by splicing the longitudinal reinforcing bars with dowels extended from the adjoining elements. In order to shorten the splice length of the bars and shift the formation of the plastic hinge away from the adjoining elements and their interfaces with the shell, UHPC is also implemented in the connection between the column section and the adjoining elements (footing or cap beam). Previous research was conducted at Florida International University on prefabricated columns emulating reinforced concrete columns with seismic and non-seismic details where UHPC was utilized in the connection between prefabricated substructure elements (columns to footing or cap beam). For the seismic detail, two layers of UHPC were incorporated, while for the non-seismic detail, only one layer was incorporated, as shown in Figure 2-2 [20]. Once tested, the specimen experienced the formation of the plastic hinge between the two layers of UHPC for the seismic detail, while for the non-seismic design, plastic hinge has shifted away from UHPC connection detail, proving that this advanced material can be successfully used to shift the plastic hinge location as needed. Furthermore, the use of UHPC in the locations of a splicing region was proven to be more effective, where the development and lap splice lengths of the reinforcing bars were shorter if compared to those developed in normal strength concrete.

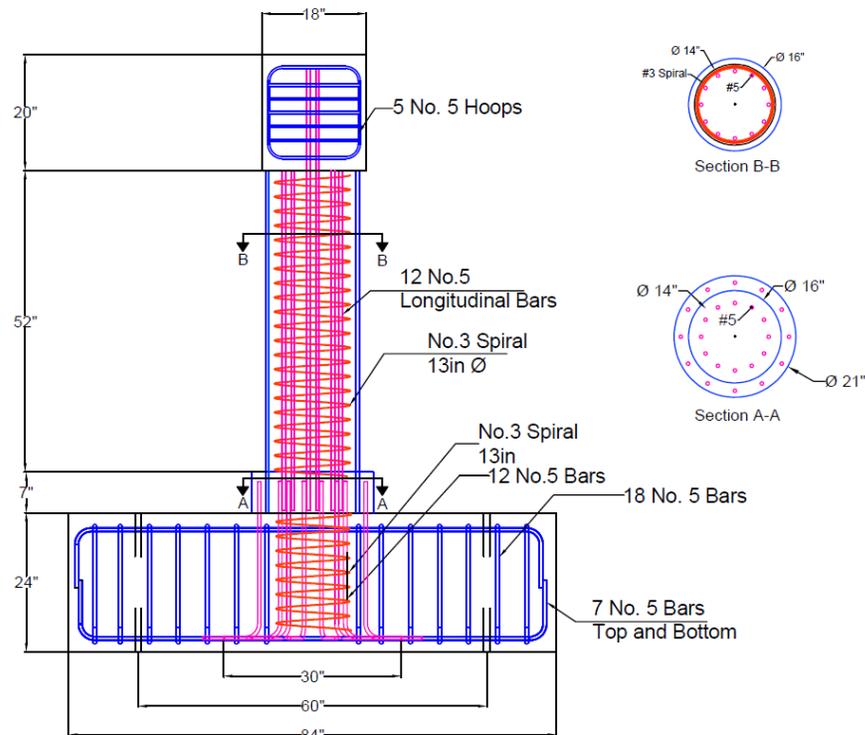
Figure 3-1 Details of the first specimen.

The first specimen was designed to have no reinforcement embedded in the UHPC shell, with the conventional steel cage located inside the inner part of the column, in the normal strength concrete. The specimen footing consisted of a conventional steel cage with #5 longitudinal reinforcing bars and normal strength concrete. The specimen had a 16 in. outer diameter UHPC shell, with 1 in. wall thickness and 12#5 longitudinal bars spliced with a set of 12#5 dowel bars, extending from the footing. #3 spiral was used in the steel cage as the transverse reinforcement, with a diameter of 13 in. and 2.5 in. pitch spacing. The same spiral was used for the transverse reinforcement of the dowel bars located in the footing. No transverse reinforcement was used within the UHPC step section due to the higher shear capacity of that section, and ductility provided by the steel fibers from the UHPC shell. The diameter of the UHPC step was 21 in. with height of 7 in.

Based on the UHPC design specifications [23], in which the lap splice length is defined as eight times the bar diameter, it was found that 5 in. was the sufficient length to splice column longitudinal reinforcement with the dowel bars extended from the footing. Besides the lap splices, another set of 12#5 dowel bars were located and developed in the outer perimeter of the UHPC step, but not in the UHPC shell. These dowel bars were intended to prevent any possible detachment of the UHPC step from the footing, which might cause racking of the column when the cyclic load is applied. The effective height of the first specimen (from the center of the applied load to the footing interface) was 69 in. Figure 3-1 shows the full reinforcement details of the first specimen. Section A-A and B-B in Figure 3-1 show the cross-sections of the reinforcement details of the UHPC step section and the column section, respectively.

Prior to testing the specimens, moment-curvature analyses were conducted on the column section (Section B-B in Figures 3-1. and 3-3.), UHPC step section (Section A-A in Figures 3-1. and 3-3.) and footing section of both specimens. In order to predict the failure region and confirm the shift of the plastic hinge away from the footing-to-column interface, a preliminary analysis had to be done. Figure 3-5 represents the moment-curvature plots for column section of both specimens and an equivalent conventional column of the same diameter for comparison purpose. Based on the results from the plot, it can be concluded that the section comprised of UHPC shell shows higher moment capacity in comparison to the conventional section, resulting in an increase of about 10%. Table 3-1 shows the moment capacities of three section for both specimens together with the moment ratios (UHPC step or footing moment capacity divided by the column moment capacity), predicting that the damage is to be expected in the column section for both cases.

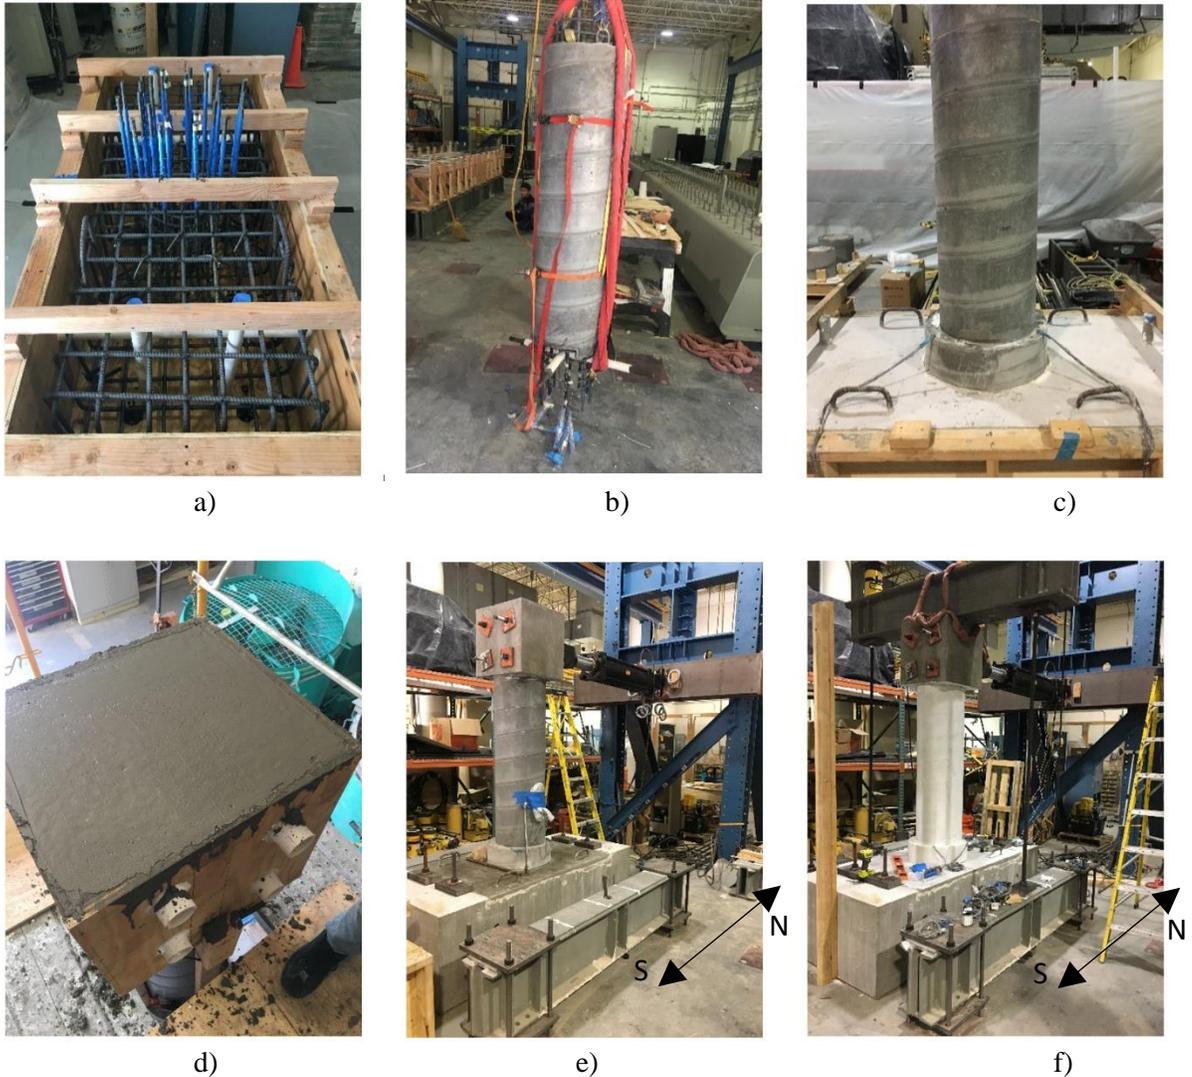
Figure 3-2 Construction sequence of the first specimen: a) footing reinforcement; b) prefabricated UHPC shell; c) UHPC step connection; d) casting of the NSC; e) connecting the specimen to the loading actuator; f) final test setup.

The construction of the first specimen started by the assembly and placement of the footing reinforcement together inside the formwork along with the two sets of extended dowel bars, as shown in Figure 3-2a. Normal strength concrete was cast in the footing formwork then UHPC shell construction started. A sonotube of a diameter same as the outer diameter of the shell (16 in.) was used to shape the outer perimeter of the prefabricated shell, while Styrofoam was used to form the inner perimeter and the 1-in. uniform shell wall thickness. Once the UHPC of the shell hardened, both Styrofoam and the sonotube were removed to form the shell shown in Figure 3-2b. As mentioned in the previous section, no reinforcement was embedded in the prefabricated shell element, whereas the column transverse and longitudinal reinforcement (steel cage) were placed in the UHPC shell cavity. During the construction process, the steel cage had to be placed inside the UHPC shell and placed together on top of the footing due to the laboratory height limitations. It should be noted that in the field construction, UHPC shell and steel cage can be lifted and placed separately on the footing element. Once both the UHPC shell and steel cage have been placed on the top of the footing, longitudinal reinforcement was spliced with the first set of the dowel bars extending from the footing. In order to shape the UHPC step, another sonotube with a height of 7 in. was used which was cast after the reinforcement splicing was completed, as shown in Figure 3-2c). Once the UHPC step hardened, normal strength concrete was cast in the shell cavity with the loading cap, as shown in Figure 3-2d. After the curing of normal strength concrete, the specimen was moved to the final test setup position, as shown in Figure 3-2e and Figure 3-2f.

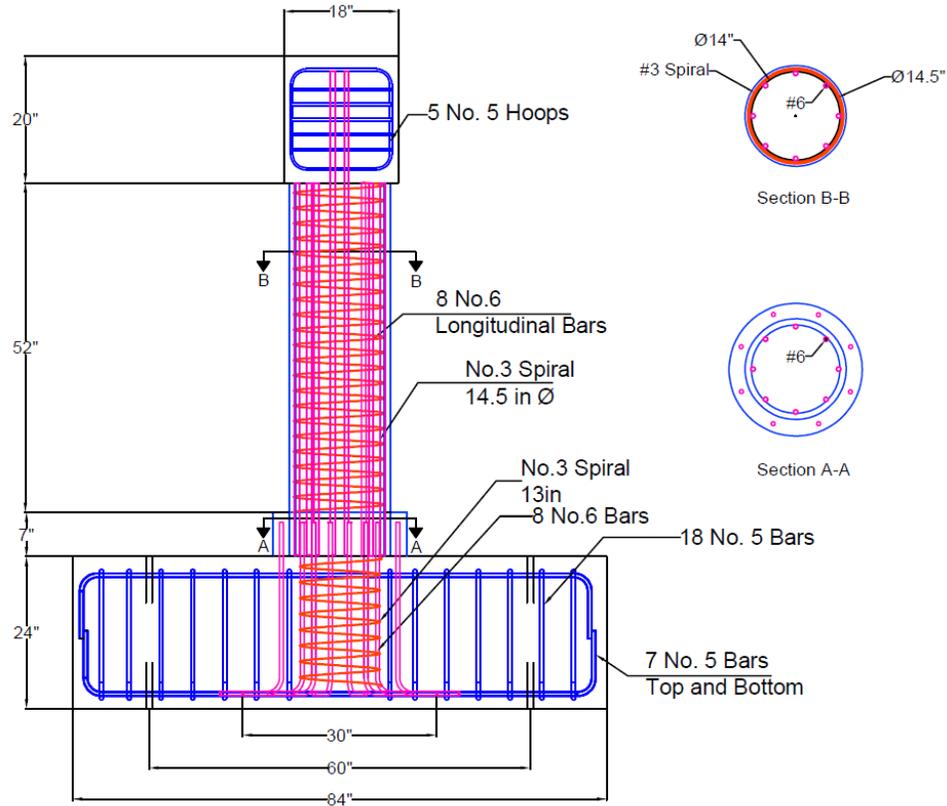
Figure 3-3 Details of the second specimen.

The second specimen was designed with two main differences in comparison to the first specimen. The first difference is that the column longitudinal reinforcement is partially embedded in the UHPC shell, while also being exposed to the normal concrete core in order to develop a better bond between the two materials. This detail was added due to the smooth surface of UHPC once hardened and potentially reduced friction between NSC and UHPC,

where it was assumed that possible slippage may occur between the two materials once the cyclic loading is applied. The second difference is the location of the spiral, which was completely embedded in the UHPC shell, around the partially embedded longitudinal bars. Since bigger reinforcing bar diameter was needed for the bar to be shared between NSC and UHPC, 8#6 bars were used for the longitudinal reinforcement instead of 12#5 bars, as used for the first specimen, where a similar area of steel was used. For transverse reinforcement, #3 spiral of 14.5 in. diameter was used, with 2.5 in. pitch spacing. For the dowel bars, #3 spiral was used, however, the diameter was smaller, corresponding to 13 in. Same diameter of the shell (16 in.) and shell wall thickness (1 in.) were incorporated to match the first specimen in order to appropriately compare the results of both specimens. Similar to the first specimen, a UHPC step was used to connect the UHPC shell to the footing where the splicing region was located. No transverse reinforcement (spirals) was used within the UHPC step. Since #6 longitudinal bars were used, the splicing region increased from 5 in. to 6 in. [21] while the UHPC step height increased to 7.5 in. but the outer diameter of the UHPC step remained the same as 21 in. The longitudinal reinforcement of the column was spliced with 8#6 dowel bars extended from the footing. Another set of 8#5 dowel bars was used at the outer perimeter of the UHPC step in order to prevent possible separation between the UHPC step and the footing. Same dimensions of the footing with the same steel cage footing arrangement were incorporated for the second specimen. The column effective height remained the same as the first column, 69 in. Figure 3-3 shows the reinforcement details of the second specimen. Section A-A and B-B, in Figure 3-3, shows the reinforcement details for UHPC step section and column section with UHPC shell.

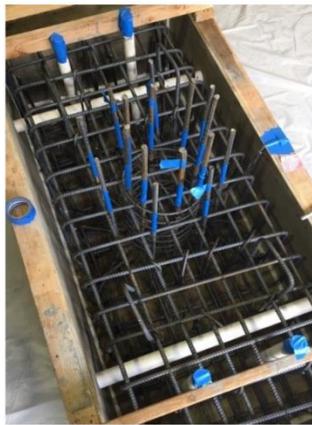
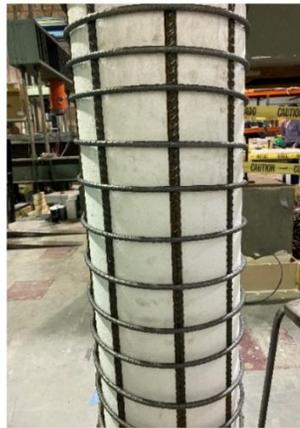
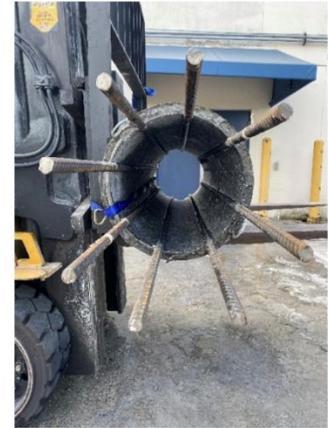
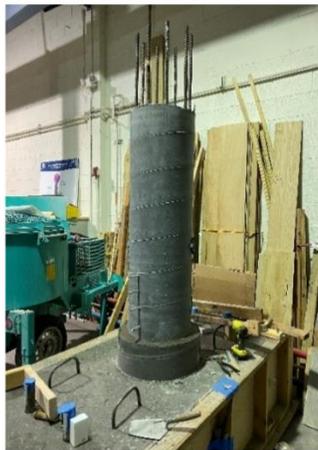
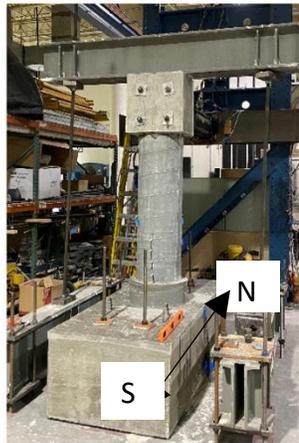
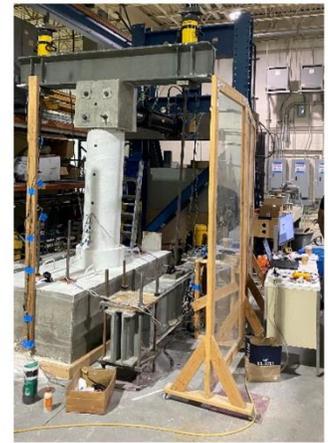
Figure 3-4 Construction sequence of the second specimen: a) footing reinforcement including dowel bars; b) steel cage; c) prefabricated UHPC shell with the embedded longitudinal reinforcement; d) UHPC shell connection with the footing using UHPC step; e) complete specimen; f) test setup of the second specimen.

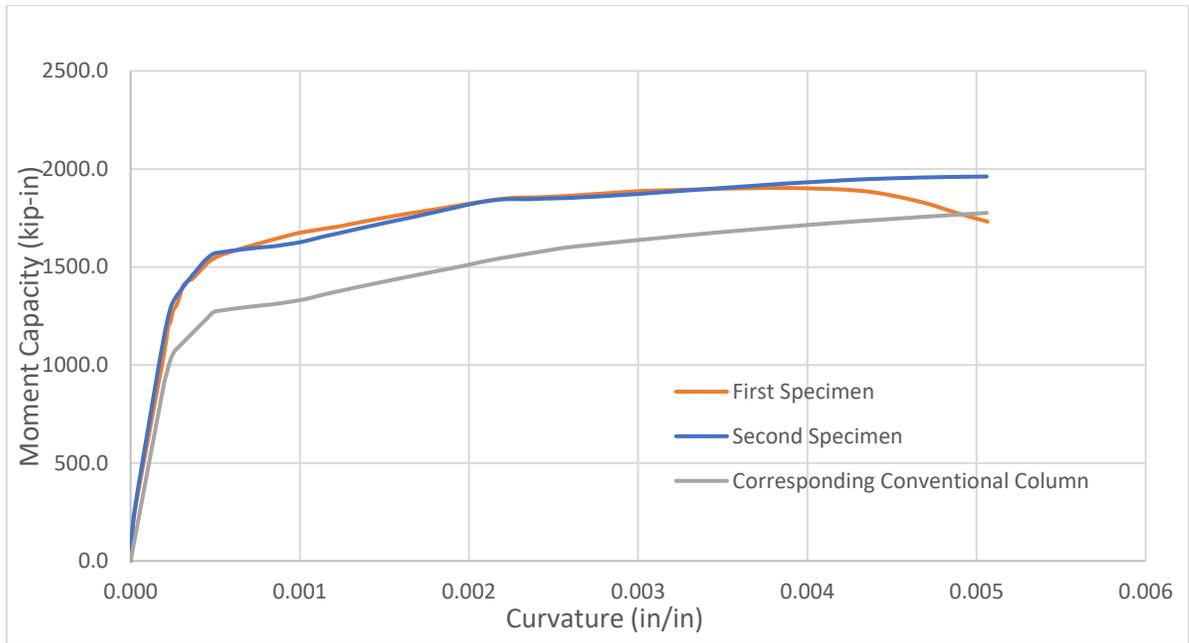
Figure 3-5 Moment-curvature curves for both UHPC shell column section and equivalent conventional column

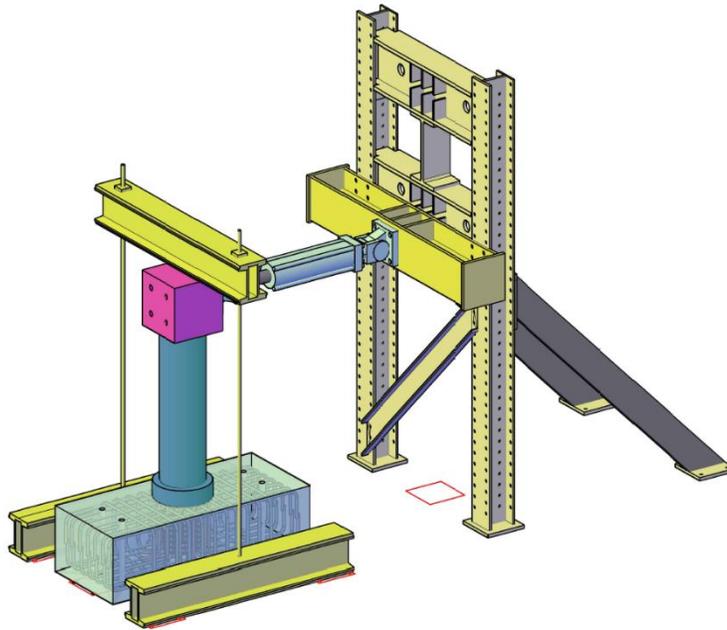
Figure 4-1 Test setup for first and second specimen.

In this research project, both specimens were tested under incremental lateral cyclic loading using a 110-kip hydraulic ram and constant axial load of 120 kips using two hydraulic jacks located on a spreader beam placed horizontally on top of the specimen. The hydraulic ram that was used for lateral displacement was attached to a steel beam, bolted to the two-column frame on the north side, as shown in Figure 4-1.

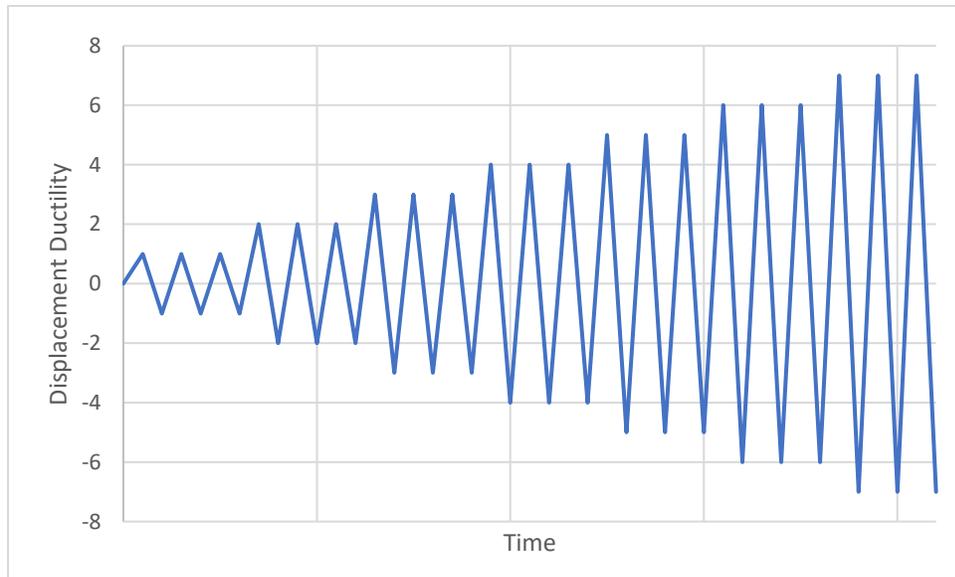
Figure 4-2 Loading protocol for lateral load.

The idealized yield displacement was based on a bilinear model and was determined by initially applying low displacement cycles. An equivalent elastoplastic system was assumed for the yielding displacement (Δ_y). After the yield displacement was obtained, the column was subjected to three cycles of $2\Delta_y$, $3\Delta_y$, $4\Delta_y$ and so on, as shown in Figure 4-2. After each cycle, cracks were traced, and the observed damage was documented. The testing of both specimens was completed once rebar rupture occurred or significant loss in lateral capacity.

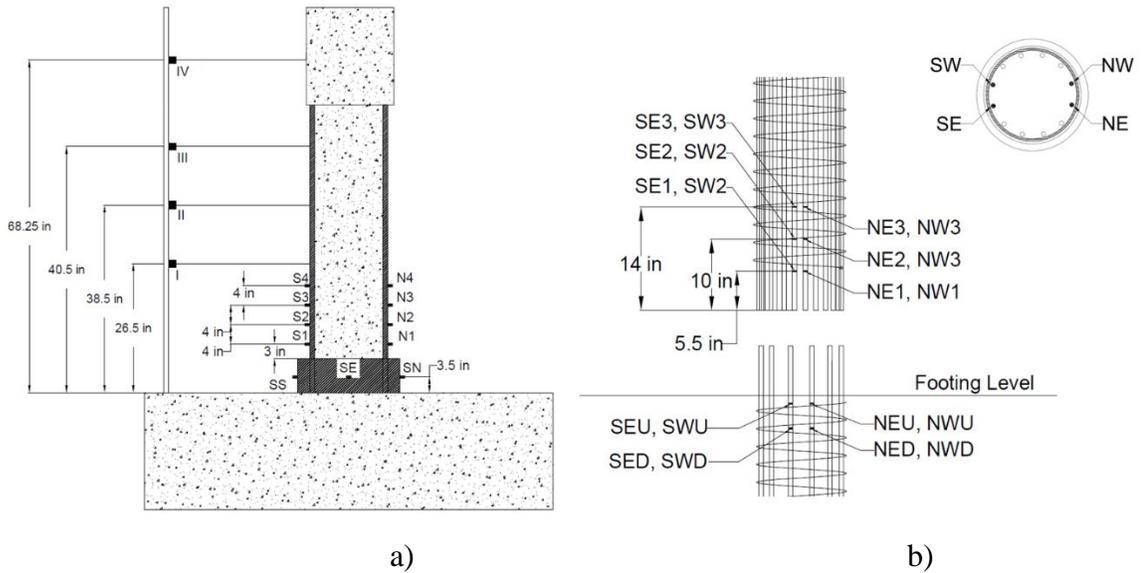
Figure 4-3 Instrumentation plan for the first specimen. a) string potentiometers and displacement transducers for displacement and rotational measurements; b) strain gauges location on column reinforcement and dowel bars.

instruments used for each specimen. Several different observations, notes and measurements were made during the testing of each specimen which includes cracking patterns, loading vs. displacement graph, curvatures, drift ratios and maximum strain values. For the first specimen, 24 different strain gauges were placed at different locations: 12 strain gauges on the longitudinal reinforcement of the column, and 12 strain gauges inside the footing. The strain gauges, located below the footing interface, were applied to the dowel bars, right below the surface, in the loading direction where tension and compression in these bars are expected. Four displacement transducers were attached to the UHPC step at two perpendicular directions (North, South, East, and West) to monitor the rotation between the UHPC step and the footing. Another four pairs of displacement transducers were instrumented on the south and north side of the column, in the direction of the loading, to record the rotation of the specimens when subjected to cyclic lateral loading. Furthermore, four string potentiometers were located on the south side of the column, at heights of 26.5 in, 38.5 in., 40.5 in., and 68.25 in., measured from the top of the footing, in order to measure the displacement of the column during the load application. Four recording cameras were placed on all four sides of each specimen, simultaneously recording the displacement and damage progression of each specimen. Figure 4-3 and Figure 4-4 show the instrumentation plan for the first and second column, respectively.

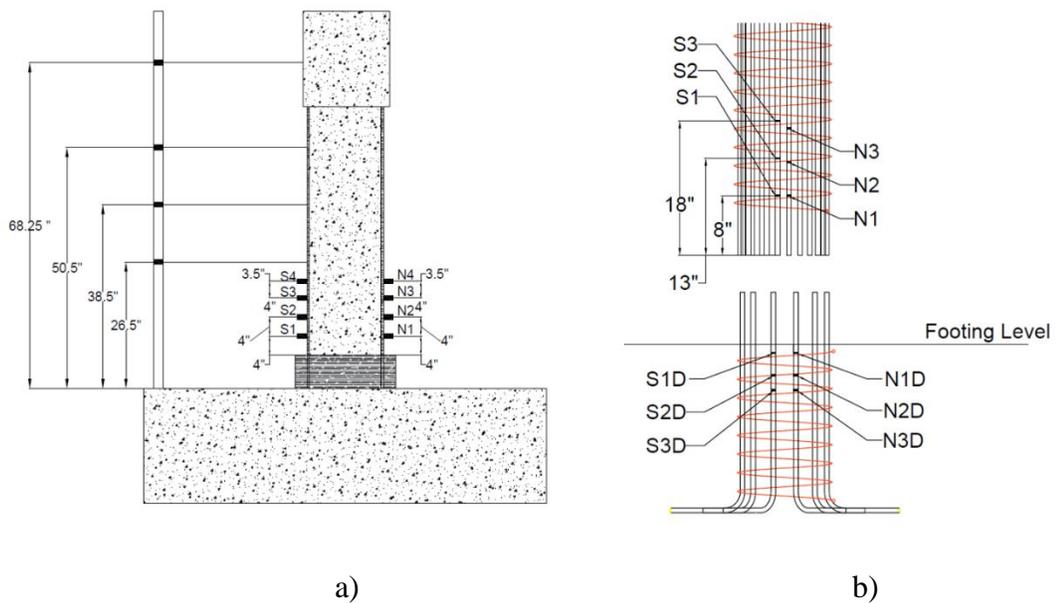
Figure 4-4 Instrumentation plan for the second specimen. a) string potentiometers and displacement transducers for displacement and rotational measurements; b) strain gauges location on column reinforcement and dowel bars.

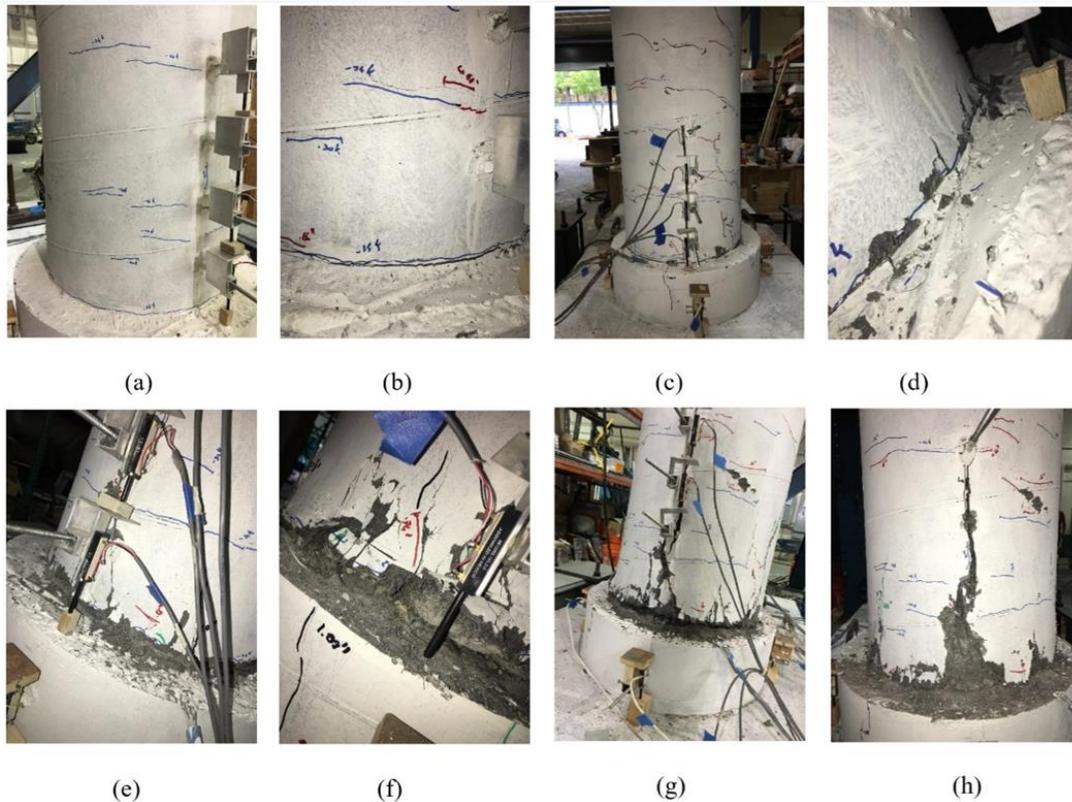
Figure 5-1 Damage progression of the first specimen: a) 0.5% drift ratio; b) 1% drift ratio; c) 1.5% drift ratio; d) 2% drift ratio; e) 3% drift ratio; f) 6% drift ratio; g) 7.5% drift ratio; h) final damage of the specimen after the instrumentation removal.

Based on the low displacement cycles, the yield displacement (Δ_y) was found to be 0.35 in., which corresponds to 0.5% drift ratio, and an applied lateral load of 27 kips (pushing from North to South). When the load was applied in the opposite direction (pulling from South to North) to cause the same yield displacement, the magnitude was found to be 32 kips. For the second and third cycles of Δ_y , a load of 30 kips was reached on both loading directions. Only minor cracks were observed and located on the interface between the UHPC shell and the UHPC step and around the holes made for the displacement transducers, as shown in Figure 5-1a.

The next displacement corresponded to $2\Delta_y$ (0.7 in.) and was applied in both loading directions, causing a drift of 1%. A lateral load of 38 kips was recorded on the positive side (pushing from North to South), however, for the negative side (pulling from South to North), a lateral load of 40 kips was recorded. For the second and third cycles corresponding to the same displacement, loads of 35 kips and 38 kips were reached on the positive and negative sides, respectively. The progression of the cracks was observed around the column during the load application, while being mostly concentrated on the interface between the UHPC step and UHPC shell as shown in Figure 5-1b.

opening of exiting cracks had continued. At this point, the steel fibers were visible at the interface between the UHPC shell and UHPC step where the largest cracks were observed, mostly concentrated on the south side of the column, as shown in Figure 5-1c.

At a drift ratio of 2% (displacement of 1.4 in.), a lateral load of 39 kips was reached for the first two cycles. At the third cycle, the load dropped down to 36 kips when the load was applied from North to South with structural cracks and minor spalling of UHPC shell, as shown in Figure 5-1d.

The next drift ratio applied had a value of 3% (displacement of 2.1 in) with a lateral load of 42 kips for the first cycle. Once the load was fully applied, a loud noise was heard, indicating the cracking of the shell and its separation from the UHPC step. Right after this loud sound, the load dropped down to 37.5 kips when the load was applied from North to South. The same displacement was applied in the opposite direction (pulling from North to South), however, no cracking of UHPC shell was observed. For the second and third cycles, a lateral load of 30 kips was applied to accomplish the same displacement for the positive side (pushing from North to South) while the negative side needed larger load magnitude, corresponding to 40 kips. The spalling of the UHPC was observed, being mostly concentrated at the interface of the UHPC shell and UHPC step, as shown in (Figure 5-1e).

For the following drift ratio of 6% (displacement of 4.2 in.), four cycles were applied where the lateral load for the first cycle reached 30 kips and 34 kips and then dropped down to 26 kips and 30 kips, for positive and negative sides, respectively. The progression of cracking continued but no rupture was observed (Figure 5-1f).

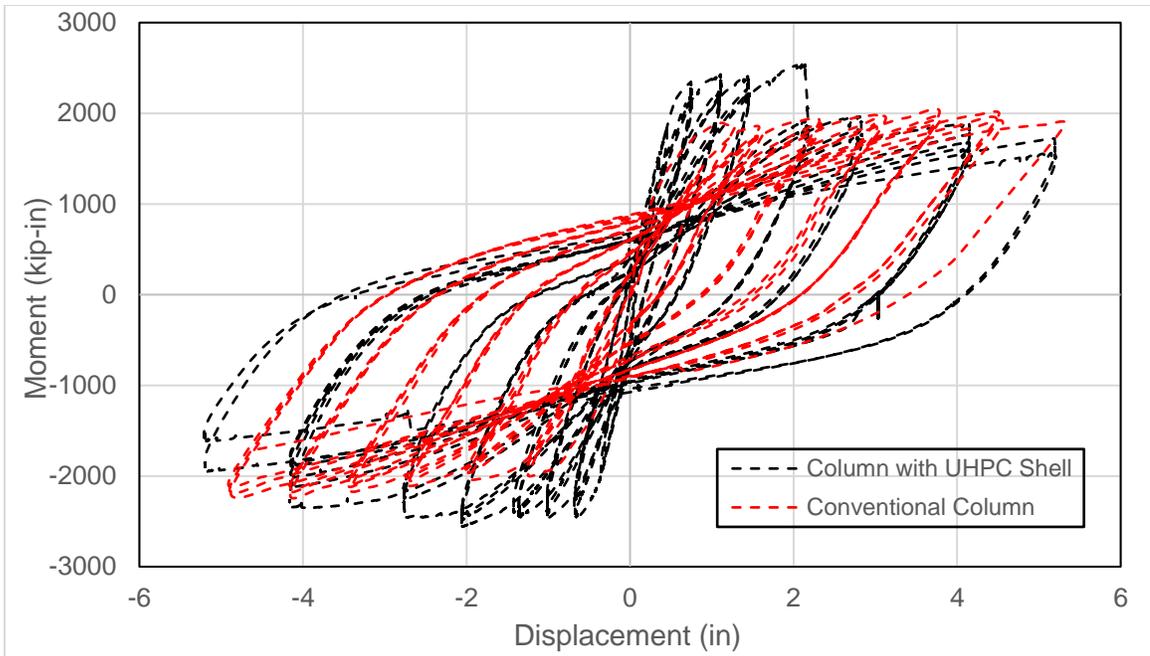
Figure 5-2 Moment-displacement response of the first specimen and the conventional column specimen.

Based on the measurements collected from the first specimen, a moment-displacement hysteresis loops for the cyclic response are plotted in Figure 5-2. The same figure also shows similar results for a conventional column that has the same dimensions with no UHPC implementation [22]. In addition, response envelopes for the first specimen and the conventional column are shown in Figure 5-3. Based on these graphs, it can be noted that the load suddenly dropped at 3% drift ratio (displacement of 2.1 in) on the positive side when a loud cracking sound was heard. This sudden drop indicated the separation of the UHPC shell from the UHPC step when the column was pushed from North to South which is shown in the later cycles for higher drift ratios. From this graph, it can be also observed that the negative side maintained the full capacity throughout the test even after reaching a drift ratio of 7.5%. Even though the shell cracked and the column lost part of its full capacity, the specimen still showed sufficient strength and behaved like a conventional reinforced concrete column with the steel cage located in the normal strength concrete core completely intact.

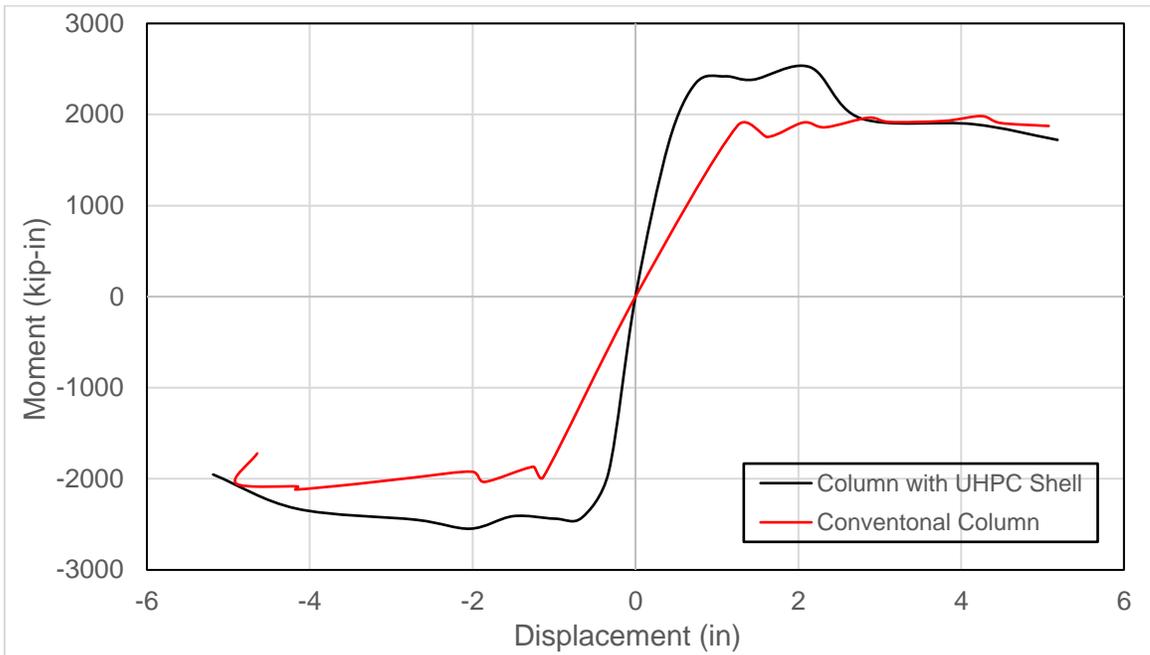
Figure 5-3 Comparison of response envelopes of the first specimen and the conventional column specimen.

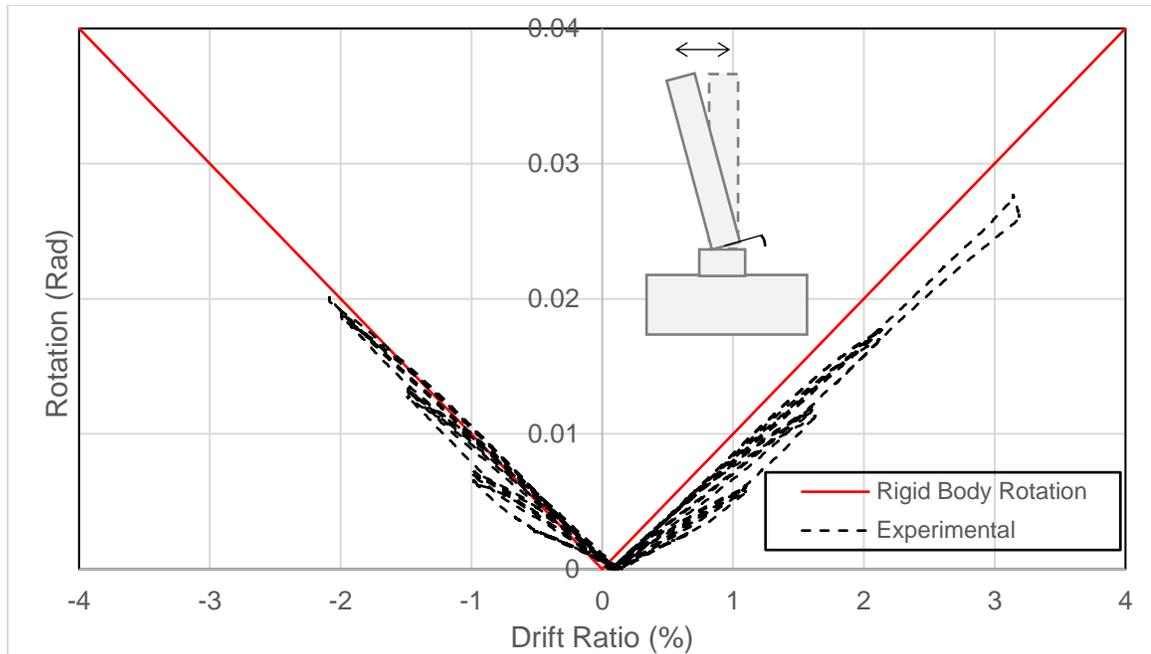
Figure 5-4 Drift-rotation response of the first specimen.

As mentioned in Chapter 4, the UHPC step was instrumented with four displacement transducers at all four directions in order to collect the rotation data between the UHPC step and the footing. Based on rotation results, the rotation between the UHPC step and the footing was negligible and can be considered zero which means that the UHPC step never rotated and the splice length of the longitudinal bars with the dowel bars was sufficient to prevent cracking of the footing. Based on the damage observations, large crack that occurred between the column and the UHPC step indicated that the rotation was concentrated at the interface between the UHPC step and the column. In order to confirm this observation, the rotation at the interface between the column and UHPC step was calculated by subtracting the measured displacement in the two opposite displacement transducers then dividing the result by the direct horizontal distance of 21 in. The drift-rotation response is shown in Figure 5-4. By comparing the rotation at the interface between the column with UHPC shell and the UHPC step to rigid body rotation, it can be concluded that the rotations were mostly concentrated at the interface between the UHPC step and the column. Figure 5-4 only depicts the results up to 2-3% drift ratio due to the damage of the shell at higher drift ratios which affected the functionality of the displacement transducers and made them erroneous.

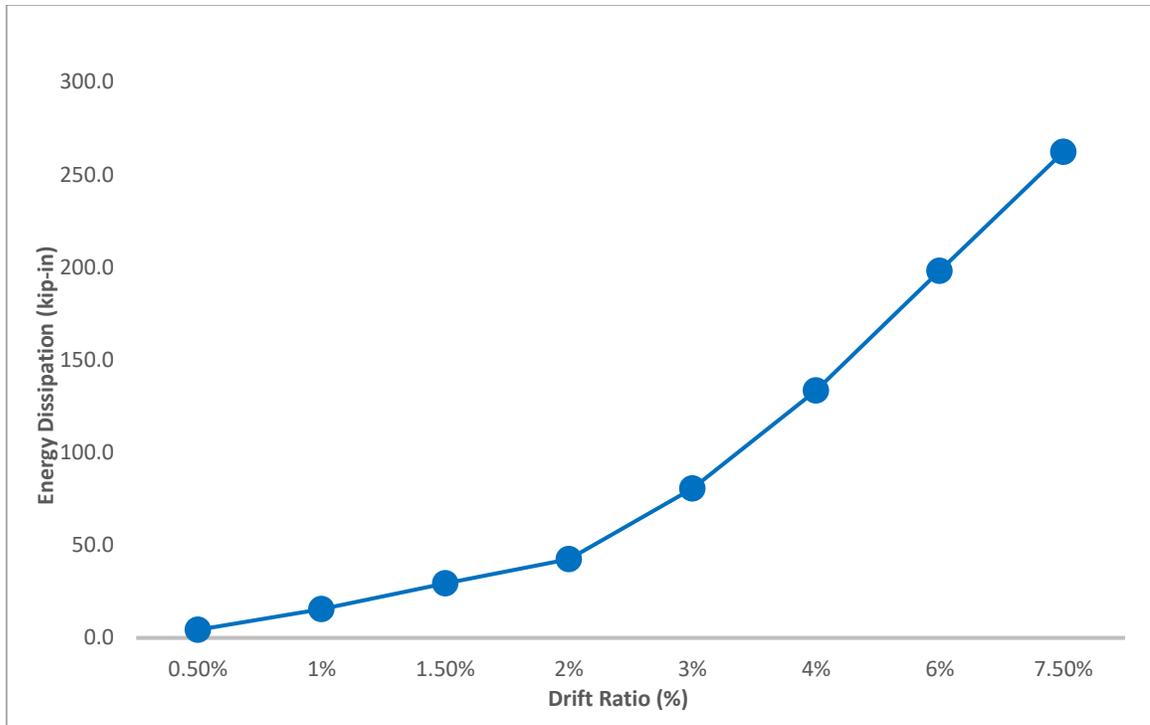
Figure 5-5 Energy dissipation at each drift level of the first specimen.

The energy dissipation graph was developed by calculating the area of each hysteresis loop in force-displacement curve for each cycle at each drift ratio. Since each drift ratio had three cycles, except the 6% drift ratio, the values of all three values were averaged and used to plot the graph which is shown in Figure 5-5. It can be observed that the first specimen had a linear energy dissipation trend until the 2-3% drift ratio when the UHPC shell has cracked. After the cracking of the UHPC shell, the conventional reinforced concrete member dissipated energy due to the inelastic behavior at higher drift ratios. At higher drift ratio, the first specimen acted as conventional column with energy dissipation due to the inelastic deformation of the reinforcing bars. Higher energy dissipation is always desirable during earthquakes events.

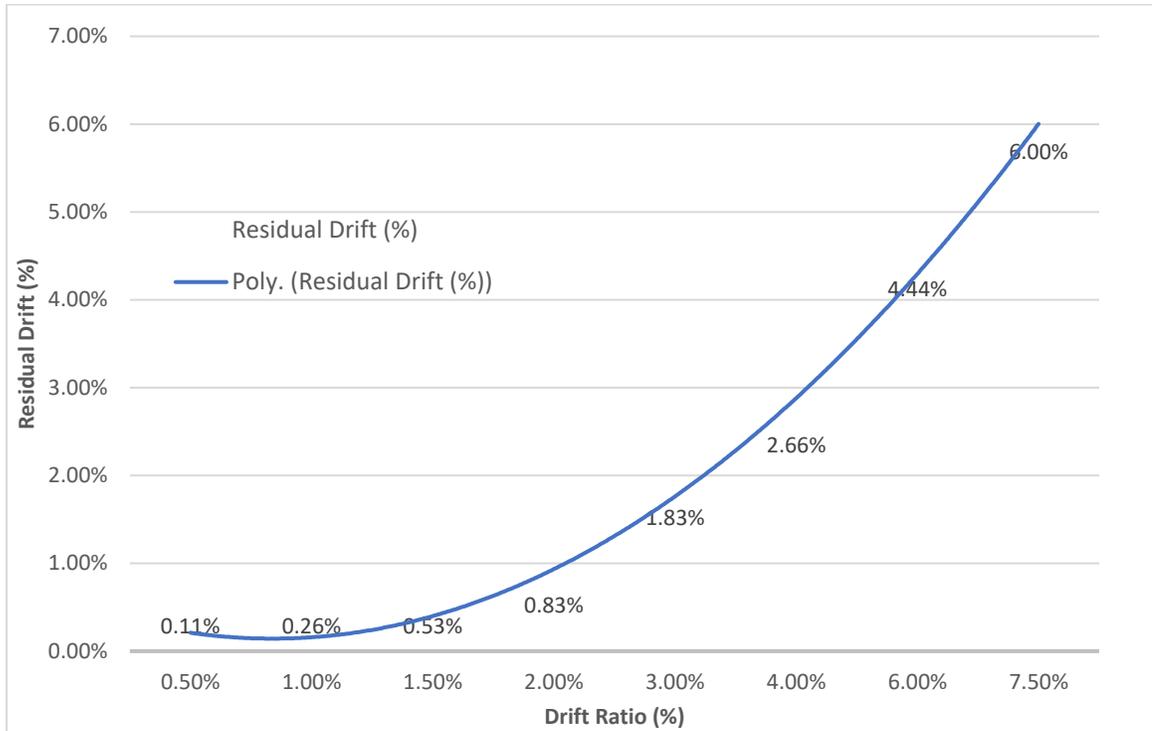
Figure 5-6 Residual drift after each drift ratio application for the first specimen.

In order to fully understand the performance of a structural system and the sustained damage after the application of cyclic loading, residual drifts need to be calculated. Residual drift represents the damage degree of the structure while also reflecting the post-earthquake reparability of the structure. Using the data gathered from the testing of the first specimen, a tradeline was plotted that shows the residual drift after each drift ratio. Since three cycles were applied for each drift ratio, the average value was calculated and used in Figure 5-6. From Figure 5-6, residual drifts were small values up to 1.5% drift ratio and increased at higher drift ration due to the specimen damage. The residual drift increased to 6% at the 7.5% drift ratio after which the testing was completed due to the rebar rupture. Higher residual drifts reflect the damage progression. This first specimen experienced

higher drift ratio due to the mode of failure by cracking the UHPC shell at the interface between the column and the UHPC step.

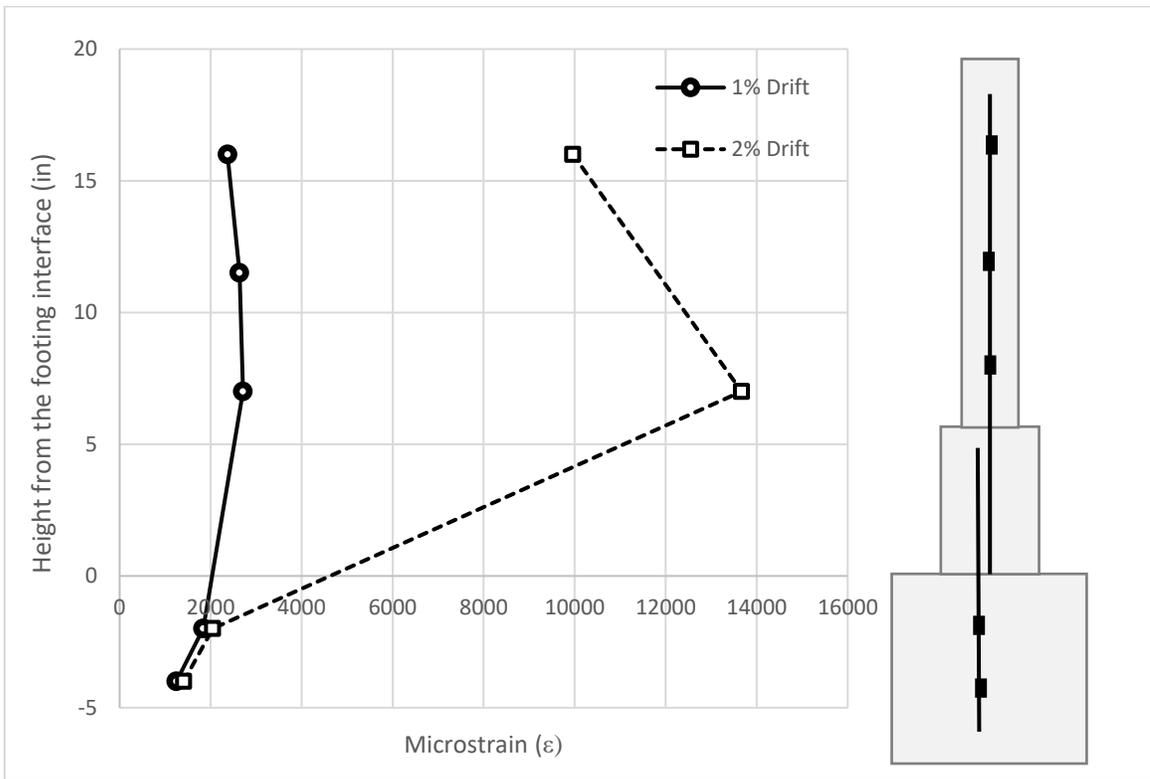
Figure 5-7 Strain distribution on the north longitudinal and dowel bars for first specimen.

For the first specimen, 24 strain gauges were used to measure strains in both longitudinal reinforcement and dowel bars. In order to display the strain progression, a strain distribution plot was developed for the North bar of the first specimen at 1% and 2% drift ratios at different column heights, as shown in Figure 5-7. Two strain gauges, instrumented on the dowel bars at 2 in. and 4 in. below the footing interface, show similar strain values less than yield strain for both drift ratios. These values show that the dowel bars located inside the footing confirm that the footing never cracked which was a requirement for capacity protected elements. Furthermore, another three strain gauges were

located on the longitudinal reinforcement of the steel cage, on the same side, 7 in, 11.5 in. and 16. above the footing interface in order to compare the strain values at 1% and 2% drift ratios. Based on Figure 5-7, the strain gauges located at the height of 7 in. above the footing showed the most visible change of the strain values which proves that the plastic hinge was shifted to be above the UHPC step away from the critical section at the footing-to-column interface. The strain gauge located at 11.5 in. above the footing interface was lost before applying 2% drift ratio, so the results are not applicable.

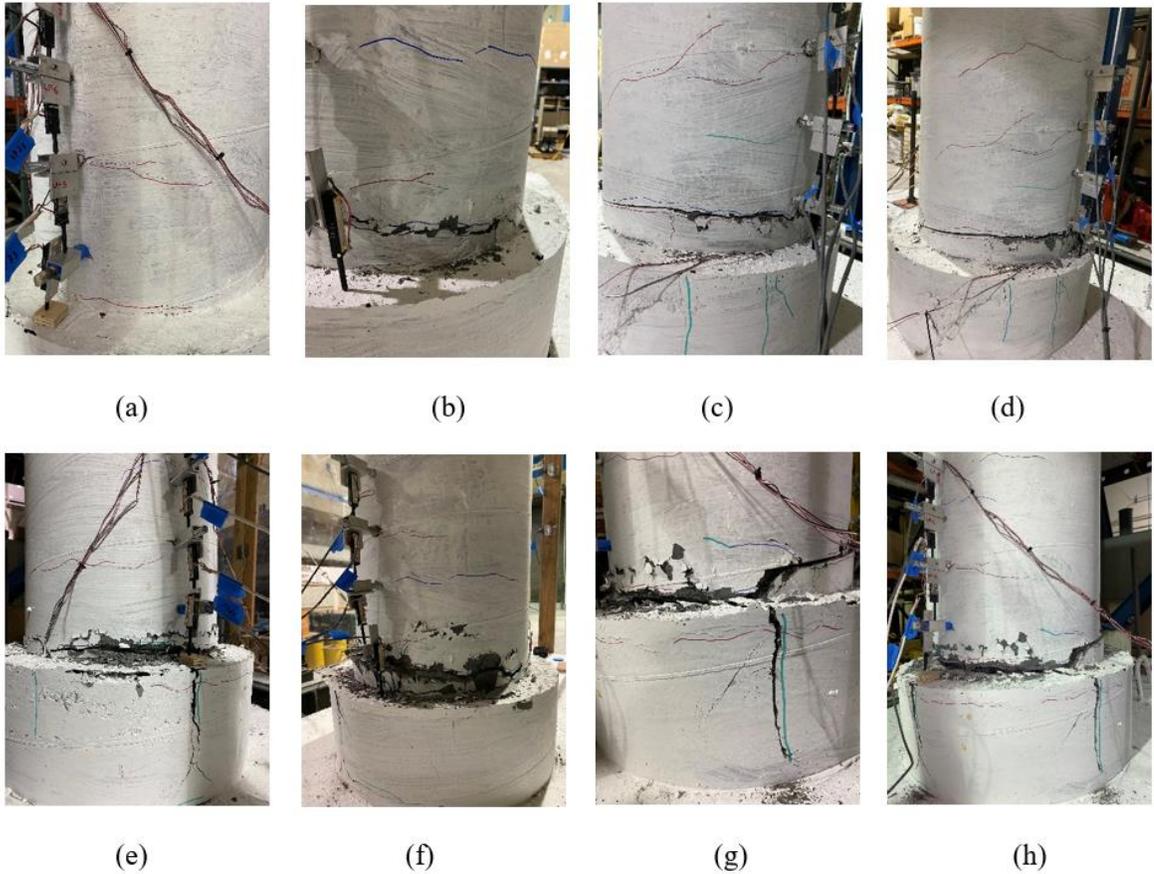
Figure 5-8 Damage progression of the second specimen: a) 0.5% drift ratio; b) 1% drift ratio; c) 1.5% drift ratio; d) 2% drift ratio; e) 3% drift ratio; f) 4% drift ratio; g) 5% drift ratio; h) 6% drift ratio.

The testing of the second specimen started by applying many cycles of lateral load equals 10 kips at both loading directions (pushing from North to South, pulling from South to North) to determine the initial stiffness of the system. After the trial run, the actual testing started by applying a drift ratio of 0.5% which corresponds to a lateral displacement of 0.34 in. When pushing the column from North to South, a lateral load of 29.5 kips was recorded that caused the targeted displacement of 0.34 in. By pulling the column on the opposite side, the lateral load slightly increased to 33 kips. For the second and third cycles, loads of 28 kips and 32 kips were recorded when pushing and pulling the specimen, respectively. Only minor cracks were noticed and were located around the UHPC shell at the interface between the UHPC shell and the UHPC step, as shown in Figure 5-8a.

The next drift ratio corresponding to 1% (displacement of 0.68 in.) was applied in both loading directions where a lateral load of 35.5 kips was recorded on the positive side (pushing from North to South). However, on the negative side (pulling from South to North), the lateral load was slightly higher by 4.5 kips (40 kips). For the second and third cycles corresponding to the same drift ratio, lateral loads of 33 kips and 38.5 kips were recorded on the positive and negative sides, respectively. The progression of the existing cracks and formation of new ones were observed while a major horizontal crack was noticed 1 in. above the interface between the UHPC step and the column, on the north side of the specimen, as shown in Figure 5-8b. This crack was a structural crack due to the

A drift ratio of 3% (displacement of 2.1 in.) was applied. For the first cycle, lateral loads of 34 kips on the positive side (pushing from North to South) and 31 kips on the negative side (pulling from South to North) were recorded. During the second and third cycles, lateral loads dropped to 27 kips and 25 kips for the positive and negative sides respectively. Therefore, lateral capacity dropped by 27% and 40% for the positive and negative sides, respectively. During this drift ratio, once the specimen was pulled from South to North, sliding of the cracked pieces of UHPC shell was observed causing further spalling and degradation of the UHPC shell. Due to the premature shell failure, and probable detachment between the longitudinal reinforcement, normal strength concrete and UHPC in the column, the shear capacity of column section dropped significantly causing the transfer of shear forces to the UHPC step with progression in cracks in the UHPC step, as shown in Figure 5-8e.
