Use of UHPC Stay-In-Place Shells in Bridge Column Construction for Accelerated Bridge Construction

USE OF UHPC STAY-IN-PLACE SHELLS IN BRIDGE COLUMN CONSTRUCTION
FOR ACCELERATED BRIDGE CONSTRUCTION

A thesis submitted in partial fulfillment of the

CIVIL ENGINEERING

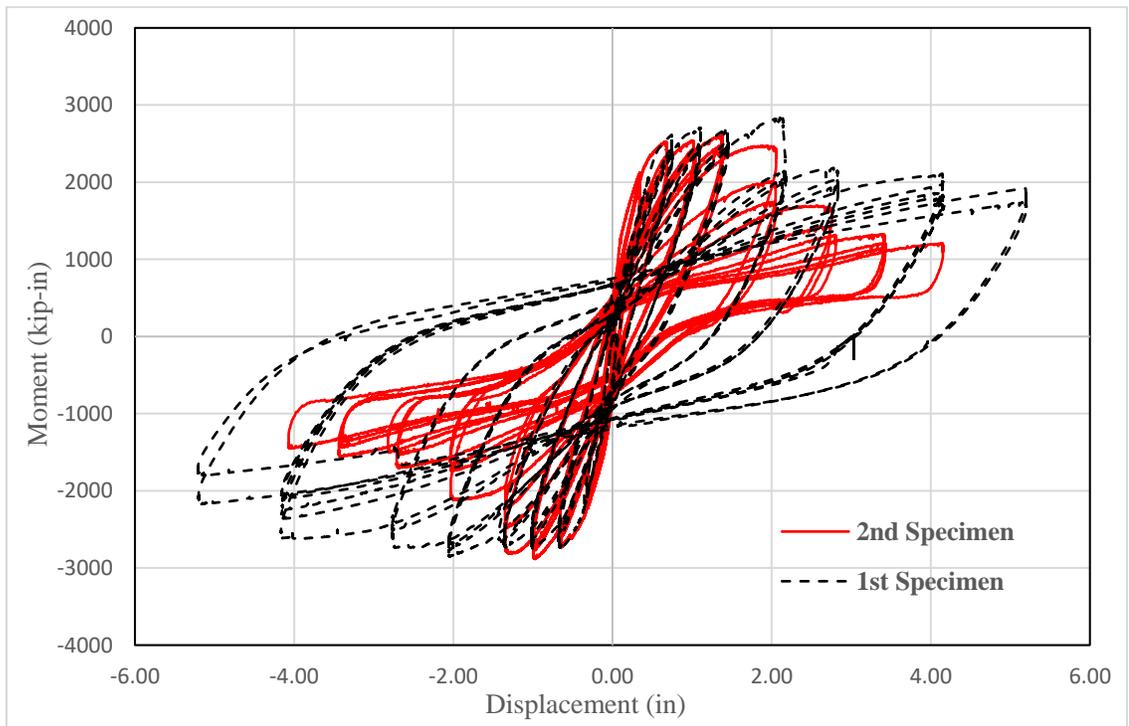
Figure 5-9 Moment-displacement response of the second specimen and the first specimen for comparison.

Using the collected data from the instruments for the second specimen test, moment-displacement hysteresis loops for the cyclic response was developed, as shown in Figure 5-9. For comparison purposes, Figure 5-9 also shows the same results for the first specimen where no longitudinal reinforcing bars were shared between UHPC shell and normal strength concrete core. Based on the figure, it can be observed that the second specimen acted poorly if compared to the first specimen due to the significant loss in lateral load capacity. The behavior of both columns was similar, with the almost matching moment

capacity up to a displacement of 1.4 in. (2% drift ratio). After 2% drift ratio, the moment capacity (lateral load capacity) of the second specimen started to drop, leading to the conclusion that the UHPC shell failed around this drift ratio. Further testing showed that the stiffness of the second specimen significantly dropped leading to the conclusion that the specimen has failed. The same behavior was presented in Figure 5-10, which shows the response envelopes of the first and second specimen. At the last cycle of 6% drift ratio, the moment capacity was half of its full capacity that was reached at the drift ratio at 2%. It can be noticed that the second specimen experienced lower residual drift due to the loss in lateral load capacity. Lower residual drifts are desirable except when restoring forces (re-centering forces, for example) are not presented in the system. In this case, the lower residual drifts reflect the significant loss in lateral load capacity.

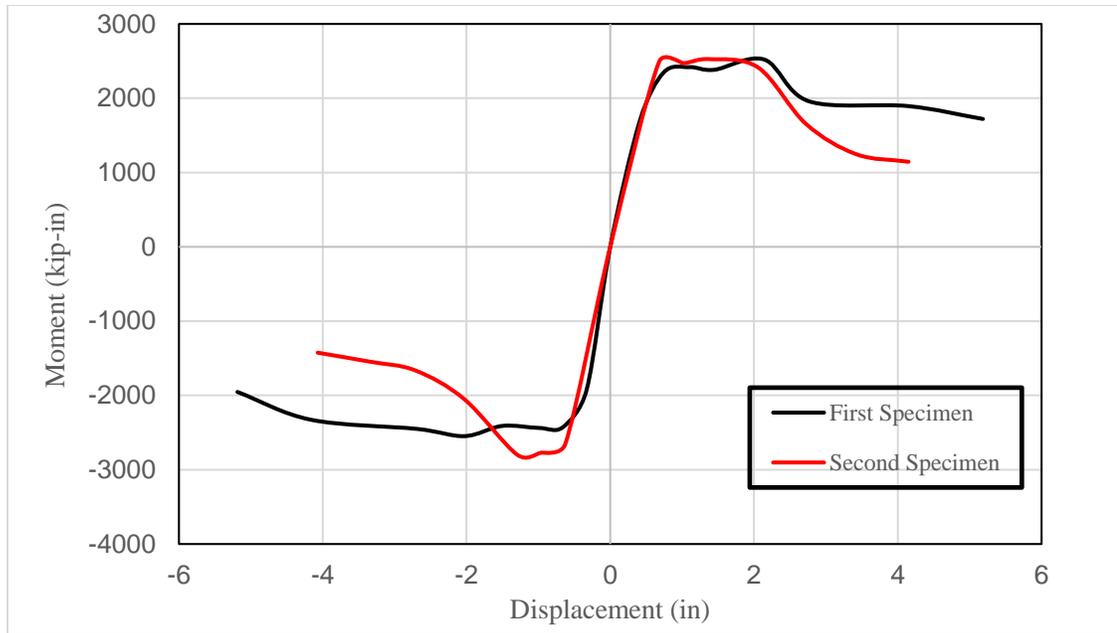
Figure 5-10 Comparison of response envelopes for both specimens.

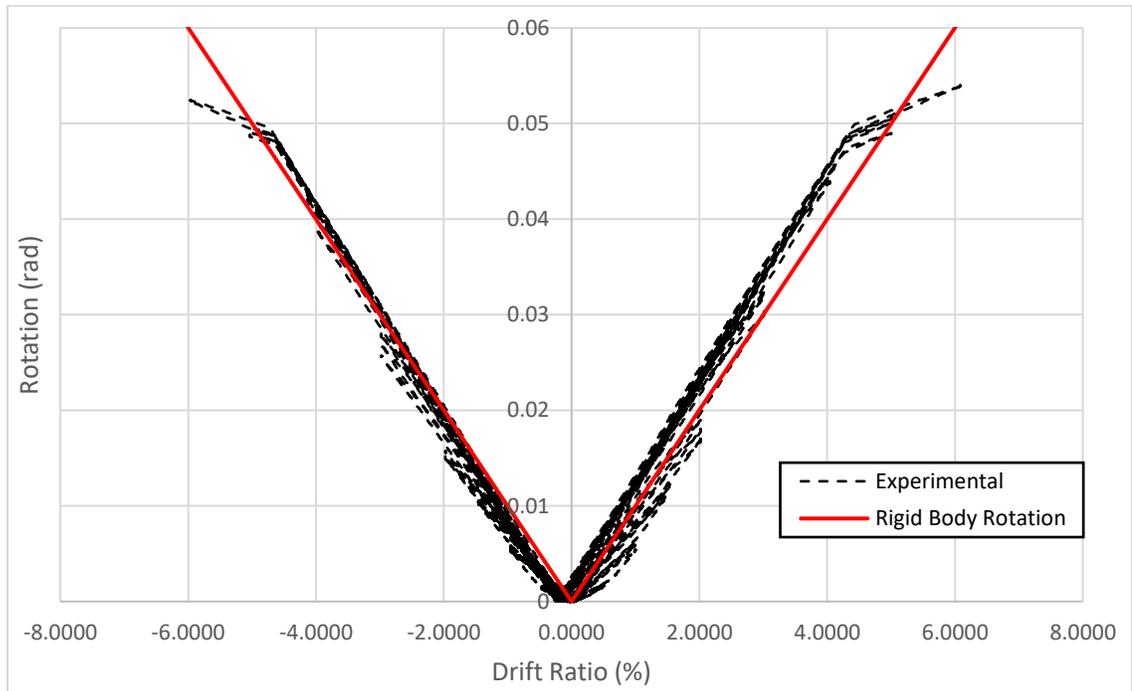
Figure 5-11 Drift-rotation response for the second specimen.

For the second specimen, no rotation was noticed between the UHPC step and the footing and has been taken as zero, same as the first specimen. Eight displacement transducers, four on the North and four on the South side, were placed to record the rotation of the column section since the major crack was expected to occur around the interface between the UHPC step and the column similar to the first specimen. Figure 5-11 shows the drift vs. rotation response of the second specimen. The drift-rotation response was plotted in a similar manner as Figure 5-4. It can be noticed that the positive side (pushing from North to South) has a higher slope which can be explained by the appearance of the major crack 1 in. above the UHPC step on the north side. This indicates that the larger rotations were recorded on the north side. Since the tipping point on the North side is 1 inch higher than the tipping point on the south side, the peak of the plot shown in Figure

5-11 on both North and South sides becomes significantly less steep between the 5% and 6% drift ratio. This behavior means that the damaged part has slid once the lateral load was applied causing higher drift ratio but no additional rotation. This sliding also can explain why the drift-rotation slopes exceeded the theoretical rigid body rotation in this plot.

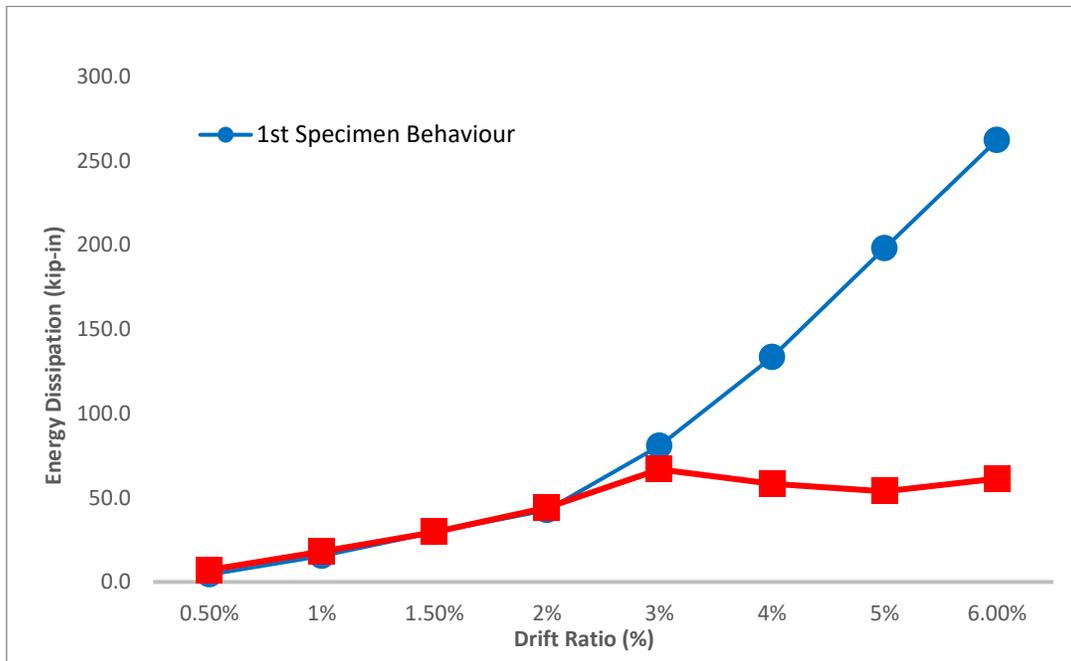
Figure 5-12 Energy dissipation comparison of both specimens.

After the testing of the second specimen, Figure 5-12 was developed to show energy dissipation trends for both the first and second specimens for comparison purposes. Up to 2% drift ratio, the second specimen behaved identically to the first specimen. However, after the UHPC shell cracked and spalled, the energy dissipation does not follow the trend path as the first specimen due to the difference in premature failure. The energy dissipation values remained almost constant up to 6% drift ratio when the testing was terminated due

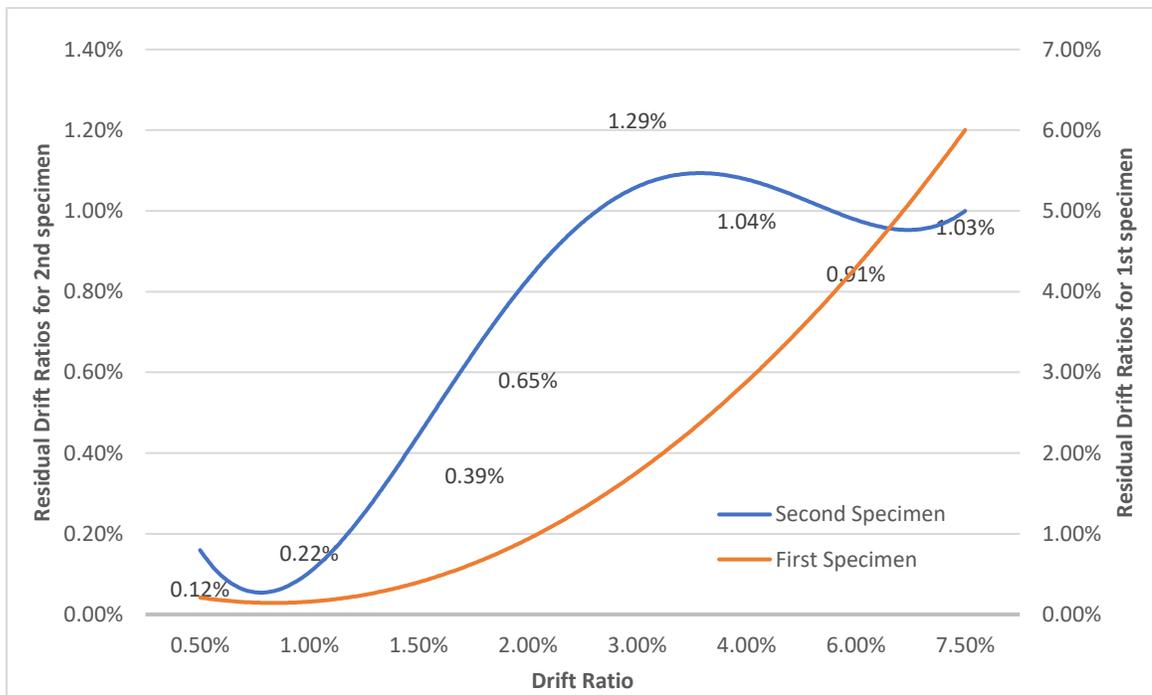
Figure 5-13 Residual drift ratio for the second specimen and the comparison to the first specimen.

Figure 5-13 shows the residual drift ratio corresponding to each drift level in the same manner for the first specimen. However, the results were different due to the different design and reinforcement placement in the UHPC shell column, showing lower lateral load

capacity right after the UHPC shell has cracked and spalled. As it can be noticed from Figure 5-13, the trend is significantly different from the first specimen. The residual drift values are similar to the first specimen up to 2%, when the UHPC shell of the second specimen has cracked and started to spall. Lower residual drifts are desirable except when restoring forces (re-centering forces, for example) are not presented in the system. In this case, the lower residual drifts reflect the significant loss in lateral load capacity.

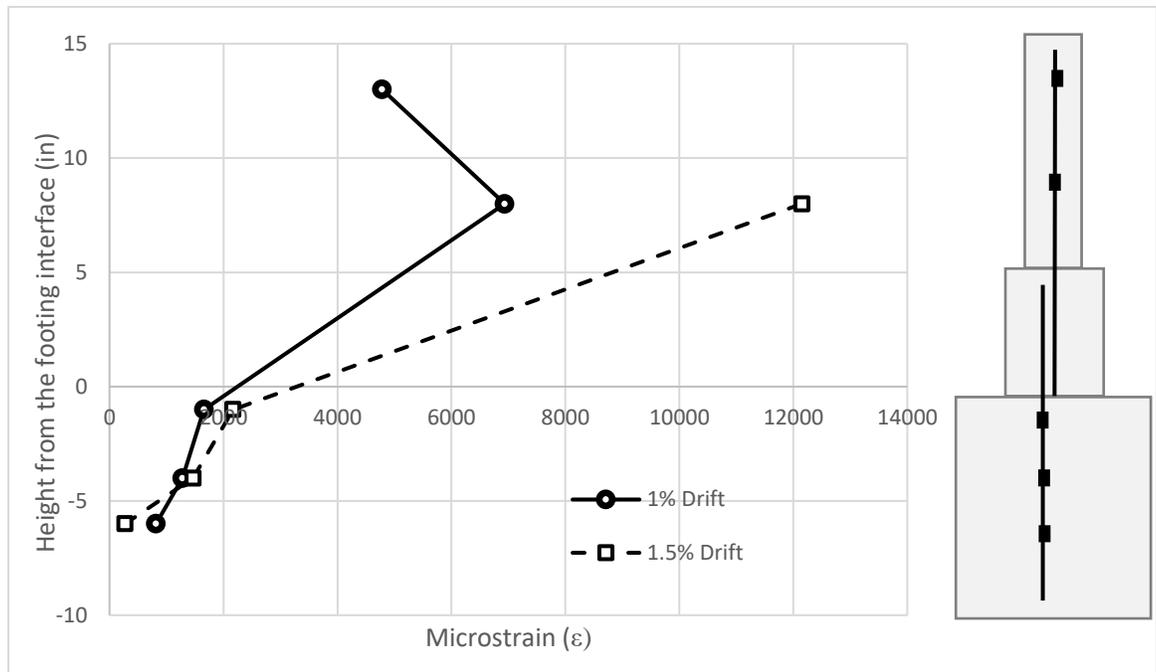
Figure 5-14 Strain distribution on the south longitudinal and dowel bar for the second specimen.

different column heights, as shown in Figure 5-14. The three strain gauges located on the South dowel bar at 1 in., 4 in. and 6 in. below the footing interface recorded similar strains below the yield strain. The strains in the South dowel bar increased slightly from 1% to 2% drift ratio indicating that the design was appropriate in preventing the cracking of the footing which is a capacity protected element. Furthermore, another three strain gauges were attached to the South longitudinal reinforcing bar at 8 in., 13 in., and 18 in. above the footing interface. Based on the plot shown in Figure 5-14, the strain gauges located at the height of 8 in. showed the most noticeable change in their strain values. However, it is typically very tough to monitor and receive correct strain gauge values at higher displacement due to their damage or wire damages which can be observed for the strain gauge located at 18 in. above the interface.
