Microbiologically Influenced Corrosion of Submerged Steel Bridge Piles in Natural Waters in Presence of Marine-Fouling

MICROBIOLOGICALLY INFLUENCED CORROSION OF SUBMERGED STEEL BRIDGE
PILES IN NATURAL WATERS IN PRESENCE OF MARINE-FOULING

DOCTOR OF PHILOSOPHY

CIVIL ENGINEERING

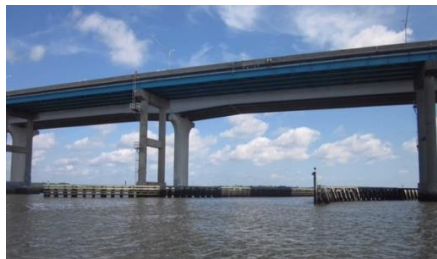
Figure 1.1. Picture of a Florida bridge over Matanzas R. with corrosion of steel piles.

Recent findings at a Florida bridge (Figure 1.1) showed that submerged steel piles had severe corrosion. Localized corrosion cells/pits were of up to 3" in diameter and penetrated through the steel thickness (Figure 1.2). Sampling and testing of water associated with the anomalous corrosion observations indicated strong presence of microbial growth that can be associated with microbiologically influenced corrosion (MIC). In particular, anaerobic sulfate reducing bacteria (SRB), acid producing bacteria (APB), and slime producing bacteria (SPB) were recovered in cultures produced from the steel and water samples. The water samples also showed high sulfate and chloride levels. In addition to the microorganisms that can cause corrosion, the affected site also had heavy marine growth (Figure 1.3). Although the role of the macrofoulers on the corrosion of the steel piles was not clear, the macrofoulers may have been associated with the corrosion development. It was thought that the effect of localized crevice environments created by the presence of the macrofoulers may support MIC.

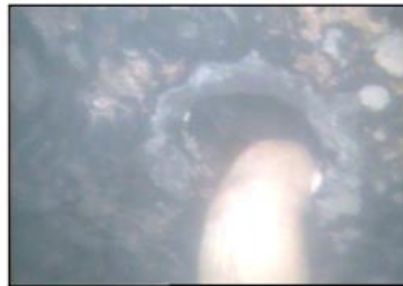
Figure 4.1. Underwater image of a hole on a steel pile due to corrosion. Photo courtesy of FDOT.

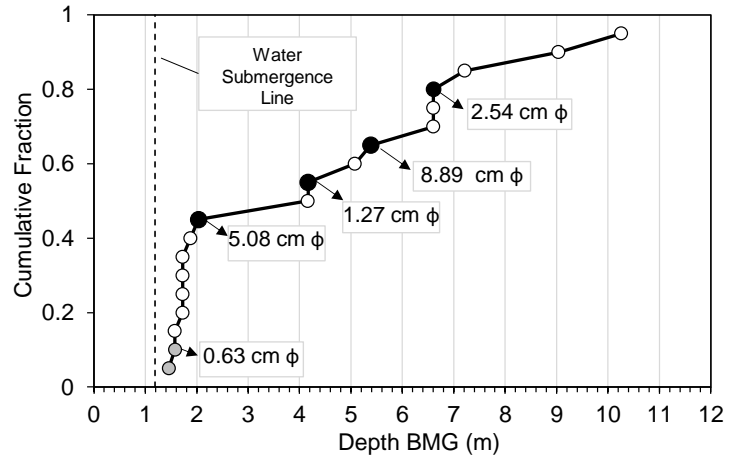
Figure 4.2. Cumulative fraction of the steel H-Pile Corrosion.

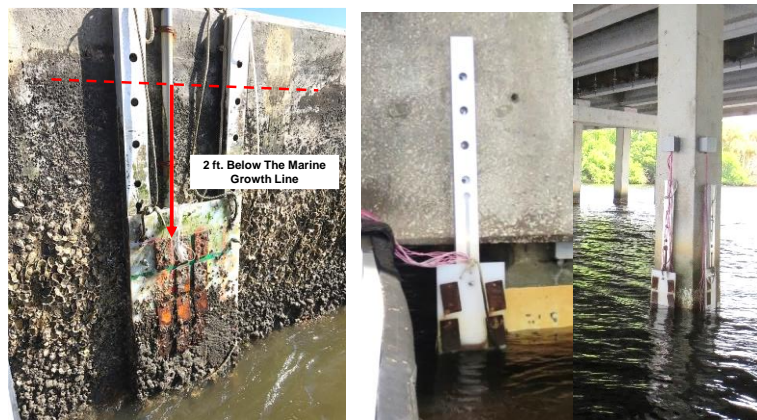
Figure 5.3. Typical Outdoor Exposure Test Rack at Three Site

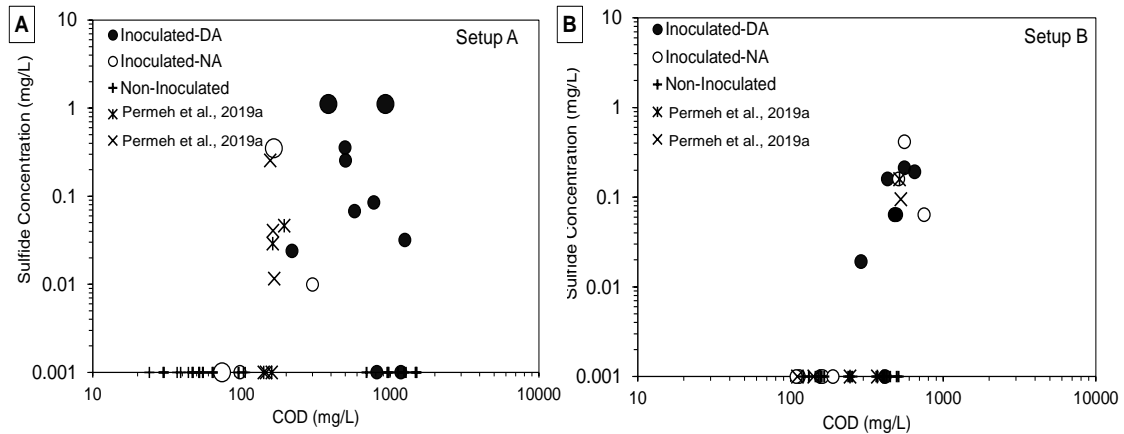
Figure 5.6. Assessment of SRB activity by sulfide concentration and COD. (A) Test Setup A. (B) Test Setup B. Data from (Permeable et al., 2019a), × -Naturally-Aerated × -De-Aerated. 0.001 mg was arbitrarily selected for the tests where no sulfide was measured.

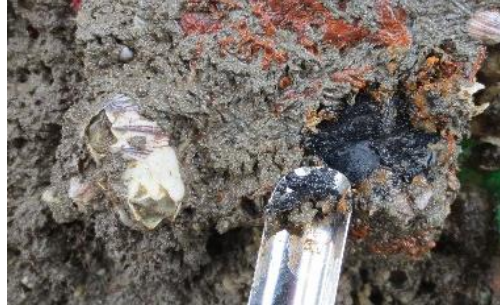
Figure. 5.16. Example of Under Fouling Surface Condition.

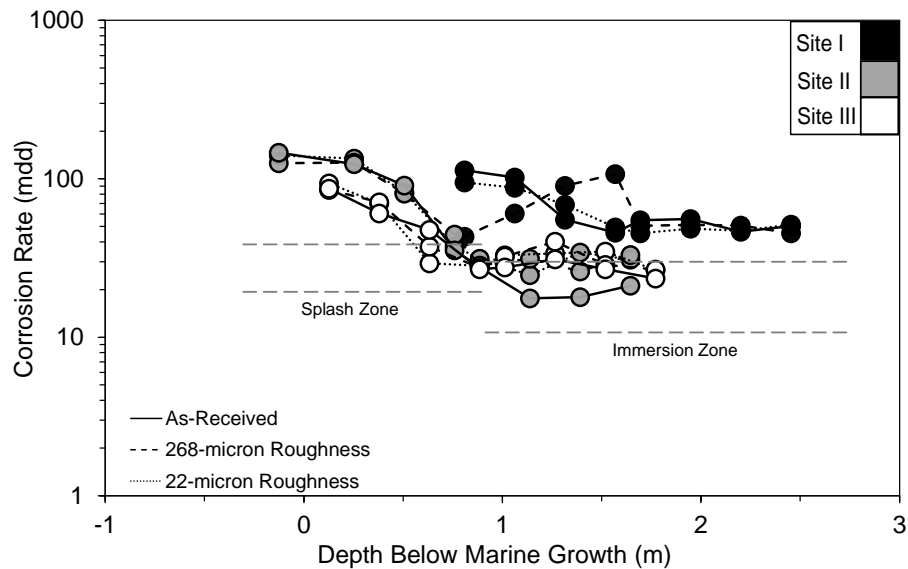
Figure 5.18. Calculated nominal corrosion rates of steel exposed in the field testing. Horizontal lines represent average corrosion rates at intertidal and immersion zones reported by Tomilson, 2014.

Results of the nominal corrosion rates calculated by Eq 5.1 are shown in Figure 5.18.

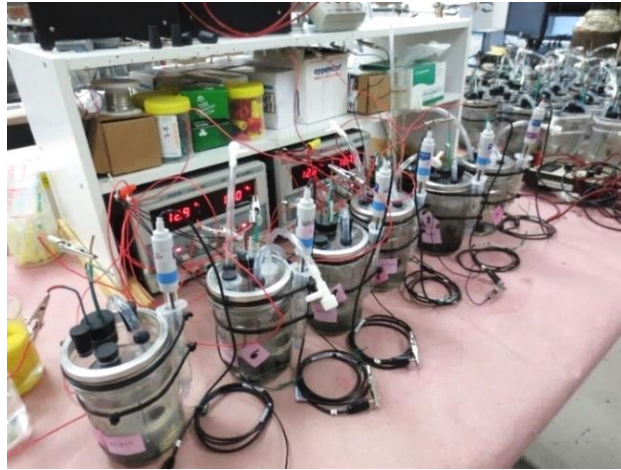
Figure 6.1. Test Setup B test cells under cathodic polarization

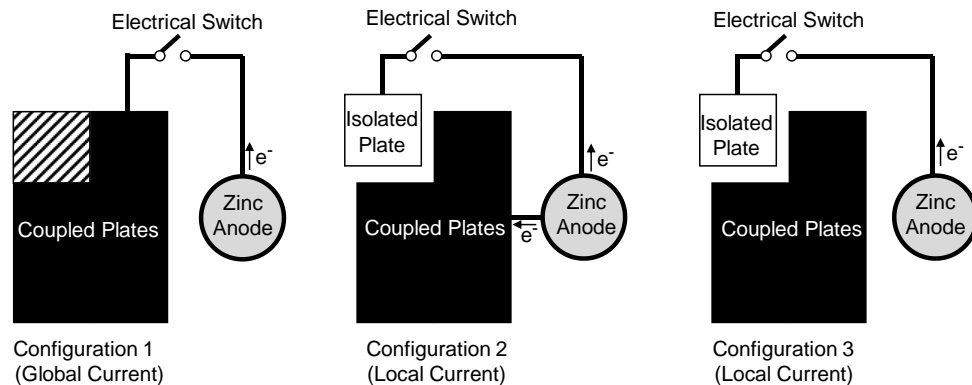
Figure 6.3. CP current test configurations for coupled steel and zinc anodes.

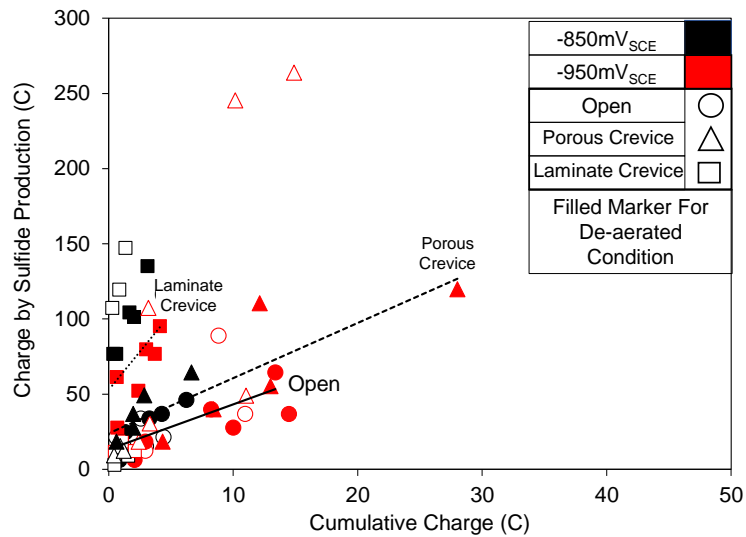
Figure 6.10. Cumulative charge associated with sulfide production and net cathodic reaction rates (lines correspond to the fitted curve).

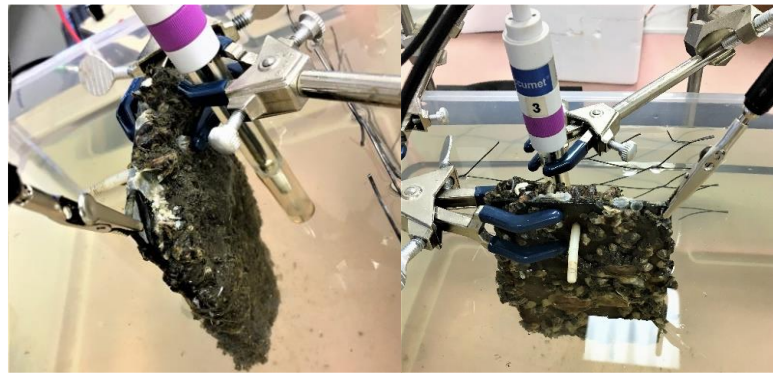
Figure 7.4. Example of Laboratory Electrochemical Test Setup.

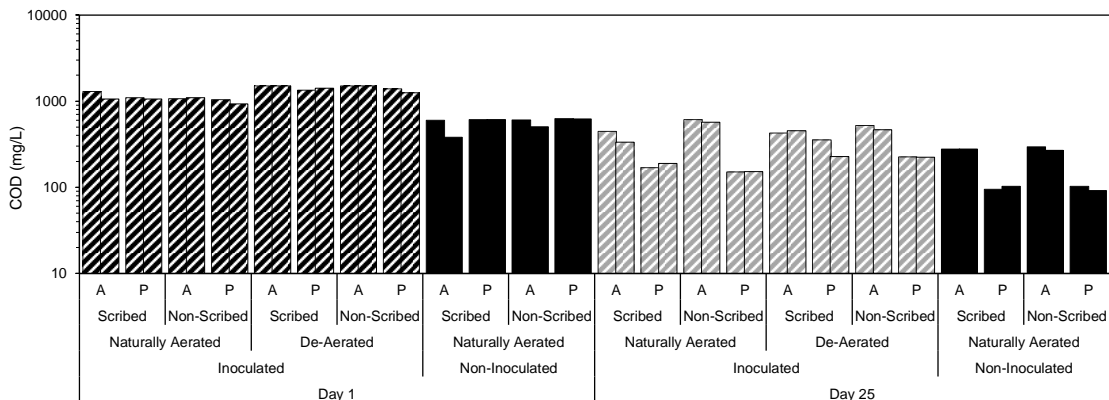
Figure 7.5. Chemical oxygen demand for laboratory coated specimens.
A: Antifouling, P: Polyurea
