Damage assessment of various structures by hurricane Andrew using aerial photographs

Sondwip Dhar

Florida International University

A thesis submitted in partial fulfillment of the

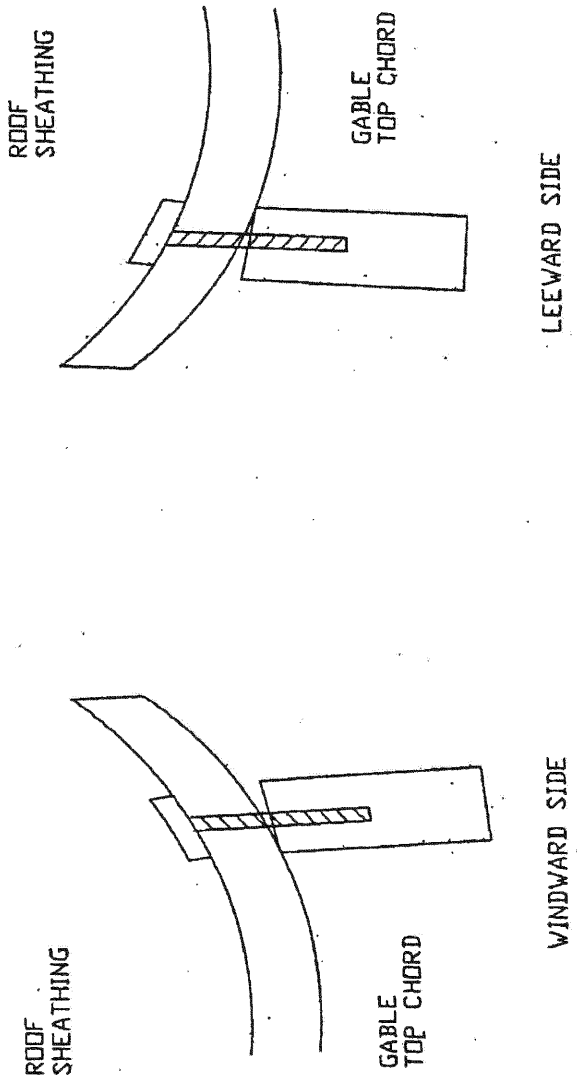
Figure 1.3 Wind Effect on Sheathing.

The SFBC (South Florida Building Code) requires nail spacing of between 6 inches on center and 12 inches on center, depending on the location of the sheathing panel. However, in sheathing that was blown off, nails were spaced much farther apart, and fastening patterns were often erratic, ranging from 10 inches to 48 inches on center. Further, it was common to find that staples and nails had been positioned to miss the underlying framing member completely. Figure 1.2 shows typical section of a gable-end and the effect of wind on the gable-end is shown in Figure 1.3. This is the pictorial representation of how the sheathing gets blown away due to strong wind force.

Exaggerated view of deflection of sheathing and gable-end top chord when wind blown into the gable-end. The fastener (nail) is being loaded in withdrawal and lateral.

When sheathing failure did occur, a common reason was inadequate or improper fastening (Cunningham and Keith 1994). When staples were used, cases were observed in which one leg of the staple missed the underlying truss or rafter. This reduced the strength of the connection by at least 50%. Some staples showed evidence that the staple was driven through the sheathing with excessive force, leaving only a partial thickness of the sheathing to resist the wind.

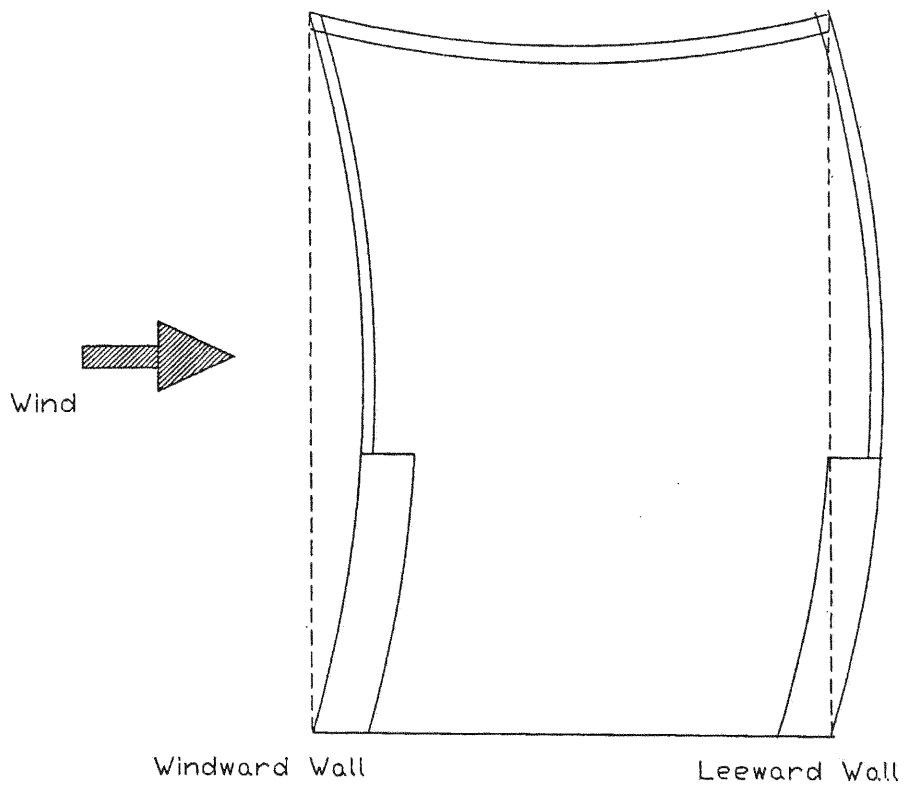
Figure 1.6 View of the windward and leeward wall.

Exaggerated view of gable-end walls and roof sheathing reacting to wind.

constructed system to be less prone to failure. Failures mechanism of a wall are as follows: poor mortar joints between walls and slab; lack of tie beams, horizontal reinforcing, tie columns, and tie anchors; and misplaced or missing hurricane straps between walls and roof were observed as shown in Figure 1.6. In some cases of failure where block walls collapsed completely because of inadequate anchorage to resist uplift and lateral forces as shown in Figure 1.4 and 1.5. In these cases, the deficiencies (and code violations) were common and included lack of tie downs, tie downs in unfilled cells, missing hooks from tie downs to the tie beams and foundation, and lack of corner bars. Wood frame walls suffered few component failures, except damage from missile impact. When failures did occur, connectors were usually the cause.

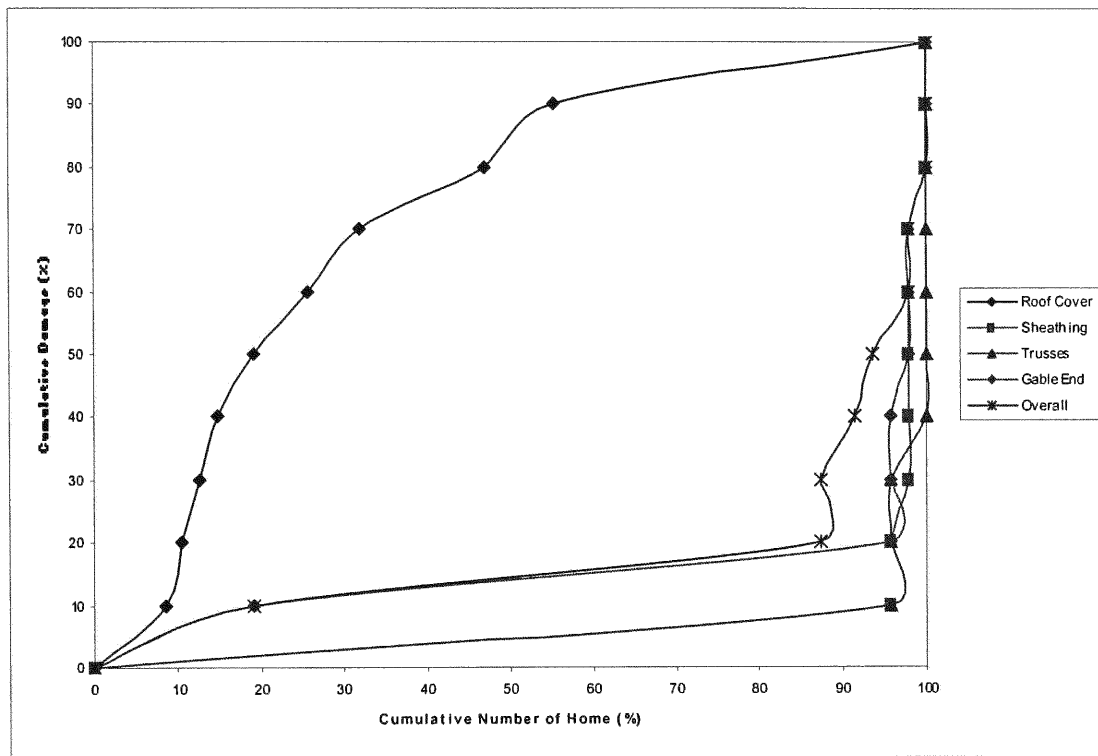
Figure 4.2 Roof Cover, Sheathing, Trusses, Gable-End and Overall Damage for SFH and Wind Speed = 135mph.

The above graph represents various structural damages for SFH type of structures for the wind speed of 135 mph. It represents that roof cover for 50% of the houses had more than 85% damage. In case of the overall 90% of the houses had more than 30% overall damage. The damage levels for gable-end, trusses and sheathing was more or less similar. The cumulative data for MFH community damage assessment is shown in Table 1 (Appendix A).

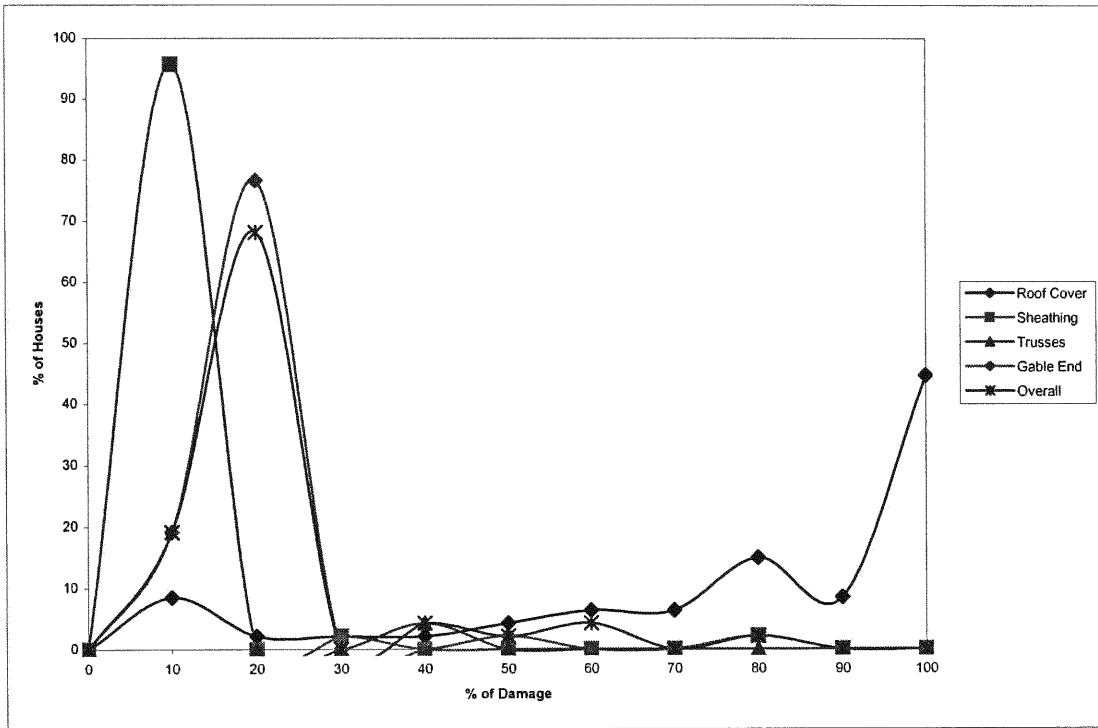
Figure 4.3 Probability Distribution Curve for SFH and Wind Speed = 135mph.

The probability distribution curve shows that for SFH structures trusses and sheathing had a maximum damage of 10% for more than 90% of the houses, following gable-end damage, which has more than 75% of the houses had 20% damage. In case of overall the peak damage is 20% for more than 65% of the houses. The probability data for SFH community damage assessment is shown in Table 1 (Appendix A).

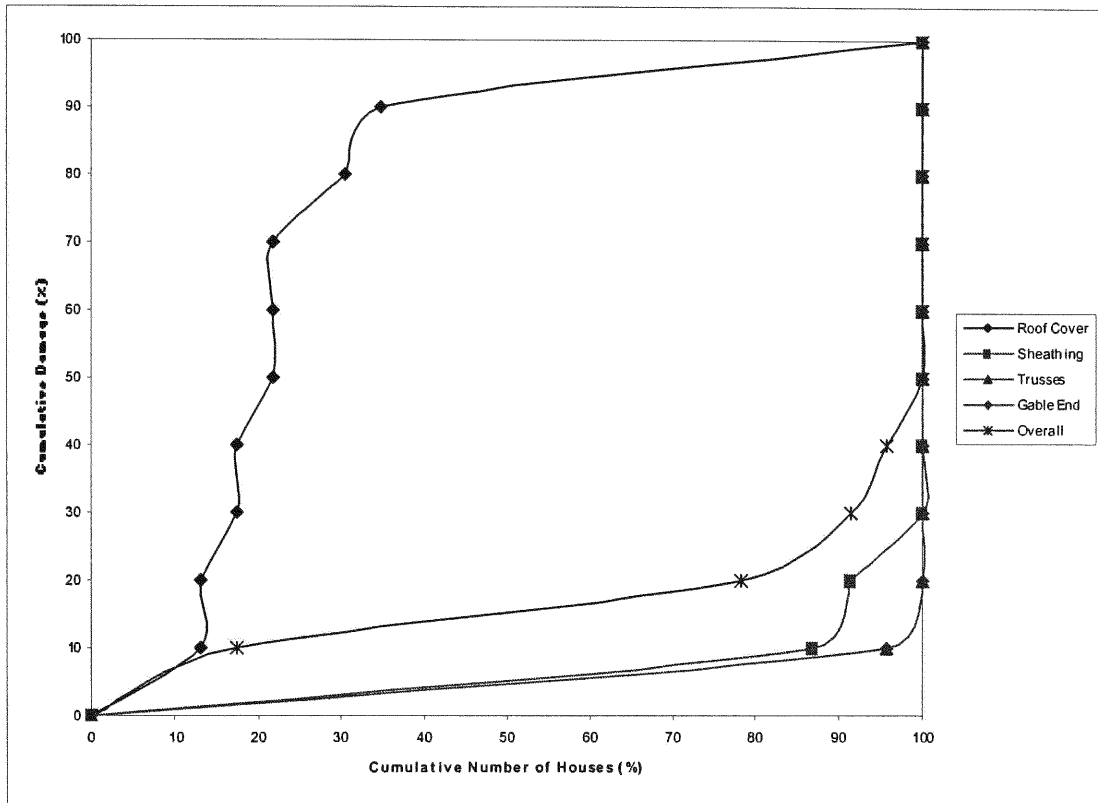
Figure 4.4 Roof Cover, Sheathing, Trusses, Gable-End and Overall Damage for MFH and Wind Speed = 135mph.

The above graph represents various structural damages for MFH structures for the wind speed of 135mph. It represents that roof cover for 50% of the houses had more than 90% damage. In this MFH community it has different damaged levels. The cumulative data for MFH community damage assessment is shown in Table 2 (Appendix A).

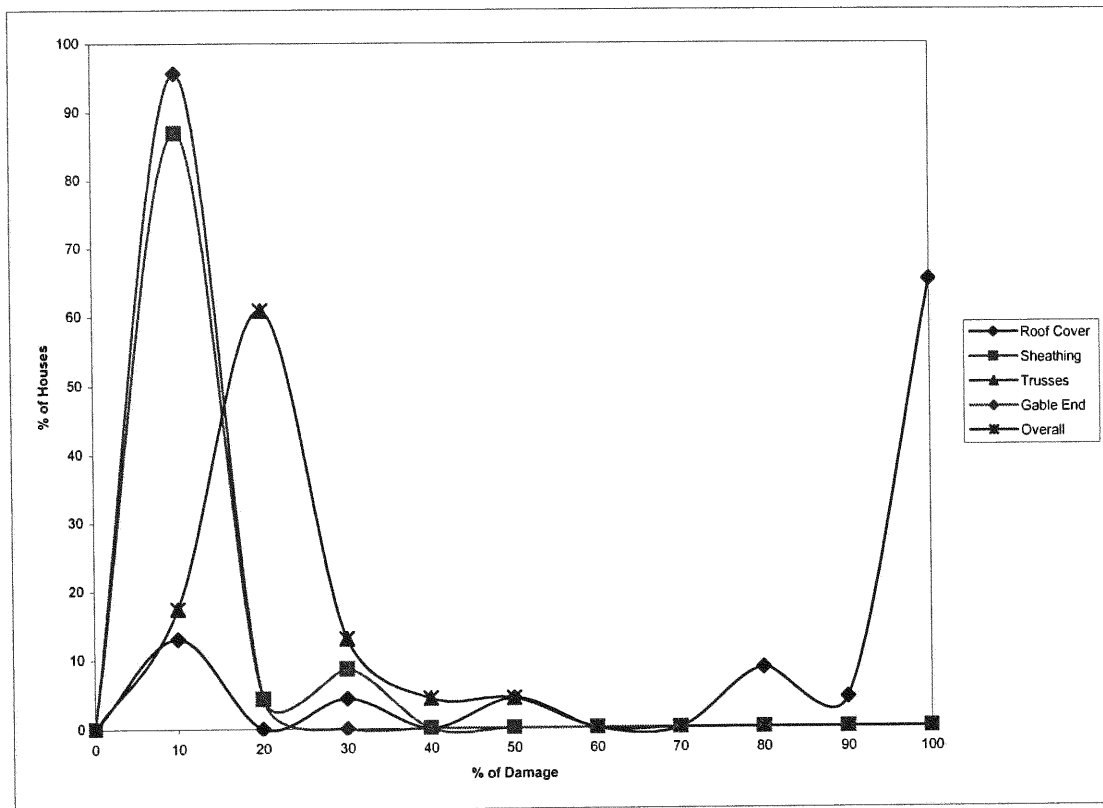
Figure 4.5 Probability Distribution Curve for MFH and Wind Speed = 135mph.

The figure represents that more than 90% of the houses have 10% gable end damage followed by 80% of the house have sheathing damage. The overall damage of MFH community is 20% for 60% of the houses. In case of roof cover it is observed that 100% damage has been cause to more than 65% of the houses. The probability data for MFH community damage assessment is shown in Table 2 (Appendix A).

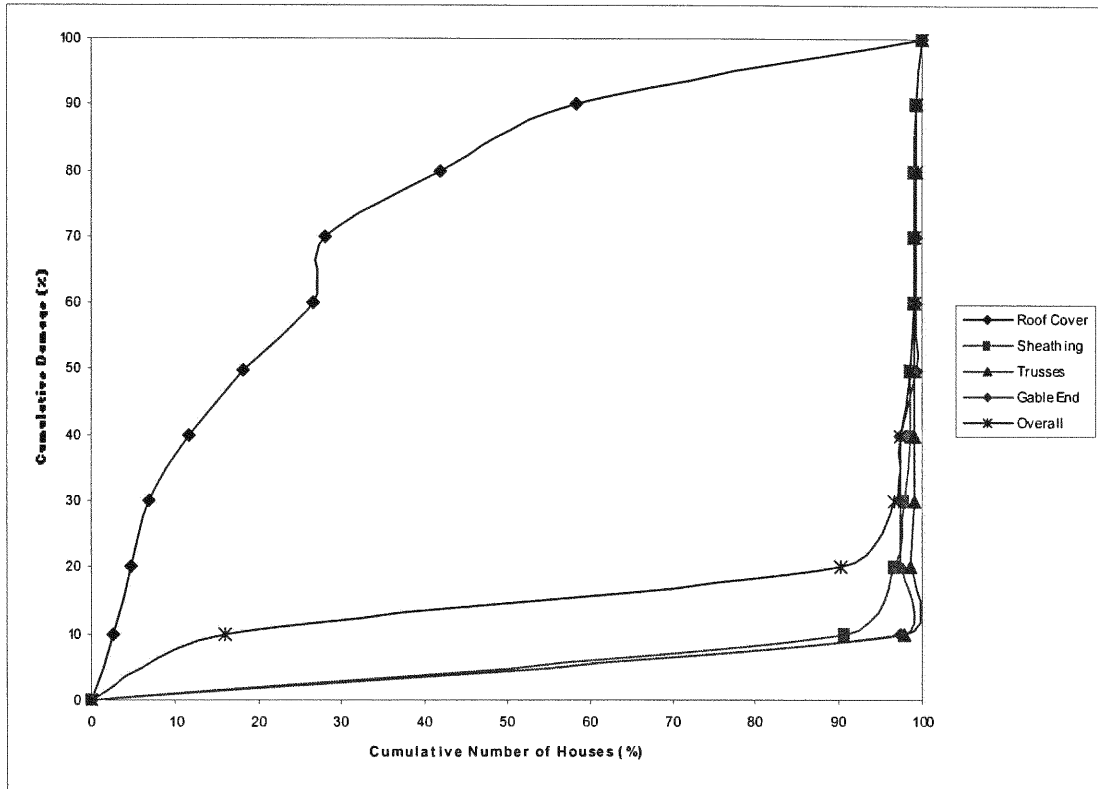
Figure 4.6 Roof Cover, Sheathing, Trusses, Gable-End and Overall Damage for SFH and Wind Speed = 138mph.

The above graph points out maximum roof cover damage for 50% of the houses, which has more than 80% of damage. These SFH structures tolerated a wind speed of 138mph. Other structural damages at this wind speed had similar curves and for 50% of the number of houses the overall damage was more than 10%. The cumulative data for SFH community damage assessment is shown in Table 3 (Appendix A).

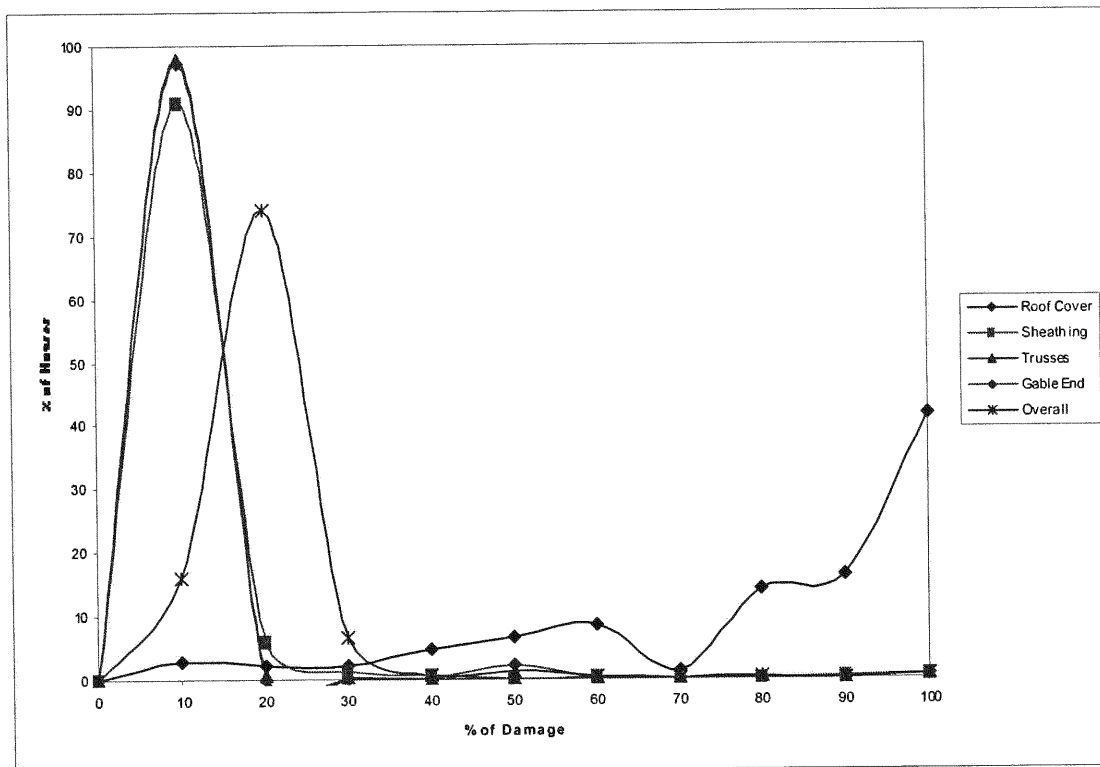
Figure 4.7 Probability Distribution Curve for SFH and Wind Speed = 138mph.

The figure represents that more than 95% of the houses had high probability damage at 10% for truss and gable-end. The overall damage of more than 70% of the houses had peak percentage damage at 20% for SFH type of structures. The probability data for SFH community damage assessment is shown in Table 3 (Appendix A).

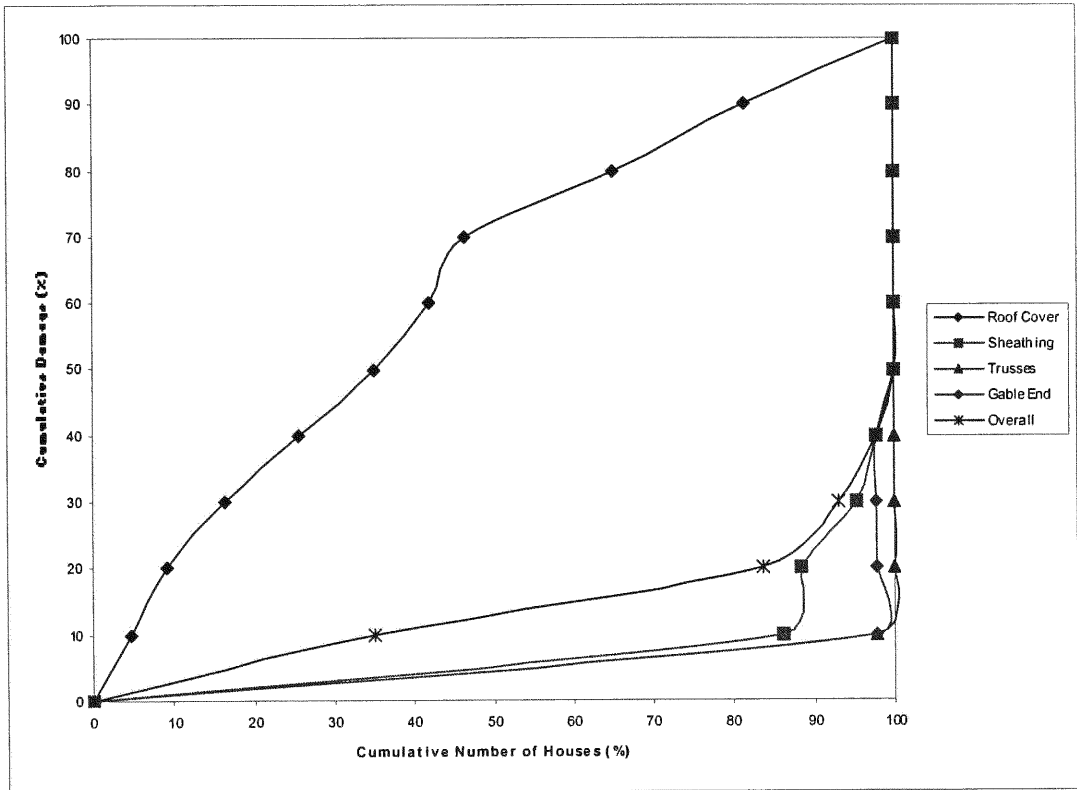
Figure 4.8 Roof Cover, Sheathing, Trusses, Gable-End and Overall Damage for MFH and Wind Speed = 138mph.

The figure shows maximum damage has been occurred in case of roof cover for MFH type of structures at a given wind speed of 138 mph. The graph shows that 50% of the houses had more than 70% of roof cover damage. The cumulative data for MFH community damage assessment is shown in Table 4 (Appendix A).

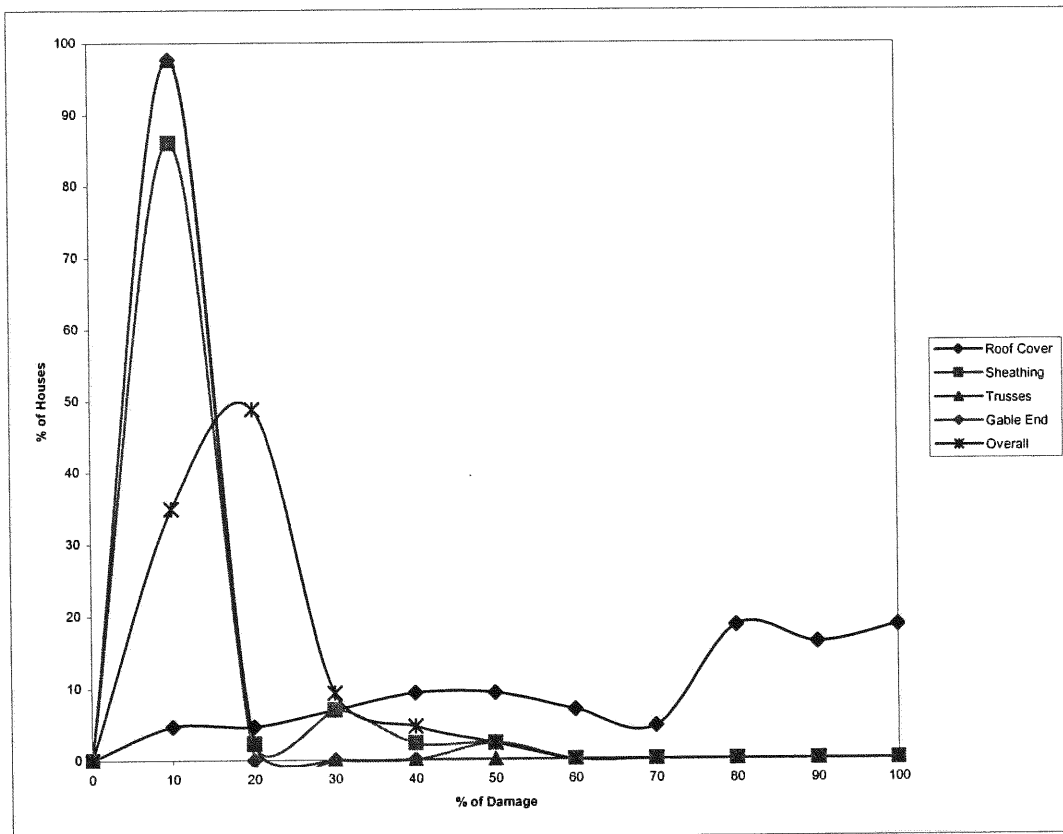
Figure 4.9 Probability Distribution Curve for MFH and Wind Speed = 138mph.

The probability distribution curve shows a maximum of 10% damage for gable-end, trusses and sheathing of more than 90%, 90% and 80% respectively. In case of overall damage it is 20% for 50% of the houses. The probability data for MFH community damage is shown in Table 4 (Appendix A).

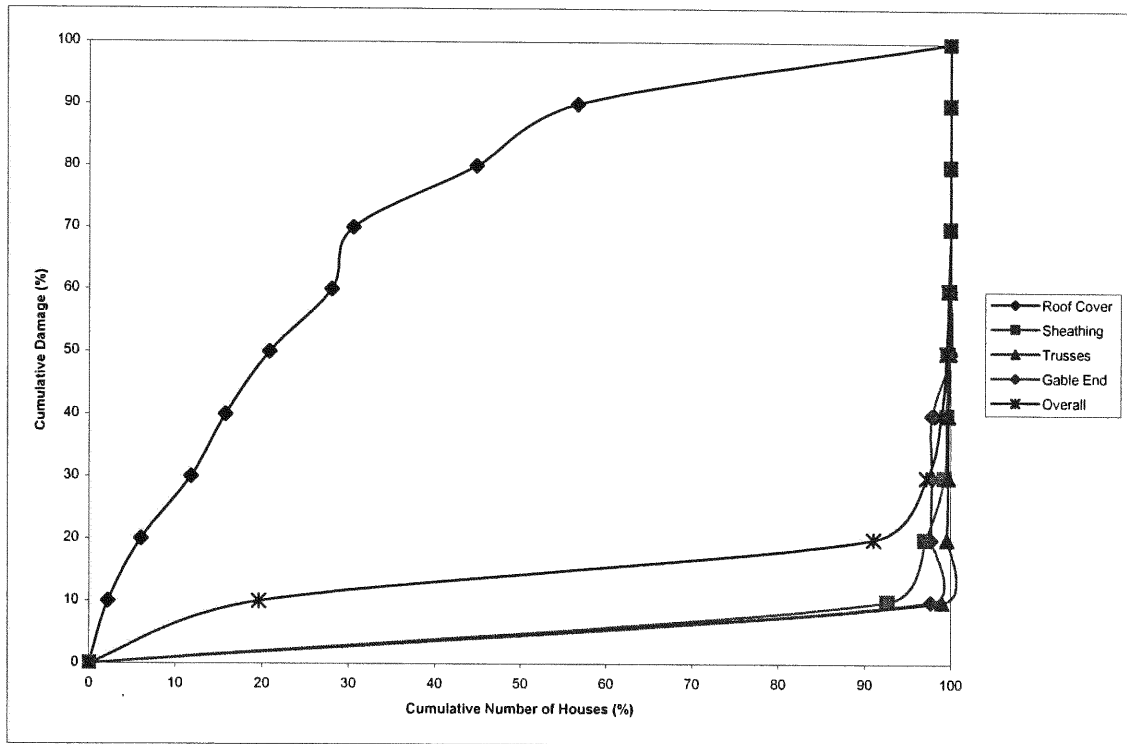
Figure 4.10 Roof Cover, Sheathing, Trusses, Gable-End and Overall Damage for SFH and Wind Speed = 140mph.

The above graph represents various structural damages for SFH type of structures for the wind speed of 140 mph. It represents that roof cover for 50% of the houses had more than 85% damage. The damage levels for gable-end, trusses and sheathing was more or less similar. The cumulative data for SFH community damage assessment is shown in Table 5 (Appendix A).

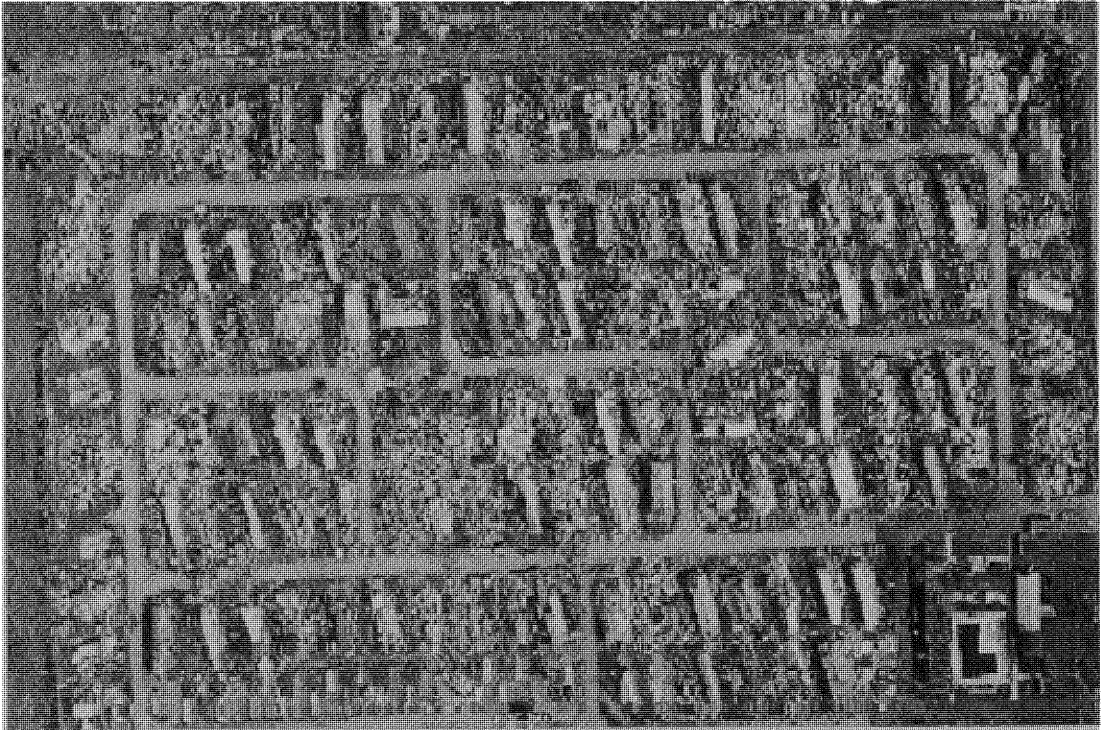
Figure 7.1.3.1. Inadequately designed foundation.

The figure shows an entire community of mobile homes, which has been drastically affected by storm surge. It's an overall view of the houses. Some of the houses have been badly damaged. Most observed failure in roof system (rafters and trusses), which might be due to installation and design shortcomings such as inadequate fastening of roof sheathing and insufficient anchoring at rake overhangs. There are three similar cases as shown in Appendix B.

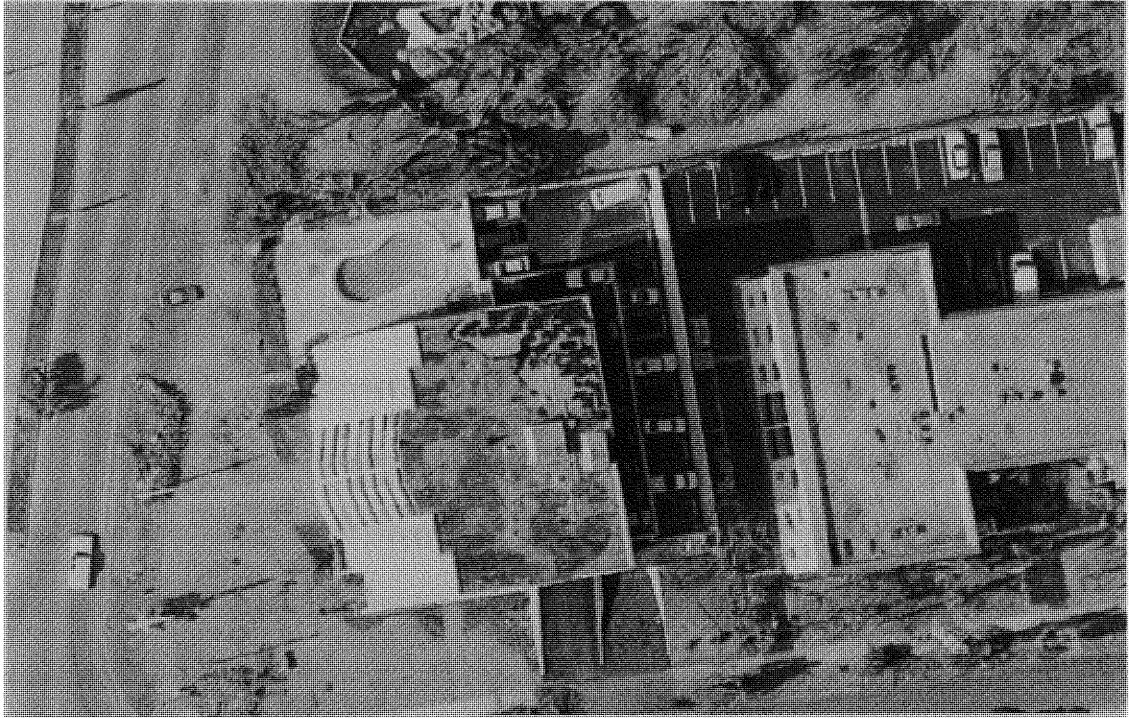
Figure 7.1.4.1. Major cracks developed in the concrete slab.

This figure shows a multistoried commercial building. The top corner portion the roof was damaged. The roof was made of concrete and the even concrete did not withstand the wind impact. Major cracks have been developed in the corner of the building. The wind direction can be predicted by this damage. The wind was blowing from north-east to south-west. The elevation of this particular building was higher than any other building hence there was no barrier to avoid such damages. There are two similar case as shown in Appendix B.

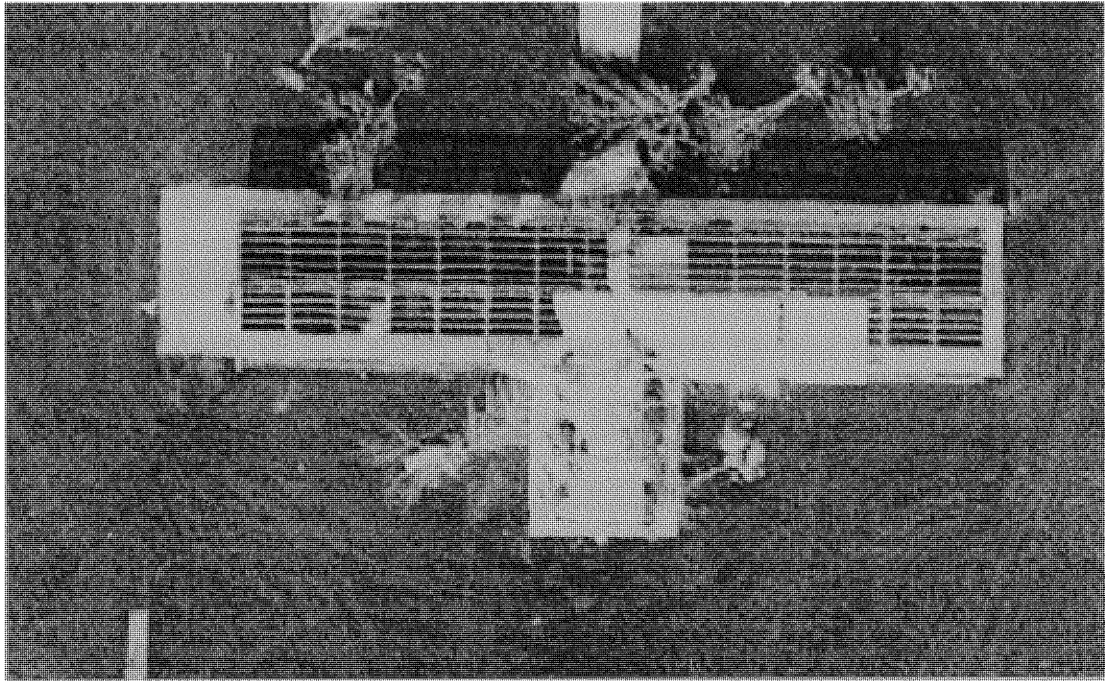
Figure 7.2.1.1. Roof cover and sheathing damage.

The figure appears to be a school building. The roof cover, the sheathing and the gable end have been completely damaged. There were few trees surrounding the house. One of the trees on the left hand side caused some minor damage to the exterior walls. Only a very small portion of the sheathing was intact. The wind direction cannot be predicted accurately. The canopy, made of concrete was also damaged. The structural stability of the trusses was strong enough to resist the wind force, and hence no major damage to the trusses. The truss connection was adequately strong enough and hence there was no major damage. There is one similar case as shown in Appendix B.

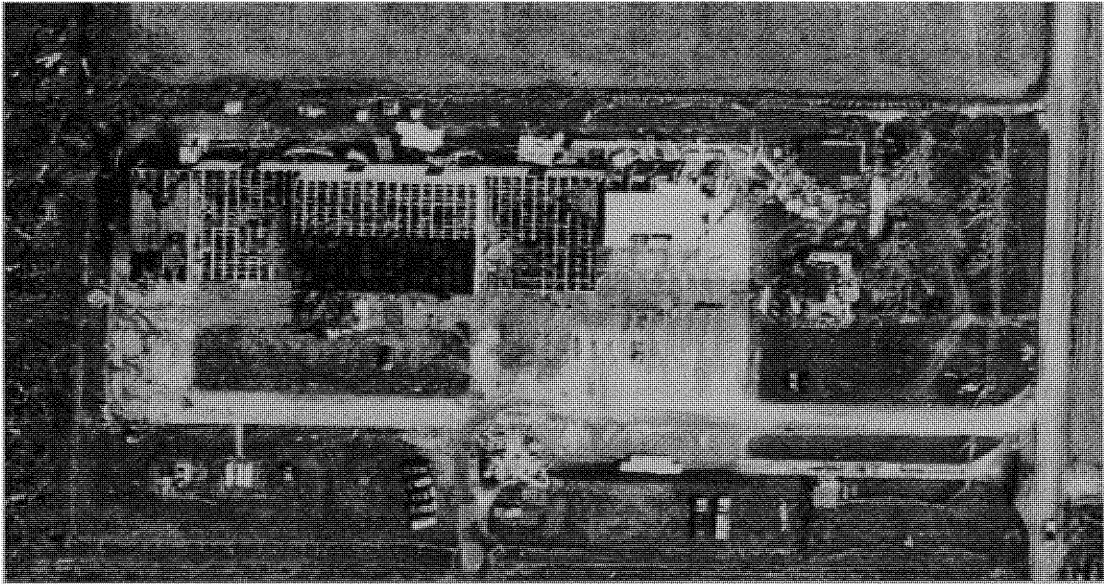
Figure 7.3.1. Partially damaged low profile hip roof.

The figure appears to be a hospital building. There has been major roof damage. Only a small portion of the roof is intact. The wind direction was not very clear. Lot of wind borne debris can be seen strewn all around the building. It might have a low profile hip roof so the overall damage was equally distributed. There has been no major structural damage as the trusses are intact and there is not even a slight displacement of it. This shows that the trusses were constructed structurally strong but not the roof covering and sheathings which got removed due to high wind speed. There are nineteen similar cases as shown in Appendix B.

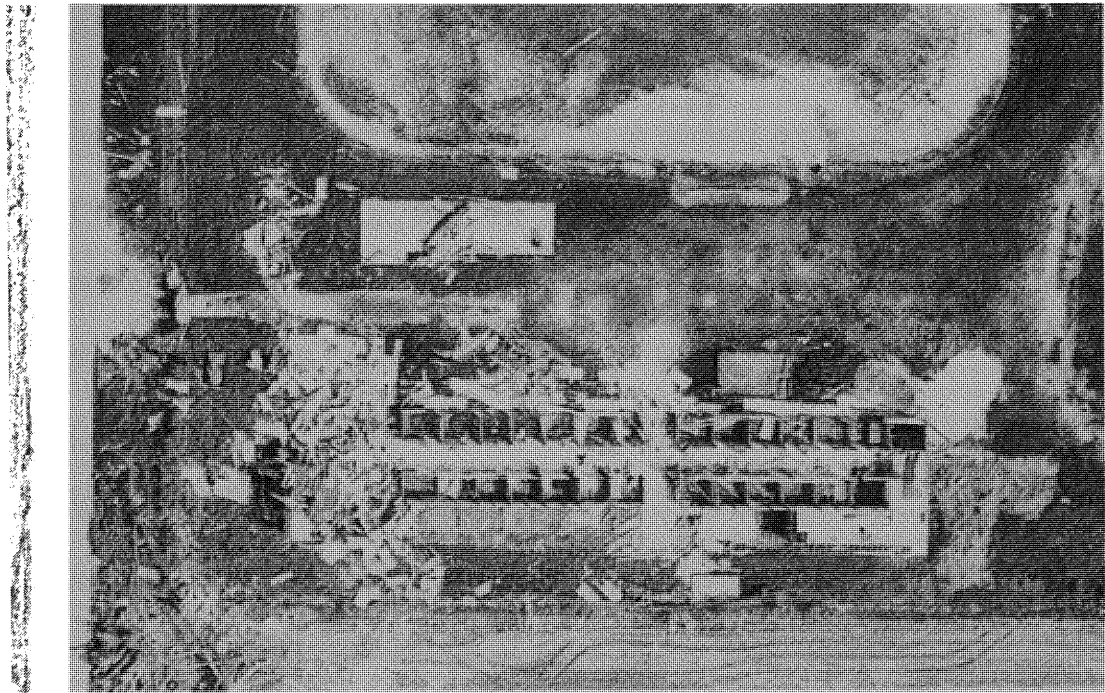
Figure 7.6.1. Weak wall foundation.

The figure shows some kind of warehouse, which has been completely destroyed by storm surge. The major damage occurred at the two ends of the long building. Gable end at both corners were completely destroyed. The roof cover and sheathing was completely destroyed. There was no sign of roof truss. The entire frame structure collapsed. Some portion of the dry wall has been destroyed as seen in the figure. The left side of the house has been badly dislocated along with debris and hence it was difficult to predict the exact damages. The destruction of the dry wall was due to the fact that the foundation of the walls may not have been adequately strong. There are three similar cases as shown in Appendix B.

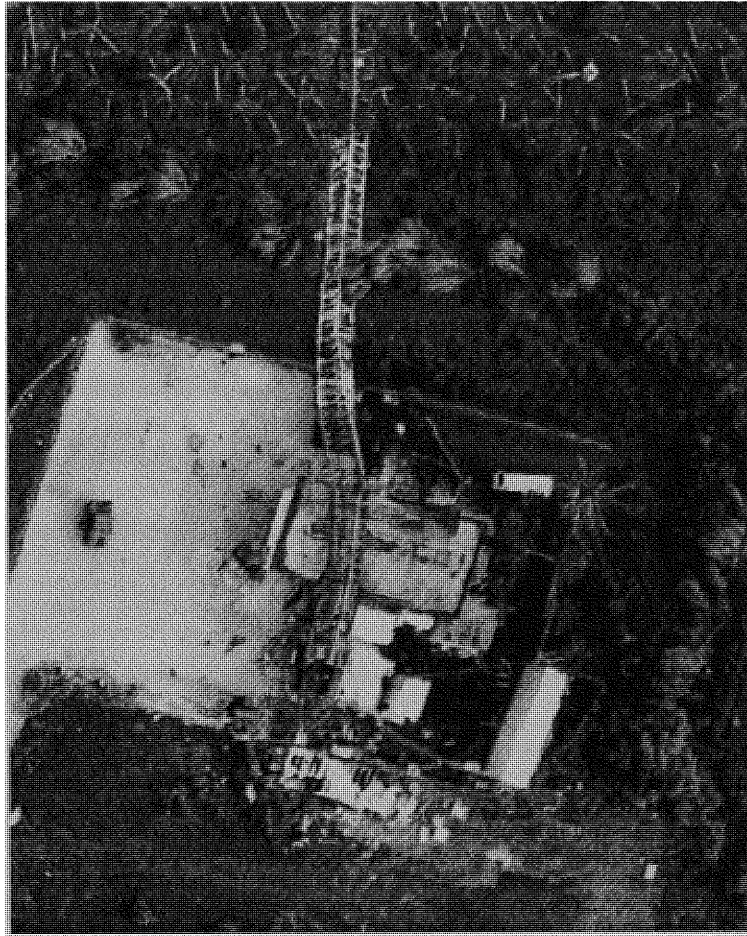
Figure 7.9.1. Weak pylon foundation.

The figure shows a pylon fallen on the house and ripping it in two parts. The foundation of the pylon might not have been strong enough to resist the wind speed. The wind direction was from east to west, which can be predicted from the movement of small trees around the house. It is, therefore, recommended that there should be no residential building around the radius of the tower, which is equal to the height of the tower to avoid major accidents and loss of life and property. There is one similar case as shown in Appendix B.

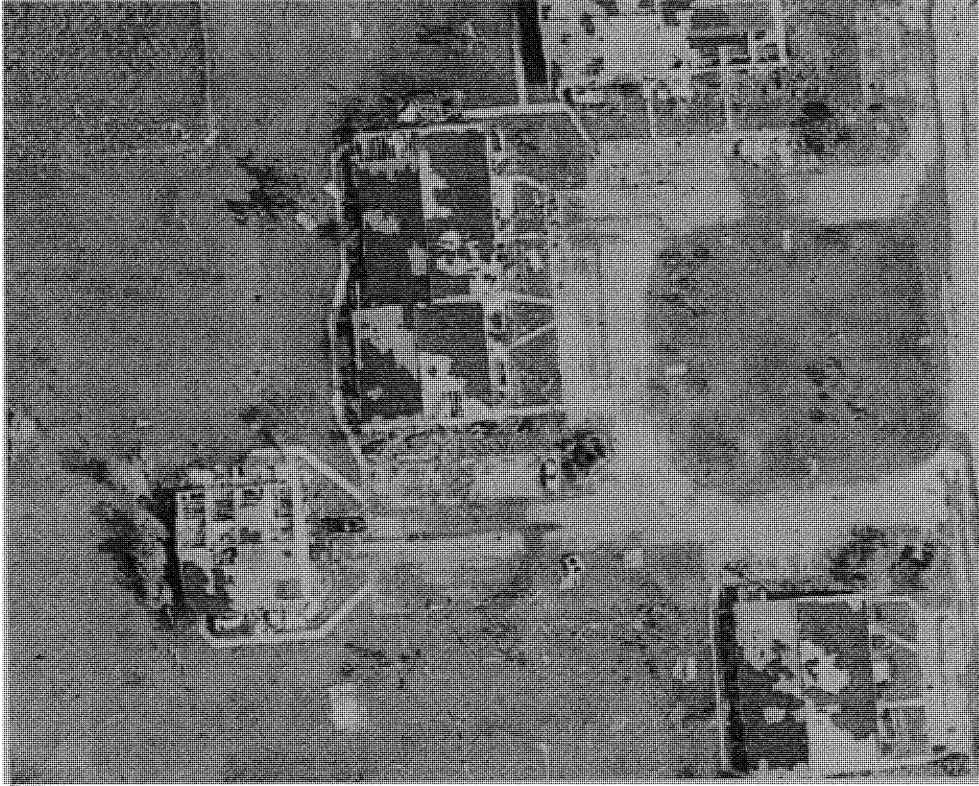
Figure 1.1. Damage to corner house.

The figure above shows extensive damage to single family homes. The corner house was severely damaged. Major portion of the roof cover and sheathing was blown off. Moreover since it was a corner house wind struck the house directly. The corner house had number of small trees, which could not create a barrier/obstruction to resist the damage caused in the corner houses.

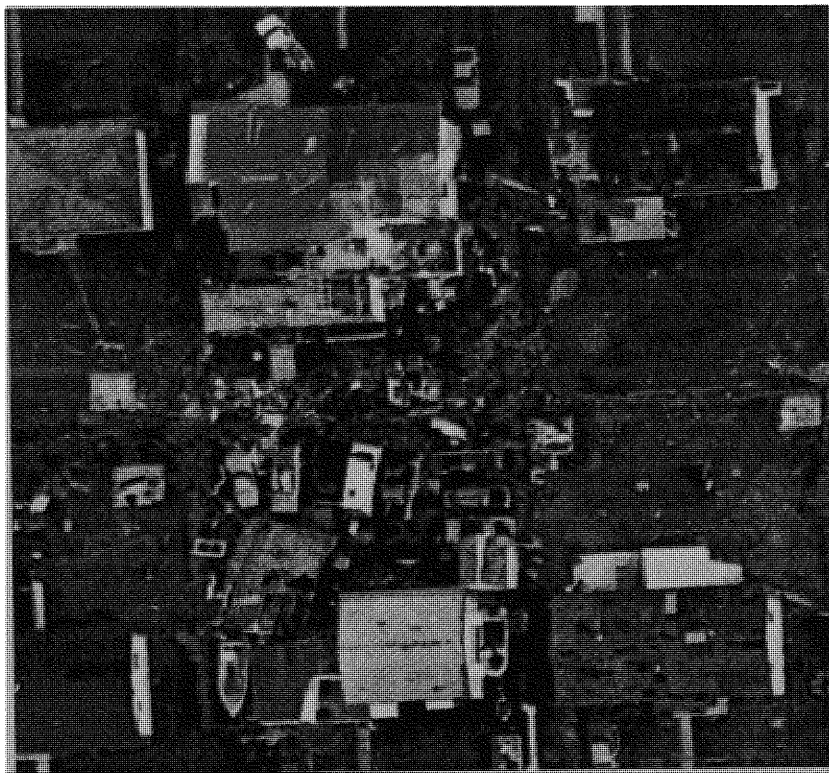
Figure 1.2. Damage due to wind-borne debris.

In this picture major damage was the roof cover damage. The velocity of the wind was adequately strong enough to blow off the roof covers of various houses, which means that roof cover material was not securely fastened together. The wind path was very clear in this picture. The wind takes a curved course from south-west to north-east direction. Wind borne debris can be seen all around the places. All the houses were structurally strong enough to resist the velocity of the wind hence major damages cannot be observed except for the roof cover damage.

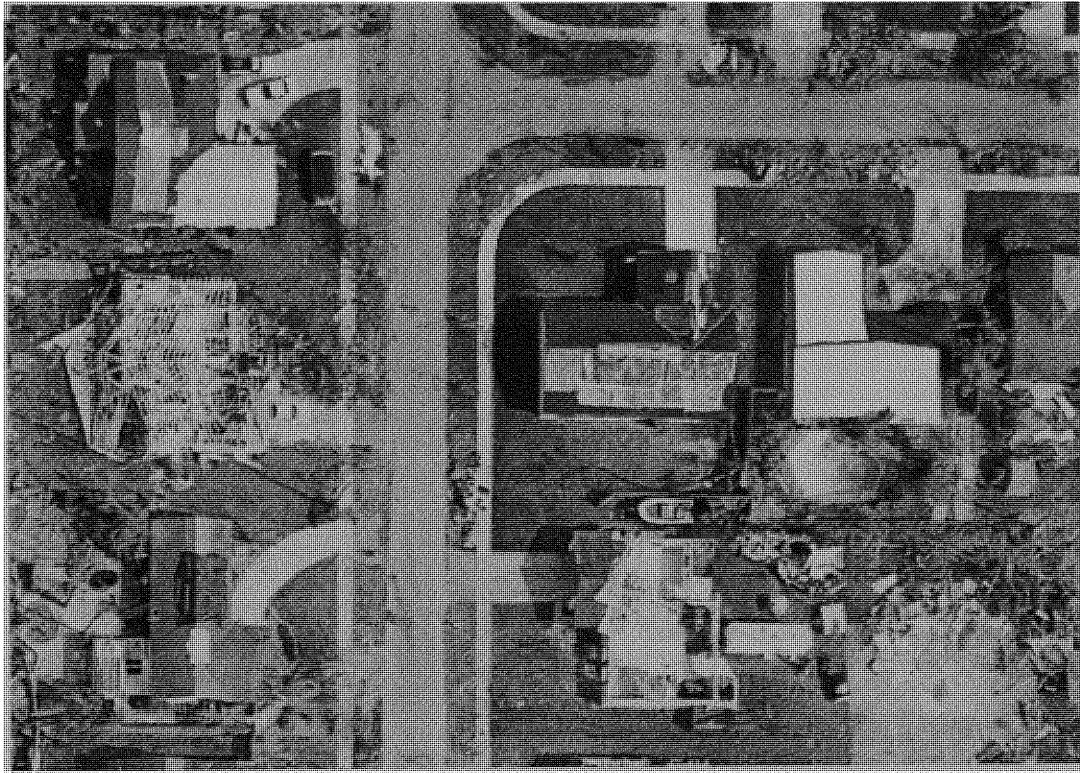
Figure 1.6. Variable roof system damage.

This figure shows some single-family homes. Some of them are highly damaged while others have minor damage. Minor damage includes only roof cover and sheathing while major damage includes roof truss and gable end damage. In case of the house, which has the roof truss, damage the wind might have blown perpendicular to the gable end. Those houses, which stood in the wind path, had minor damages to the roof cover and the sheathing. The wind direction was from east to west.

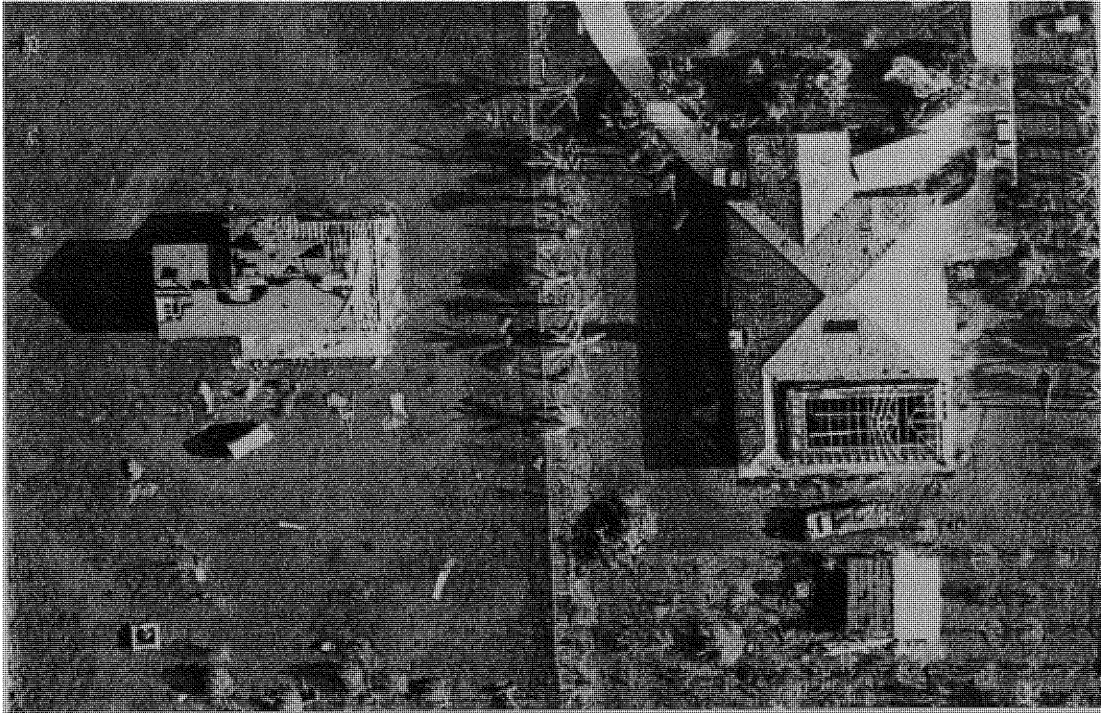
Figure 1.11. Destroyed gable-ends.

This is a typical example of single-family homes. The house having the differential roof elevations, part of the roof cover and the sheathing was blown off and the sheathing was exposed. The wooden trusses got inclined due to strong wind force. Similar is the case for the house in the left hand side. The roof of this house was partly damaged and one of the gable end was completely destroyed. The trusses fell into one another due to lack of secondary connection between the individual trusses.

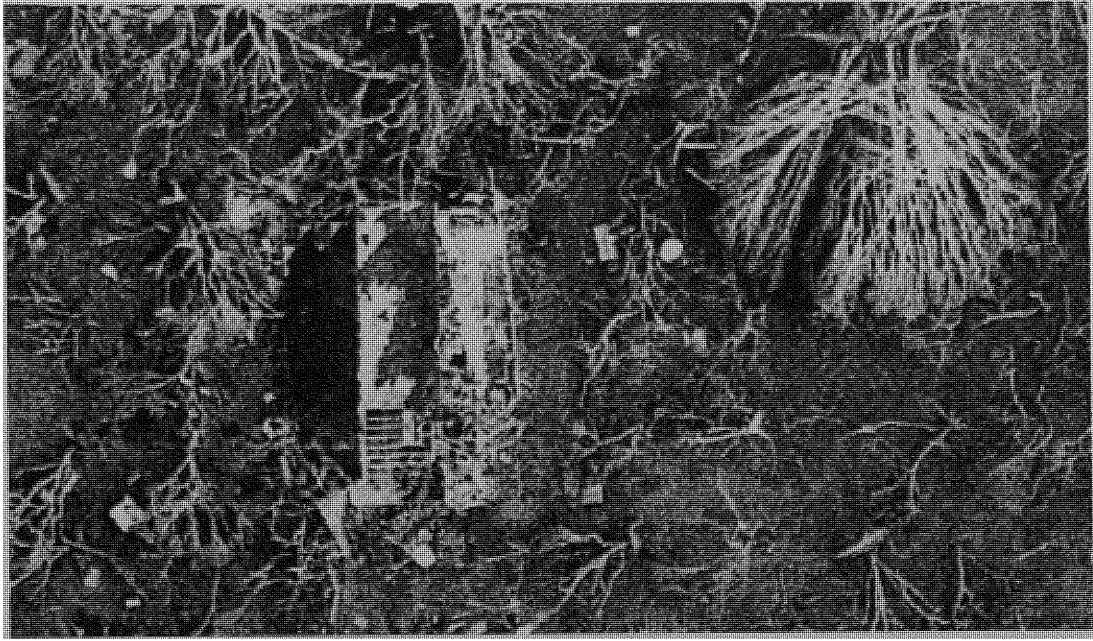
Figure 1.12. Exposing of truss skeleton.

This figure shows a single family home with 75% damage to the roof. Some portion of the house was damaged due to the trees surrounding the house. The front right hand corner was severely damaged. Even the walls have been extensively damaged as a result of which the gable end in the front is missing. Its is very usual that the truss in the corner portion was also destroyed. The missed sheathing exposed some portion of the truss, which has minor damages. Certain amount of the debris can be seen around this house. An over all damage of 80% is estimated. The wind was blowing south to north direction so the front portion was struck by the wind directly perpendicular to the gable end and hence major damage can be seen occurred in the front rather than the back portion.

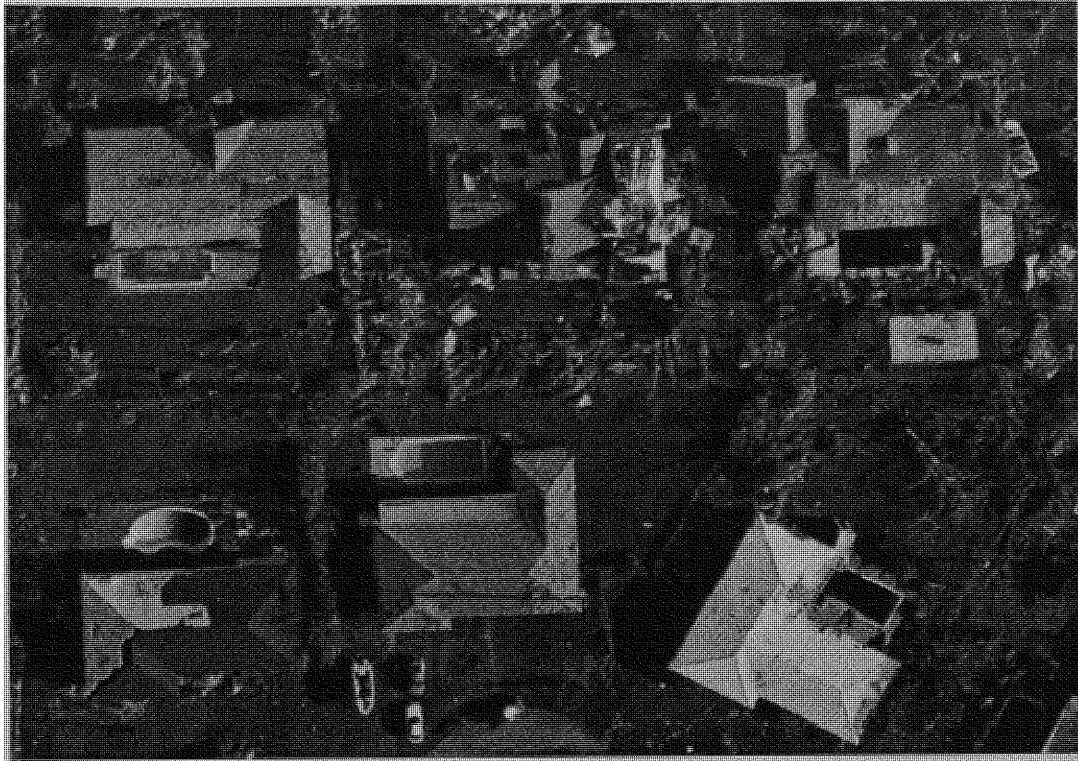
Figure 1.13. Curved wind path.

This figure shows clearly the wind path and destruction of the houses along that path. The wind was blowing from south-east to north taking a curved path. In case of the first house the entire roof cover is missing hence there was 100% damage to the roof cover. In case of the house in the middle of the second row. An over all damage of 40% damage could be observed. The wind struck that house at an angle damaging one of the gable-end along with some trusses on the right hand side. The roof cover and the sheathing got collapsed inside the house. Small amount of debris can be seen around the house. The wind blew from the gap between the two house and hence established a clear path to damage the middle house in the second row.

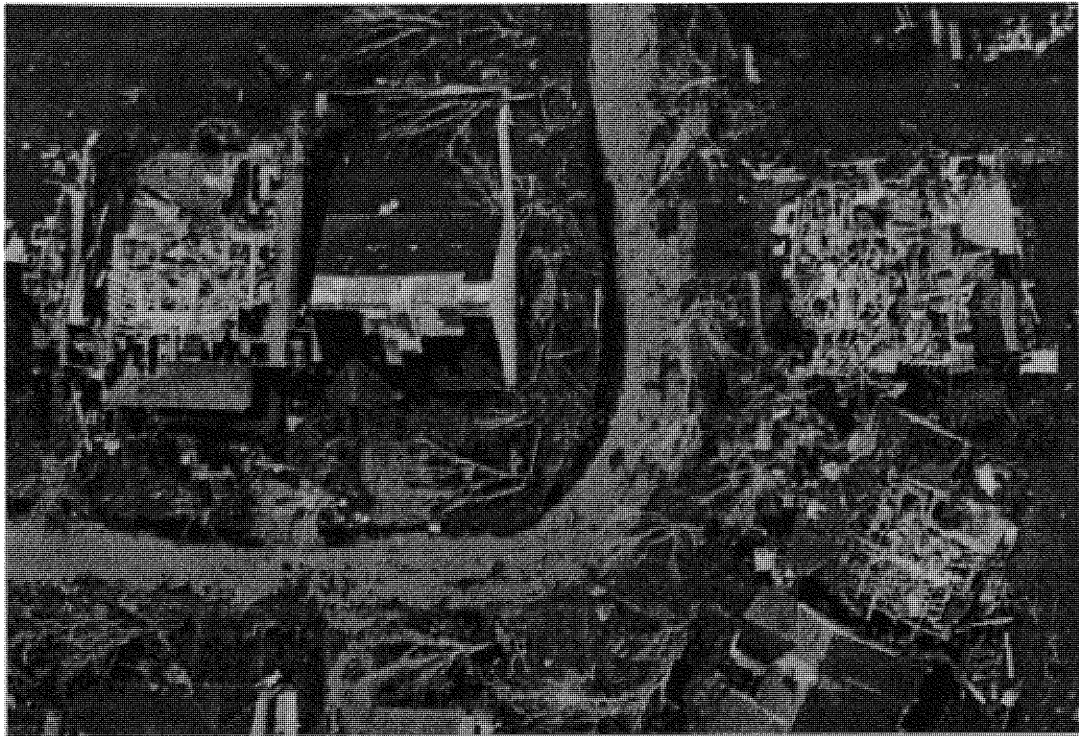
Figure 1.14. Overall damage of 100%.

This figure consists of four houses, which has an overall roof damage 100%. In these units, it shows that roof structures and the walls have been destroyed. It is predicted that there was a small tornado that went through these buildings as debris could be found at some far distance. The wind had blown from right to left. One of the houses that had very less roof damage the reason for that is the building is oriented differently and the wind had an aerodynamic path to destroy the roof system of the house just behind this house.
