Damage assessment of various structures by hurricane Andrew using aerial photographs

Sondwip Dhar

Florida International University

A thesis submitted in partial fulfillment of the

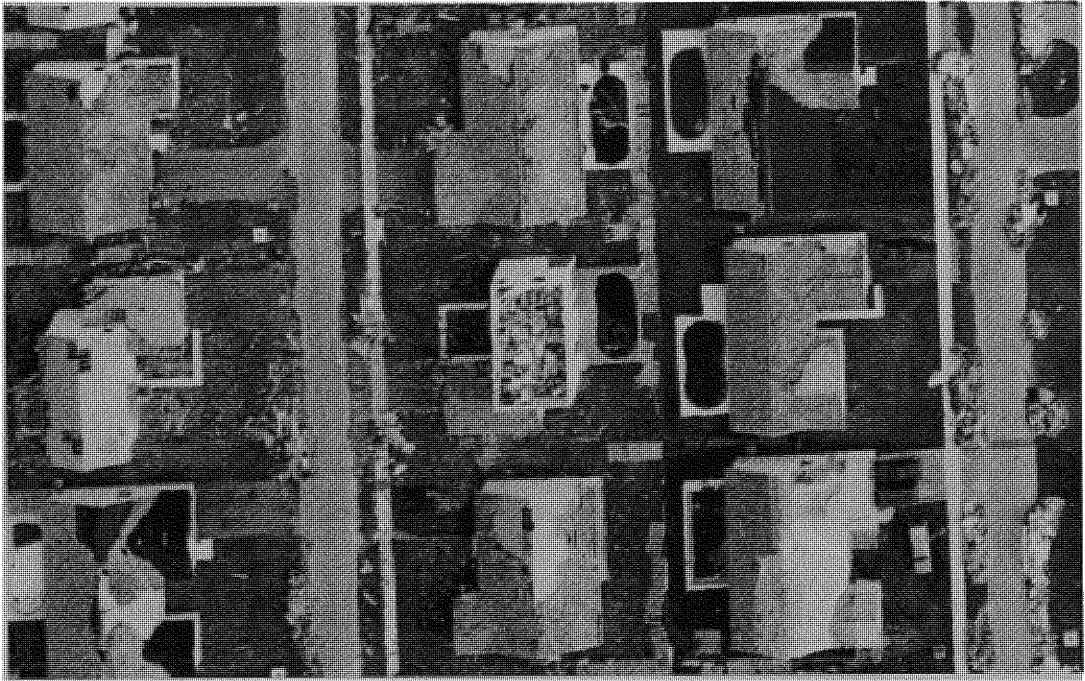
Figure 1.15. Inward collapse of roof trusses.

This figure shows that the house in the middle shows that the whole roof has gone. Most of the trusses are scattered within the house. As this picture shows, trusses did not blow from the house. The reason could be following: first, this house lost all its roof sheathings and the trusses were exposed to rain. Then the trusses became weak all the roof framing collapsed. Second, the house had inadequate nailing and connection of the roof framing. Another point to be noted is that the adjacent houses were not so severely damaged which means that there was some inadequate bracing connection between the truss members and hence there was a collapse of the structure.

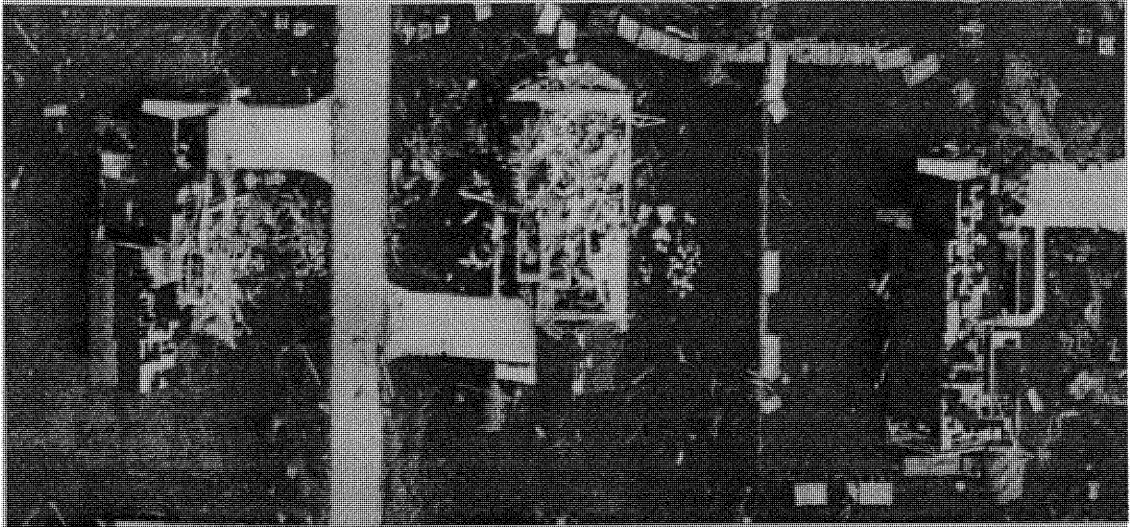
Figure 1.16. Debris damaged the adjacent house.

The above figure shows three single-family homes of which the middle house has been badly destroyed. The wind blew from east to west and striking the middle house damaging the entire roof frame. The over all roof damage is 100%. Consequently debris from this middle house flew and fell on the building on the left hand side and damaging the roof and the dry wall of the building. Any extension of the roof beyond the wall surface elevates wind pressure on both the sheathing and framing systems at these locations.

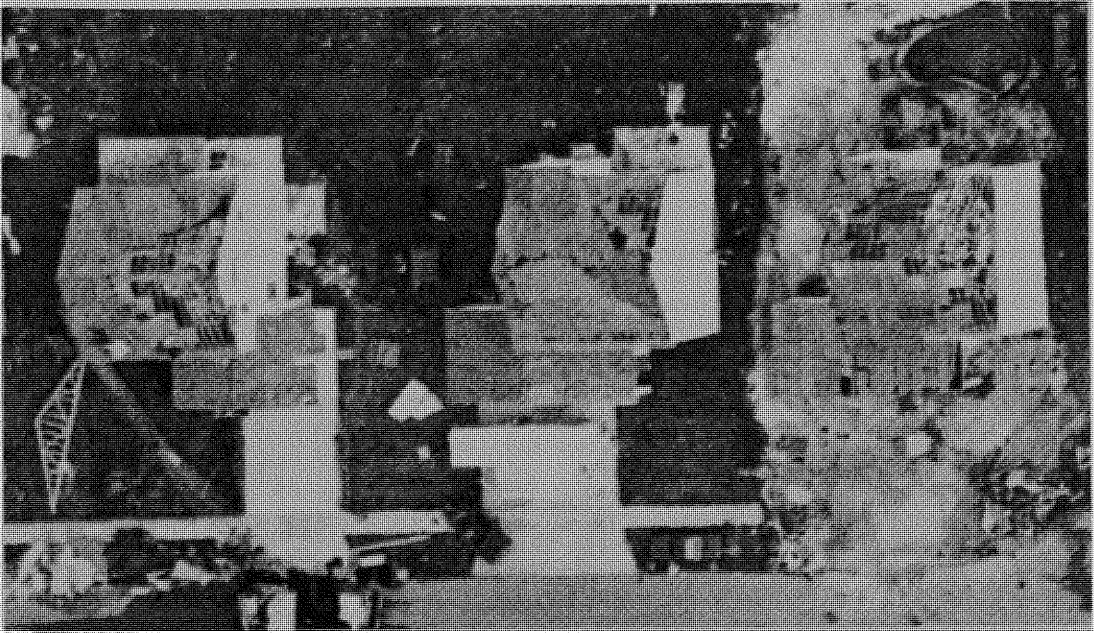
Figure 1.18. Comparative destruction of three single-family homes.

This figure gives comparative destruction of three single-family homes. The two houses on either end have major roof damage. Gable end failure is very prominent. The failure end seems attributable primarily to poor or nonexistent bracing between gable-ends and rest of the structure. Bracing of the roof framing at the plane of the roof deck during construction and supplemental distribution of inward and outward forces into the roof “diaphragm” when gable-end walls are subjected to high winds.

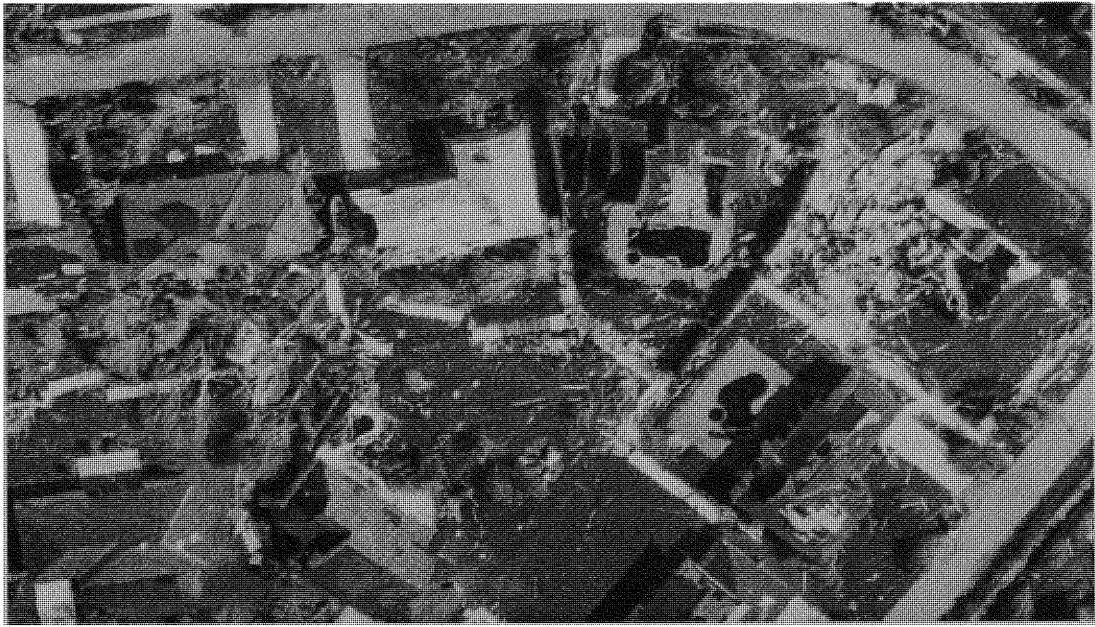
Figure 1.20. Failure occurred due to development of suction force.

This figure illustrates wind damage was caused by wrenching and bending forces imposed by gusting winds and the rapid increase in wind force as wind speed increases. With a doubling in wind speed the wind force on the structure increases four times. The wind struck the buildings produced pressures against the building on the windward side and the suction, which pulled the building on the leeward side. Failure occurred might be due to external pressure and suction on the wall combining to push and pull the building off its foundation.

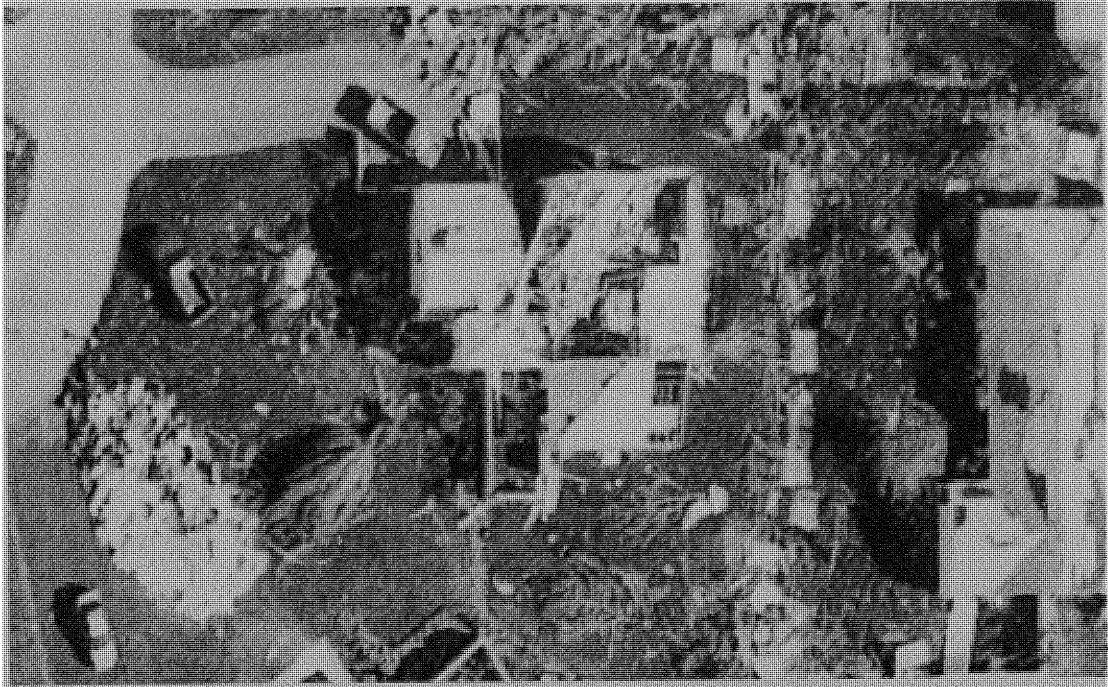
Figure 1.22. Wood-frame wall lacked strength due to roof failure.

This is an example of a two-story, wind damage house. The wood-frame second story of this house was stressed and crucial damage was the roof truss damage. When the roof structure fails, the wood-frame walls may lack the strength by themselves to withstand severe wind loads. Secondary lateral bracing should be evaluated, particularly for tall gable roofs on all types of homes. Rubble could be found surrounding this house. The wind direction was from east to west.

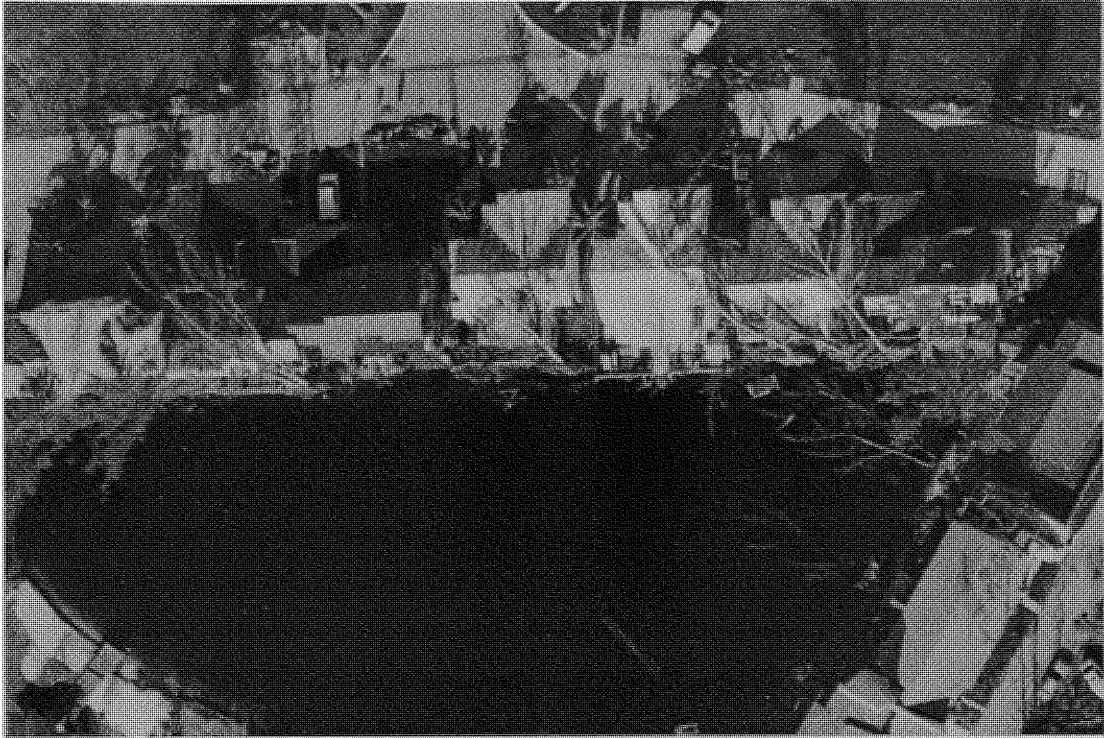
Figure 2.4. Damage due to fallen trees.

This figure shows rows of single-family house around an artificial lake. Some of these houses had roof cover damage due to fallen trees. The trees were so long they became unstable and fell on the roofs. In some cases there were 100% roof cover damage. The wind was blew from south to north. There was no major structural truss damage. Common performance problems affecting roof coverings included poor installation and inadequate material characteristics relative to the storm severity.

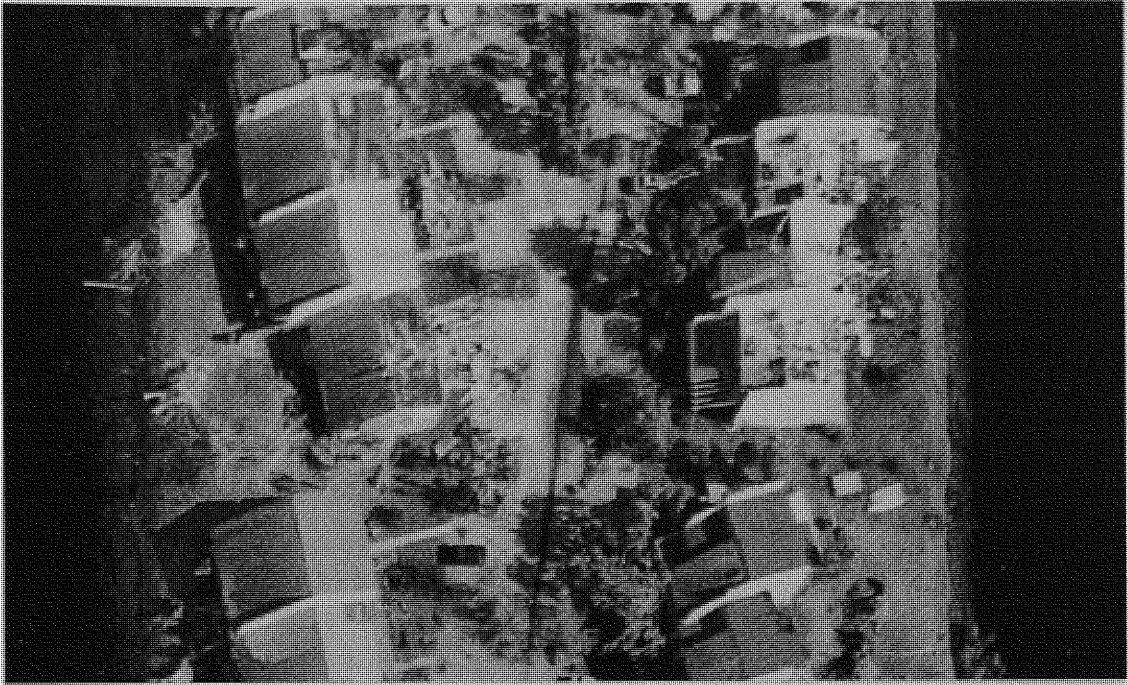
Figure 2.5. Collapsing of roof truss due to saturation load.

The figure shows two storied single-family homes situated near an artificial lake. Three buildings had an over all roof damage of 90%. There is a severe loss of plywood sheathing indicating inadequate connections. Debris got collapsed inside the houses. In case of two buildings there is a structural damage to the roof frame might be due to lack of truss connections between them. The wind had blown from east to west and hence some minor damages could be observed in the houses on the left-hand side.

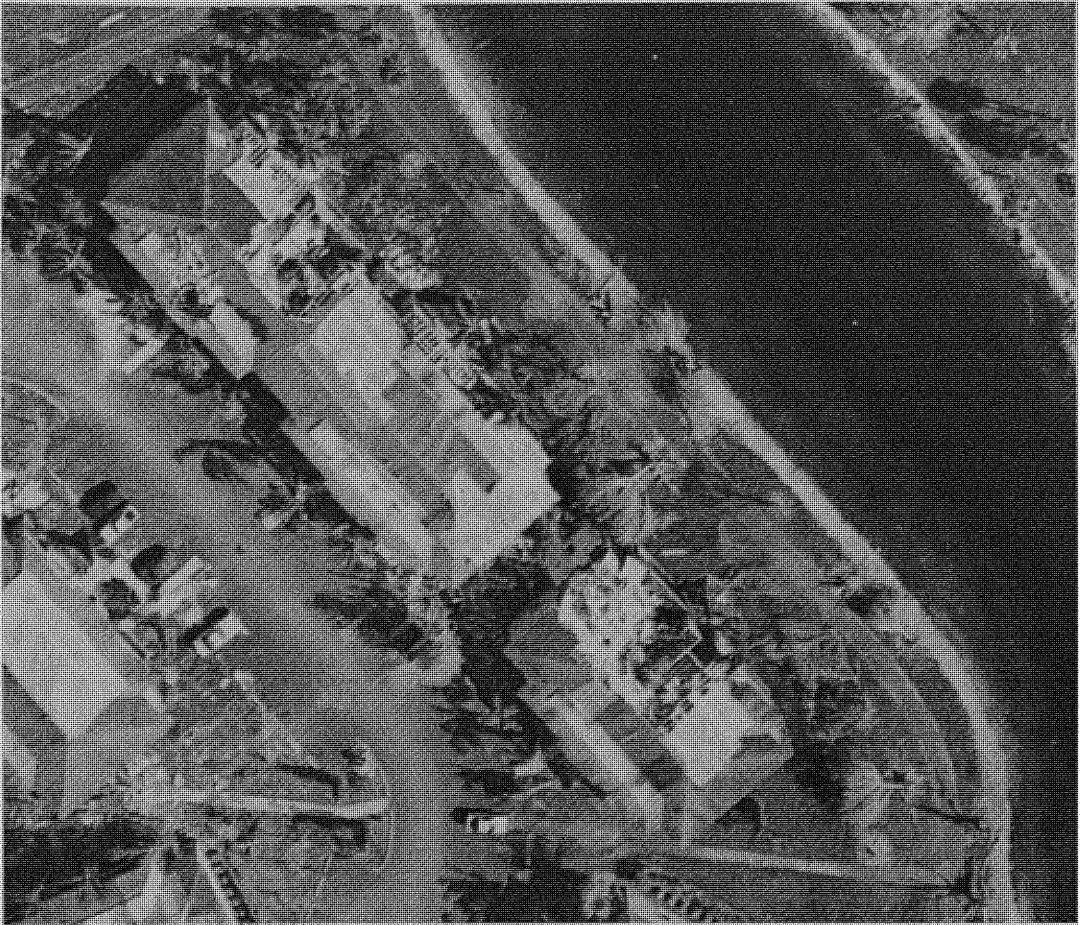
Figure 2.6. Aerodynamic hip roof.

This image shows two storied single-family homes around an artificial lake. The house consists of hip roof with partial roof damages in the two buildings as seen in the above figure. Hip roof is more efficient aerodynamically and therefore introduces lesser loads to the structure and its components. The corner failures in the wood-frame second storied might be due to improper connections of the top plates at the corner joints.

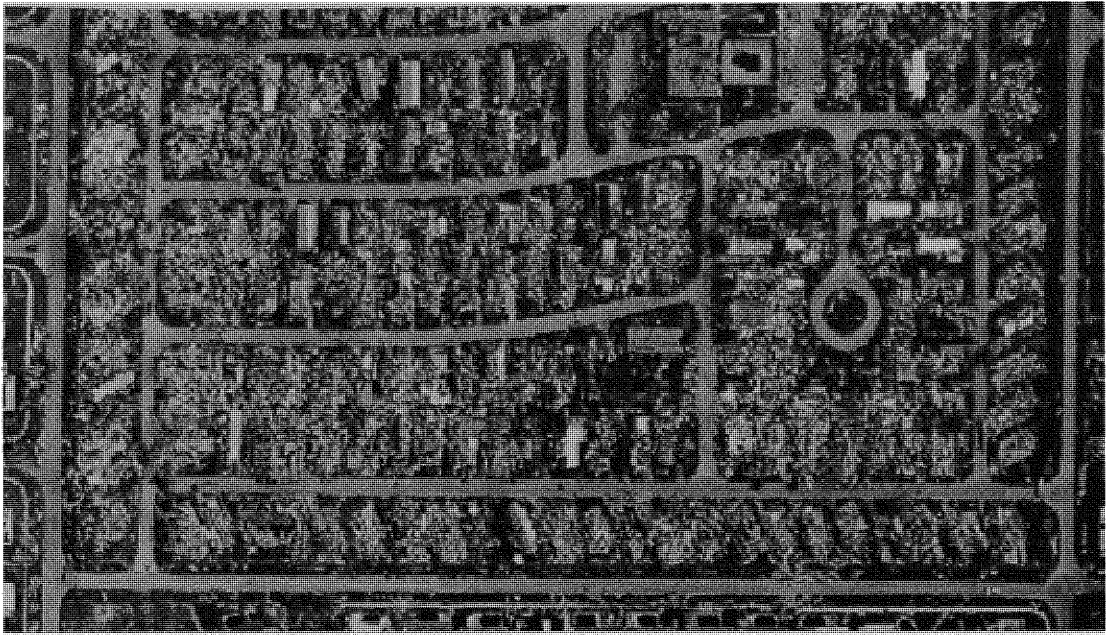
Figure 3.1. Severely racked exterior walls.

This figure indicates that more than 70% of the mobile homes have more than 60% roof cover damage. More than 70% of these houses have more than 50% damage to their sheathing. The main structure of roof such as trusses and gable-ends in this area show that more than 60% of these houses have more than 50% damage. It appears that the overall damage of homes is mostly contributed to the trusses and gable ends damage. In this figure, it shows that more than 50% of mobile homes have 100% roof damage; some structures are totally destroyed.

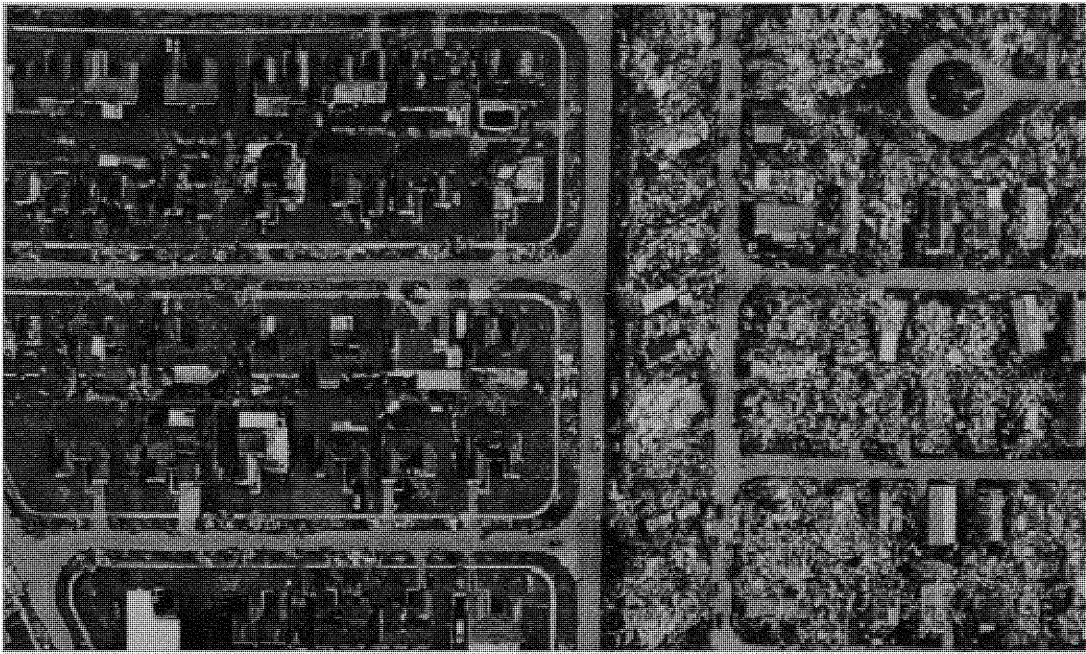
Figure 3.2. Comparison between single-family homes and mobile homes.

This figure clearly illustrates and compares the damage between single-family homes and mobile homes. In case of mobile homes more than 70% of the mobile homes have more than 50% roof cover damage. The over all damage to the mobile homes were about 90%. Most of the mobile homes were reduced to rubbles. Whereas in case of single family homes there were less than 30% roof cover damage. All the roof covers of the townhouses have more than 10% damage in that particular area. The wind direction was from right to left.

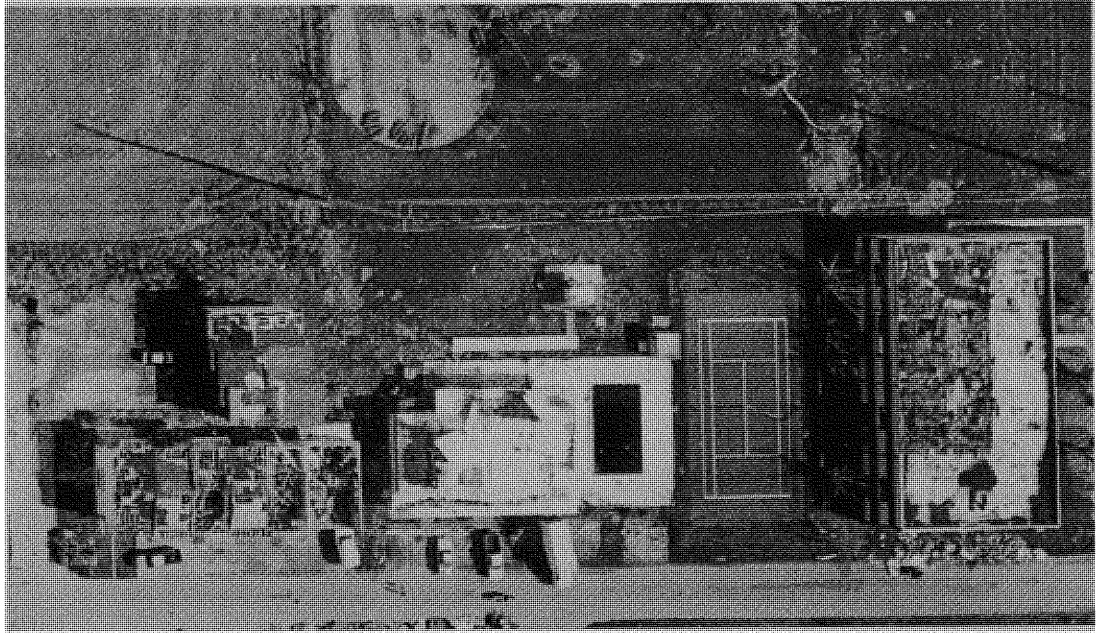
Figure 4.2. Strong anchorage between panels.

The figure shows damages in a clubhouse. Major damages are in roof cover and sheathing. In some places trusses can be seen but they are not structurally damaged. The anchorage between the panels was adequately strong enough and hence it could survive the wind force. The wind direction cannot be predicted accurately, although a rough guess can be made about the wind direction. The wind might have blown from north to south, this is evident from the fact that there was a fallen tree.

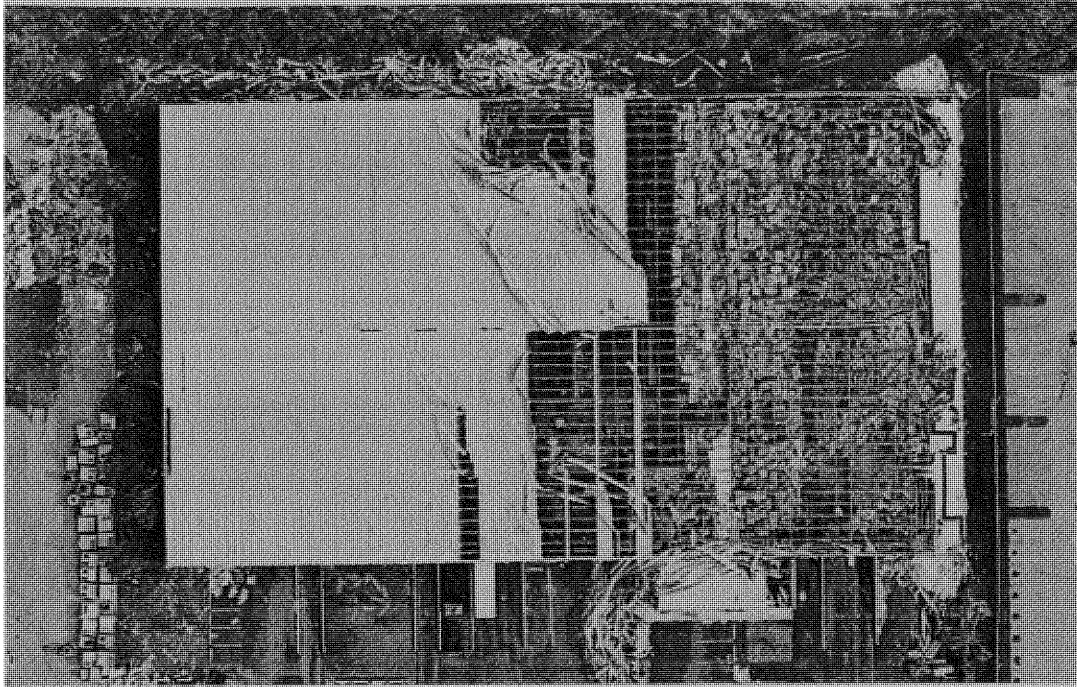
Figure 7.1. Blowing of roof cover sheets.

This figure illustrates a big shopping mall, which has major roof cover damage. In case of large shopping malls there are neither cover tiles nor sheathing. There is special roof cover material directly placed on the metal truss. The wind might have blown from east to west damaging the roof cover partially. Whereas the metal truss has not been damaged at all. In case of the extended porch bending and twisting of metal frame is observed. The porch metal truss could not withstand the storm surge.

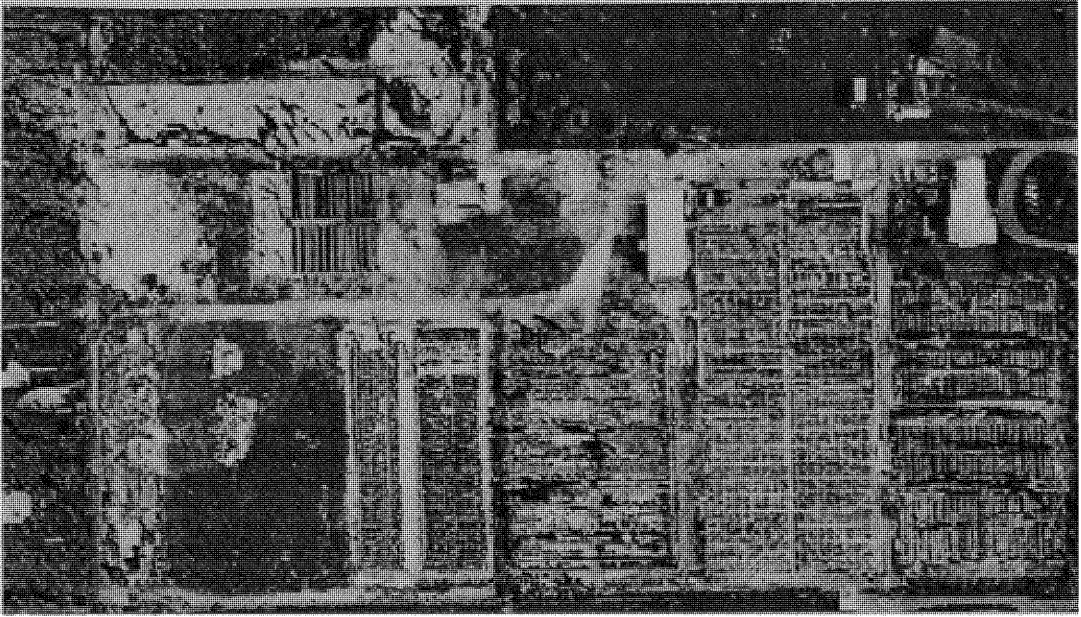
Figure 8.2. Major structural damage.

This image looks like a warehouse, which is severely damaged. The roof cover of the entire storehouse has been removed by strong wind force. Some structural damages of the truss can be observed. The wind damage cannot be predicted very accurately as there are no trees surrounding the warehouse. Even the concrete structure (i.e. the roof), which can be seen on the top left hand corner, did not survive the wind impact. Major cracks can be seen very clearly.

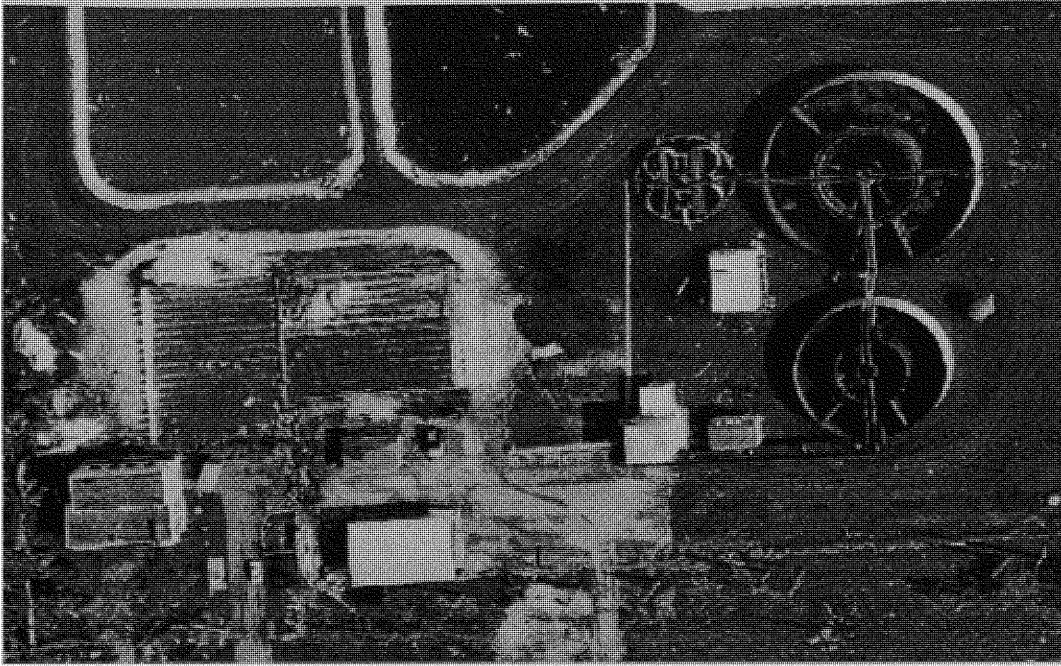
Figure 8.3. Damage to filter beds.

The figure shows a wastewater treatment plant. There has been no major damage to the overall structure as most of the construction was done with high strength concrete. Damage has been observed in a number of places around the building area and the filter beds. Wind direction cannot be predicted accurately with such minimum damages.

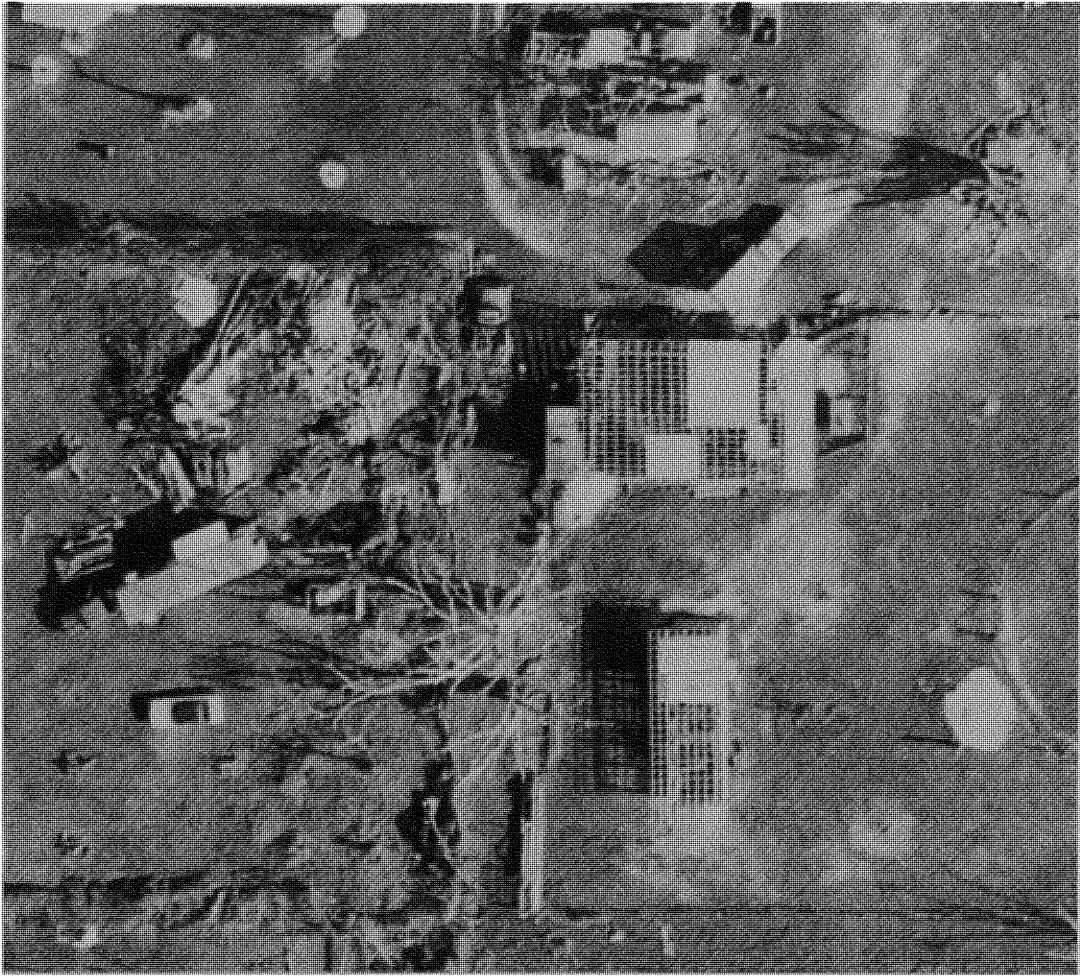
Figure 8.10. Strong bracing connections.

The figure shows that more than 70% of the roof covers are missing. More than 70% of the sheathing are also damaged. The trusses were intact without and structural damage. The bracing connection was adequately strong enough to resist the wind force. Wind borne debris can be found at some distance from the houses. The wind was blowing from east to west. This was evident from the accumulation of wind borne debris.

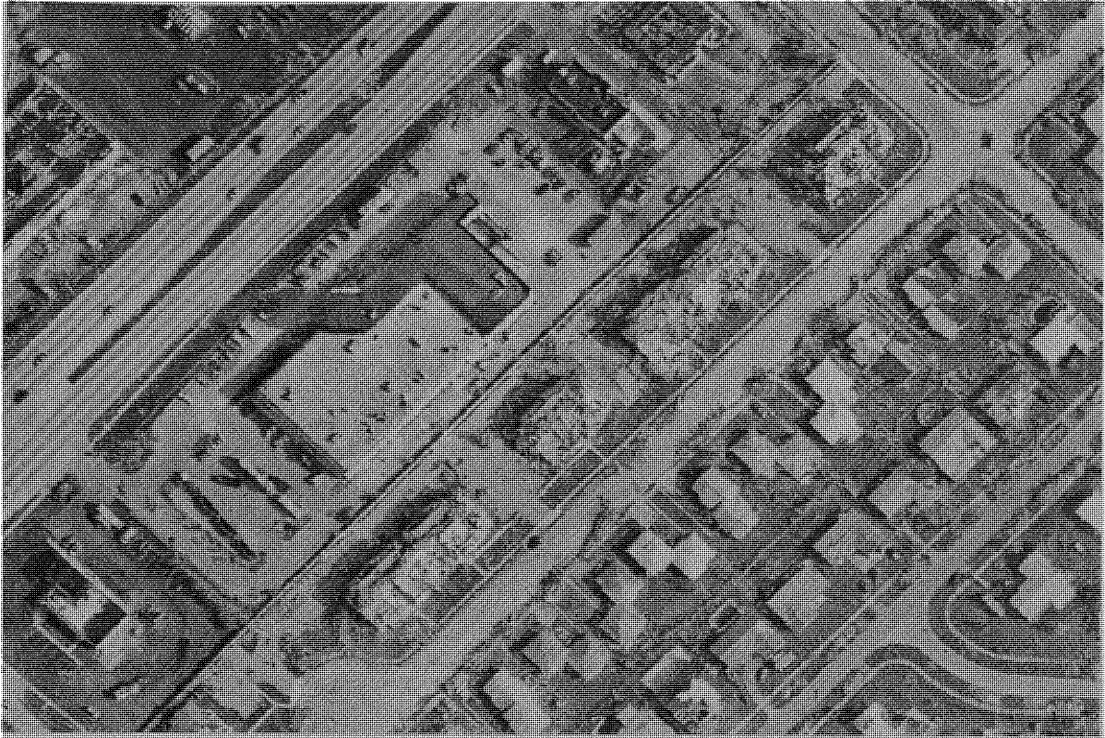
Figure 8.16. Lack of connection between roof cover and sheathing.

This image illustrates 80% roof cover damage in four major buildings, which have long roof span. The roof coverings might not be adequately attached, and corner and eaves regions of roofs were frequently damaged. Tile roofs, composed of either extruded concrete or clay, showed failures in both nailing and mortar connection. Clay tiles seemed more susceptible to damage from flying debris than concrete tiles. For steep roof systems, as seen above roof failure occurred at the ridge or gable ends where wind-induced force were the highest.

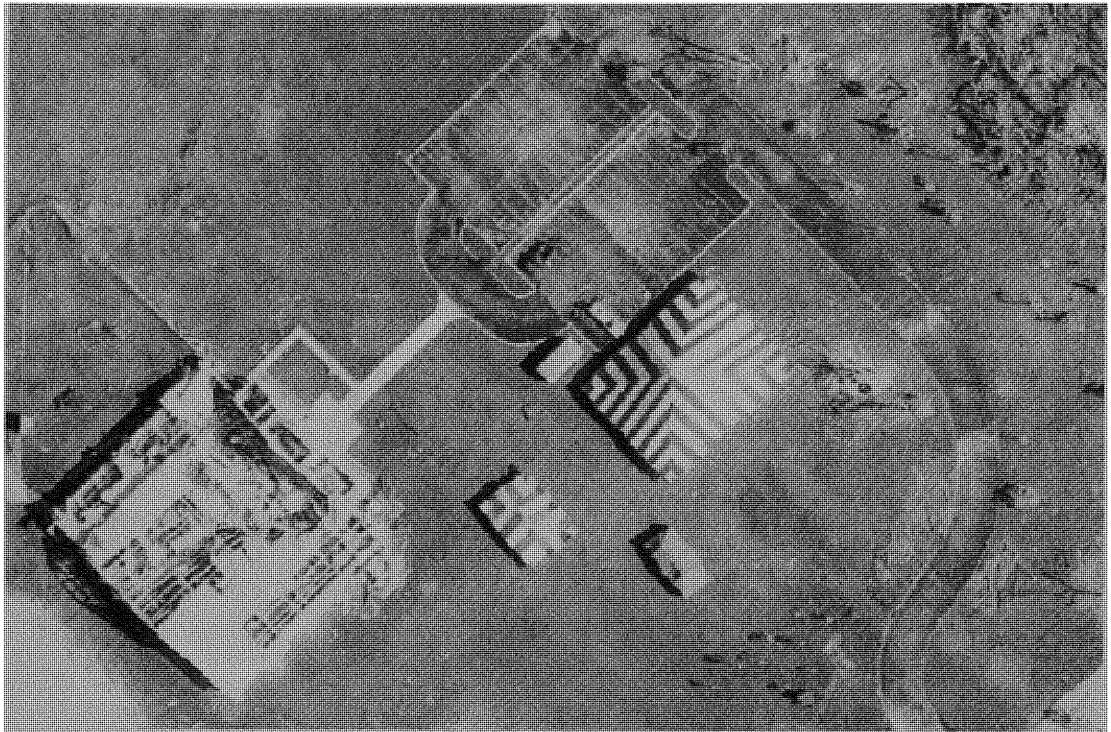
Figure 8.18. Breaching of the building envelope.

Complete failure of the middle portion of the roof is clearly visible. The truss got collapsed within the house. This might be due to breaching of the building envelope which eventually led to roofing removal, broken windows, collapsed doors and damage of to the exterior cladding. There was no damage to the gable end and hence it was intact due to usage of proper construction system and foundation anchorage. There were no other houses or trees surrounding this house, which could provide resistance to the wind to avoid such damages.

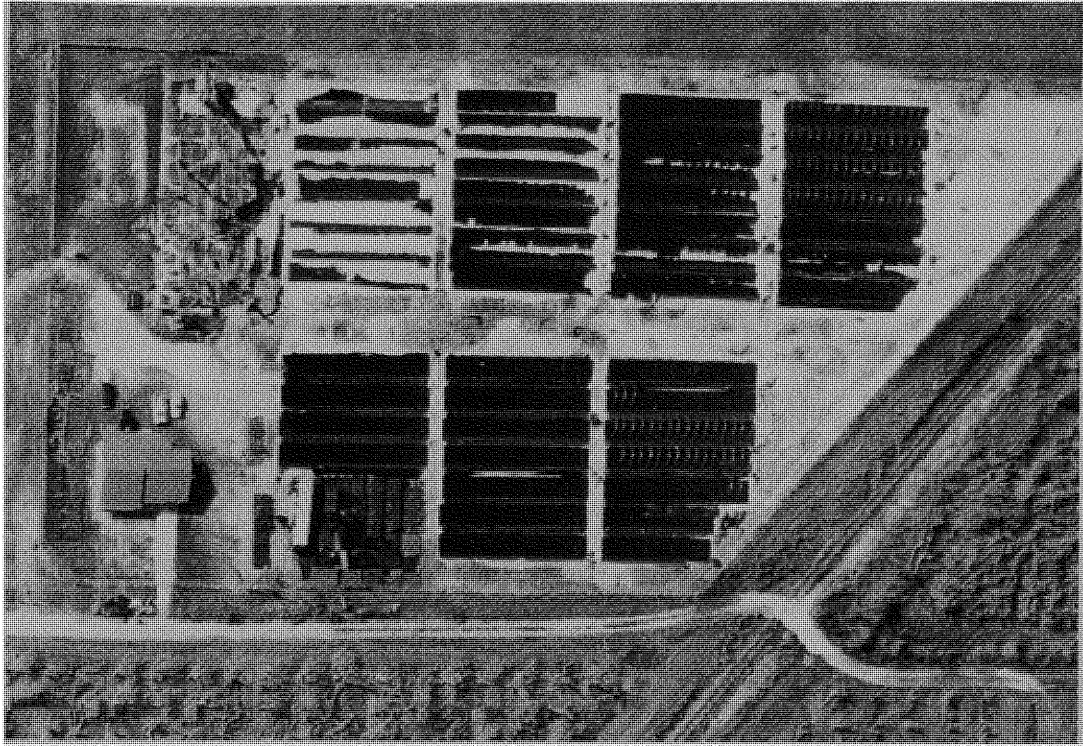
Figure 9.1. Progressive damage of roof cover.

The figure shows that it was some kind of a factory, which has been destroyed partly, that is damage was visible only on the left-hand side. As observed from the damage the factory has metal truss, which has been badly twisted, and bended resulting the truss damage as 100%. It is very clear from the above destruction that the wind had blown from west to east as the extent of damage can be seen from more towards the left hand side and gradually reducing as it progresses. The roofing system of this factory was an AC sheet covering which failed due to improper connection. Progressive damage is very clear from the above figure.

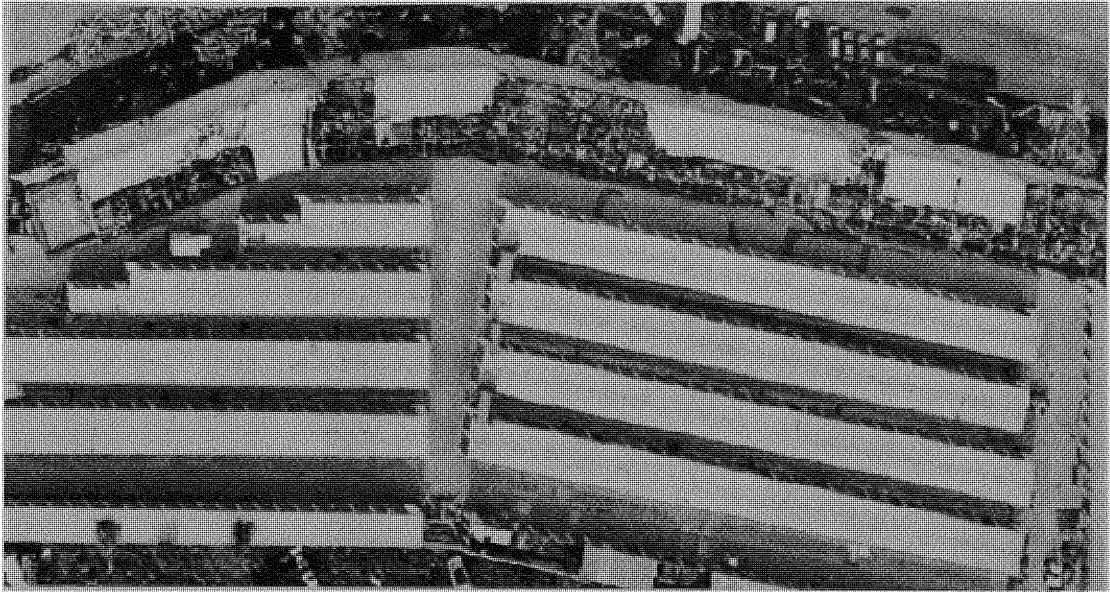
Figure 9.2. Peripheral damage.

This is an example of a small factory building with metal frame and AC sheet covering. Due to the strong hurricane wind force the AC sheet covering had been blown off and exposing the truss skeleton. Once the sheathing was lost, the building envelope was effectively breached. Wind pressure now exerted against the inside of the building leading to possible failure of the walls and against the underside of the remaining sections of the roof, increasing the likelihood that the remainder of the roof would be lost.

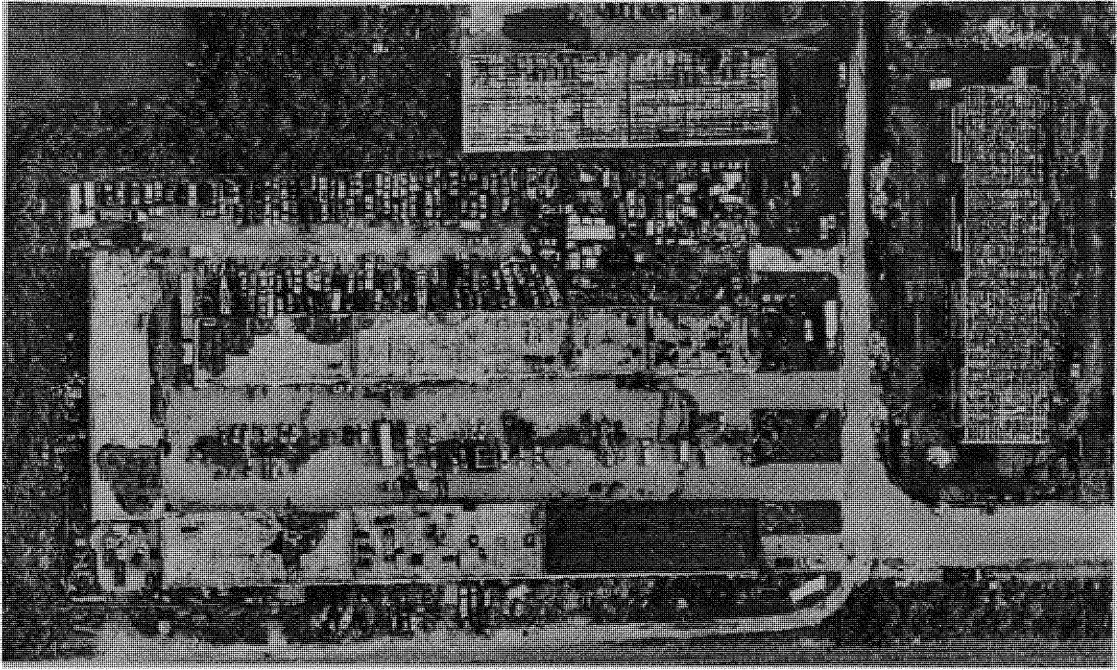
Figure 10.2. Collapsing of concrete roof.

This figure shows a huge building with concrete roofing. This building look like a shopping mall. Roof damage can be observed. It shows that even concrete cannot withstand the high wind impact. Generally the corner portion was mostly affected and the steel portion was exposed. Incase of the right side of the building the roof seemed to be collapsed. This may be due to the wind, which might have blown from east to west causing an impact to the dry wall, and hence the collapse was observed. Even vehicles parked got pusher to the left side by wind velocity.

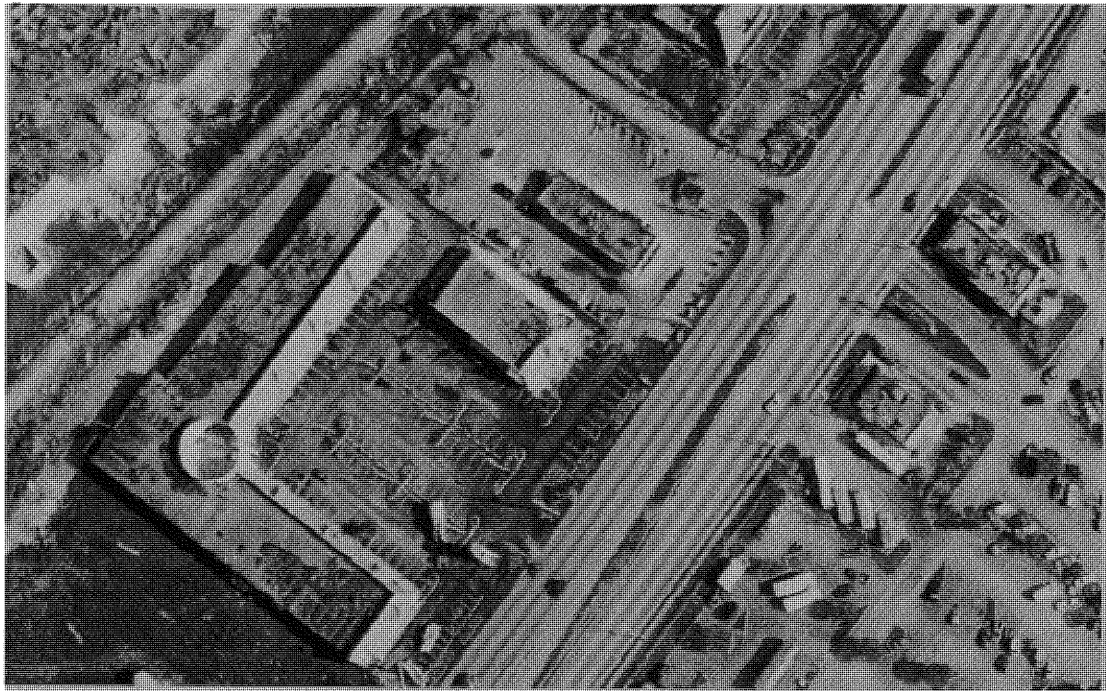
Figure 10.3. Usage of low-grade concrete.

This figure shows a small business center. This business center has concrete roofing system. The force of wind exposed the steel reinforcement part. As seen from the picture even the heavy vehicles were displaced. Some of the debris can be found lying along side of the building. High grade concrete must be used to counteract the wind impact. There were no major trees to function as a barrier and protect from the roof damage.

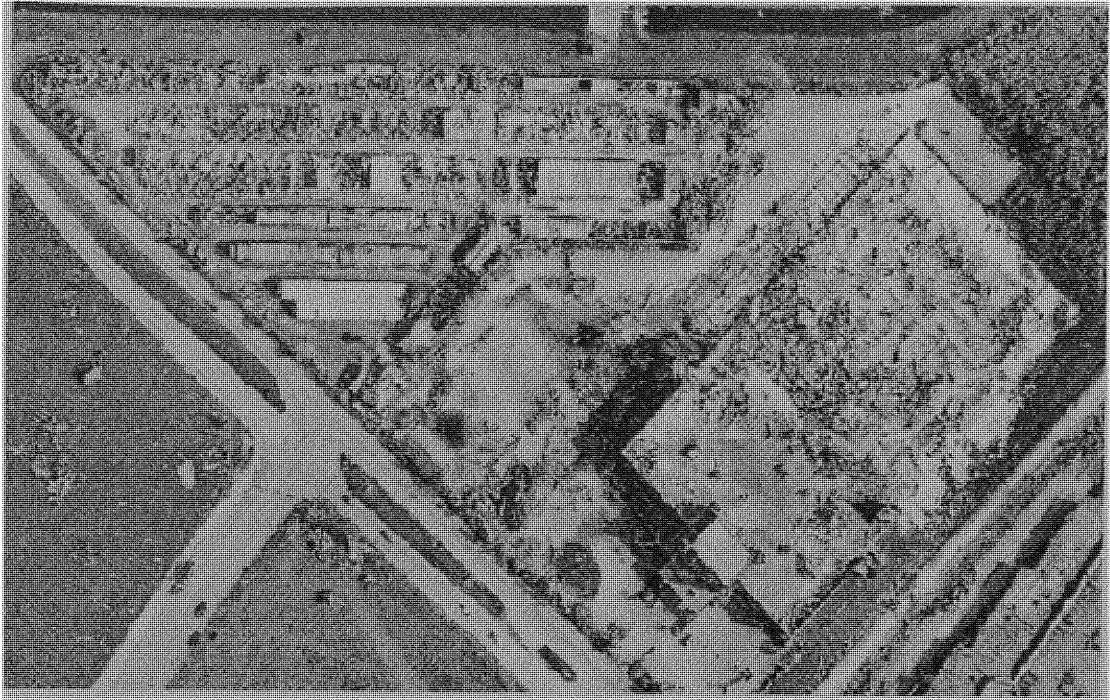
Figure 10.5. Omission of reinforcement bars at the intersection.

This figure shows some kind of workshop. The area is partly built with gable-end roofs and the other portion there is a concrete structure. In case of the gable-end roof it has metal roof covers instead of tiles. The wind stream generates uplift as it divides and flows around a structure. According to Bernoulli's principle, as the wind speeds up across the roof, the pressure drops, generating uplift. The roof, in effect, acts as an airfoil and attempts to take off from the remainder of the building. Failure of the walls was observed which might be due to the omission of reinforcement bars at the wall intersections or at corners. These intersections provided continuity of tie beam reinforcing. When this deficiency existed in combination with failure of the tie beam to roof connection, the wall collapsed.

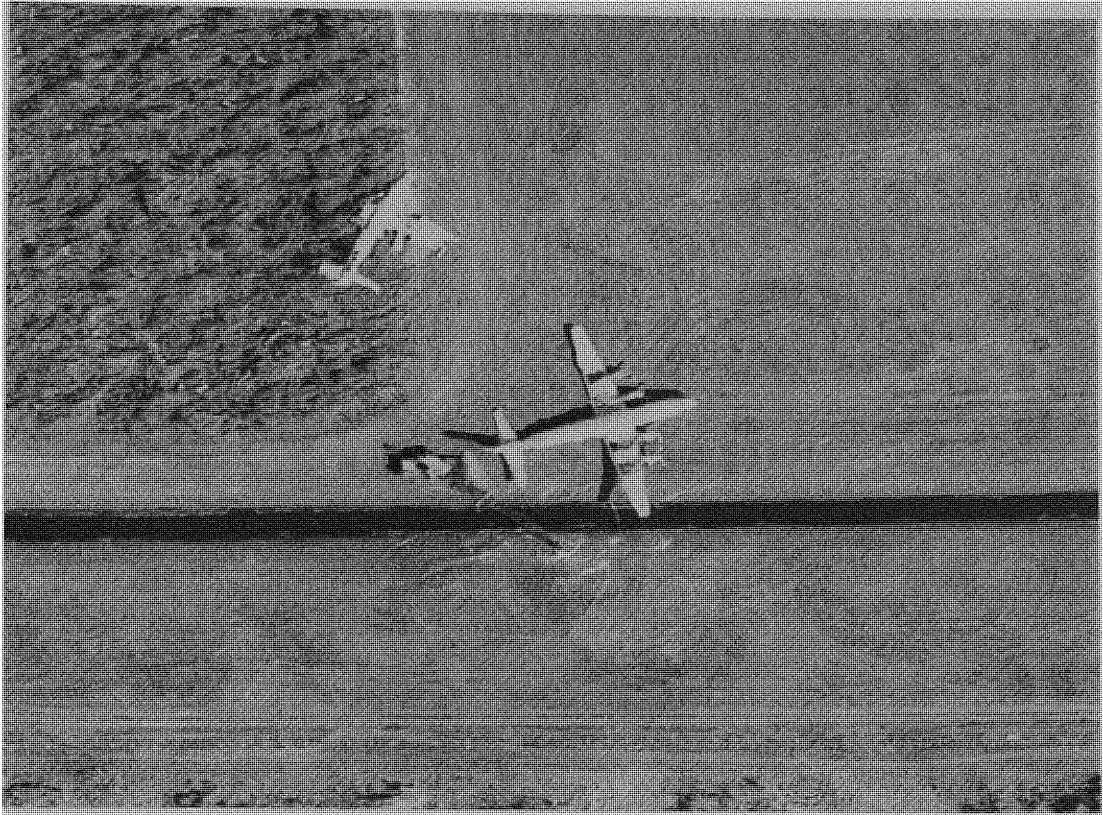
Figure 13.2. Dynamic objects cannot withstand the strong wind force.

The figure shows two small planes, which were grounded, might be due to the wind effect of the hurricane. It can be concluded that any dynamic object present during the hurricane may not withstand the impact and can lead to accidents as seen in the above figure. In these case it is believed that the wind pressure high enough to push the airplane down. The airplane fell in open field and hence there was no damage to life or to the property.

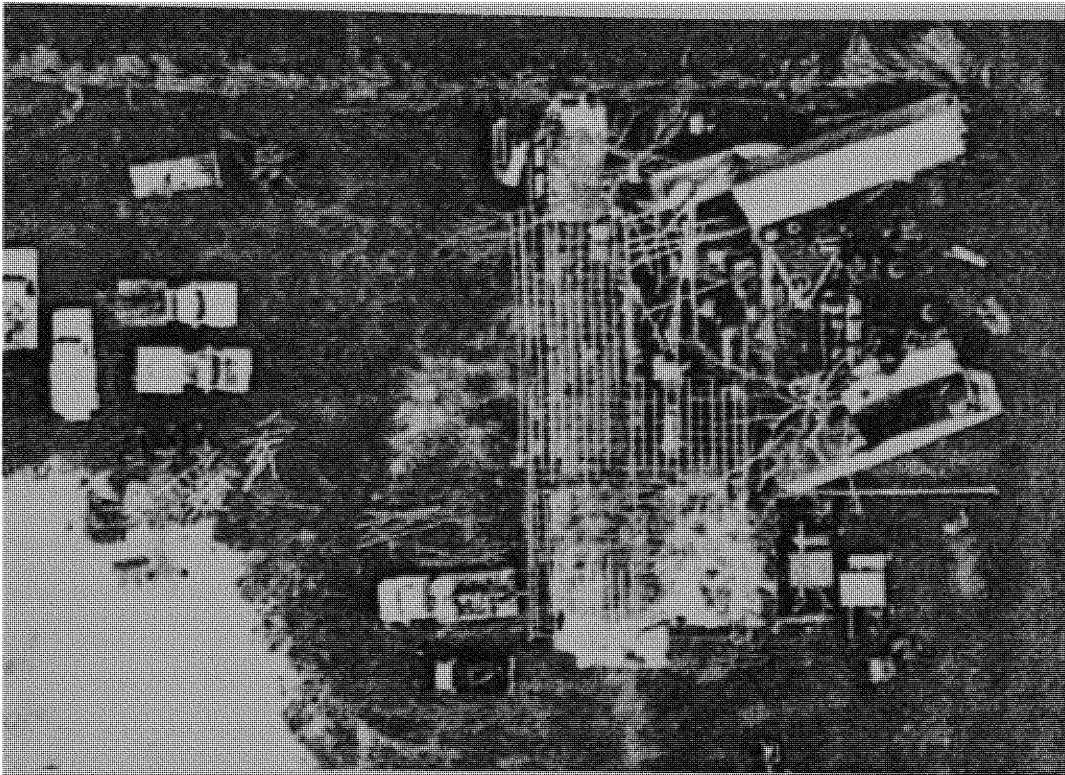
Figure 13.3. Damage due to overturning of heavy vehicles.

This figure illustrates major roof cover and sheathing damage. Once the sheathing was lost. The building envelope was effectively breached. Wind pressure was now exerted against the inside of the gable end-wall leading to possible failure. Once the wind managed to lift one layer of shingles tabs, the shingles acted as a sail, bending at the attachment and tearing it away. One of the major causes of the damage was due to overturning of the truck. In case of this particular structure the roof was subjected to wind forces from many directions.
